PRELIMINARY REPORT ON ACCIDENT AT TURØY, NEAR BERGEN, NORWAY ON 29 APRIL 2016, INVOLVING AIRBUS HELICOPTERS H225, LN-OJF OPERATED BY CHC HELIKOPTER SERVICE AS

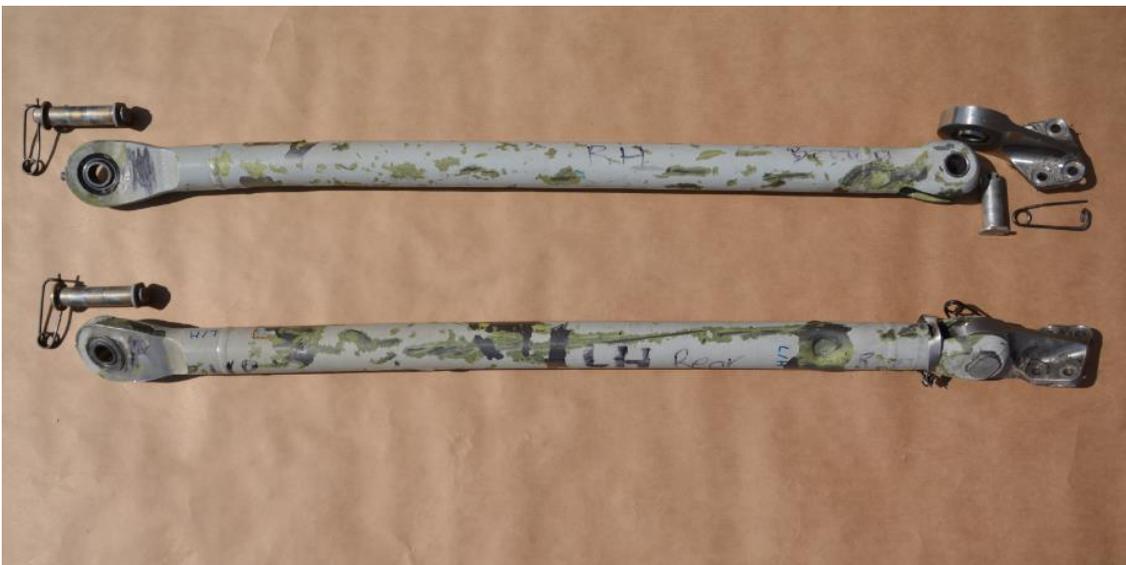
Figure 3: MGB Right and left hand aft suspension bars with attachment fittings. Photo: AIBN

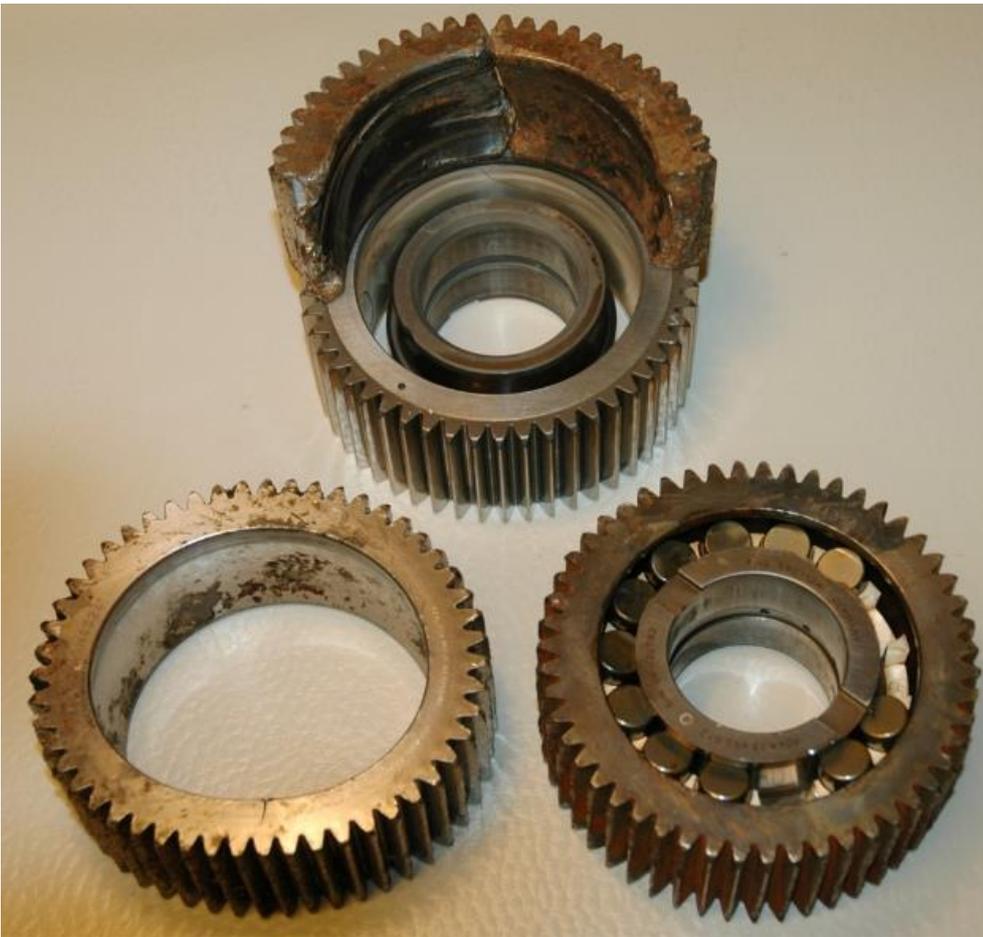
Figure 6: Parts from second stage planet gear. (The fractured gear is placed on top of a sample gear that was not involved in the accident.) Photo: AIBN
