# REPORT

AVIATION 2025/08

***Aviation accident at Reinsvoll Airfield in  
Innlandet county on 28 August 2023 with  
MLP Aviation LTD Christen Eagle II,  
LN-TBN***

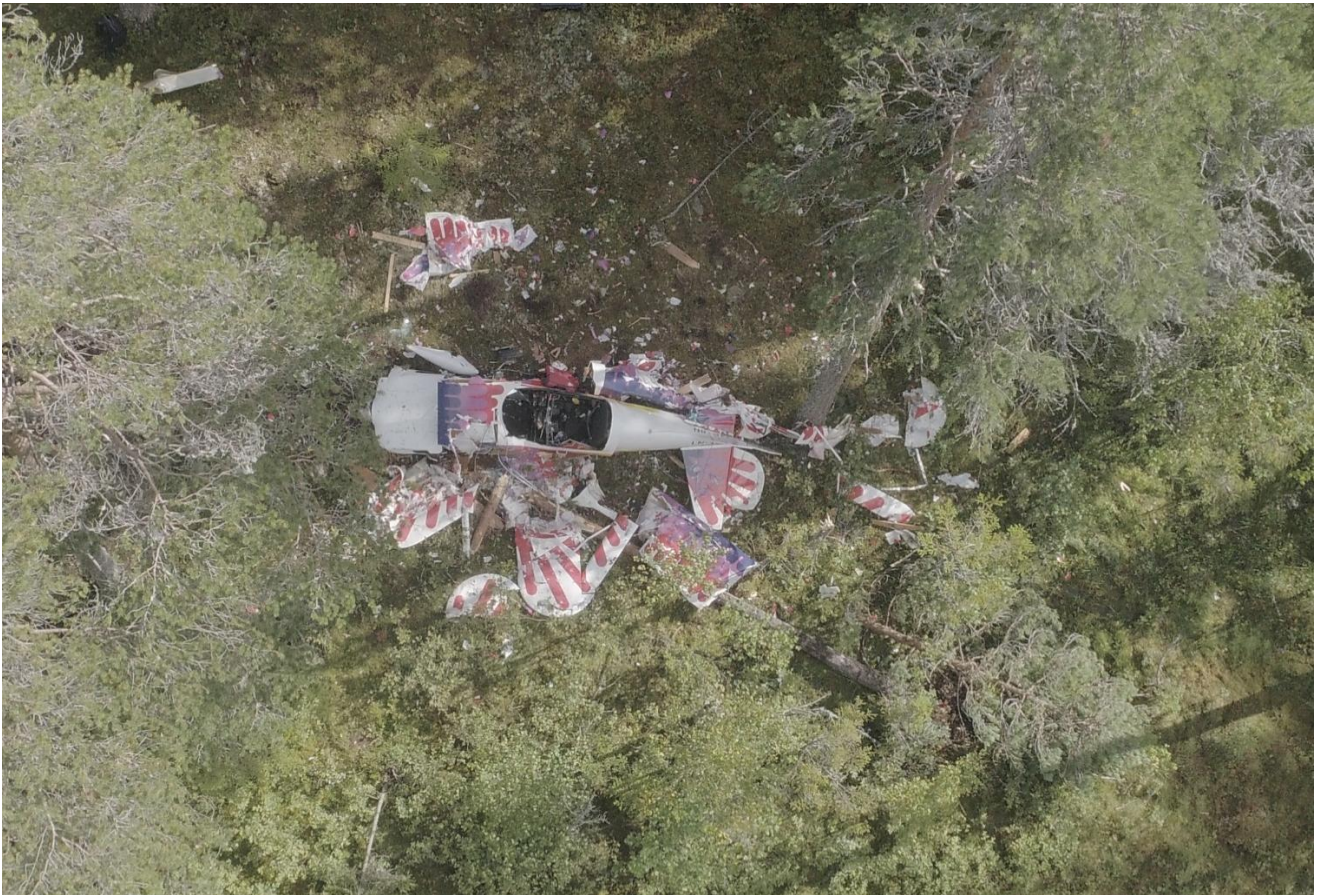
The aircraft was completely destroyed, and all parts were found within a small area (see Figure 4). For a more detailed description, see Sections 1.12 and 1.16.

*Figure 4: Overview of the accident site the day after the accident. The bodies of the deceased have been removed, and some parts of the wings have been repositioned. Photo: NSIA*

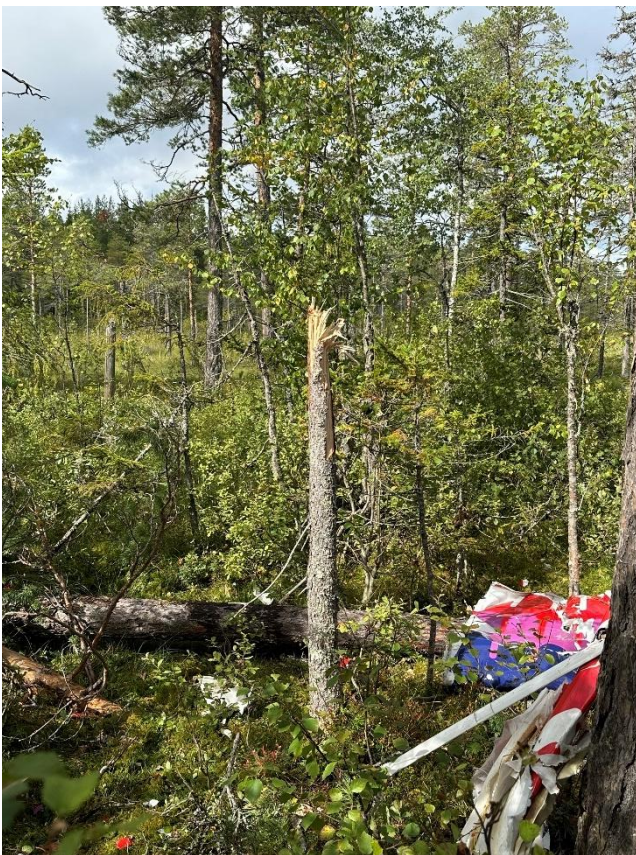
The aircraft cut through two smaller trees and left scratches and cuts in the bark of a larger tree. Tree number 1 was the smallest tree and was cut off just under two metres above the ground (see Figure 12). Tree number 2 was broken close to the root and cut into four pieces. The bottom section was 5.9 metres long and was lying across the ground from where the tree had been standing, pointing towards the left-hand side of the aircraft. The second-lowest section was approximately 0.8 metres long and was lying to the left of the aircraft. The second-highest section was approximately 1.3 metres long and was lying about 7–8 metres in front of the aircraft. The treetop had snapped backwards and was lying behind the aircraft. The total length of the tree was just under 13 metres. The centre cut through the tree appeared to run from the bottom upwards, seen from the aircraft's assumed direction of travel. The other two cuts through the tree were at an angle, with the lowest point on the tree's right-hand side (seen from the aircraft's assumed direction of travel).

Figure 12: Tree number 1. Photo: NSIA

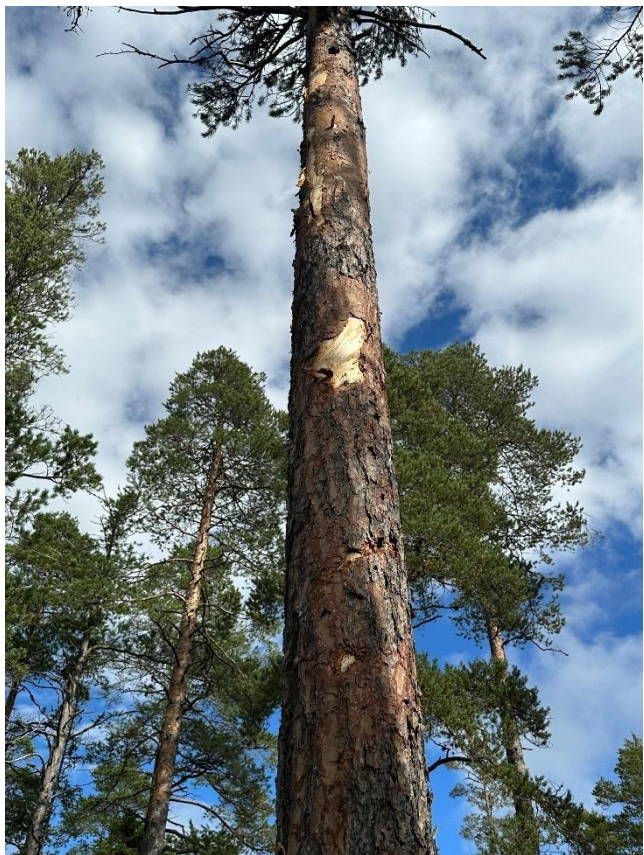
Tree number 3 stood directly behind where the aircraft tail was lying. The lower 5.5 meters of the tree had multiple scratches and cuts in the bark (see Figure 13).

Figure 13: Tree number 3. Photo: NSIA

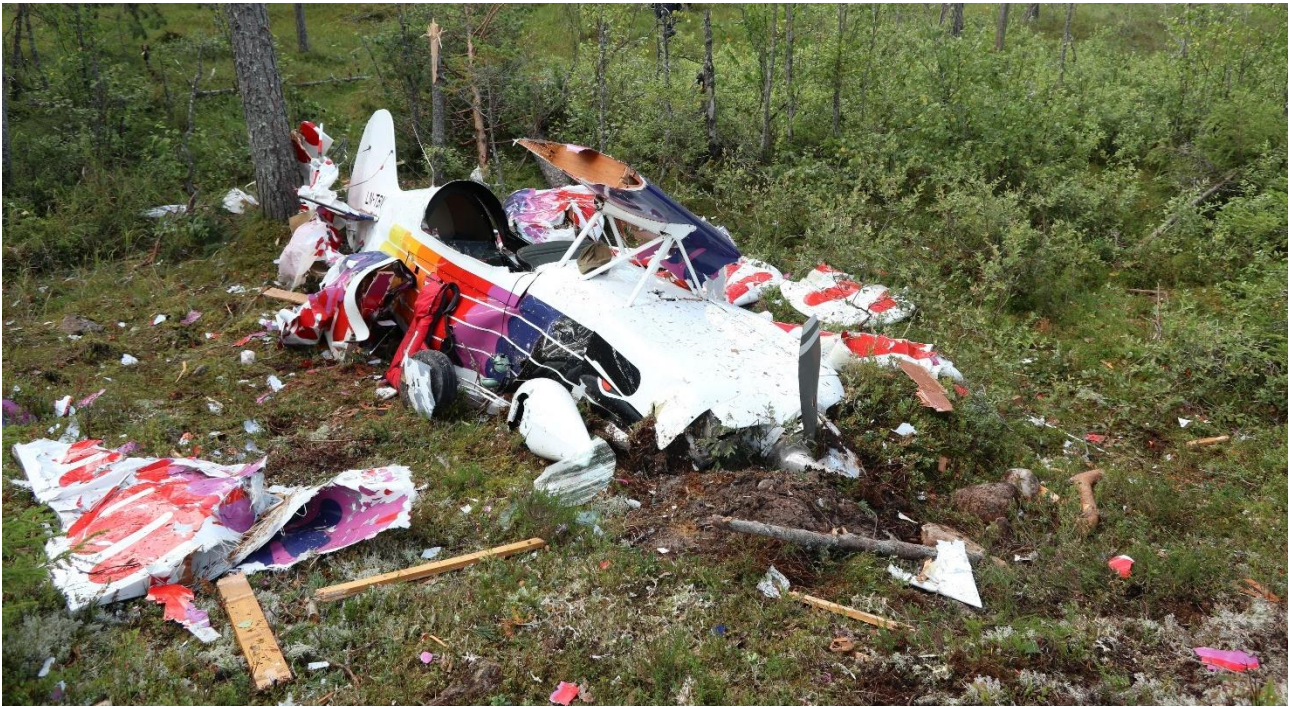
All parts of LN-TBN remained within a relatively small area at the accident site (see Figure 4 and Figure 14). The aircraft had come to rest against a small rise in the terrain. The lower part of the propeller spinner was in the ground resting against a rock on the right-hand side. One of the propeller blades was pointing straight up and looked relatively undamaged, with the exception of two small deformations on the front of the blade near the blade root. The second propeller blade was bent backwards beneath the aircraft. The nose of the aircraft was bent down slightly and pressed inwards, and the fuselage was slightly bent to the left. The acrylic glass in the canopy was shattered, while the canopy frame was in the locked position.

Figure 14: From the accident site. Photo: NSIA

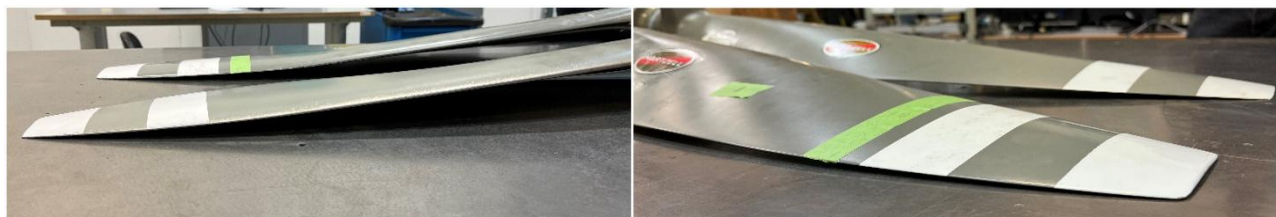
- The outer half of blade no. 1 was bent slightly forwards. With the exception of a couple of minor deformations on the front of the blade close to the blade root, there were no obvious signs of external damage.

Figure 15: Propeller blade no. 1 from LN-TBN (marked with green tape) placed next to a propeller blade of the same type shows that the outermost part of the blade is bent forwards. Photo: NSIA

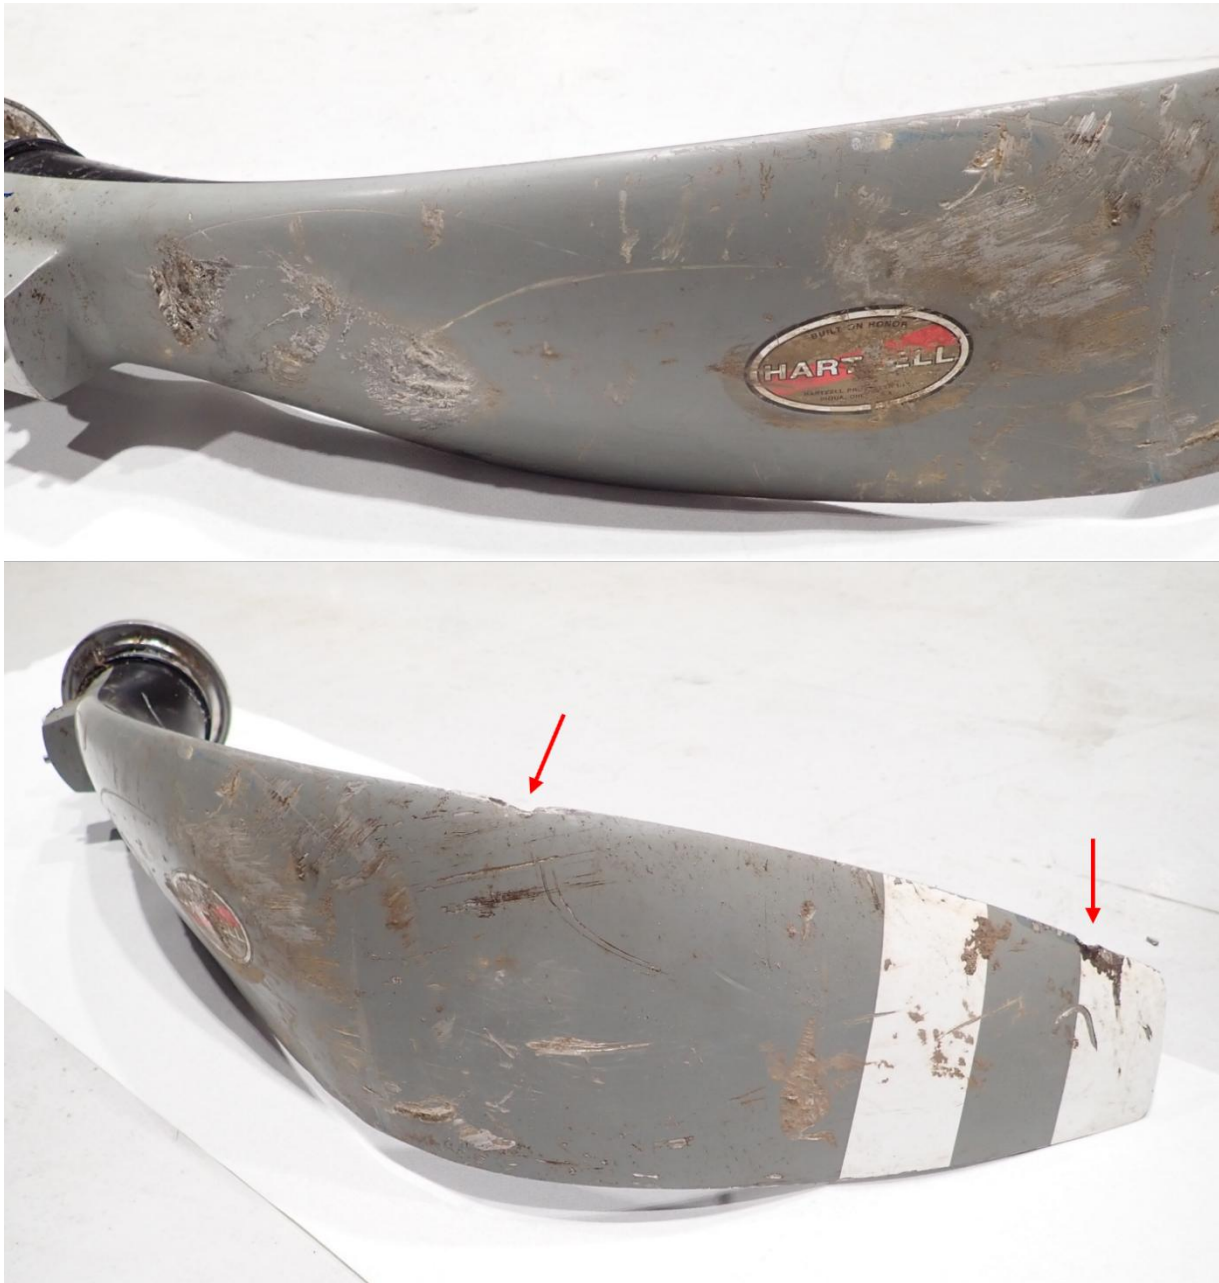
Figure 16: Propeller blade no. 2 from LN-TBN. Red arrows indicate two significant cuts in the leading edge of the blade. Photo: NSIA

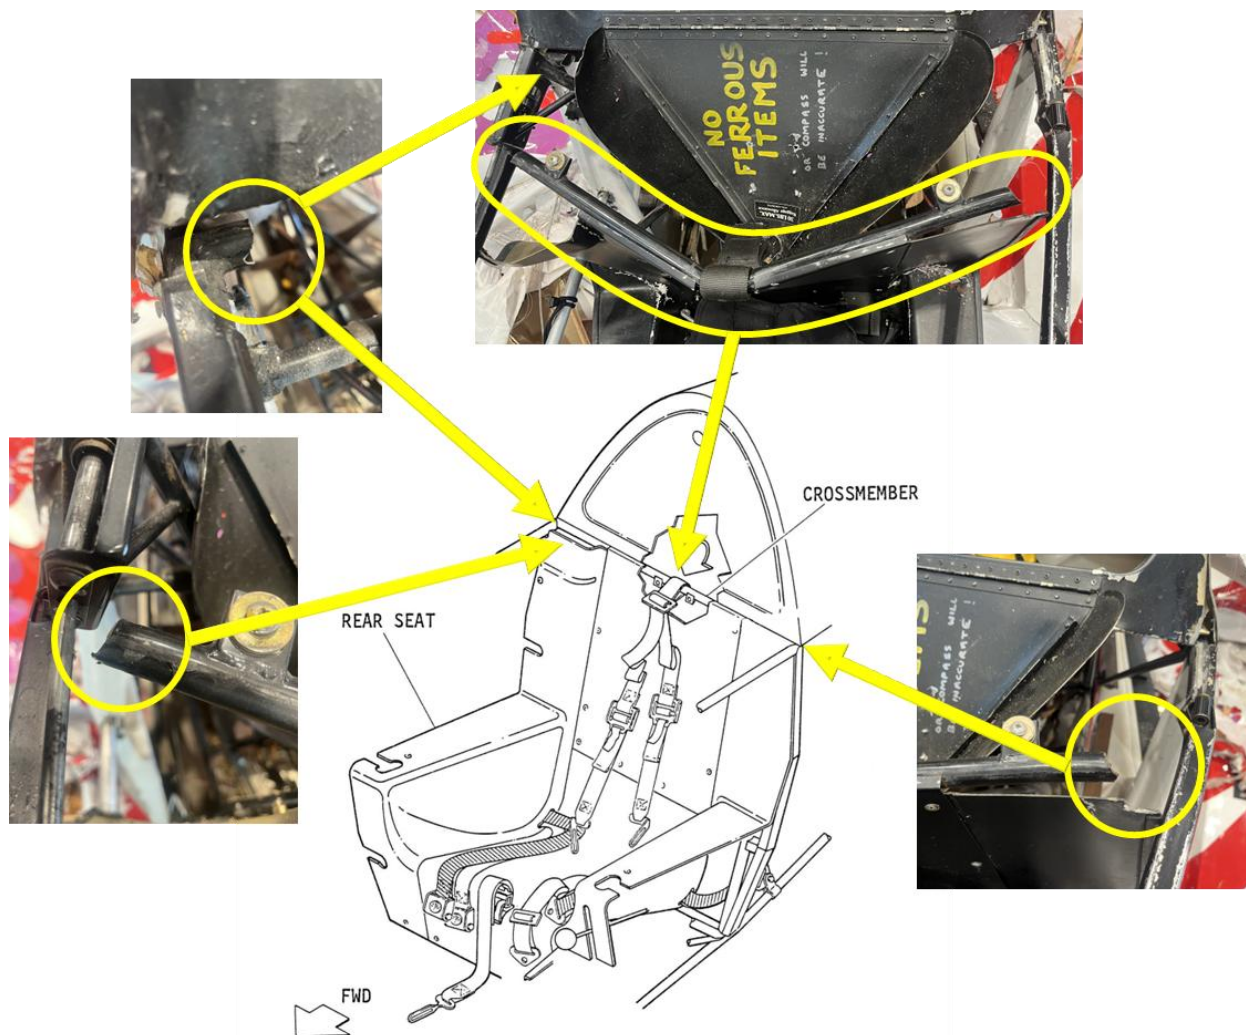
In the rear cockpit, the crossmember to which the shoulder harness was attached was bent forwards. The crossmember had also torn off near its attachment points to the upper longerons on both sides (see Figure 17).

Figure 17: Fracture in the attachment and bending of the crossmember for fastening the shoulder harness in the rear cockpit. Illustration: Christen Eagle. Photo: NSIA

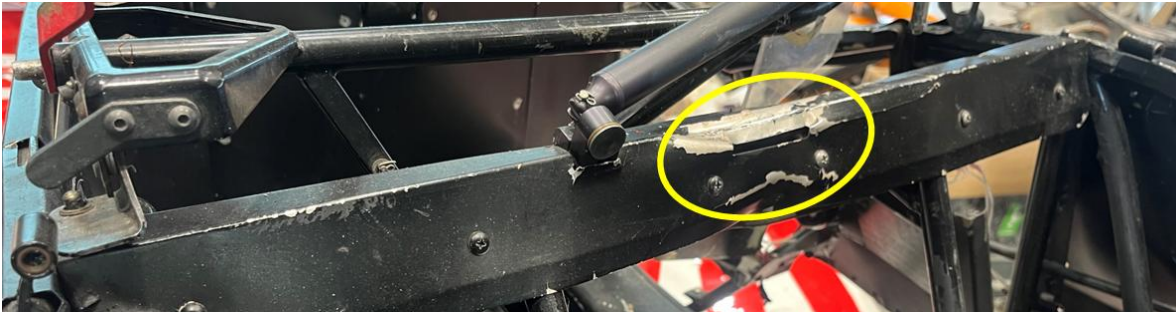
In the front cockpit, the shoulder harness was found to be loose, and there was no bending or damage to the crossmember to which the harness should have been attached. Above the crossmember was a bracket that concealed the crossmember itself. This had an oblong hole through which the harness should have been threaded (see Figure 18). The harness had no visible damage. Approximately 14 cm from the end of the harness there was a three-bar slide adjuster. The webbing should have been threaded back through the slide adjuster to lock the harness to the crossmember (see Figure 20).

Figure 18: Crossmember with overhead bracket, which the shoulder harness in the front seat should have been fastened through and around. Photo: NSIA

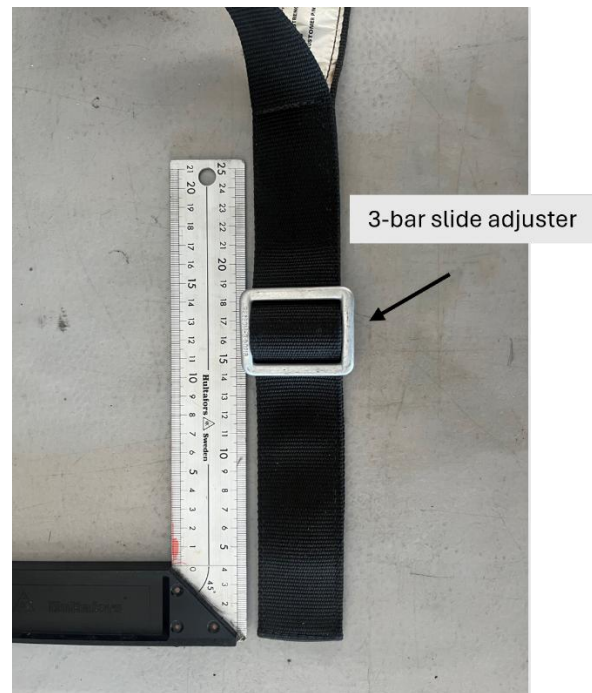
Figure 20: Slide adjuster for attaching the shoulder harness in the front seat. Photo: NSIA
