REPORT AVIATION 2025/10

Serious aviation incident on approach to Svolvær Airport Helle on 22 December 2022 involving a De Havilland Aircraft of Canada Limited DHC-8-103, LN-WIP, operated by Widerøe's Flyveselskap AS

Report on serious aviation incident

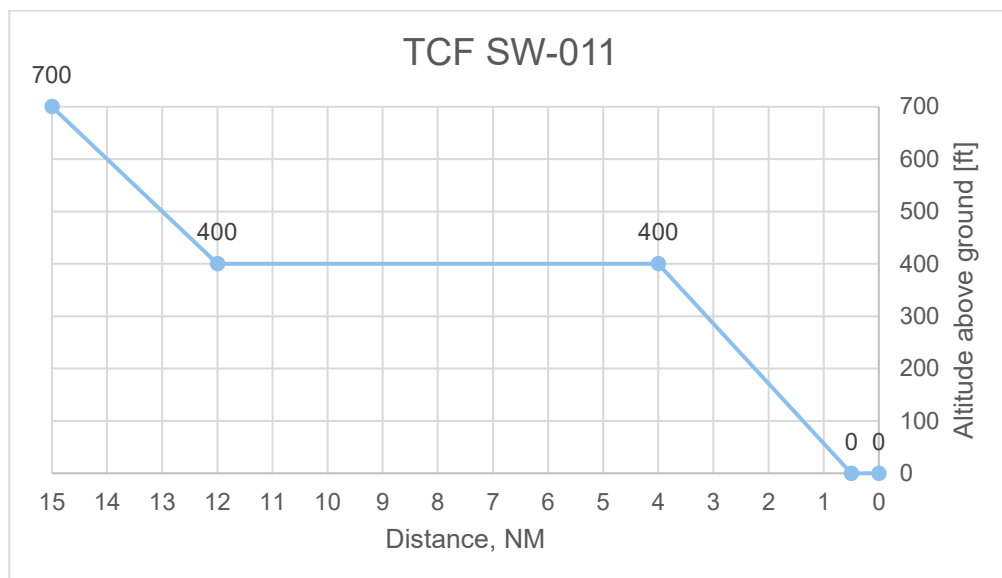
Software version SW-011 was installed on LN-WIP's EGPWS. In this version, the TCF profile starts with bias factor of 0.5 NM from the runway threshold and then followed the vertical profile as shown in Figure 4.

Figure 4: TCF for SW-011. Source: Honeywell EGPWS Pilots guide. Plot: NSIA

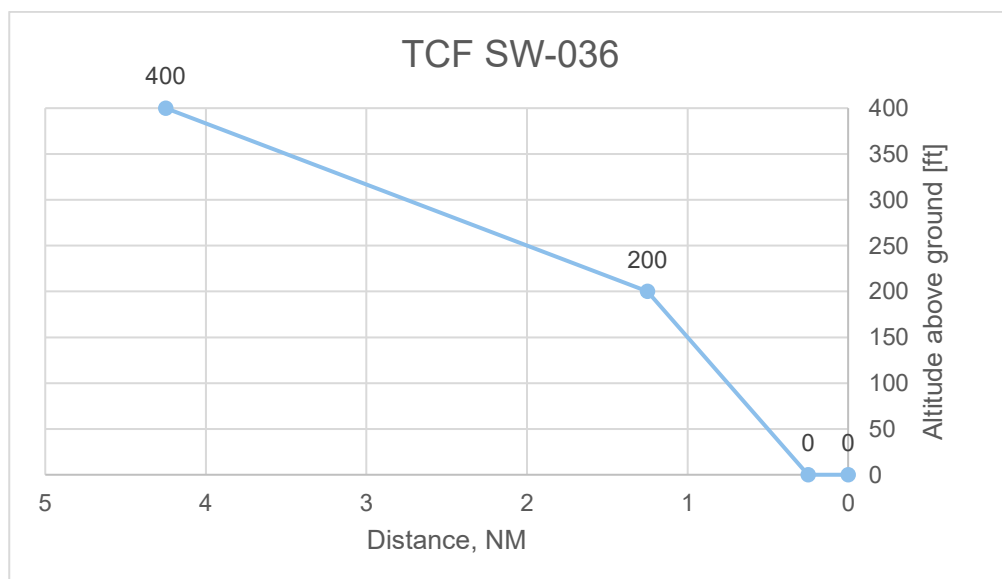
Honeywell had a more recent software version designated SW-036. In this version, the TCF profile started with a bias factor of 0.25 NM from the runway threshold and then follows the vertical profile as shown in Figure 5. However, this new software version was not available for the hardware version of EGPWS installed in LN-WIP and other similar aircraft in Widerøe's fleet at the time of the incident. EGPWS had thus been updated to the most recent software version available for the hardware installed.

Figure 5: TCF for SW-036. Source: Honeywell EGPWS Pilots guide. Plot: NSIA

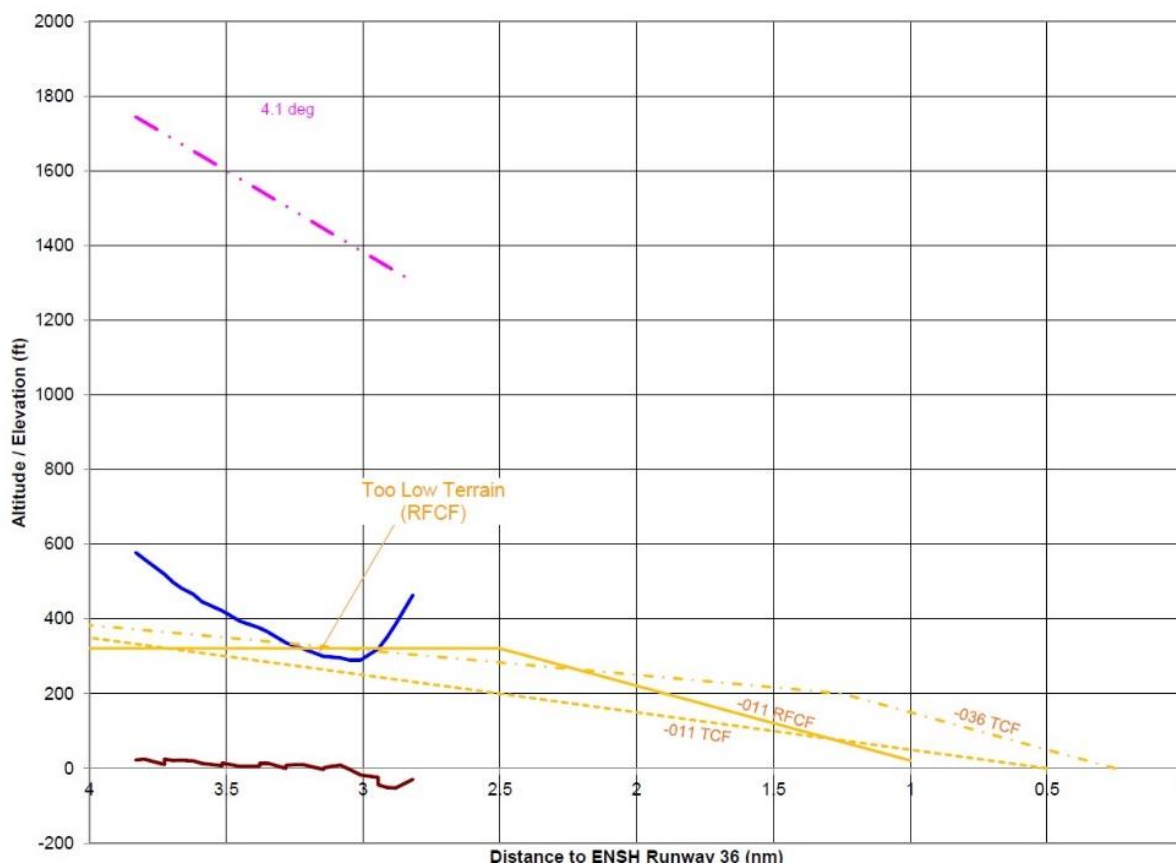
In the figure below, the following envelopes are drawn to illustrate their relationships:

- SW-011 RFCF
- SW-011 TCF
- SW-036 TCF (the envelope available in the latest software – requires a newer MK-VIII hardware)

Figure 7: Graphic representation of the EGPWS log. Source: Honeywell

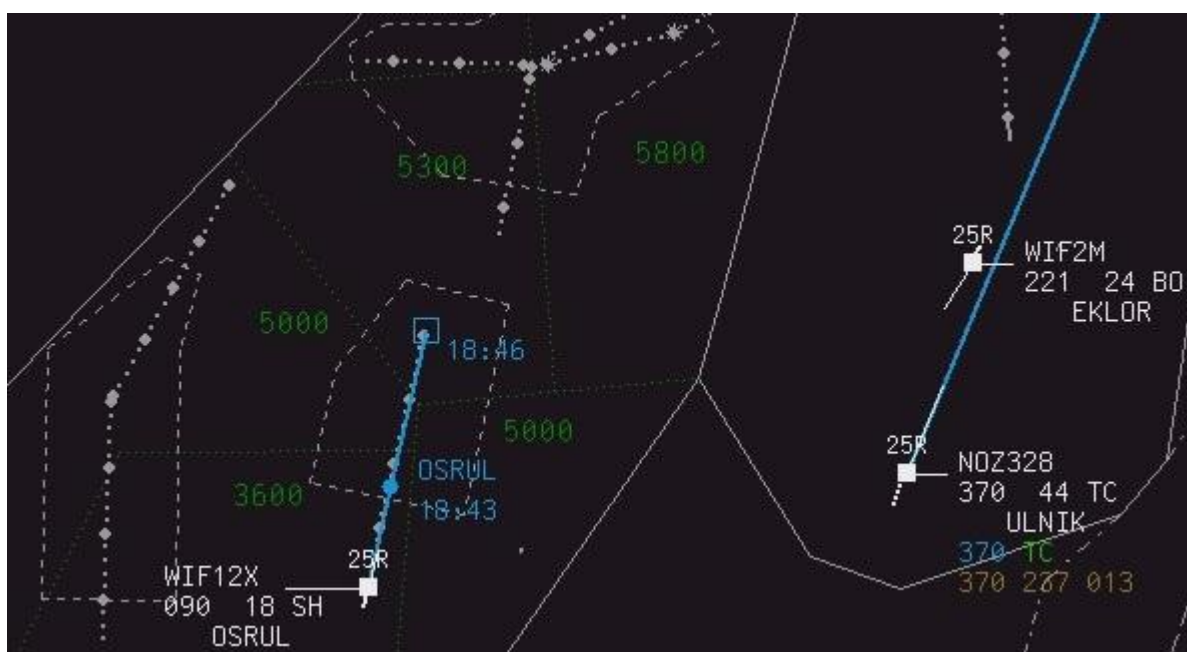
Figure 11 shows the NATCON radar display at 1840 hrs. WIF12X is at FL90 and has been cleared to OSRUL.

The aircraft at the bottom right of the screen, flight number NOZ328, has been interrogated about its pressure setting and responded with 1,013. This is evident from the flight information overview on the radar screen, where '013' indicates that QNH has been set to 1,013, i.e. standard pressure. This is consistent with NOZ328 flying at FL370. Neither the aircraft involved in the incident (WIF12X) nor another Widerøe aircraft (WIF2M) had a mode S transponder capable of transmitting their pressure setting. This means that their pressure settings were not visible to the air traffic controller.

Figure 11: NATCON radar image at 1840 hrs. Source: NSIA / Avinor ANS

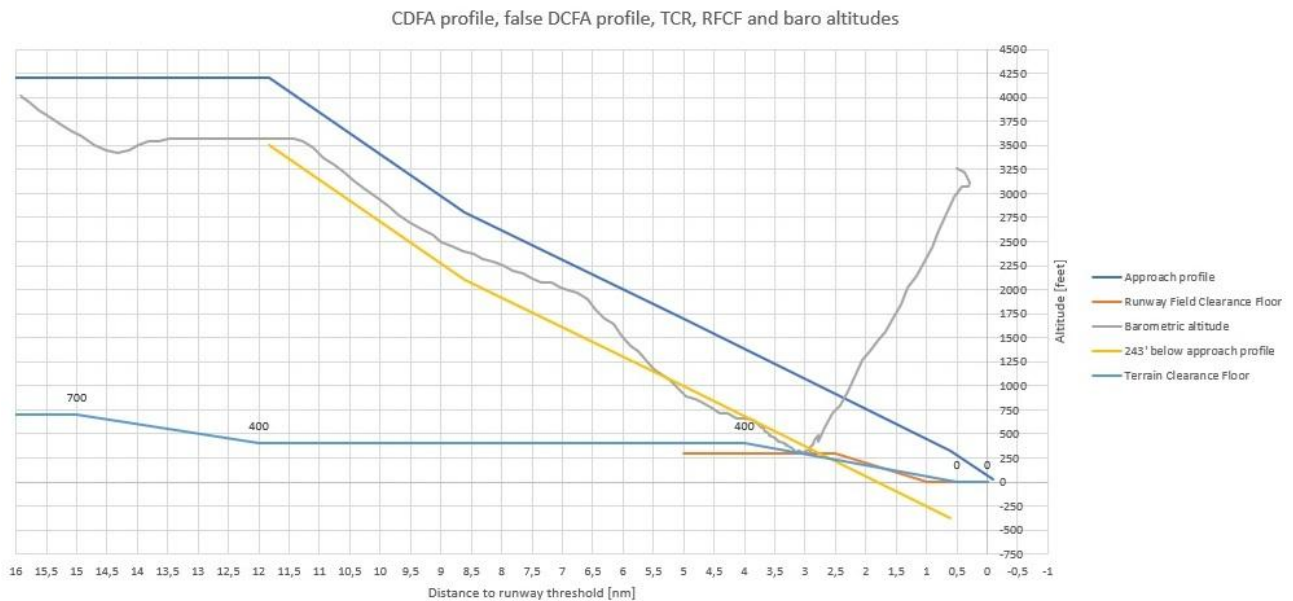
Figure 13: Graphic representation of EGPWS testing. Source: Widerøe. Plot: NSIA

The yellow line represents an approach flown 243 ft below the approach profile. As shown in the figure, the aircraft would not penetrate neither the TCF nor the RFCF profile during such an approach (243 ft lower), and the EGPWS system would not give any warning.
