PRELIMINARY REPORT ON ACCIDENT AT SOGNESAND, NORWAY ON 16 NOVEMBER 2020, INVOLVING AIRBUS HELICOPTERS AS 350 B3, LN- OAX OPERATED BY HELI TEAM AS

Date: 28.01.2021

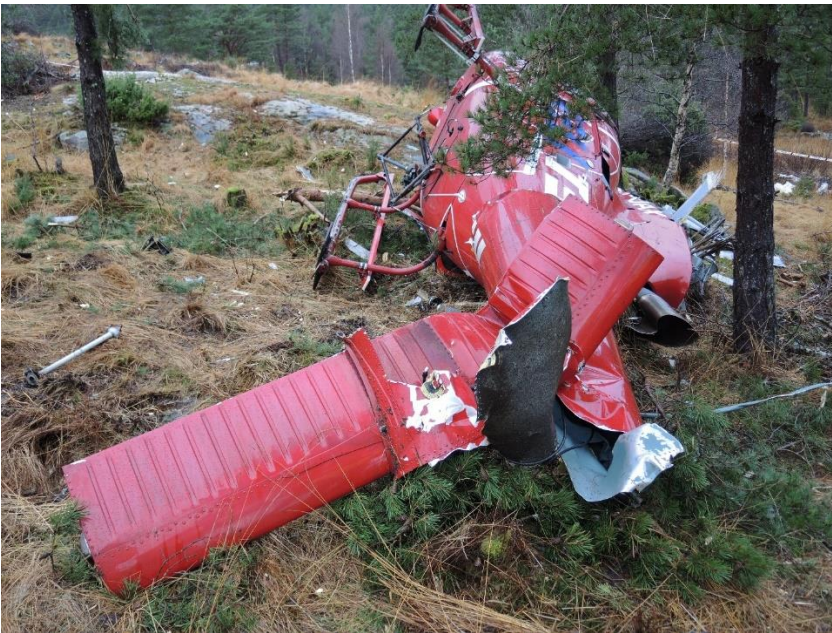
After very short time, the helicopter hit some trees before turning slightly to the left. The helicopter came to rest on the right-hand side about 33 meters from the location where the concrete should be delivered.

Helicopter at accident site laying on the right-hand side pointing towards north
