REPORT AVIATION 2023/08

Serious aviation incident during approach to Stavanger Airport Sola on 25 September 2020 involving a Sikorsky S-92A, LN-ONQ operated by Bristow Norway AS

Report on serious aviation incident

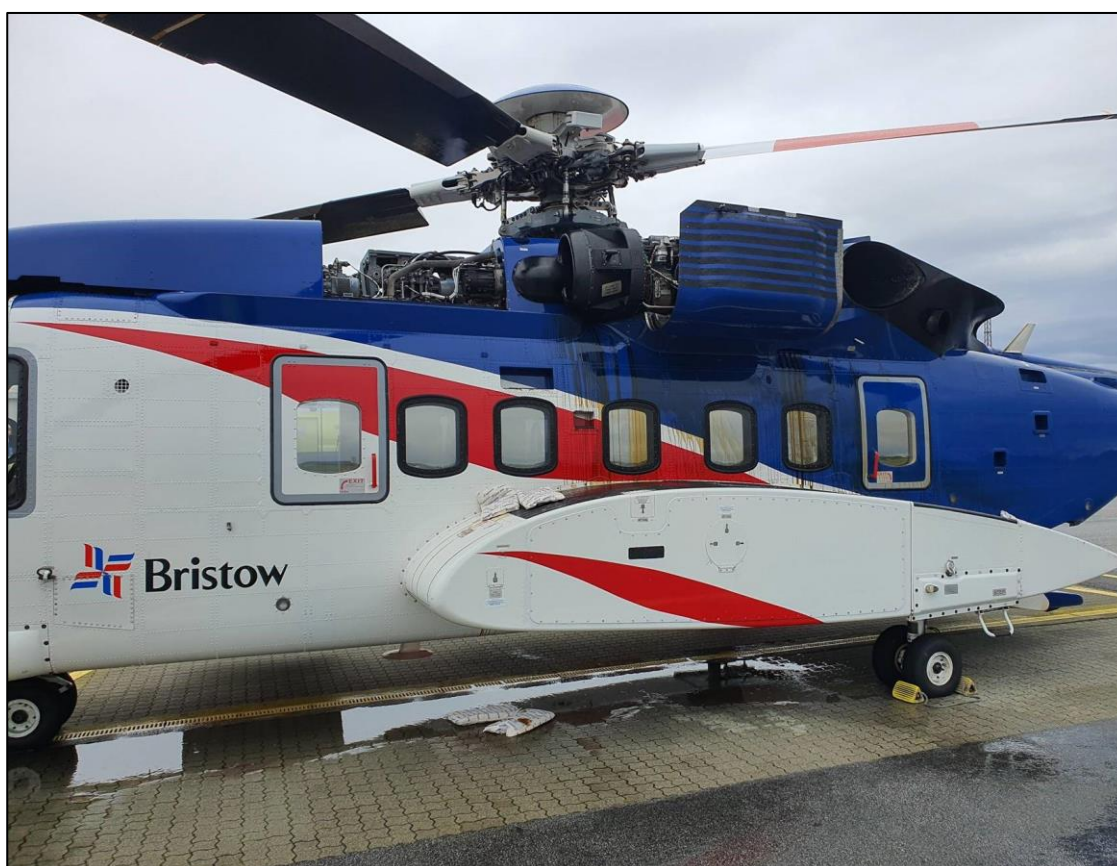
Once the helicopter was parked, it was observed that oil from the area near the left engine was running down the exterior of the fuselage along the cabin (see Figure 3). The cover plates in the area were opened, and personnel from the fire and rescue service measured temperatures close to 250°C on the outside of the left main gearbox's input module. There was smoke, but no fire. A check of the oil level in the main gearbox showed that approximately 4 litres were missing.

Figure 3: LN-ONQ shortly after landing. Visible oil spill on the left side of the fuselage and open cover plates around the left engine and main gearbox. Photo: Bristow Norway / NSIA

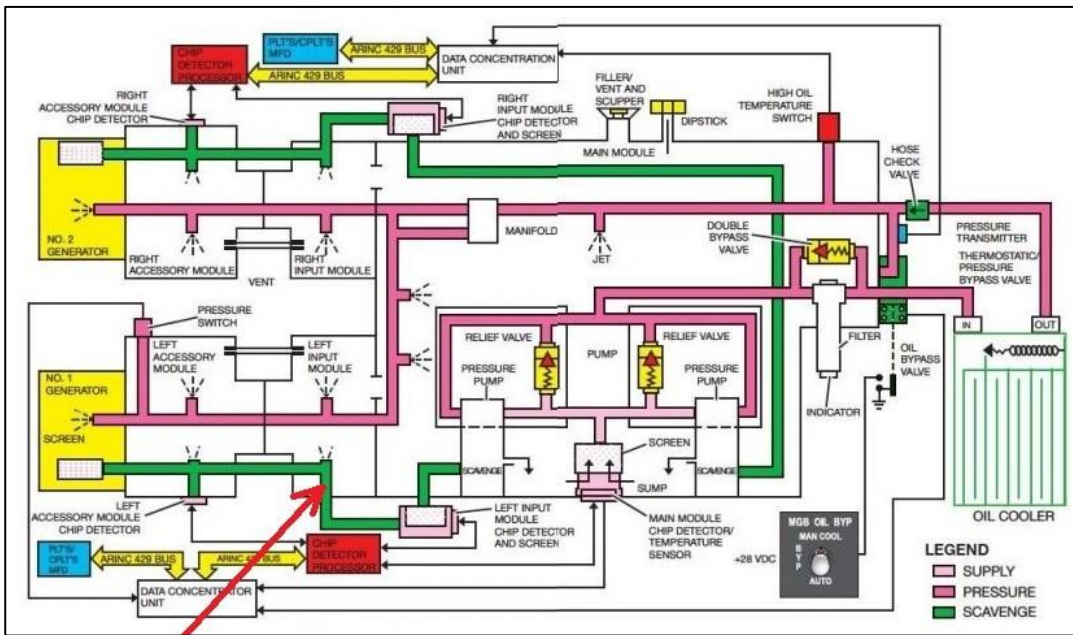
Figure 7: Schematic diagram of the oil system for the main gearbox. The place where the washer got stuck is indicated with a red arrow. Source: Sikorsky Aircraft Corporation/NSIA

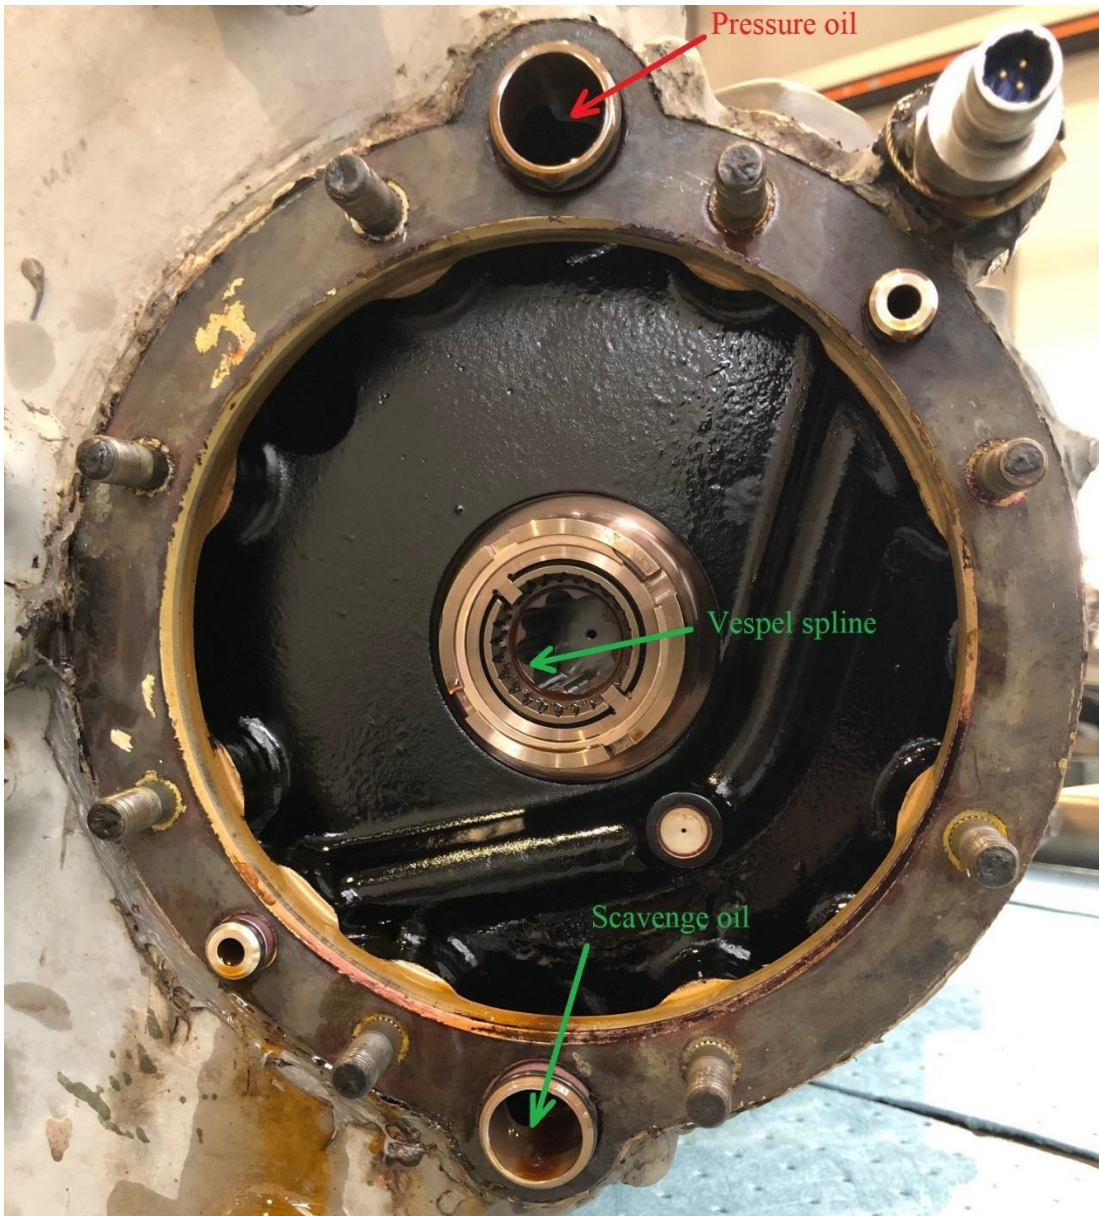
A Vespel spline is located between the input module and the generator (see Figure 9) and must be replaced every 3,000 flight hours. To replace the Vespel spline, the generator must be disconnected. Disconnection and reconnection of the generator must be done in accordance with Aircraft Maintenance Manual (AMM) 24-21-01-900-002.¹⁰ During this work, eight nuts and their washers (part number MS20002-6) must be unscrewed and later refitted (see Figure 9).

Figure 9: The flange of the accessory module where the generator was connected. The eight stud bolts holding the generator can be seen around the flange. The generator is fixed with the corresponding washer and nut on each of the stud bolts. Photo: NSIA

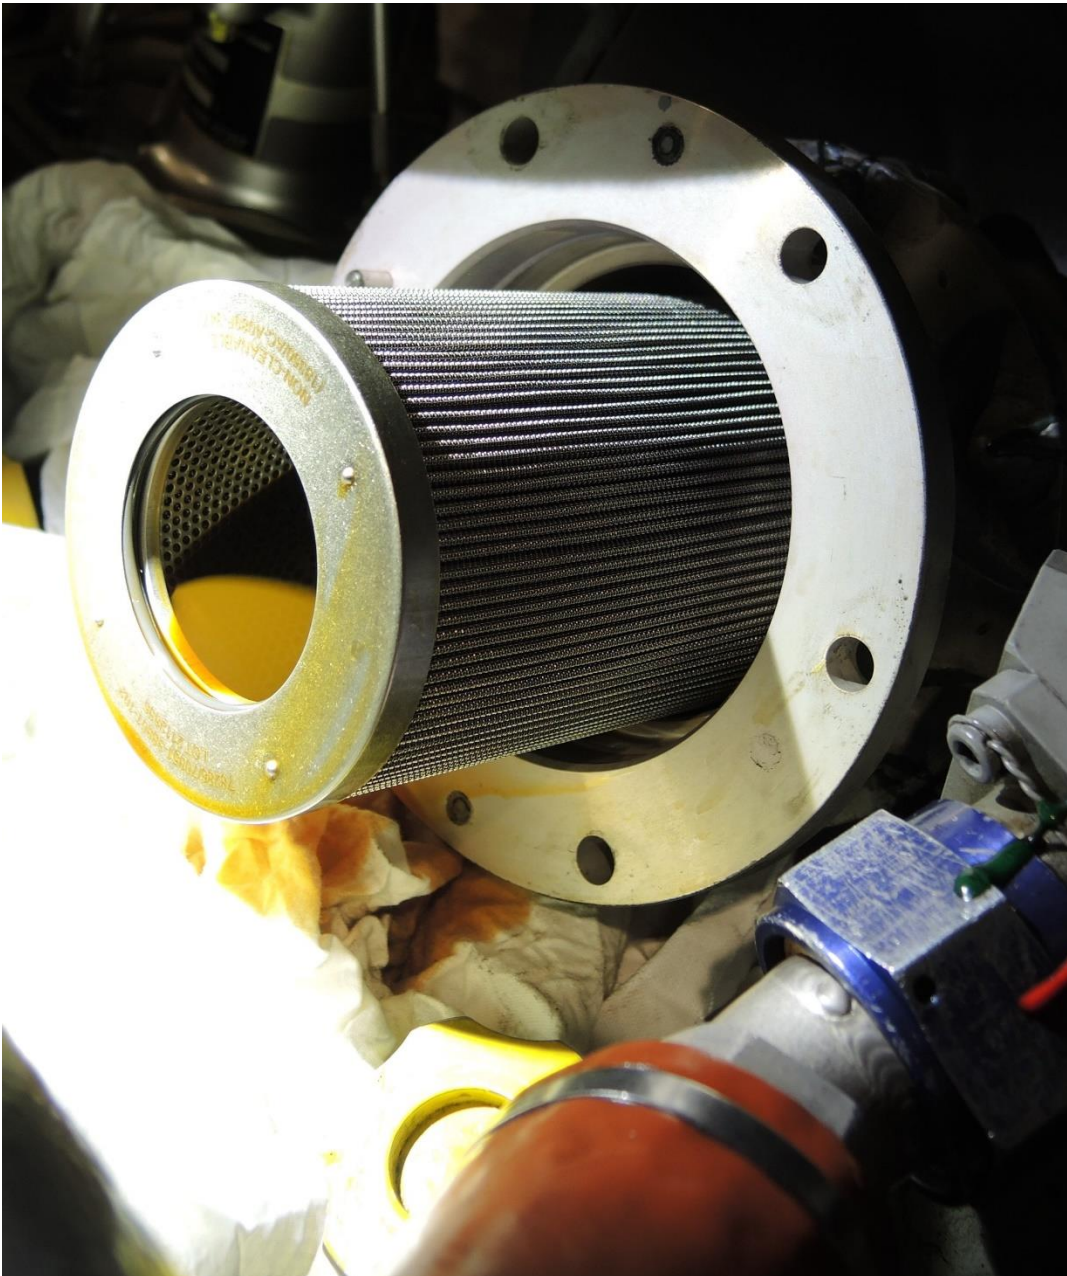
- The main gearbox's oil filter was opened and examined, and grey-brown oil was found inside the filter element. The technicians considered this to be abnormal, as the oil usually flows through the filter element and back to the gearbox (see Figure 11). No visible particle contamination was found in the two filter elements that together make up the filter.

Figure 11: The oil filter after the filter housing had been removed. Brown oil can be seen inside the filter element. Photo: NSIA

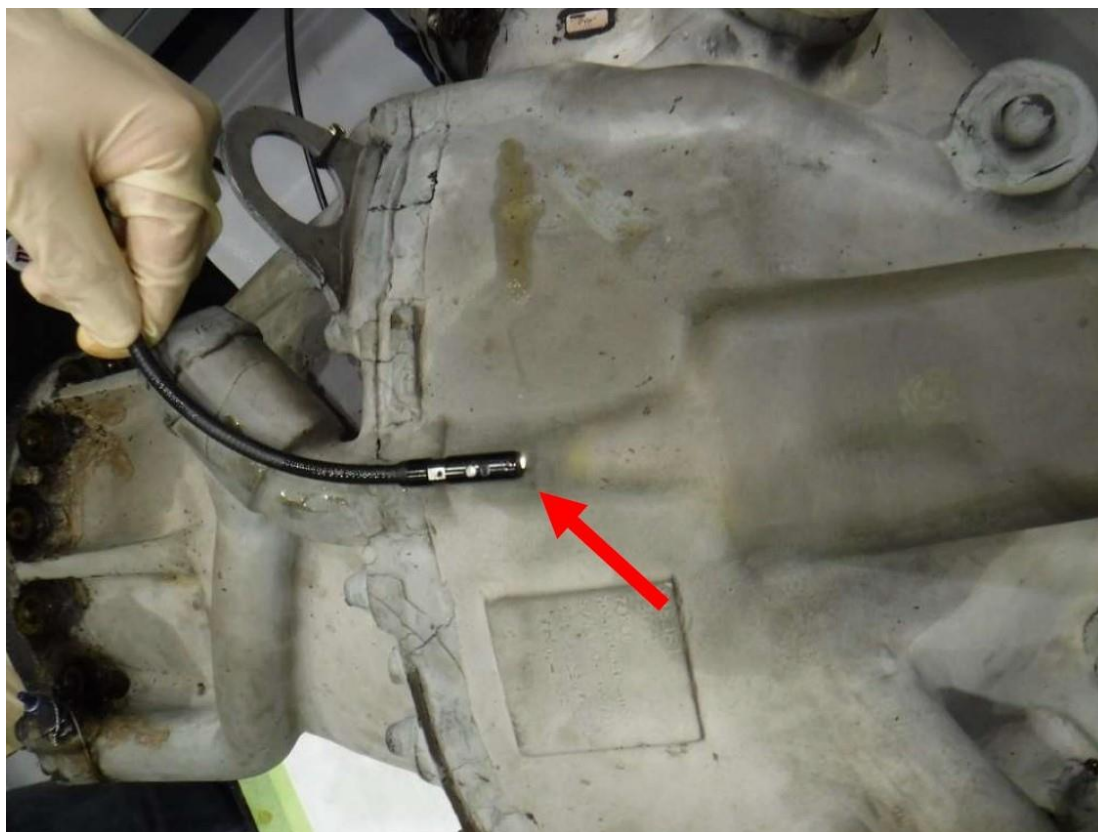
- The unit was then examined internally with a borescope (peephole inspection). That was when a washer was observed in the input module's scavenge oil passageway. The position of the washer is illustrated in Figure 12. No other foreign objects were found inside the parts that could be accessed with a borescope.

Figure 12: Left input module seen from below. The connection for the main gearbox module can be seen on the left side of the photo. The end of the borescope (the flexible inspection equipment) is laid over the passageway that was followed into the washer. The red arrow indicates where the washer was found. Photo: NTSB/NSIA

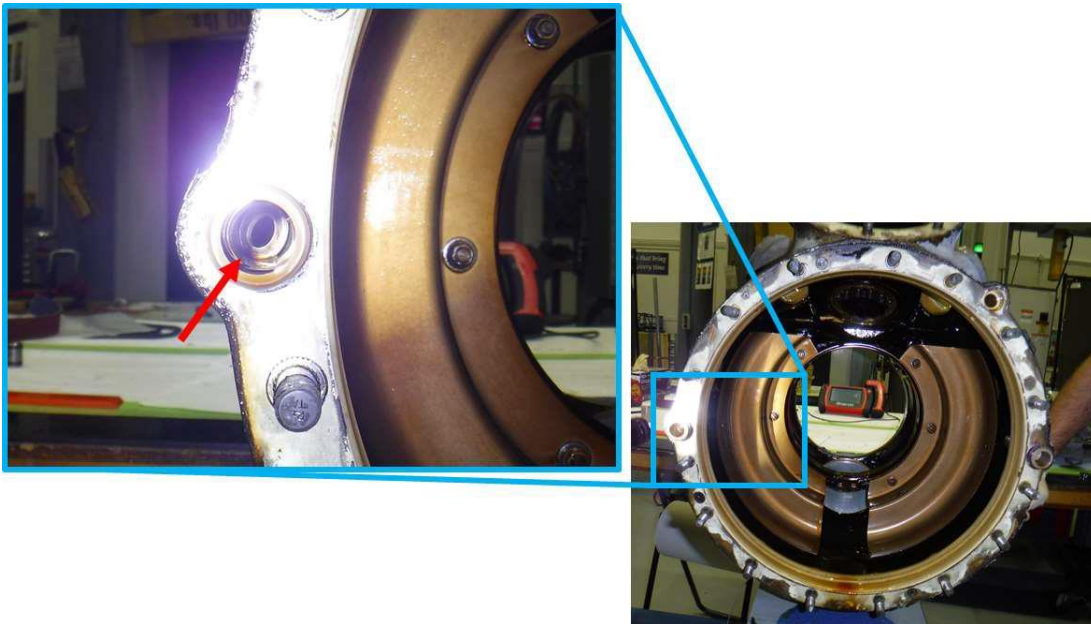
Figure 13: The washer as it was found in the scavenge oil passageway after the input module had been disassembled. The unit is photographed lying on its side. When the module is installed in the helicopter, the passageway is at the lower end of the unit.

The heat development and oil leakage in the main gearbox occurred as a result of a metal washer that had entered a scavenge oil passageway in the left input module and become jammed. This caused a substantial narrowing of the passageway. The NSIA believes it is likely that the washer entered the module in connection with maintenance and via the openings that are exposed when the generator is disconnected from the flange on the accessory module. The NSIA has not been able to establish when the washer entered the gearbox. The last maintenance where the washer may have entered was 487:35 flight hours before the incident. The NSIA therefore considers that the washer has been in the main gearbox for at least that long. The investigation has shown that Bristow has a potential for improvement in keeping track of consumables.

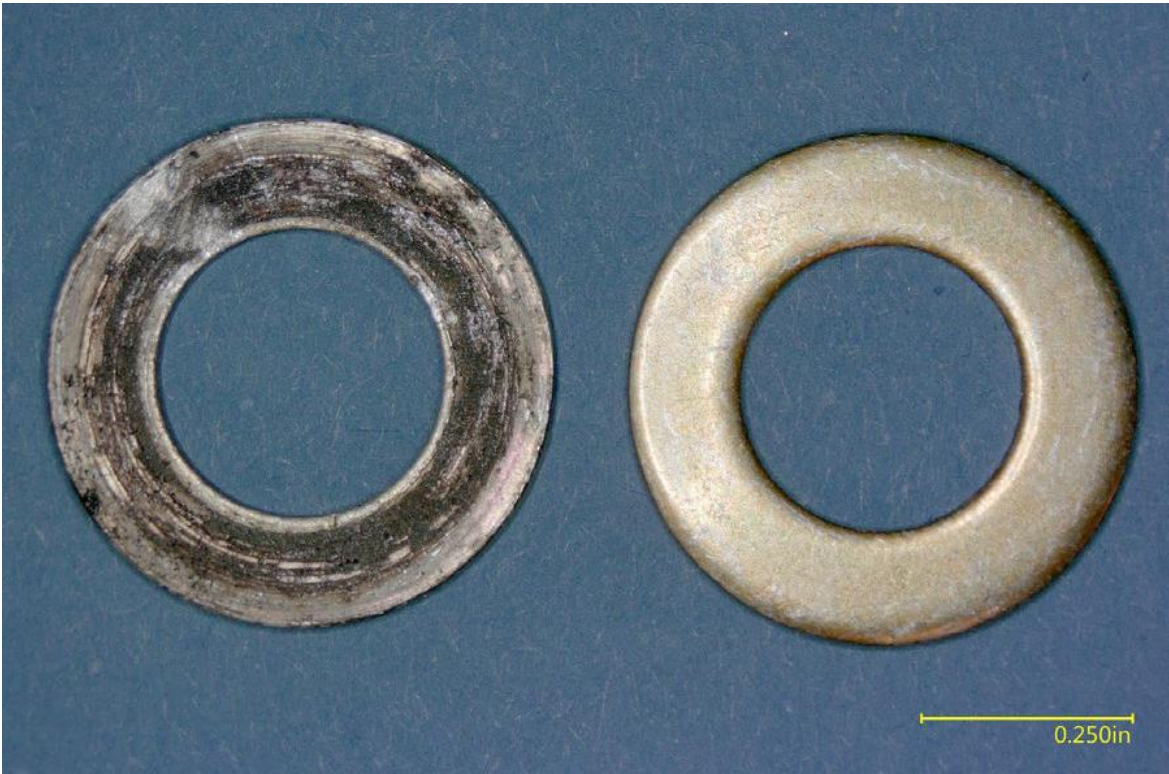
Based on measurements and knowledge of washers used on the gearbox, the washer was assumed to be of type MS20002-6. The washer found in the main gearbox was compared with a reference specimen (see Figure 14 and Figure 15). A test conducted with an X-ray fluorescence spectroscopy (XRF) alloy analyser showed that both washers were essentially made of iron (Fe) with a surface of cadmium (Cd). The reference washer had a higher content of iron, which could indicate that some of the surface coating on the washer found in the return oil passageway had been worn away. Circular grooves and missing cadmium indicated that the washer had previously been mounted.

Figure 14: The washer found in the main gearbox on the left, and the reference washer on the right. Photo: NTSB/NSIA

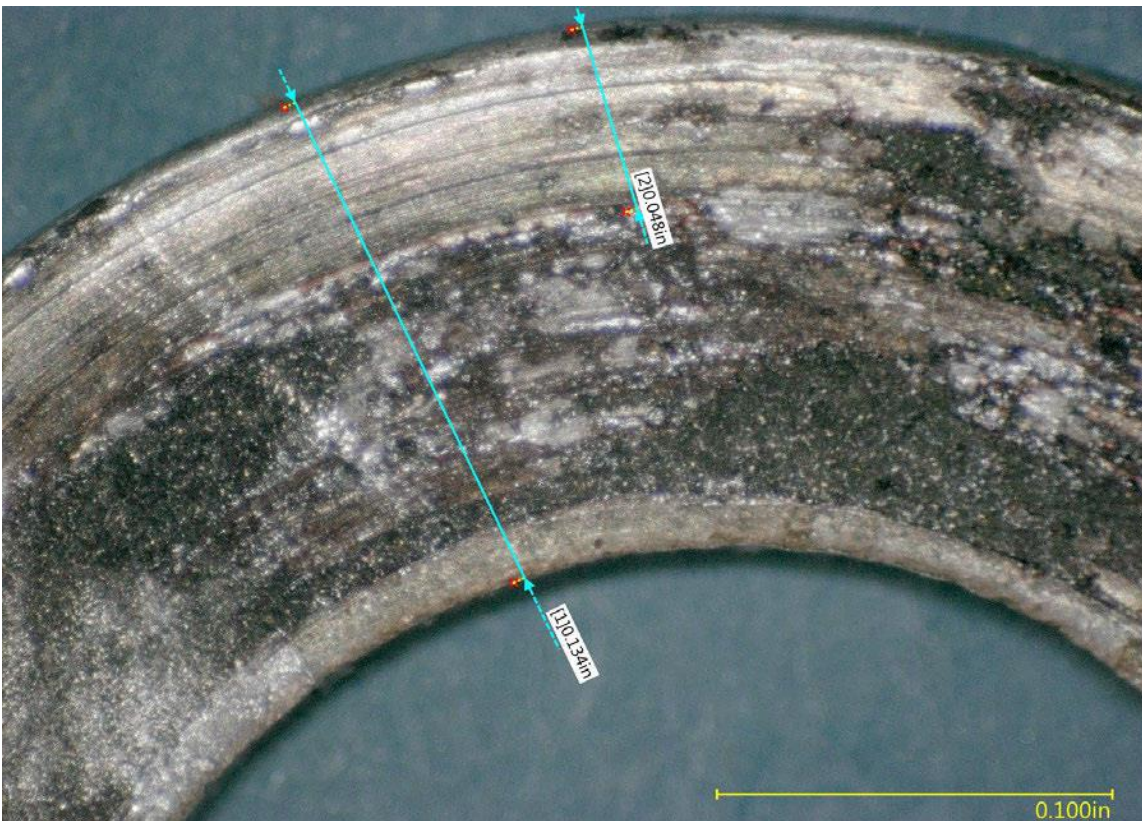
Figure 15: Detail photo of the washer found in the main gearbox. Circular grooves and missing cadmium indicate that the disc has previously been mounted. Photo: NTSB/NSIA

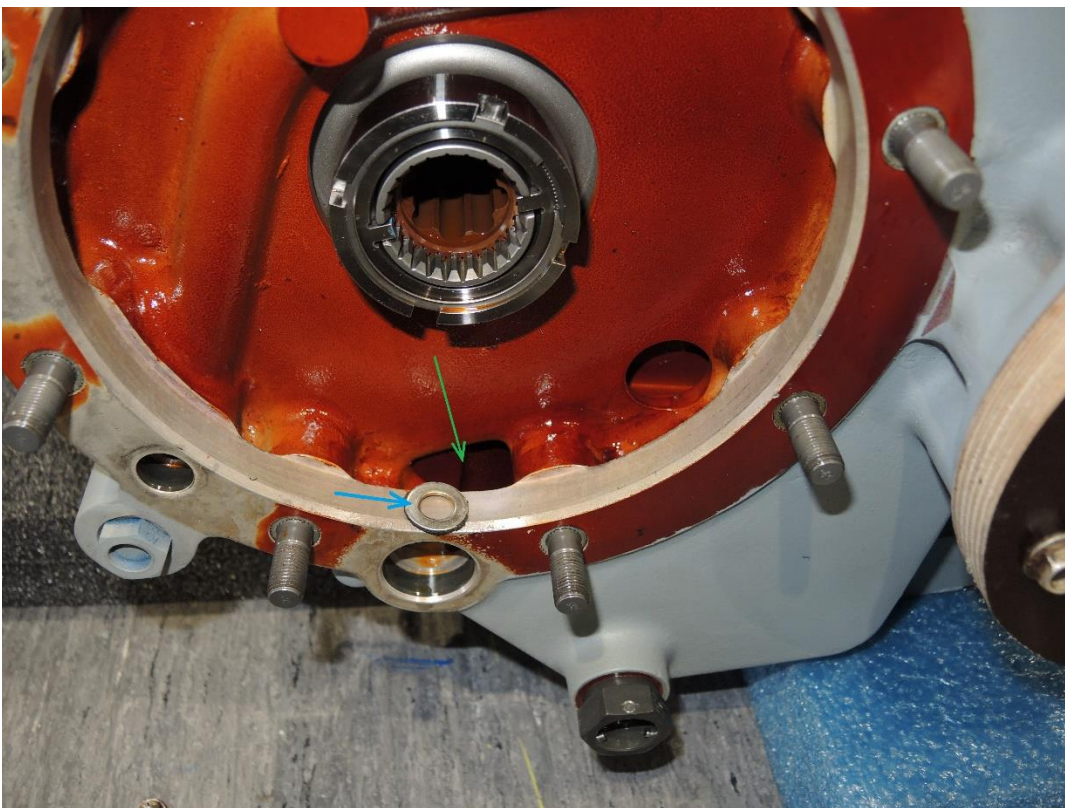
During the initial investigation of LN-ONQ at Bristow Norway, the NSIA observed small loose metal washers lying on a work table. None of the employees who were present could explain where the washers belonged. The NSIA believes that it is important to reduce the risk of FOD as much as possible, and that it was possible at the time in question to have better control over the relevant small parts.

Figure 16: The flange of the accessory module. The blue arrow points to a washer of the MS20002-6 type, and the green arrow points to an opening through which the washer could fall into the accessory module. Photo: NSIA

Following the incident, the helicopter operator has introduced several FOD preventive measures to avoid similar incidents in the future, including the establishment of a FOD policy and program adapted to the maintenance organization as well as the establishment of instructions for consistent practice to cover exposed areas during maintenance in addition to the education and training of personnel.
