PRELIMINARY REPORT AUGUST 2024

ACCIDENT IN THE SEA VEST OF SOTRA, VESTLAND COUNTY, NORWAY 28 FEBRUARY 2024 WITH SIKORSKY S-92A, LN-OIJ, OPERATED BY BRISTOW NORWAY AS

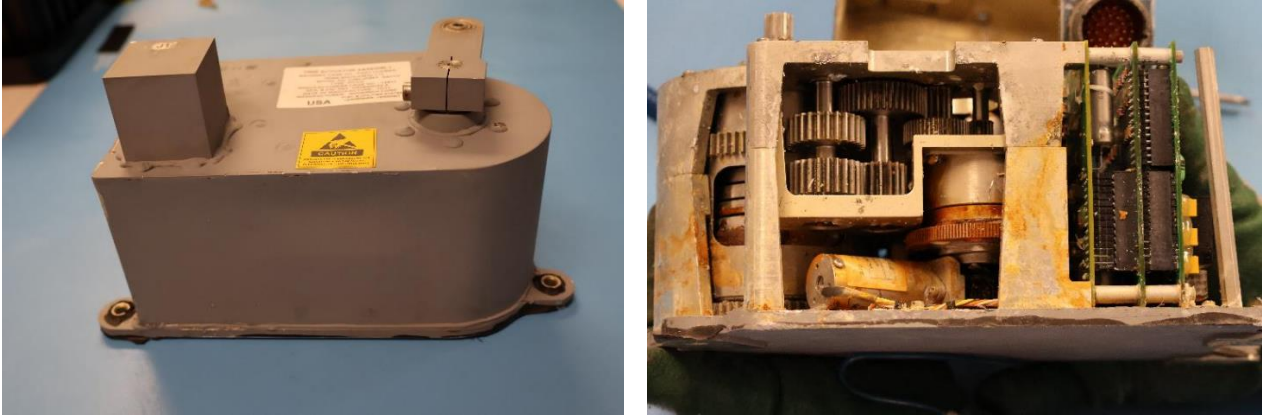
After thorough investigation in cooperation with the manufacturer of the trim servo system and together with both NTSB and Sikorsky a fault was found on one of the three circuit boards in the pitch trim servo, see fig. 2 and 3. This fault appears to have a potential of explaining the helicopter movement seen in the recorded data. A total of 12 circuit boards were tested, three from each of the four trim servos. Two circuit boards had physical damage and failed during tests. No other faults were found on the remaining 9 circuit boards. The fault in the pitch trim servo is still under investigation.

Figure 2: The pitch trim servo as found and opened showing circuit boards. Photo: Collins Aerospace/NSIA

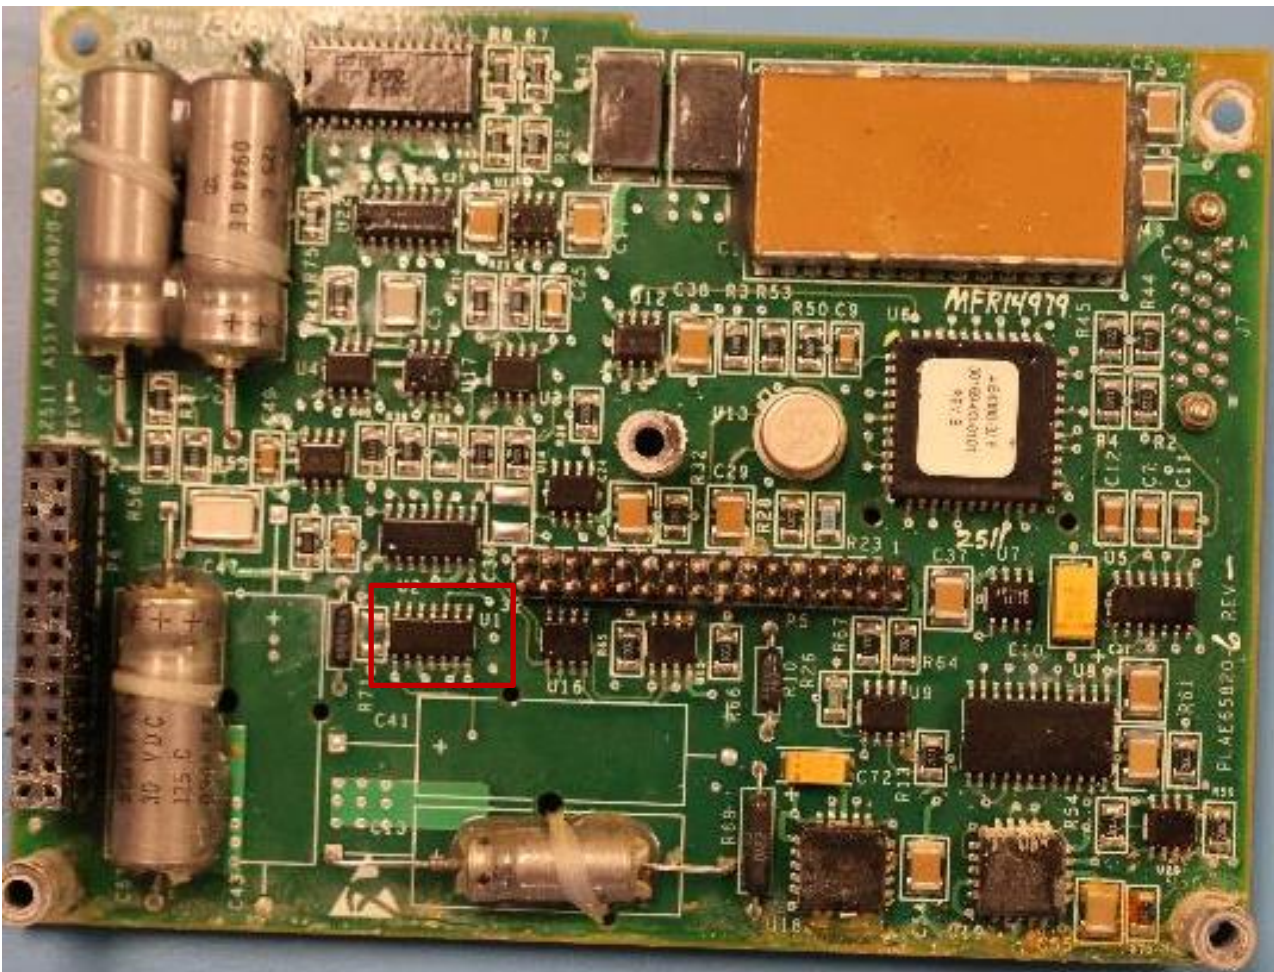
Figure 3: The circuit board with a component found to have failed highlighted in red. Photo: Collins Aerospace/NSIA
