C.A.P. 182

Report of the Royal Norwegian Commission
for the
Investigation of Civil Aircraft Accidents
on the
Accident to Viking G-AHPM near Stavanger,
Norway on 9th August, 1961

Report on the Investigation
of
The Accident to Cunard Eagle Airways Ltd.
Viking Aircraft G-AHPM
near
Stavanger Airport, Sola, Norway
on 9th August, 1961.

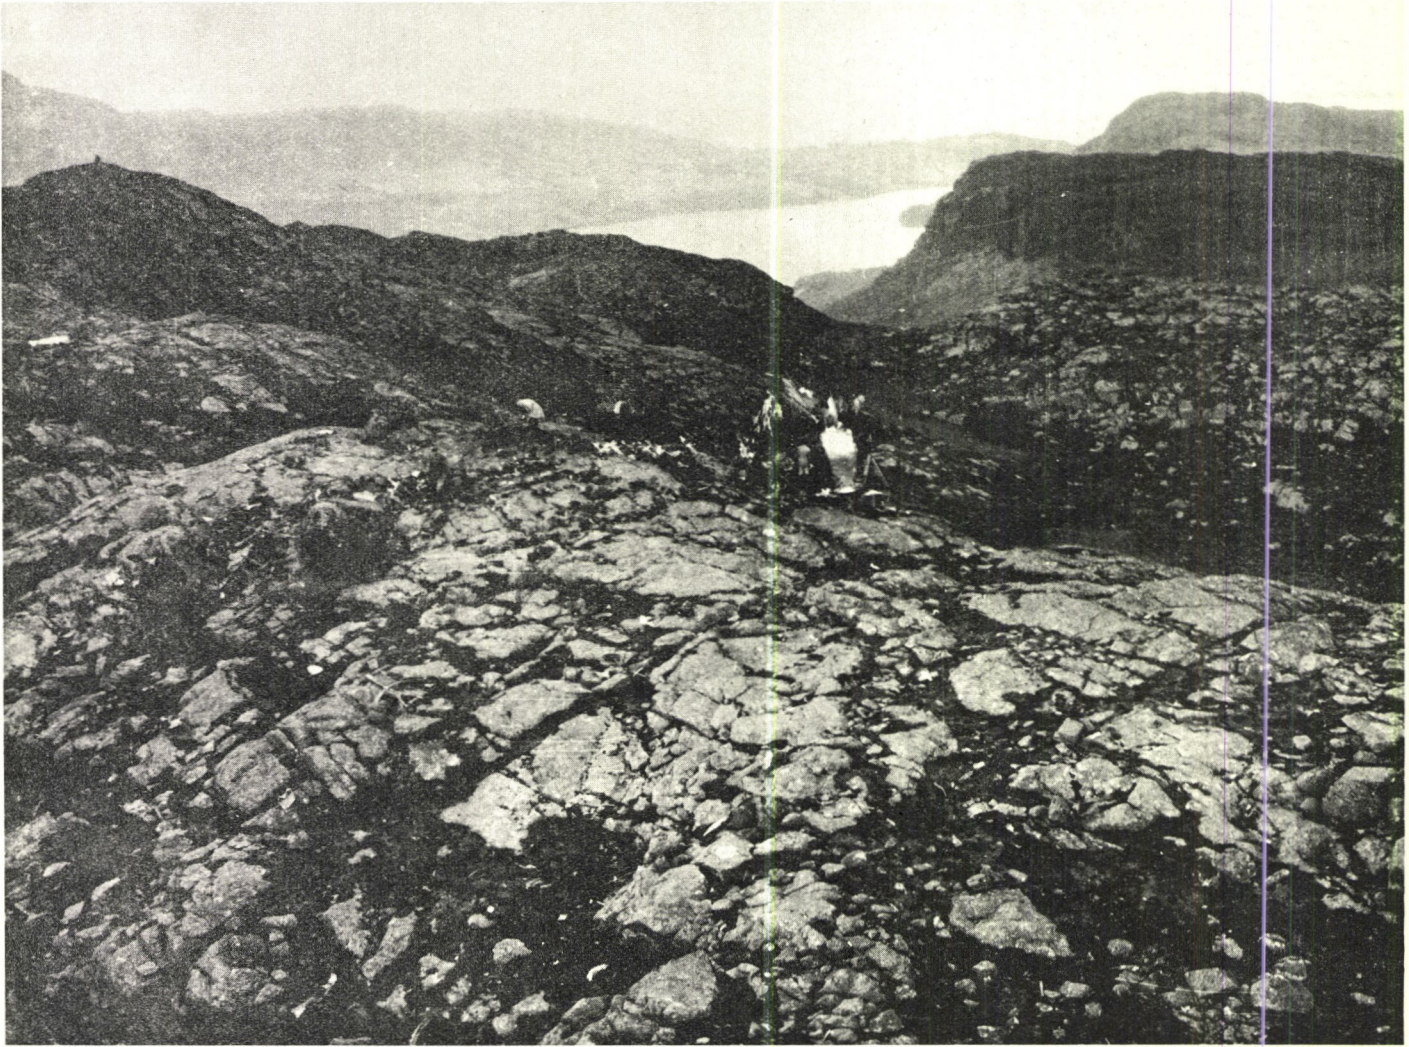
Accident Site from North East

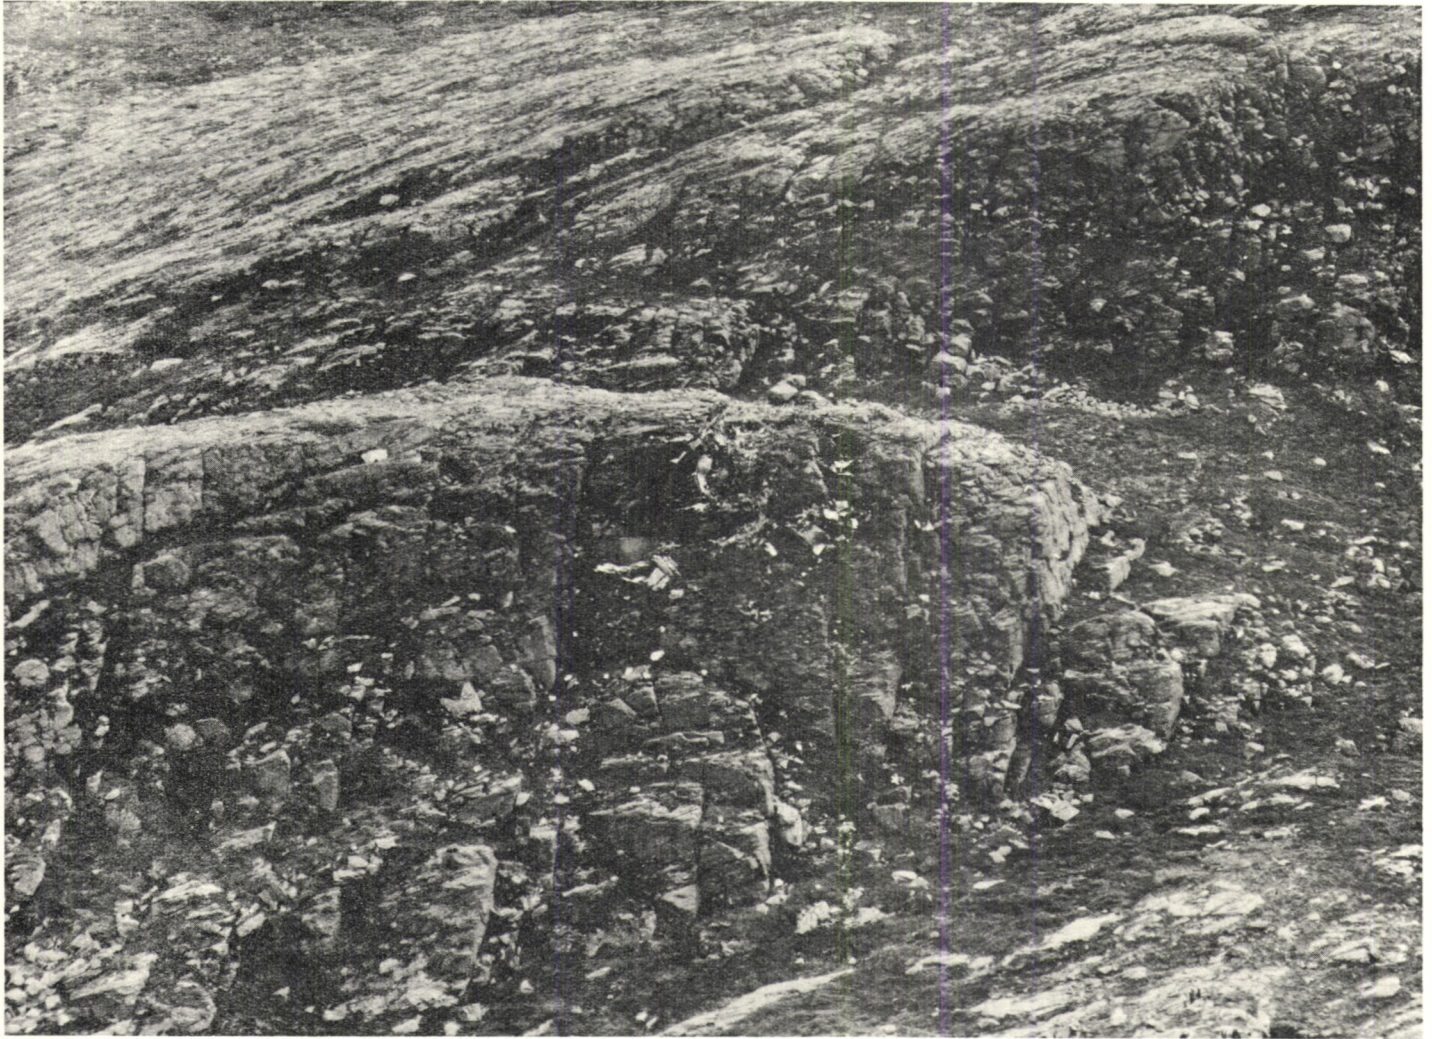
Accident Site from West
