# REPORT

SL 2010/01

REPORT ON AIR ACCIDENT ON 11 MAY 2005 AT  
KOLSÅS IN BÆRUM, AKERSHUS, NORWAY  
INVOLVING EUROCOPTER AS 350 B3 ECUREUIL,  
LN-OPY, OPERATED BY AIRLIFT AS

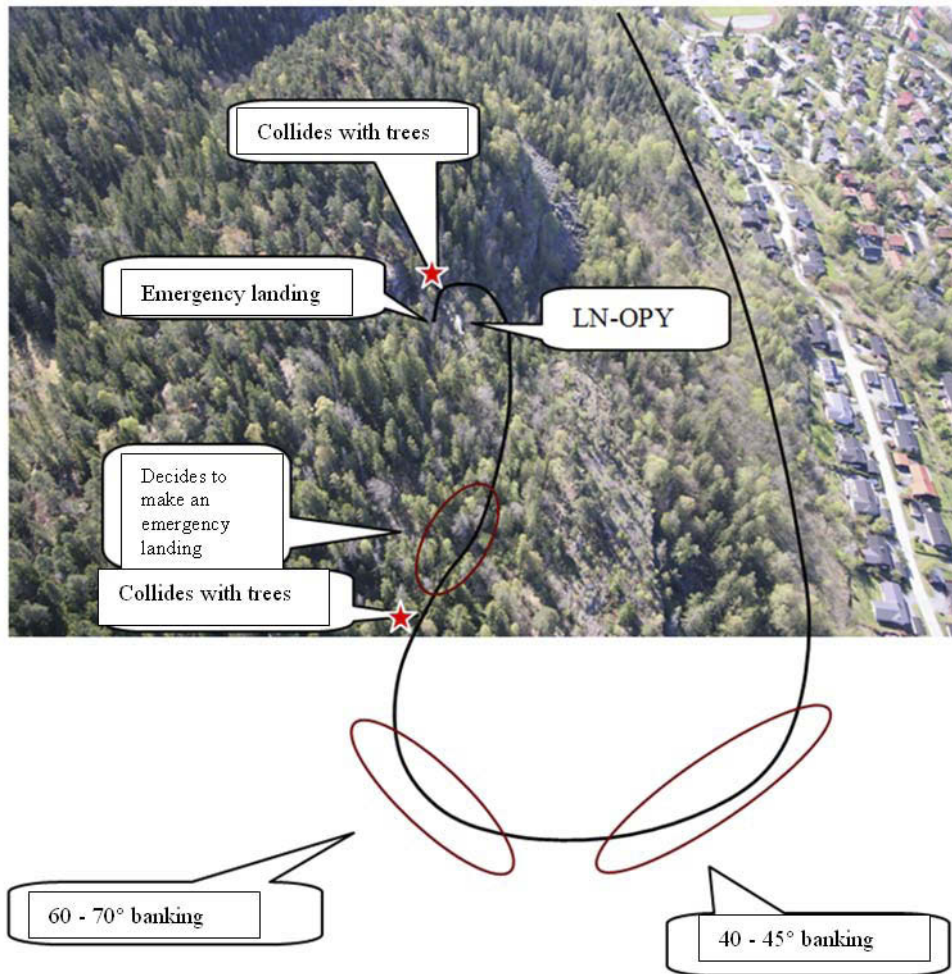
- 1.1.4.9 After few meters, the helicopter hit some treetops and the main rotor suffered damage. The place is indicated on Figure 2. The commander has stated that the damage to the main rotor resulted in heavy vibrations in the helicopter. The flight controls were imprecise, although the helicopter was still controllable to a certain extent. He said he remembered hearing abnormal whistling or howling noises in the helicopter, but was unable to determine whether they were coming from the warning system, the emergency locator transmitter (ELT) or something else. He feared the vibrations might cause the helicopter to break up, and his assessment of the situation was that an emergency landing was needed as soon as possible.

Figure 2: The accident site looking towards the south. Estimated flight path and bank angles are shown. A sports field is visible in the top right corner. (photo: the police)

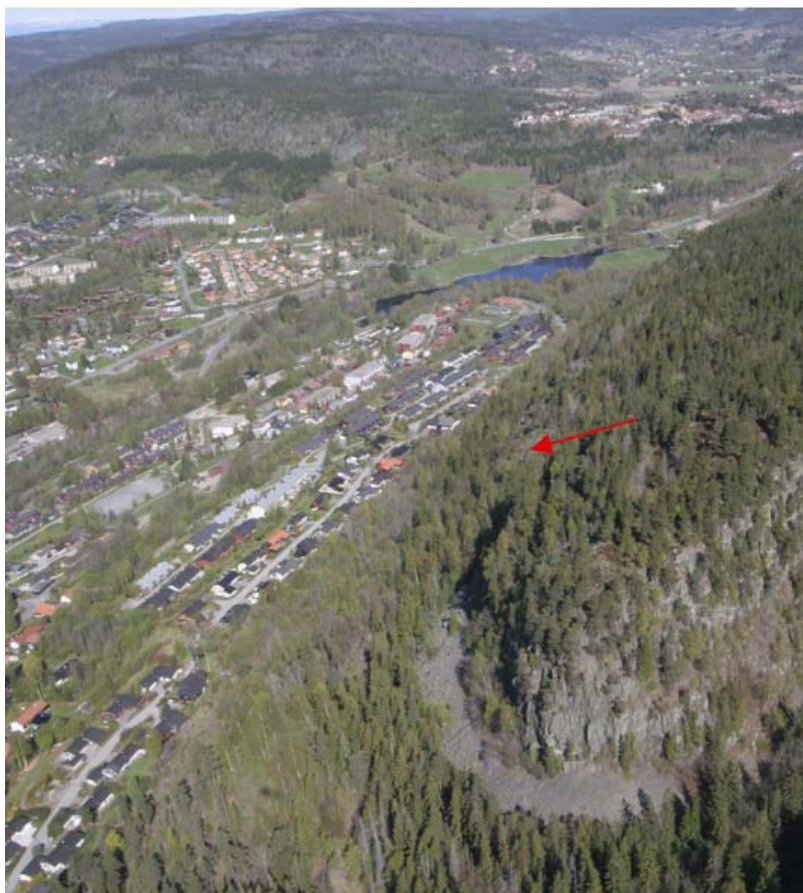
Figure 3: Kolsås looking towards the northwest. The accident site is indicated by a red arrow (photo: the police).

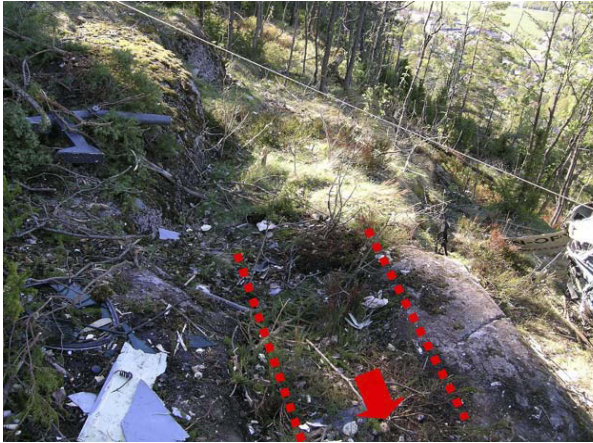
- 1.1.4.14 The flat part of the plateau was scarcely larger than the helicopter's landing gear (see Figure 5). For a moment the commander was elated that had been successful in mastering the autorotation and making an emergency landing in particularly demanding circumstances. However, the vibrations in the helicopter caused it to slide off this ledge and roll over onto its left side. When the main rotor hit the ground, the helicopter turned from a northwesterly to a southeasterly heading. The helicopter came to rest lying on its right side (see Figure 6).

1.12.2.2 Several small parts from the helicopter were found in the area where the main rotor blades hit the trees immediately before of the accident site. The aft part of the tail boom with the tail rotor lay approx. 10 meters above the wreckage on the slope. The tail rotor and fins were damaged, but relatively intact. Large and small parts of the main rotor blades were strewn over an area up to 100 meters from the wreckage. Part of the front right landing gear (skid) was found near the ledge where the emergency landing had been made (see Figure 5).

Figure 5: The ledge where LN-OPY made an emergency landing. The dotted lines show the position of the helicopter's landing gear. The arrow shows the direction of the helicopter before it tipped over.

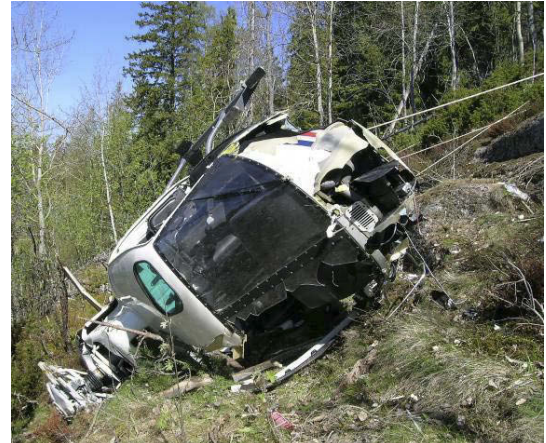
Figure 6: Main wreckage seen facing north.

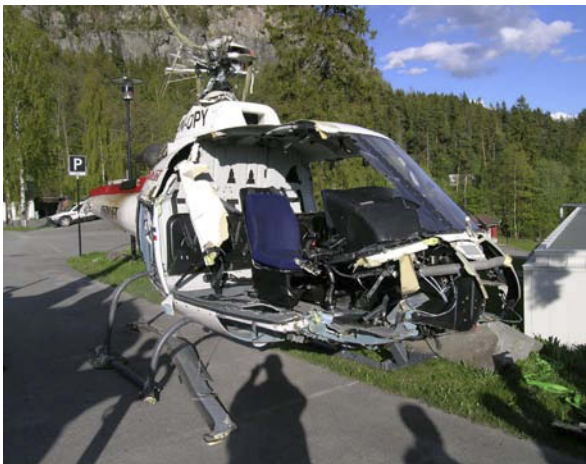
1.12.2.3 Apart from the broken off parts already mentioned, the wreckage of LN-OPY was chiefly in one piece. The right side of the cabin and the cockpit were seriously damaged (see Figure 7). In addition, the helicopter’s nose and underside had been partly compressed and several access covers were broken or torn off (see Figure 8).

Figure 7: The damaged right side of the cabin.

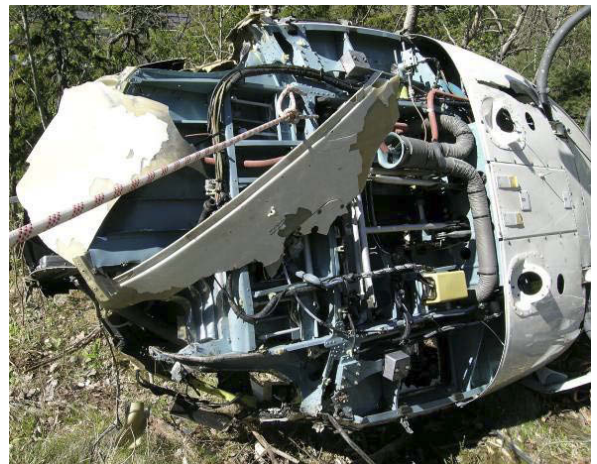
Figure 8: Damage forward and under the helicopter.

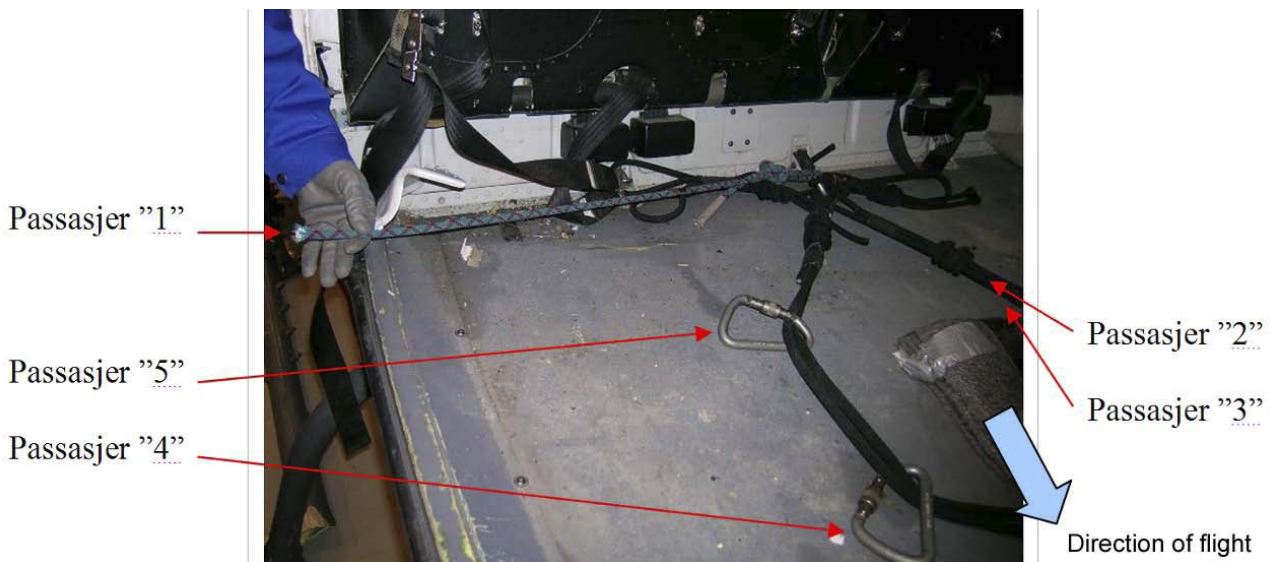
Figure 10: How the passengers were fastened in. The blue rope, which was attached to passenger "1", was originally approx. 40 cm longer, but was cut during the rescue operation.
