REPORT

SL 2010/05

**REPORT ON SERIOUS AVIATION INCIDENT AT
SANDEFJORD AIRPORT TORP 26 MARCH 2006
INVOLVING AIRBUS A321 OY-VKA OPERATED BY
MY TRAVEL AIRWAYS SCANDINAVIA**

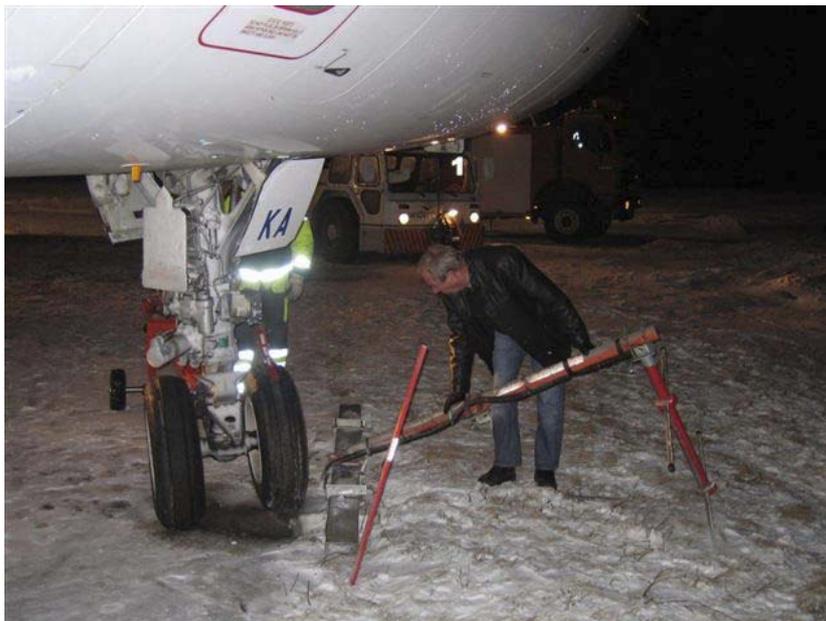
The Localizer Monitoring antenna and the base at the end of runway 18 were damaged.

Figure 1: Damaged Localizer Monitoring antenna with concrete base.

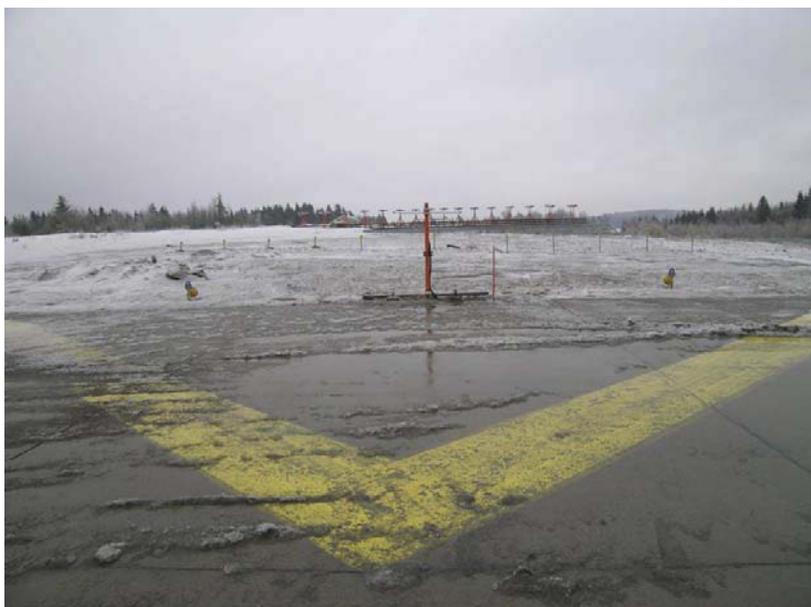
Figure 2: Repaired Localizer Monitoring antenna.

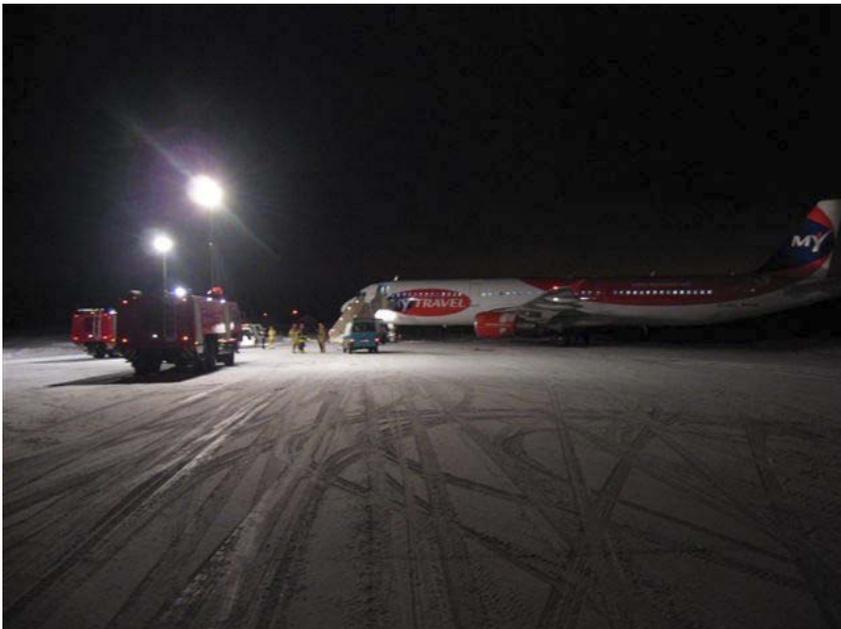
Figure 3: Reflections in frozen moisture in the vehicle tracks indicate a slippery runway.

- 2.3.5 By analysing the moisture- and temperature conditions after the event, it shows that the runway was moist before it became covered by snow (cf. item 1.7.7). The air temperature at 2 m height was measured to be - 1 °C. (Runway Report at 1451 UTC). During the afternoon the air temperature at 2 m height dropped to - 2 °C. The dew point spread was 1°C. The air temperature and dew point temperature at the runway surface may be different from those measured at 2 m. The Runway Report at 1741 UTC said that the runway was covered by 8 mm wet snow while the Runway report at 2028 UTC said that the runway was covered by 13 mm dry snow. From this AIBN conclude that the runway started out as a bare and moist runway which gradually was added moisture by snow fall. Combined with a fall in air temperature it is probable that the lower layer of moisture froze to ice at the same time as moist new snowfall was added on top. Hence, it is deducted that when OY-VKA landed the runway was covered by a thin layer of ice with fresh snow fall on top. AIBN consider this illustrates some of the uncertainty regarding decisions whether the snow is wet or dry. The definitions for wet and dry snow is "the possibility to make a snow ball or not". In relation to the ability to support tire to ground friction these definitions may be useless (cf. Figure 3).

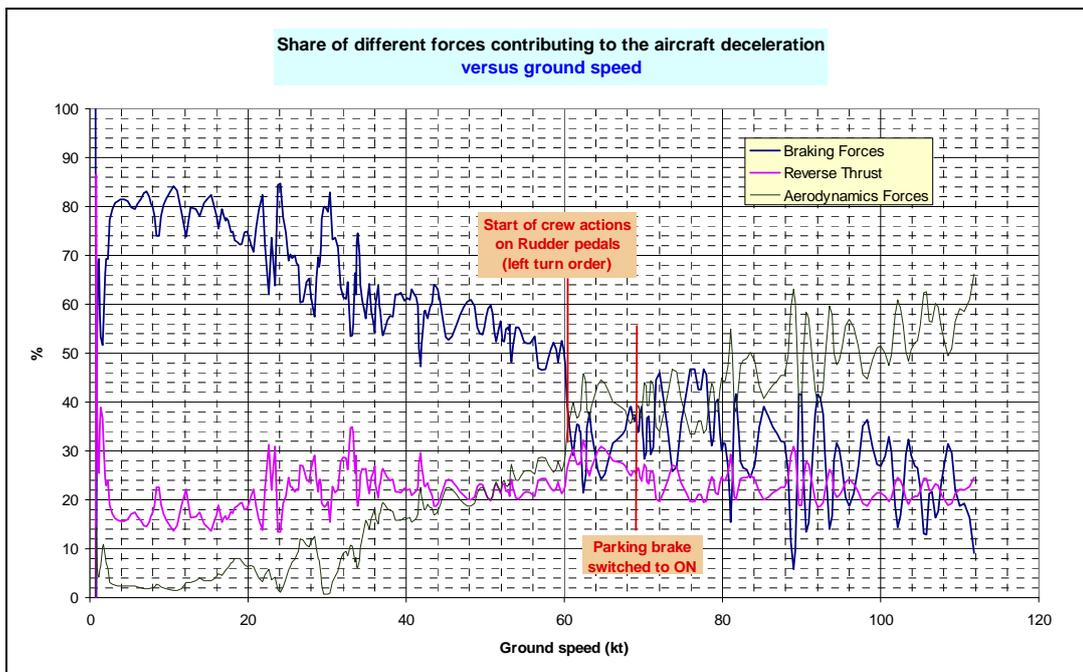
Figure 6: Graph showing the percentage distribution of braking forces from laps/spoiler, reversing and from wheel brakes.

The graph in Figure 6 shows that reversing contributed to approx. 20 % of the overall braking force and was relatively constant during most of the braking action. The graph further shows that the braking force from the wheel brakes contributed to approx. 20 % down to 60 kt. At this speed, the commander applied the parking brake and steered towards the left following advice from the first officer. The intention was to steer the aircraft towards the left side of the runway as the terrain on the left side looked better for a runway excursion. This caused the aircraft to unintentionally skid sideways while the mass velocity vector continued along the same path as before. This caused the main wheels and the nose wheels to skid sideways through the snow resulting in the retardation force from the runway surface contamination to increase to approx. 80 % of the total braking force towards the end of the braking run. The reversing continued to contribute the remaining 20 % of the total braking force down to about 20 kt.

brakes. The graph shows deceleration from 112 Knots Ground Speed (KGS), and that the drag (air resistance) varied from approx. 50 % just after touchdown, to approximately zero below 30 kt. Reversing contributed approx. 20 % of the total brake force throughout the braking course (disregarding the rolling friction which was negligible). We see that the braking friction varied a lot. This means that the conditions were very slippery and that the anti-skid system was working to the full. The average percentage from the wheel brakes shows a gradual increase from around 20 % at 110 kt to approx. 25 % at around 70 kt where the commander engaged the PB. He did this because he could not feel any effect from the wheel brakes. AIBN has found that this is a common experience for pilots who attempt to brake on a slippery surface (Braking Action POOR).

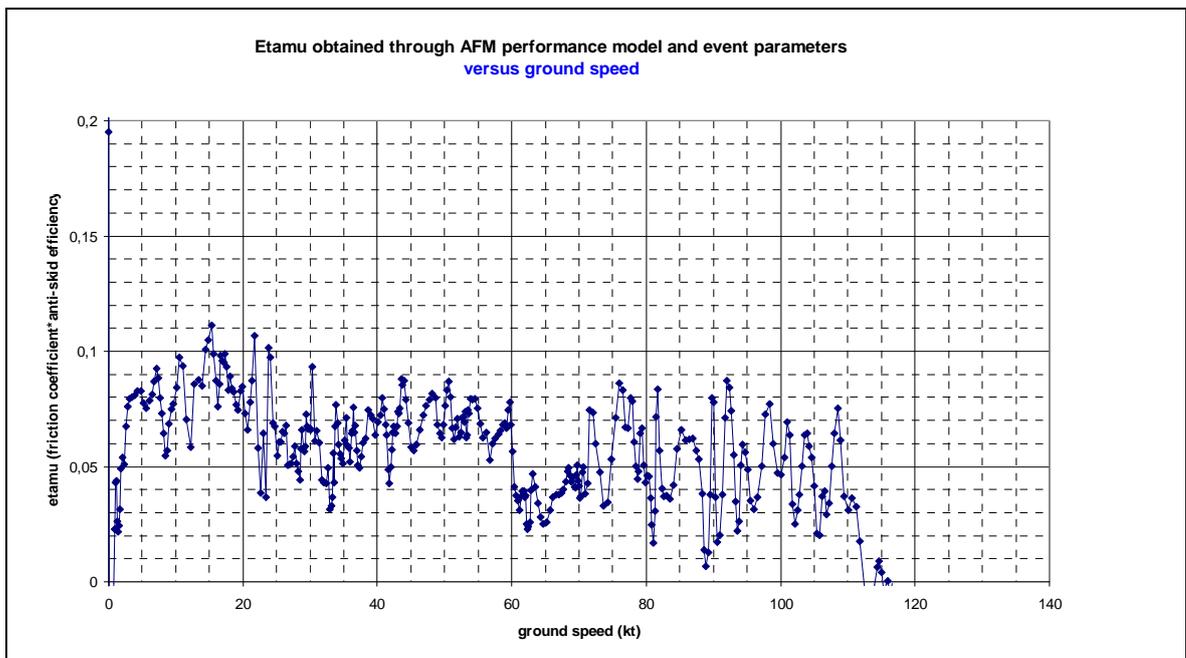
Figure 7: Graph showing the aircraft's effective brake coefficient.

The graph in Figure 7 shows that the aircraft's effective friction coefficient (*"airplane effective μ "* in the Airbus terminology, or Airplane Braking Coefficient (ABC in the Boeing terminology) was in the region of 0.05. This corresponds to POOR Braking Action.

- 2.6.4 Figure 7 shows the Airbus' computer calculation of the airplane braking coefficient" (ABC, or "*effective μ* "). The graph also shows that the average braking coefficient was approx. 0.05 from approx. 110 kt down to approx. 70 kt. That is the speed at which the commander engaged PB because he did not sense any braking actions from the wheel brakes (ref. Figure 6). Figure 7 shows that the ABC fell from approx. 0.05 to 0.04 when the PB was turned on. This is compatible with the friction theory and a result of the anti-skid system being disconnected. This caused the wheels to lock, and the friction changed over to a pure gliding friction which is lower than a slip friction. Figures 6 and 7 further show the effect of the commander's turning left by means of the nose wheel steering. Thereby the aircraft's nose turned gradually towards the left while the aircraft mass velocity vector continued along the same runway path. The friction from the main and nose wheels, which were then skidding more and more sideways along the runway direction through the snow, gradually increased up to 0.06-0.07, and up to approx. 0.08 at the end.

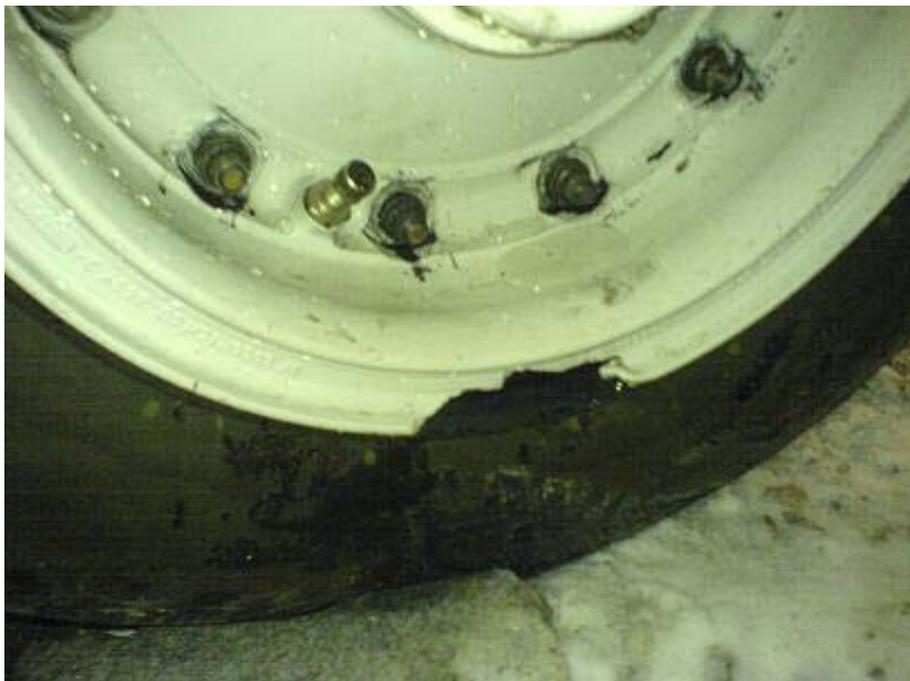
- 1.12.1.1 The aircraft sustained damage to the right-hand nosewheel rim and fuselage. The right-hand nosewheel rim was cracked by the concrete base and a bit of about 5 cm long was broken off from the rim. The right-hand nosewheel tyre was scraped on the side. Figure 8.
- 1.12.1.2 The lower fuselage sustained a small dent in the skin on the right-hand side. The damage came from the impact with the Localizer Monitoring antenna, when this was bent to the side by the fuselage. The indentation was localised between station nos. 14 and 15 and was around 10 x 14 millimetres long and approx. 1.8 millimetres deep. Figure 9.

Figure 8: Damage to the nosewheel rim.

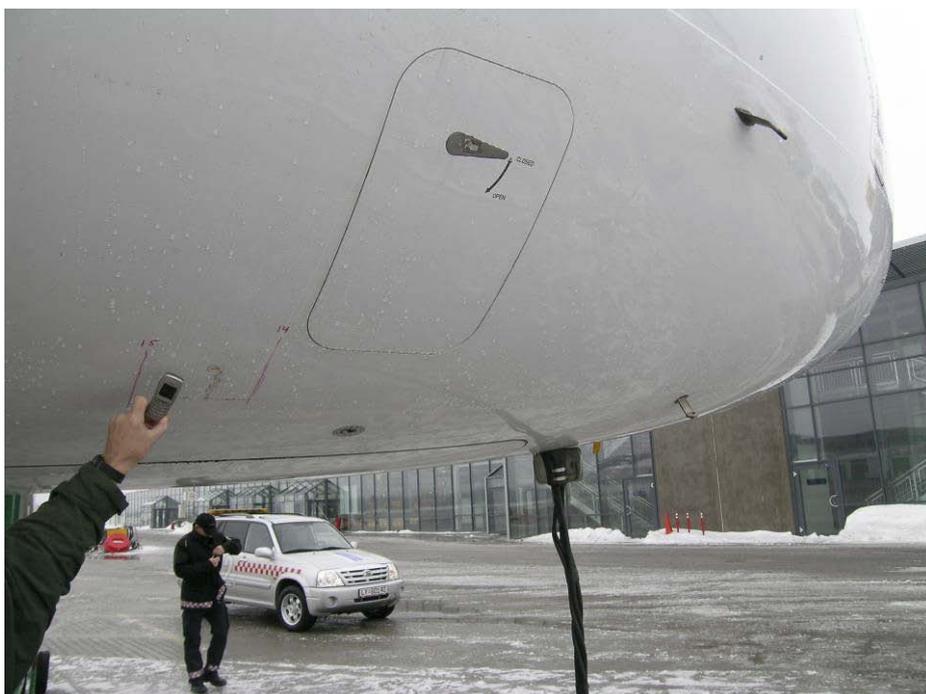
Figure 9: Minor indentation in the fuselage between stations 14 and 15.

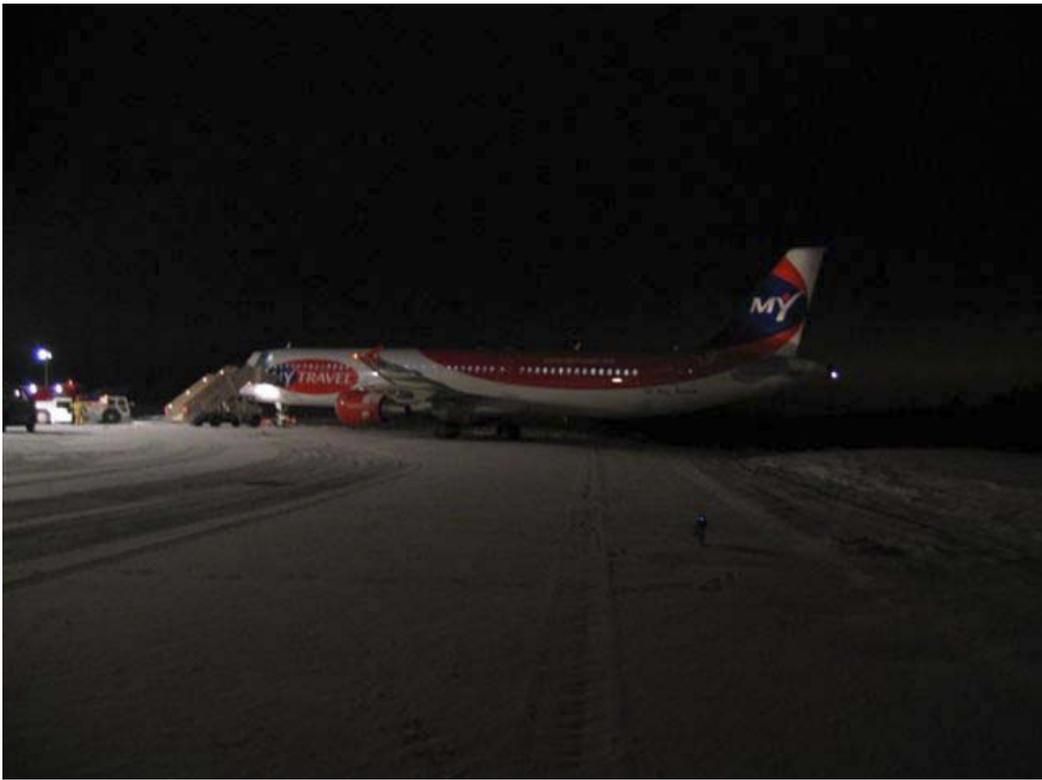
The aircraft stopped with the nosewheel perched against the concrete base of a Localizer Monitoring antenna and ended up standing across runway 18 with its nose facing approx. 65° (HDG 114°) off the runway direction, and with the right-hand side main wheel approx. 2 metres away from the end of the hard runway surface. Figures 10 and 11.

Figure 10: The aircraft stopped across runway 18 at the end of the hard surface.

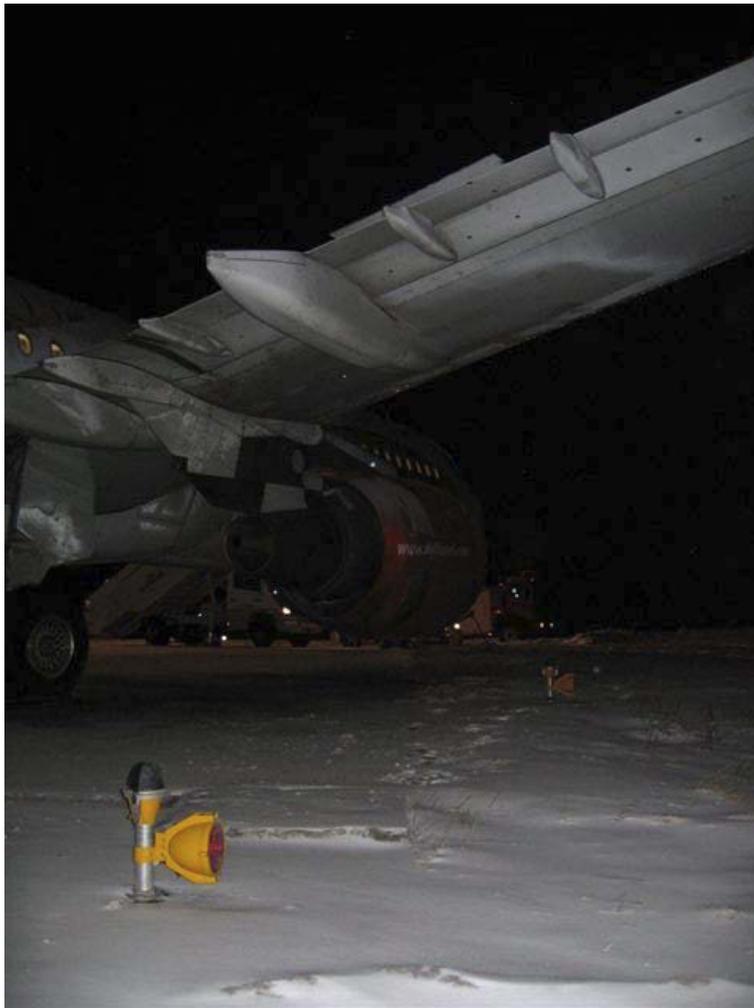
Figure 11: The right main wheel ended up approx. 2 m from the end of the runway.

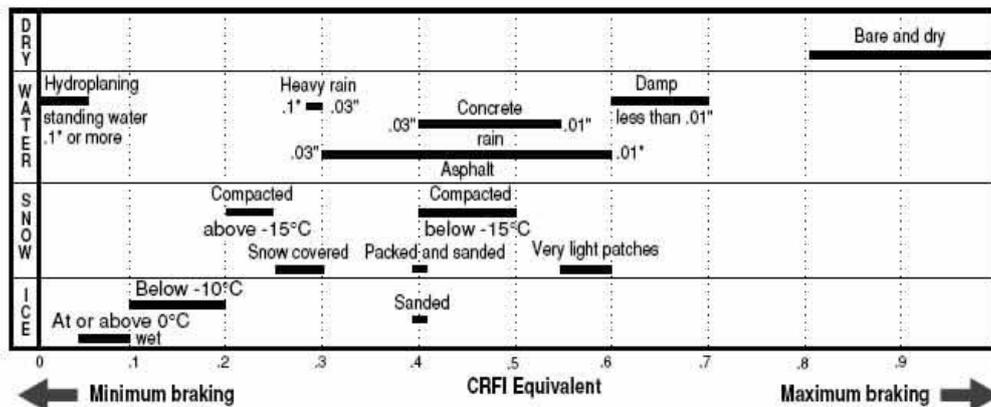
Figure 1. Uncertainty of friction measurements on contaminated surfaces (Transport Canada 2004)

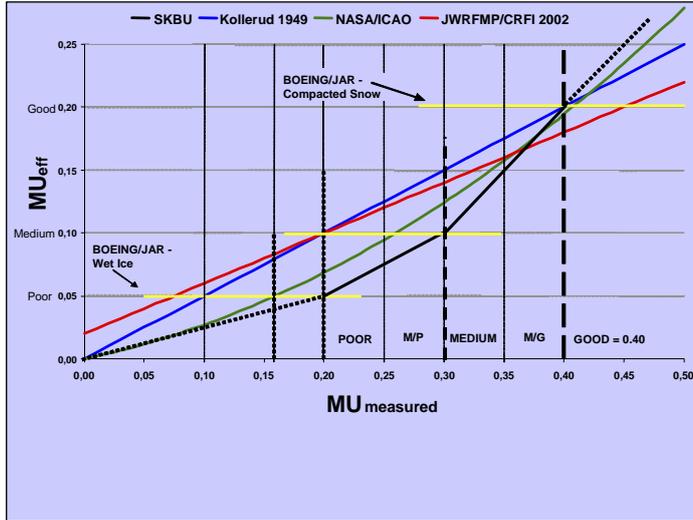
1.18.9.2 Figure 1 in Appendix L shows different correlation curves between measured (reported) friction figures and "airplane effective μ " (or ABC). We see there is little difference between Kollerud's correlation curve and the Canadian curve. Roughly speaking, the effective friction coefficient is half of the measured and reported one. The figure also shows the ICAO-recommended correlation curve (green) and the Norwegian approved curve (black). The latter is the most conservative, and the one that has proven the most practical over several years on contaminated Norwegian winter runways.

Figure 1. Correlation between measured μ and effective μ . (Norheim, Avinor 2006).

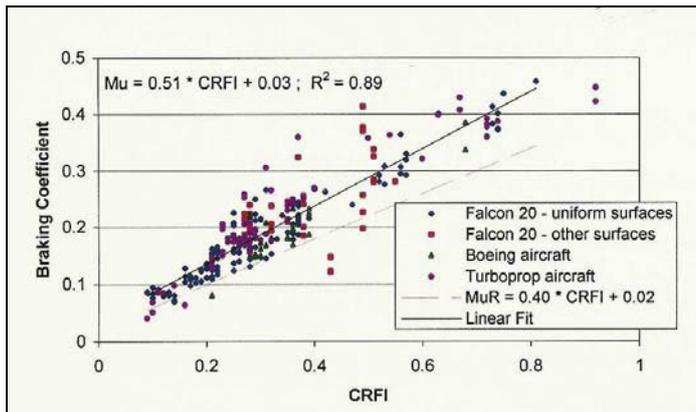
Figure 2. Airplane Braking Coefficient vs Canadian Runway Friction Index (CRFI, TC 2004).
