SL 2010/07

REPORT ON SERIOUS INCIDENT AT BERGEN AIRPORT FLESLAND ON 5 SEPTEMBER 2009 WITH PIPER PA-28-161, LN-BTS

Date: 09.03.2010
SL Report: 2010/07

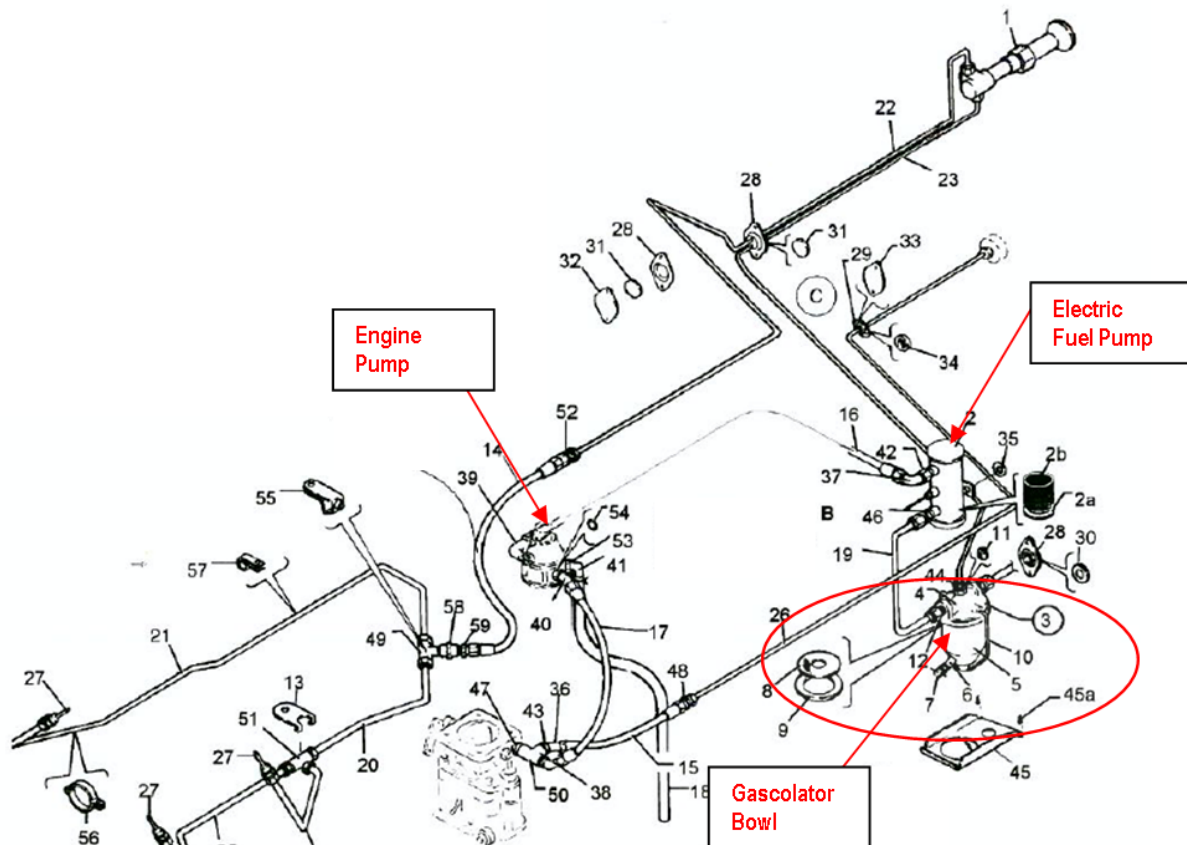
The fuel strainer is located low in the engine compartment and is designed to capture any water and other contaminants before the fuel reaches the engine. The location of the fuel strainer is between the fuel tanks and the electrical fuel pump, see Figure 1:

Figure 1: Section of the forward part of the fuel system on PA-28-161 (serial nos. lower than 16110). The gascolator circled in red

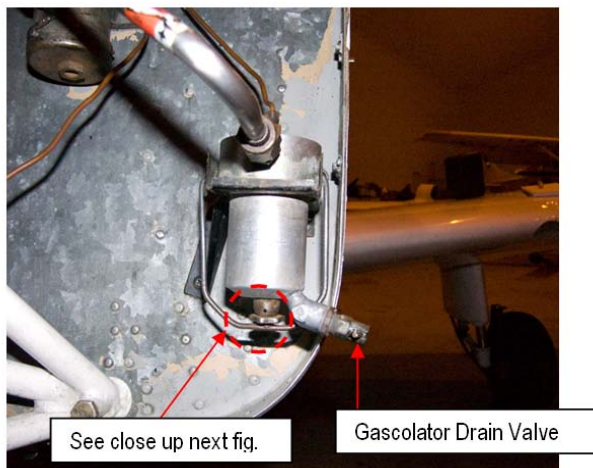
- the gascolator bowl seemed to be looser than normal, in spite the fact that all parts and the locking wire were installed (Fig. 2)
- parts of threaded section of the fastening clamp which holds the bowl in place (WIRE – bail, Part Number 100871-02) had been destroyed (Fig. 3)

Figure 2: Location of the gascolator assembly on the firewall in the engine compartment (locking wire removed). The fuel tank is located in the wing which can be glimpsed in the background.

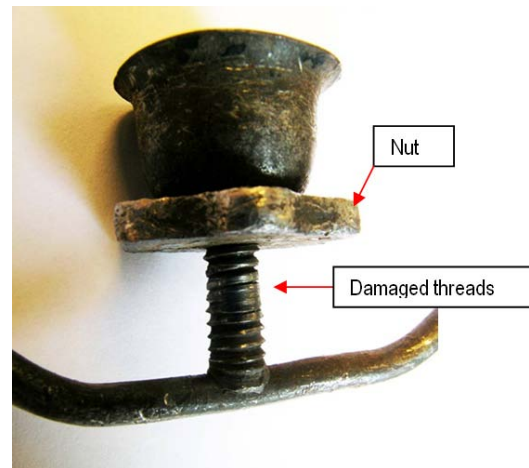
Figure 3: Damaged thread section in the fastening clamp which holds the bowl in place

The leak discovered during the pre-flight inspection and findings from the technical examination after the incident indicate that the gascolator bowl was loose, and that the engine stopped as a result of interrupted fuel supply. The gascolator bowl coming loose is probably connected to the damaged threads on the fastening clamp which is intended to hold the bowl in place. The nut, which is tightened to hold the bowl up, has most likely slid down the worn-out threads when the stub with

the drainage valve was pushed in and to the side upon drainage. This resulted in a leak in the top assembly gasket.

As the gascolator must be must loosened every 50 flight hours, the thread section on the fastening clamp and the tension nut is exposed to wear and tear over a period of time. The technician's discretionary assessment decides when the parts are due for replacement with regular operation. The Accident Investigation Board emphasises that personnel engaged in maintenance of aircraft materials must be vigilant and replace worn components, even if the components apparently "can take one more flight". In the opinion of the AIBN, the condition of the fastening clamp in question and the information that spacing washers are used to postpone replacement of such clamps give rise to concern.

The gascolator bowl came loose so that the fuel supply was interrupted and the engine stopped just after take-off. This is a safety problem which could result in a serious accident. Worn threads on the wire bail probably caused the problem. The AIBN recommends that the CAA-N considers measures to ensure that the components in question be checked during periodic inspection.

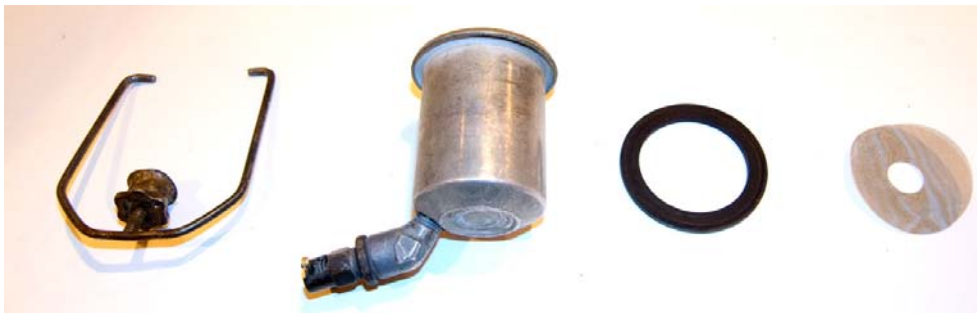
The gascolator bowl must be disassembled and the bowl and filter cleaned (cf. Figure 4) at both the 50-hour and 100-hour inspection (see "Piper Cherokee Warrior Service Manual Table III – Inspection report PA-28-151/161 Engine Group Item 25"). Checking the condition of the fastening clamp and tension nut is not mentioned in the maintenance documents.

Figure 4: Parts of the gascolator assembly: Fastening clamp, bowl with drain nipple, gasket, filter
