SL 2011/03

REPORT CONCERNING AIR INCIDENT AT HANKØ,
ØSTFOLD COUNTY, NORWAY 27 OCTOBER 2009
WITH EUROCOPTER AS 350 B3, LN-OZT

Date: 01.02.2011
SL Report: 2011/03

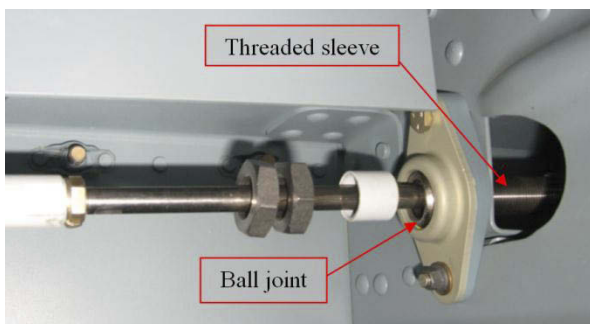
The commander called the technical manager at EHC, who asked him to remove the forward cowling underneath the helicopter in order to look for faults. The commander explained that he could see two nuts which had come off the threads completely and were hanging on a rod that was part of the tail rotor controls (see figure 1).

Figure 1: Loose nuts. (Photo: Helifly Maintenance) Figure 2: Flexball control connection (area A in figure 3).

EHC had an agreement with the Part 145 organization Helifly Maintenance for technical maintenance of LN-OZT. A licensed technician from Helifly Maintenance established that the forward attachment of the tail rotor's flexball control was completely loose. The two forward nuts had come loose and were hanging on the rod, and the threaded sleeve had displaced backwards and out of the ball joint. The two rear nuts could be turned by hand.

The entire tail rotor and tail rotor control were then inspected, but no more faults were found. Pictures were taken of the rod and nuts before the flexball control was installed in accordance with the maintenance manual. After start-up, a functional test was performed on the ground and in low hover before the helicopter was flown back to Torp for further examination. The flight from Hankø to Torp was uneventful.

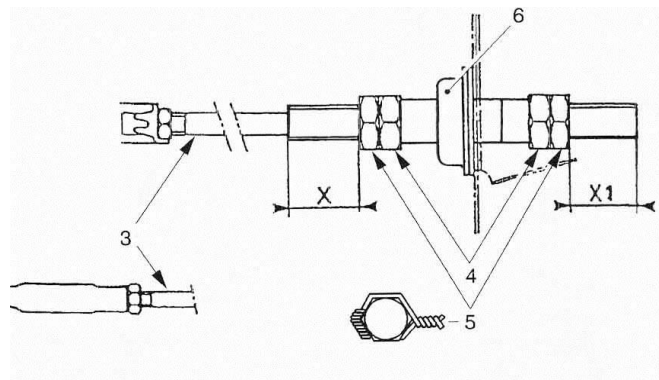
Chapter 67.20.00.501 of the Maintenance Manual refers to "Tail rotor controls, Rigging: Version without auto-pilot". The text in Item 3.2 g) states: *"Tighten locknuts (5). Safety locknuts (5) on Teleflex¹ control supports (intermediate lever side and rear servo-control side)"*. See also the drawing (figure 2) where it is indicated that locking wire must be used. None of the mentioned four nuts which were discovered to be loose, had holes for locking wire.

The nuts shall not be locked with locking wire as shown in figure 2. The symbol for use of locking wire has by error been introduced on the figures showing the flexball control. This will be corrected by Eurocopter.

Eurocopter stated that they would continue to use the same design, but that they had changed the installation procedures. Since the beginning of December 2009, the helicopters have been produced with new procedures where the nuts must be tightened with a torque of 5 to 7 Nm while the flexrod is held in place with a specially designed tool so that it is not twisted during the tightening (ref. Service Bulletin 67.00.50).

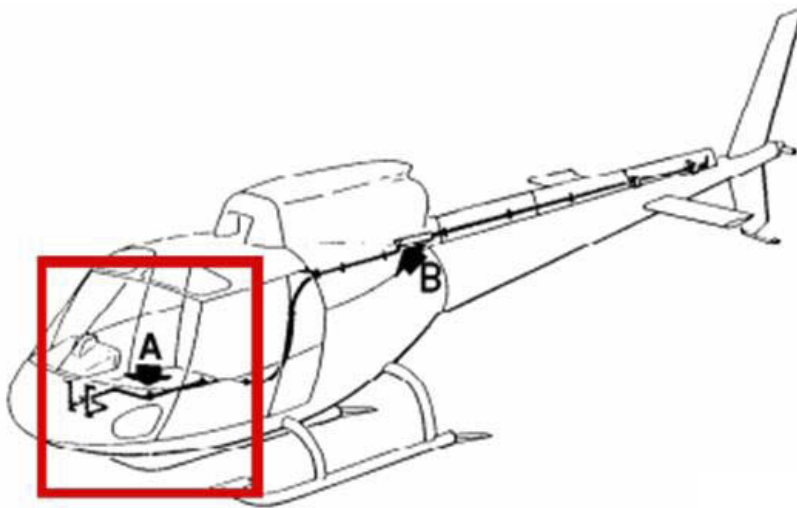
Figure 3: Loose nuts discovered in point A of the flexball control installation.

Eurocopter stated that this design is safe and robust, but that the nuts were probably not fastened correctly and that this was not discovered during the quality inspection before delivering the new helicopters to the customers.

In spite of the fact that the locking method for the flexball control, according to Eurocopter, has functioned satisfactorily for almost 20 million flying hours, the AIBN believes that the locking of the flexball control can be improved by using self-locking nuts or locking wire.
