REPORT

SL 2011/09

REPORT ON THE SERIOUS INCIDENT AT OSLO
AIRPORT GARDERMOEN NORWAY 31 JANUARY
2008 TO BOMBARDIER CL-600-2B19, OY-RJC,
OPERATED BY CIMBER AIR DENMARK

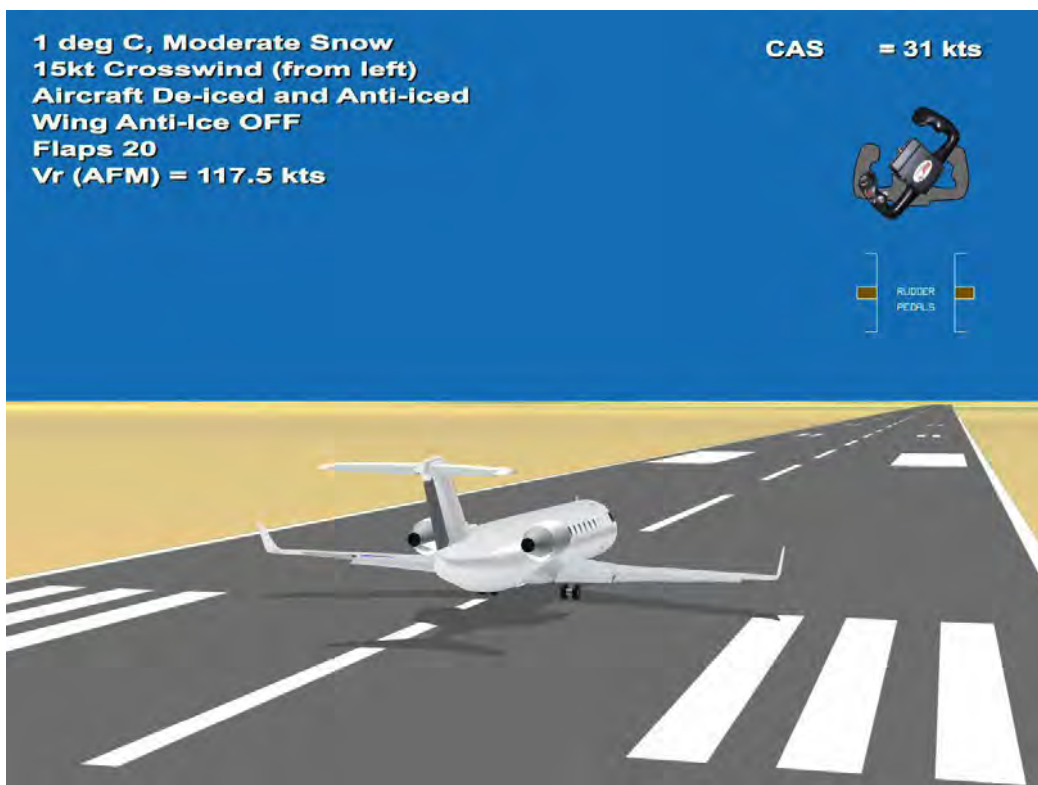
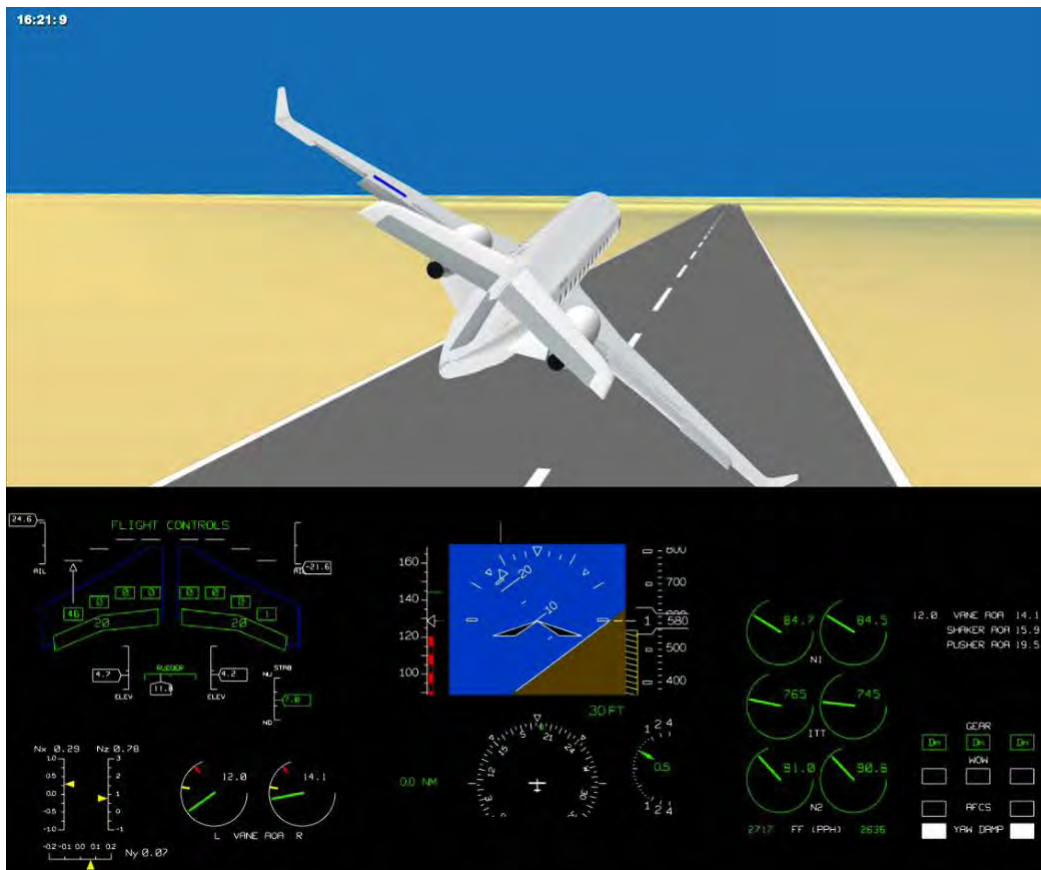
Figure 1: Animation of the take-off with OY-RJC. Full animation is available at <http://www.aibn.no/aviation/reports/2011-09-eng>. Note: The animation is based on data from DFDR. Surroundings and weather conditions are not representative for the incident in question.

Figure 1a) Commencing take-off.

Figure 1b) Shortly before Stick pusher activates.

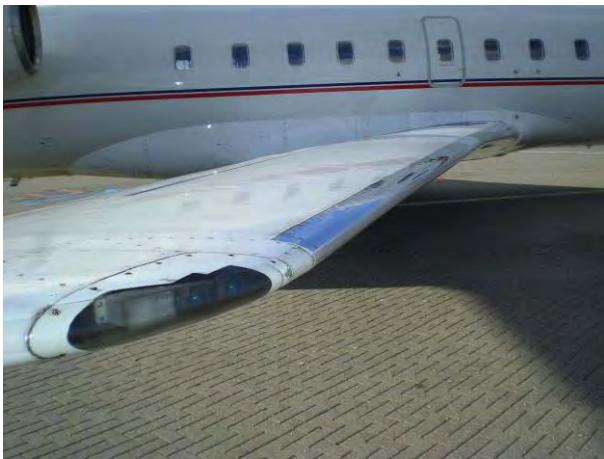
Figure 5: Right wing leading edge OY-RJC.

Contamination on the leading edge and upper wing, ground effect and crosswind are known factors of significance for the wing's ability to produce lift during take-off. The effect of these factors is described in further detail in 1.16. The wings of OY-RJC were inspected after the incident to rule out irregularities such as sealant protrusion. This could have been a contributing factor in a previous accident in Moscow (see 1.18.1). The wings on OY-RJC were without dents and irregularities which could have disturbed the airflow (Figure 5).

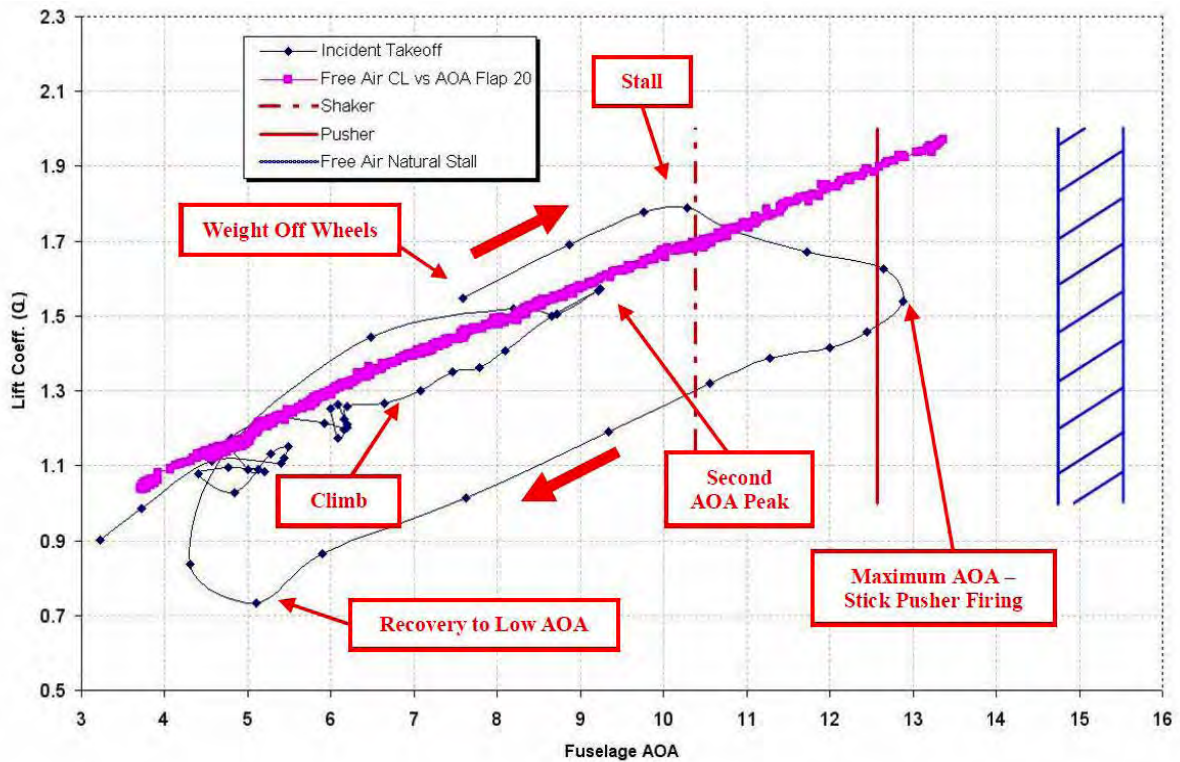
Figure 11: The lift coefficient versus angle of attack during the take-off in question (C_L -alpha)

1.16.5 For the simulation to conform with observed data, it was also necessary to introduce a *“nose down pitching moment”* in the model just after take-off. According to Bombardier, this indicates that the symmetric loss of lift occurred over the inboard wing:

–The simulation match indicates that this symmetrical loss of lift was most likely confined to the inboard wing because this would cause an aerodynamic nose down moment as required by the model.”

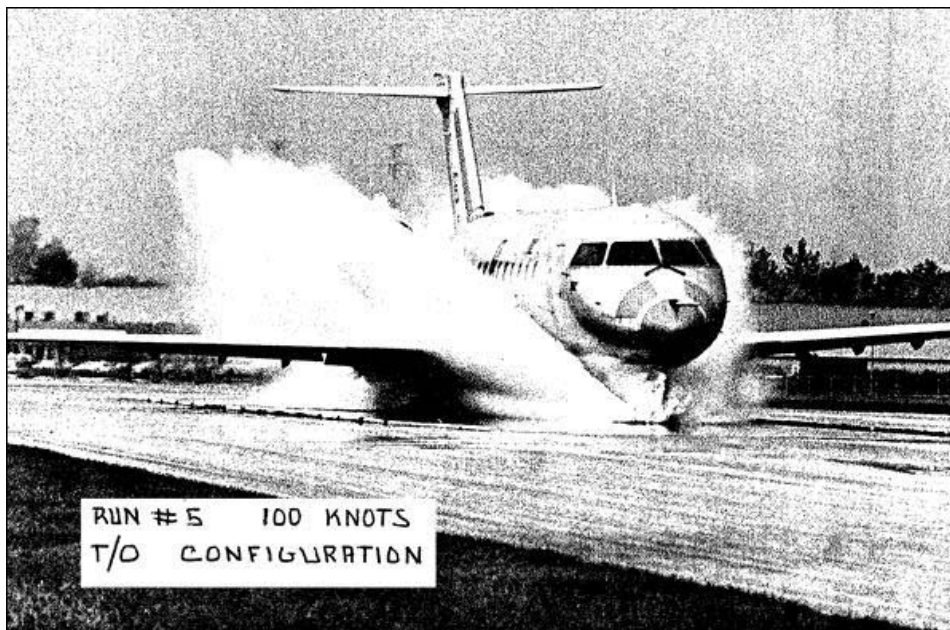
Figure 12: Photo from the Water Ingestion Test. Note that the spray from the nose wheel will hit the wing leading edge and the surface and underside of the wing in the area where stall is normally initiated.

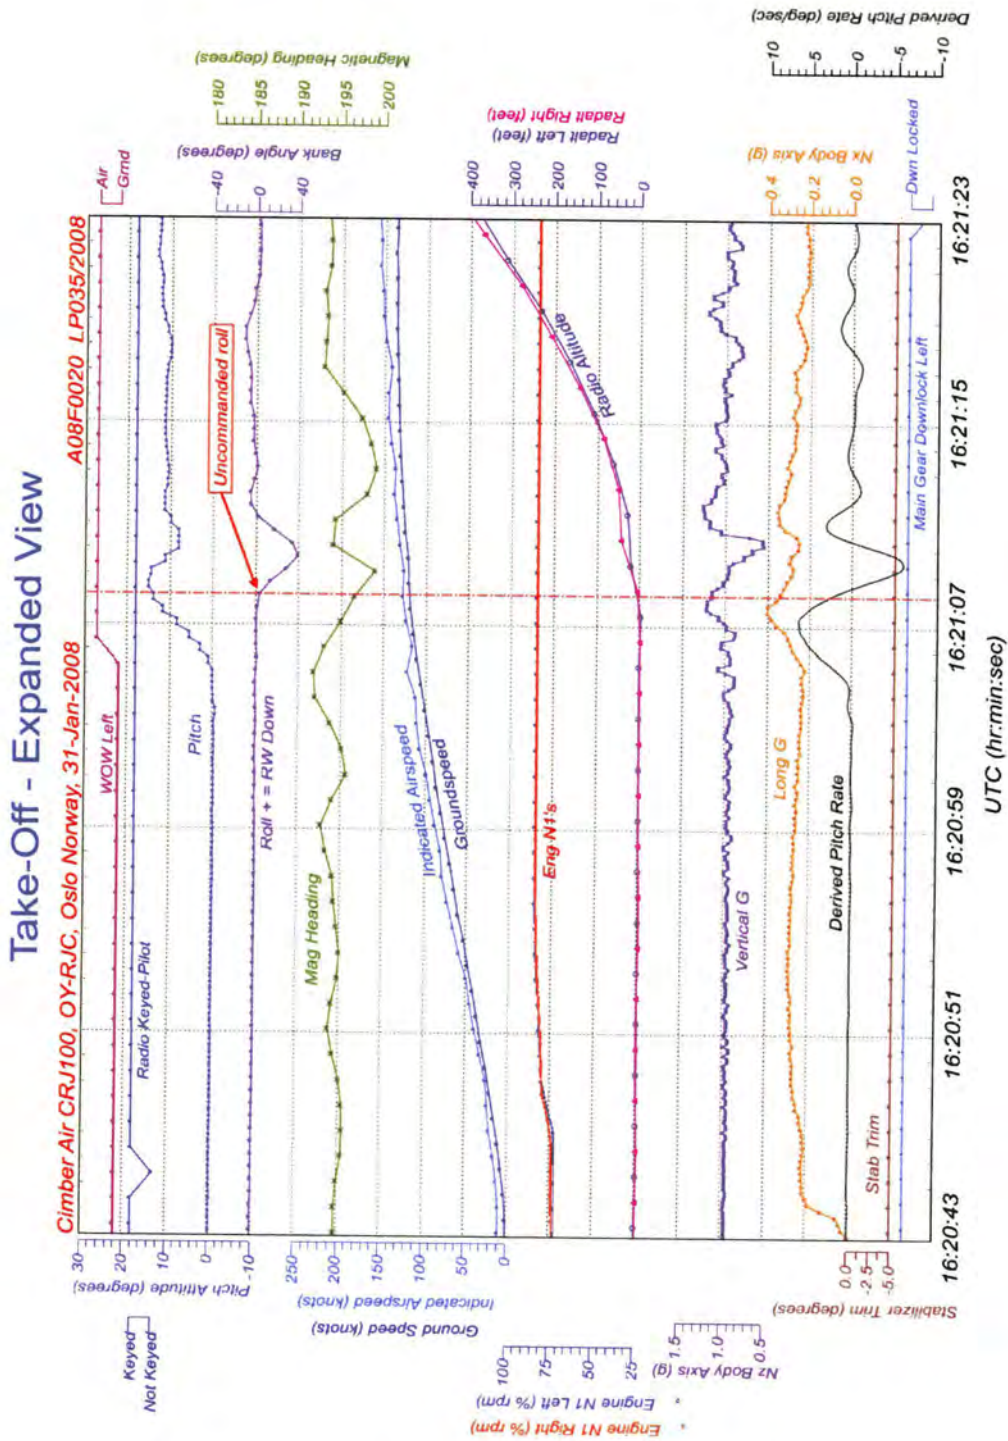
Figure 3: DFDR plot showing expanded view of take-off.

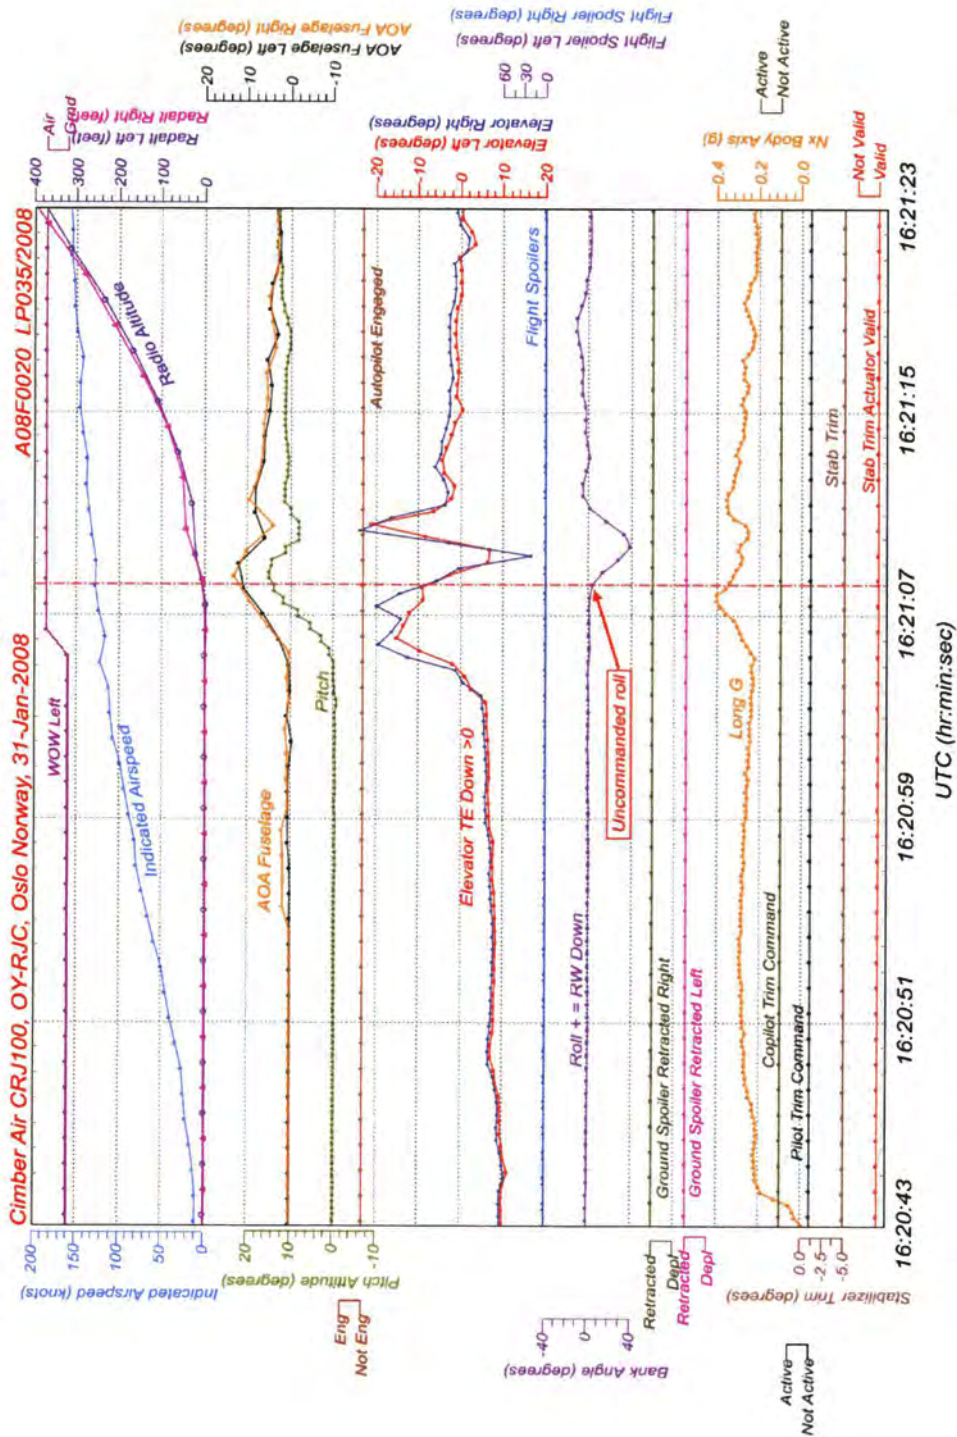
Figure 4: DFDR plot of longitudinal controls.
