REPORT

SL 2011/15

REPORT ON SERIOUS AIRCRAFT INCIDENT AT
BODØ ON 24 FEBRUARY 2008 INVOLVING A
SIKORSKY S-61N, G-ATFM HELICOPTER
OPERATED BY BRITISH INTERNATIONAL

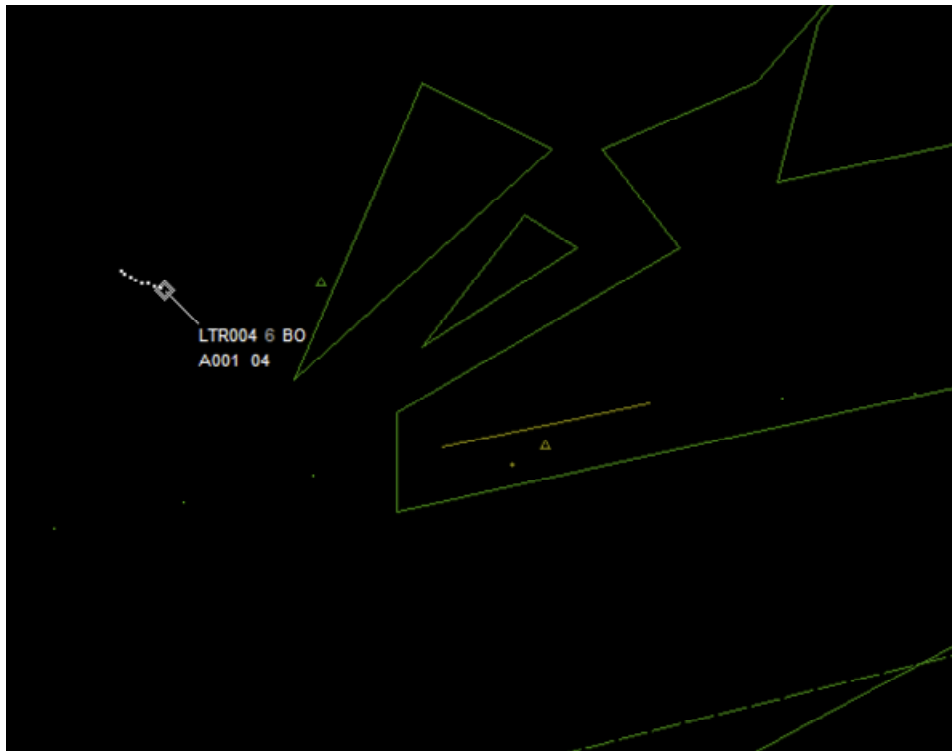
Radar print-out at 14:34:56Z. Position approx. 2 nm NM from Store Hjartøy, 100 ft, 40 KGS.

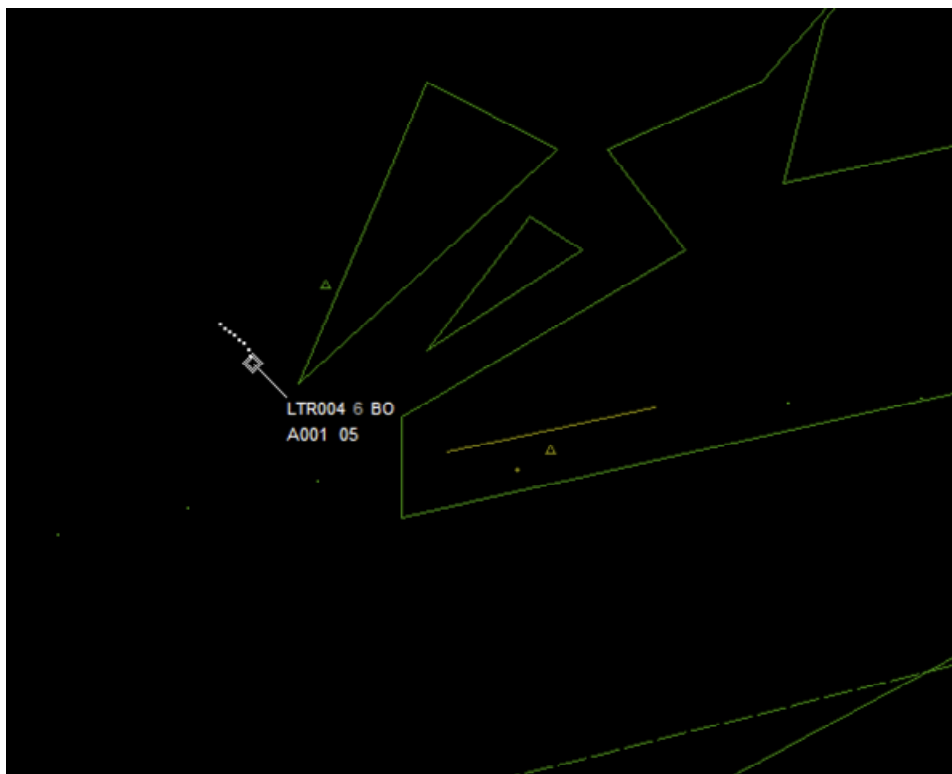
Radar print-out at 14:36:00Z. Position approx. 0.5 NM from Store Hjartøy, 100 ft, 50 KGS.

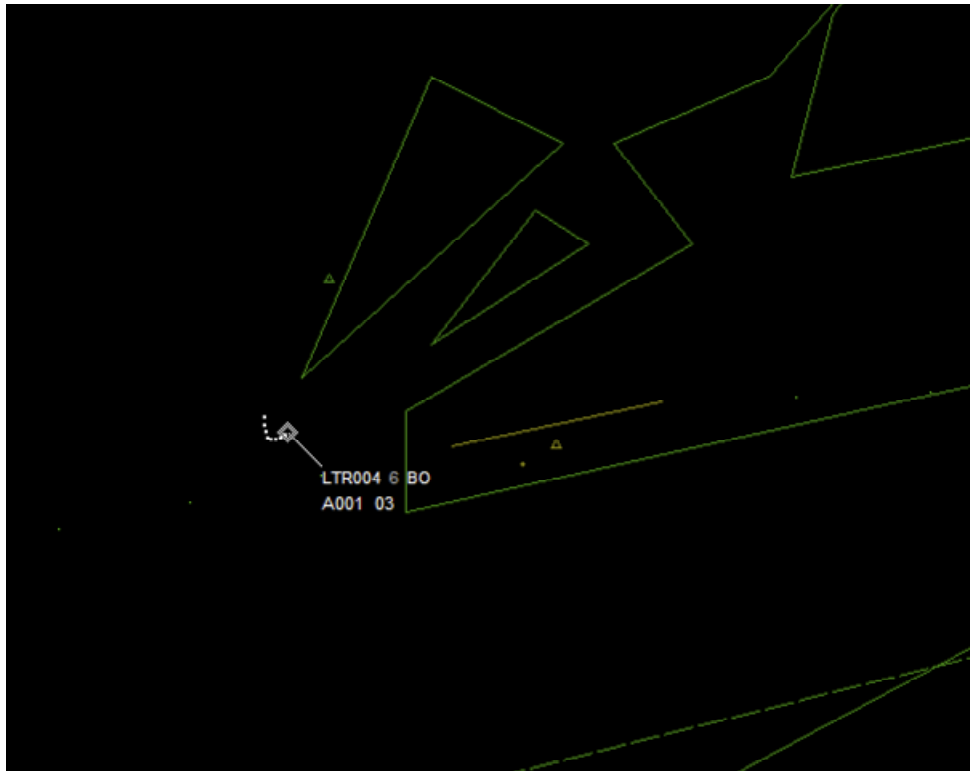
Radar print-out at 14:37:00Z. Position approx. 2 NM from runway threshold 07, 100 ft, 30 KGS, parallel centre line towards Bodø harbour.

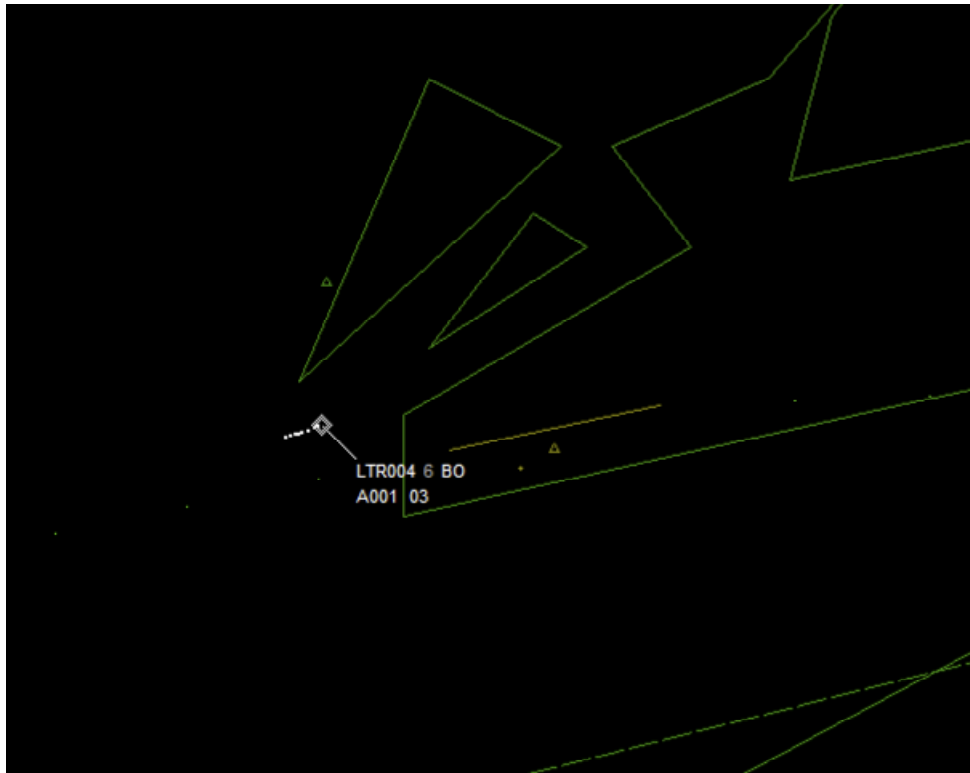
Radar print-out at 14:37:30Z. Position approx. 1.5 NM from runway 07 threshold, 100 ft, 30 KGS, course towards Bodø harbour.

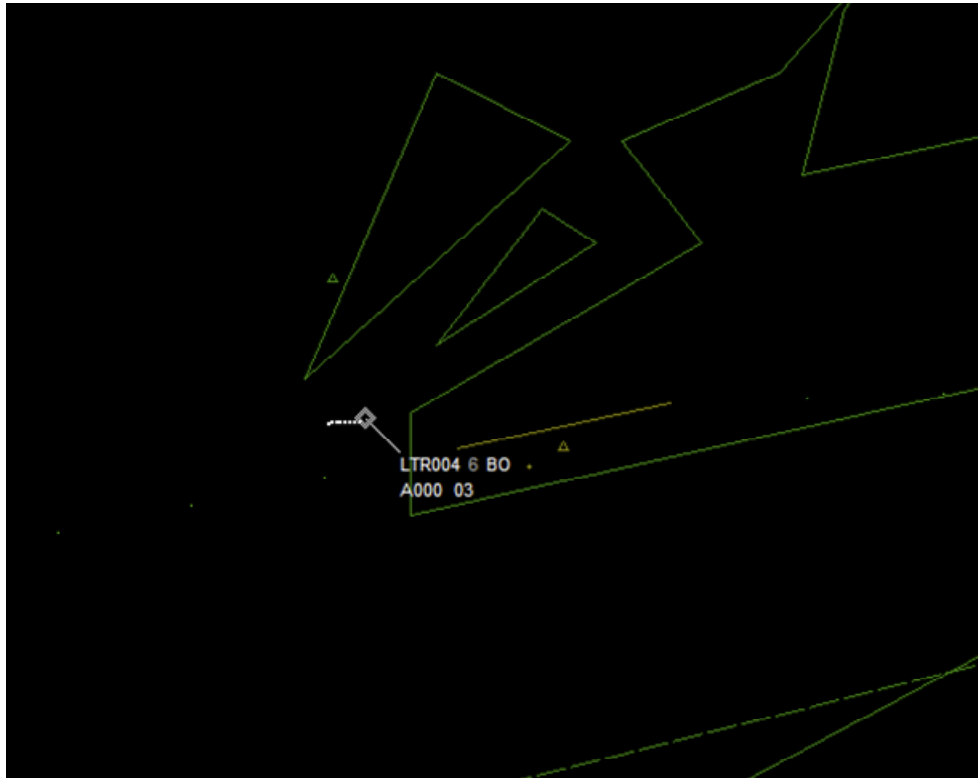
Radar print-out at 14:38:00Z. Position approx. 1.5 NM from runway 07 threshold, altitude 0 ft, ground speed 30 KGS. Course correction from TWR/Radar towards runway.

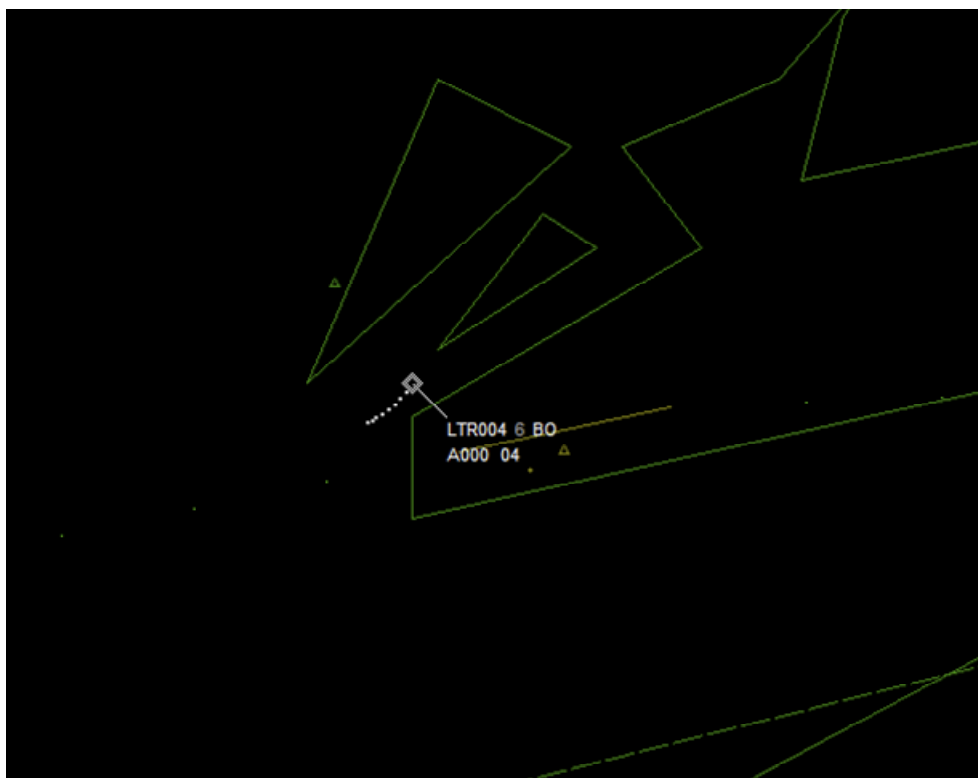
Radar print-out at 14:38:30Z. Position approx. 1 NM from runway 07 threshold, altitude 0 ft, 40 KGS. Course towards Lille Hjartøy.

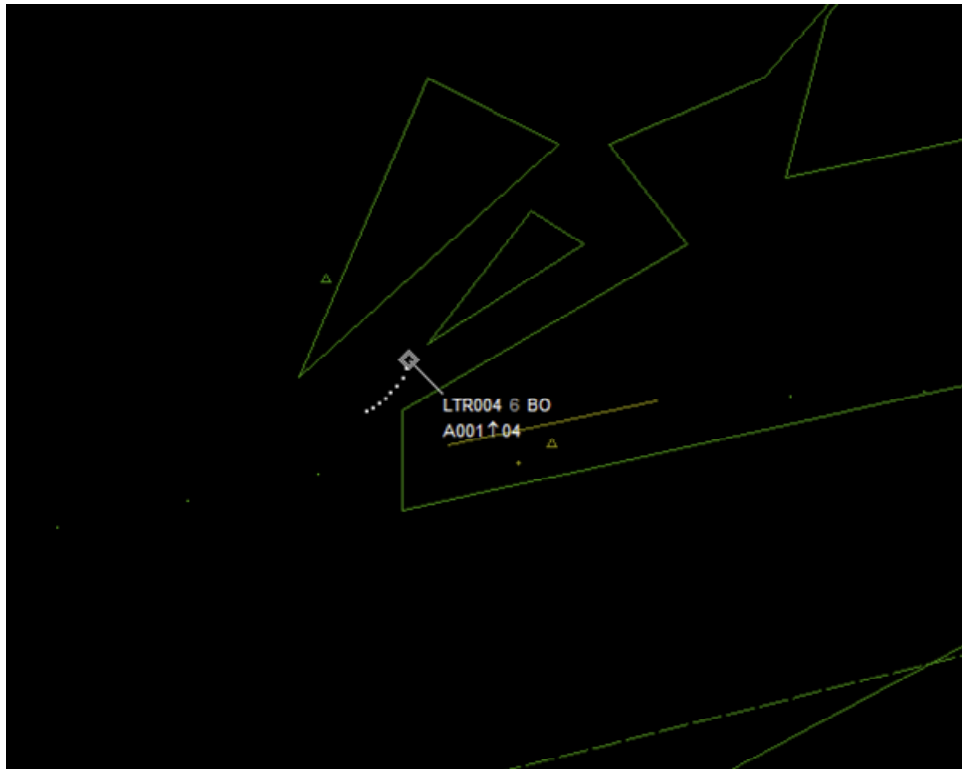
Radar print-out at 14:38:38Z. Position approx. 200 m from Lille Hjartøy, altitude 100 ft in a climbing left turn following request from TWR/Radar, 40 KGS.

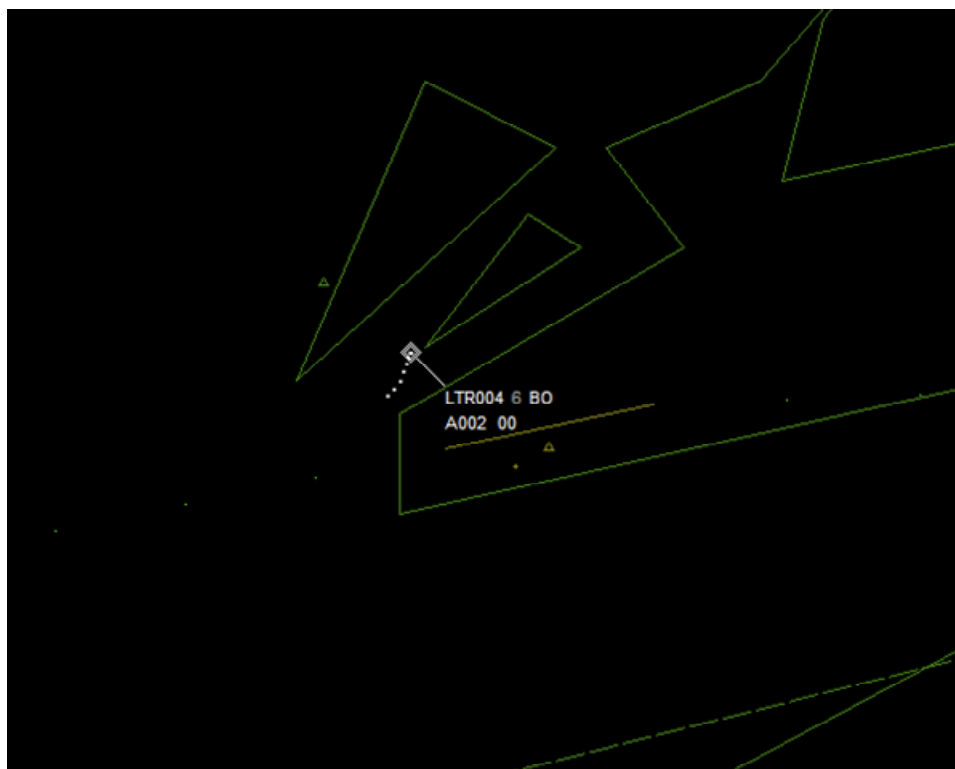
Radar print-out at 14:38:54Z. Position approx. 100 m from Lille Hjartøy, altitude 200 ft, ground speed 0 KGS with winds from approx. 090° 25-30 kt.

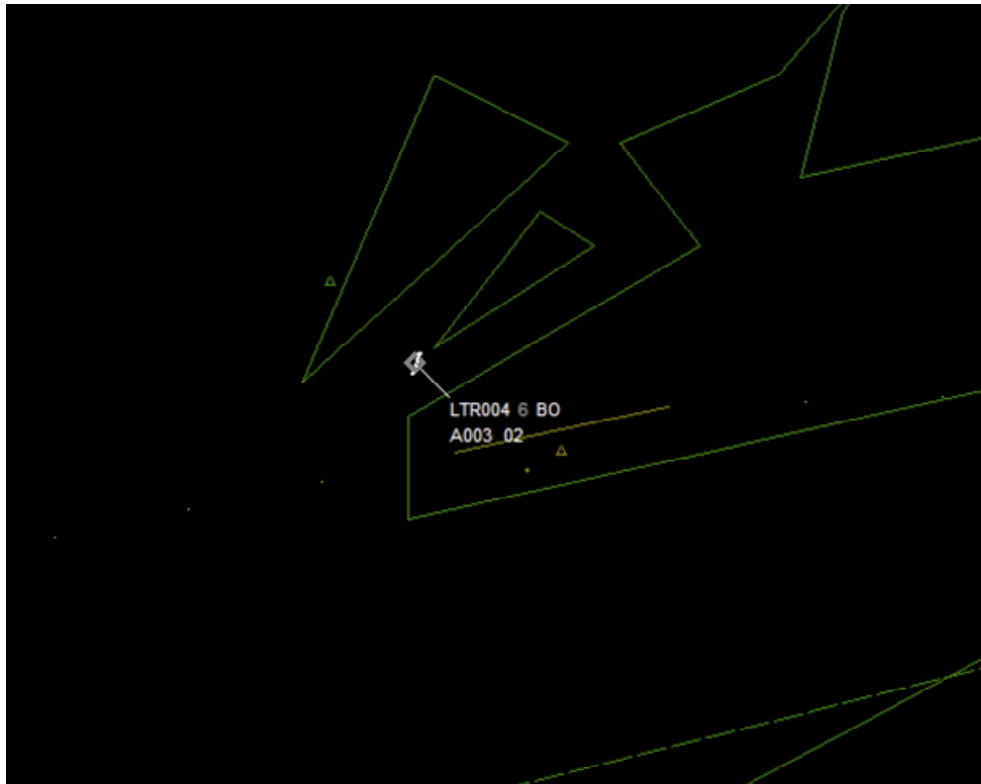
Radar print-out at 14:39:04Z. Position approx. 100 m from Lille Hjartøy, hover at 300 ft.

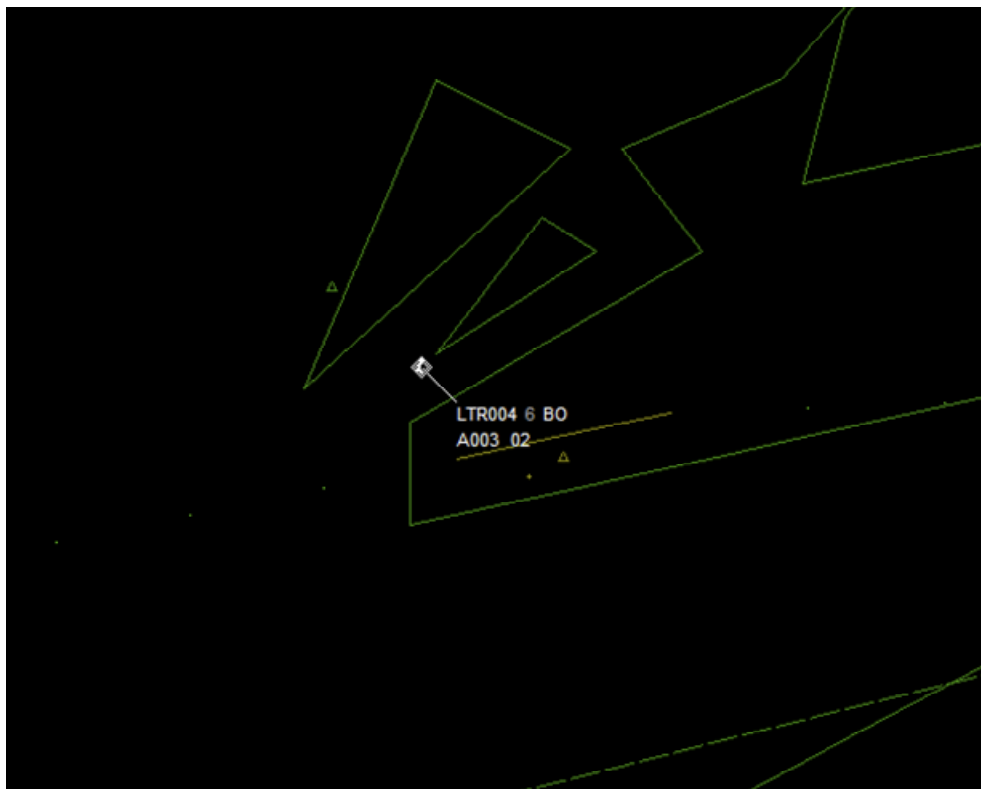
Radar print-out at 14:39:12Z. Position approx. 100 m from Lille Hjartøy, hover at 300 ft.

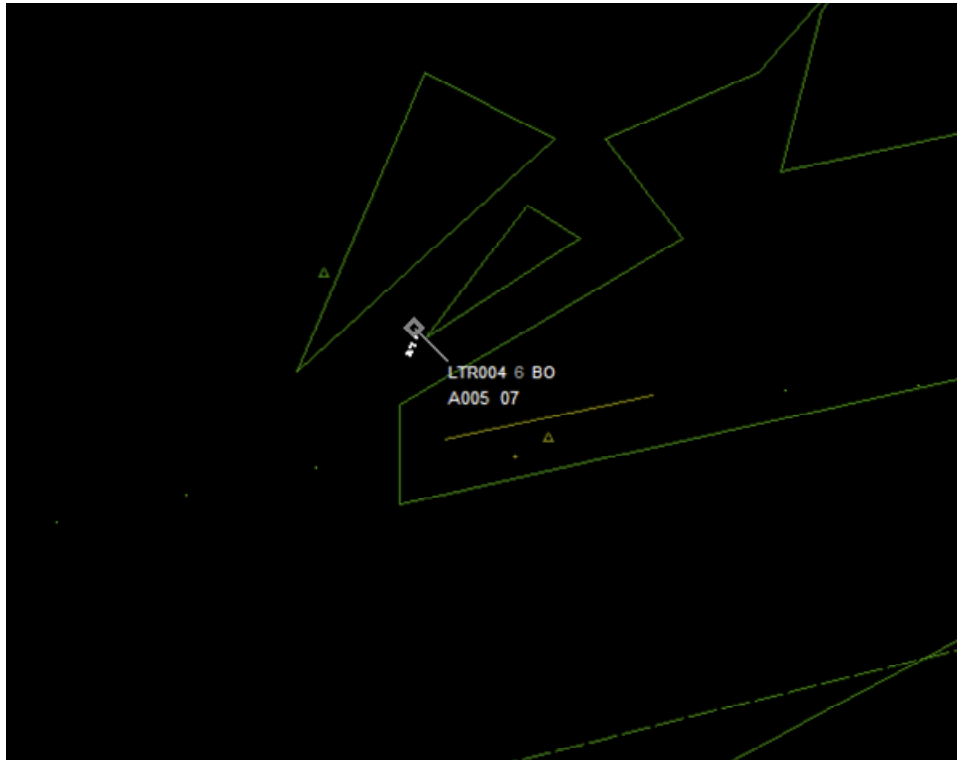
Radar print-out 14:39:23Z. Position approx. 100 m west of Lille Hjartøy in a climbing left turn after a strong request from TWR/Radar. Altitude 500 ft, ground speed 70 KGS with tailwind.

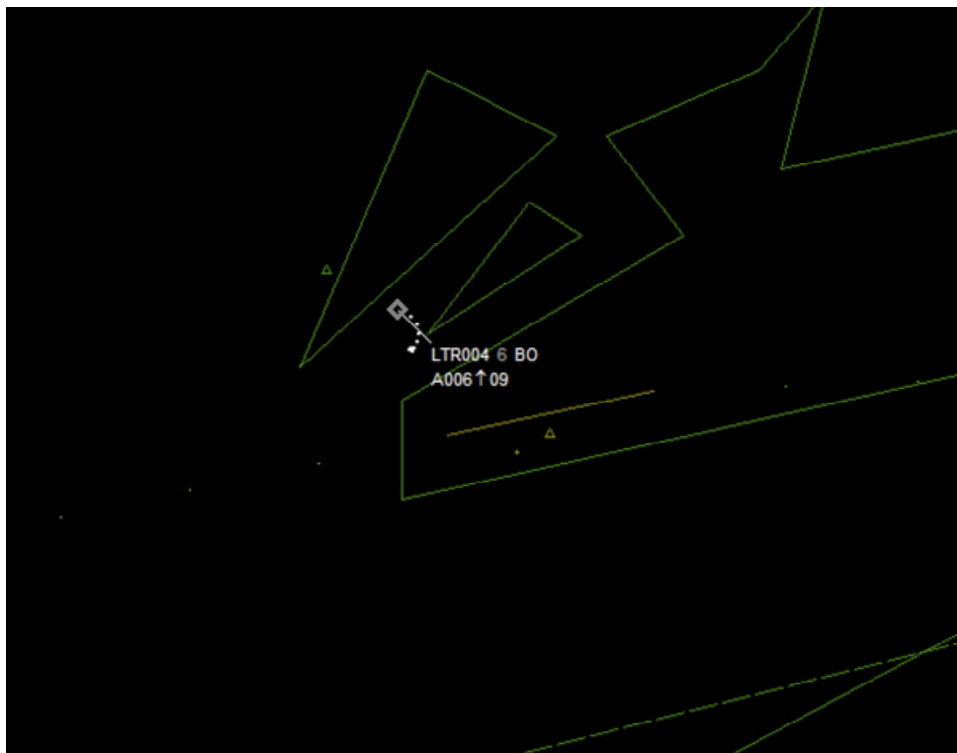
Radar print-out at 14:39:30Z. Position approx. 100 m east of Store Hjartøy in a left climbing turn, altitude 600 ft, ground speed 90 KGS in tailwind.

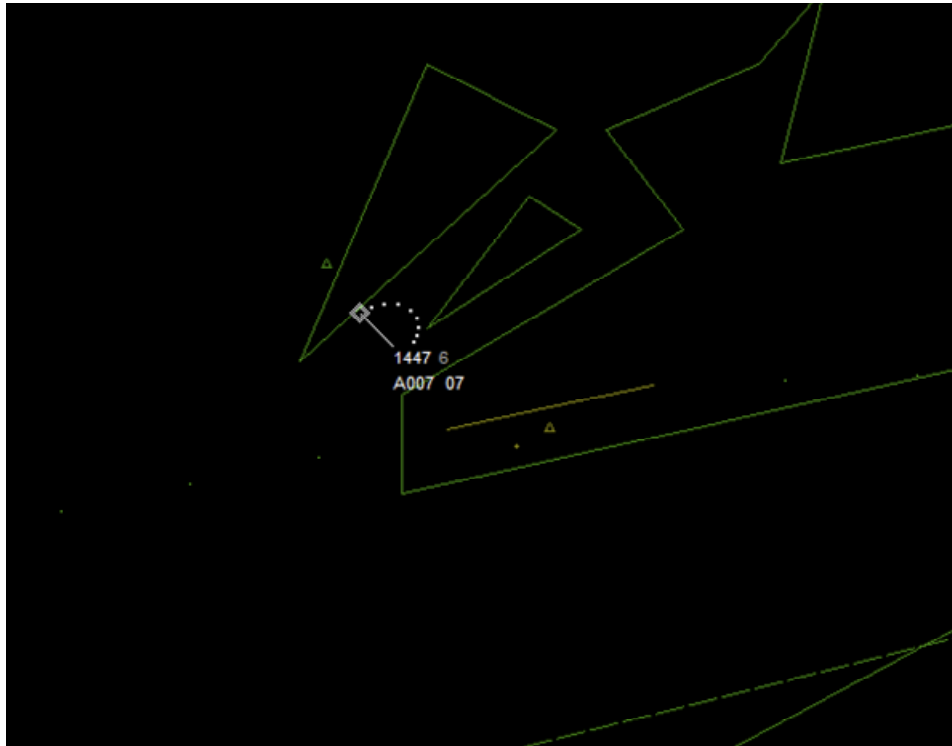
Radar print-out at 14:39:41Z. The position is tangential to the east side of Store Hjartøy, altitude 700 ft, ground speed 70 KGS, course 180°.

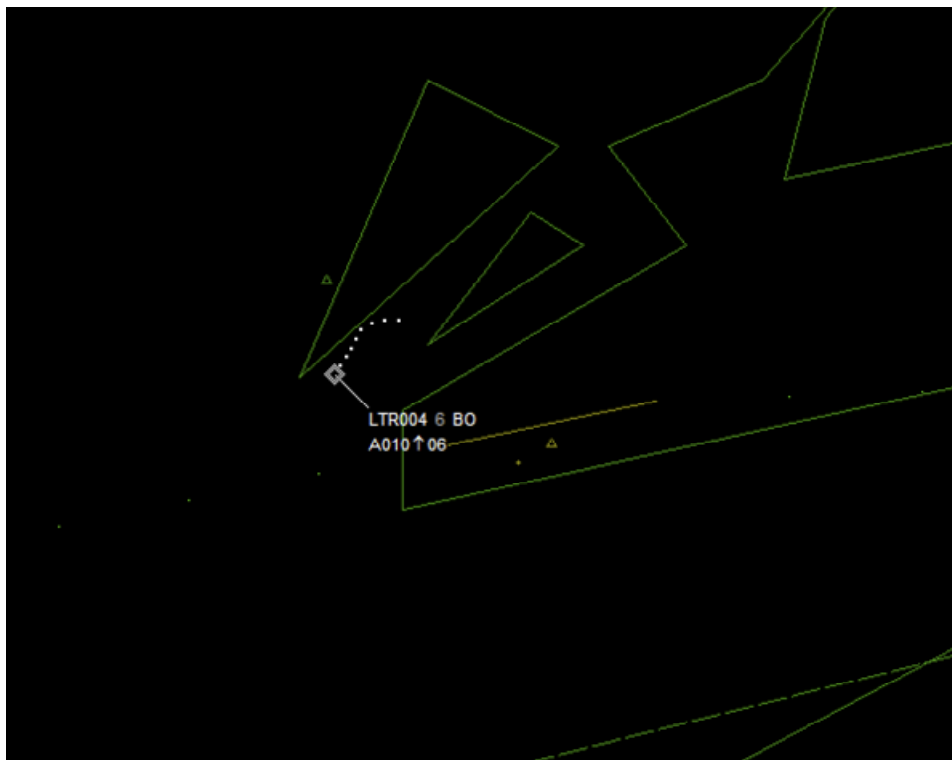
Radar print-out at 14:40:00Z. Position approx. 100 m east of the southern point of Store Hjartøy, altitude 1 000 ft. and climbing, ground speed 60 KGS, course 180°.

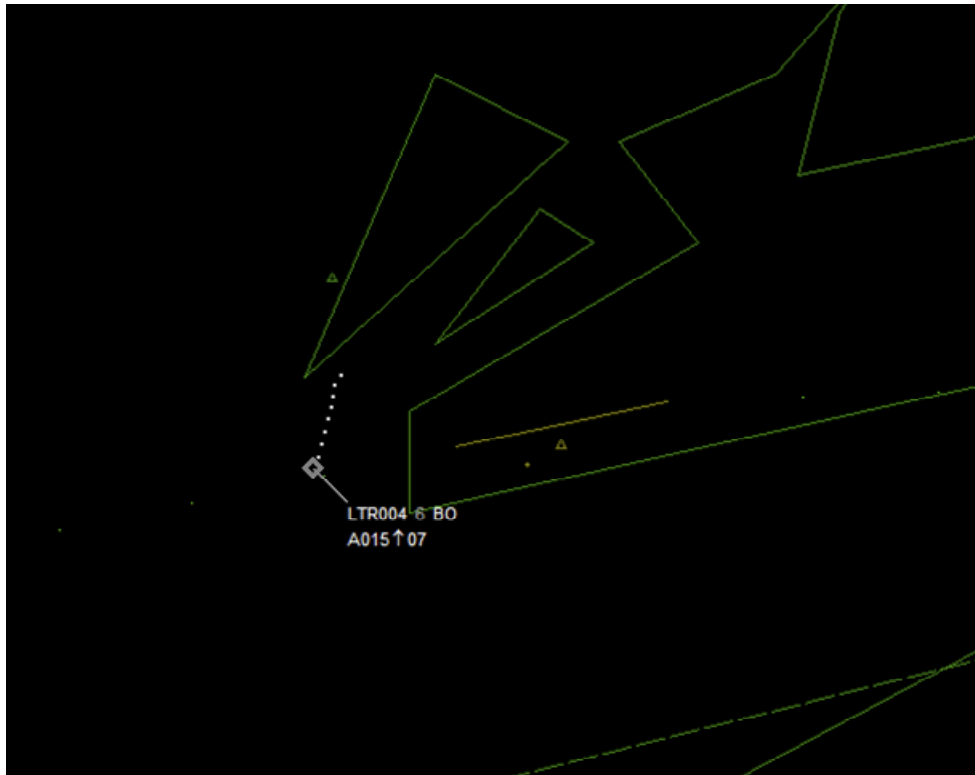
Radar print-out at 14:40:31Z. Position approx. 2 NM west of runway 07 threshold, crossing Localizer towards the south, altitude 1 500 ft and climbing, ground speed 70 KGS, course 180°.

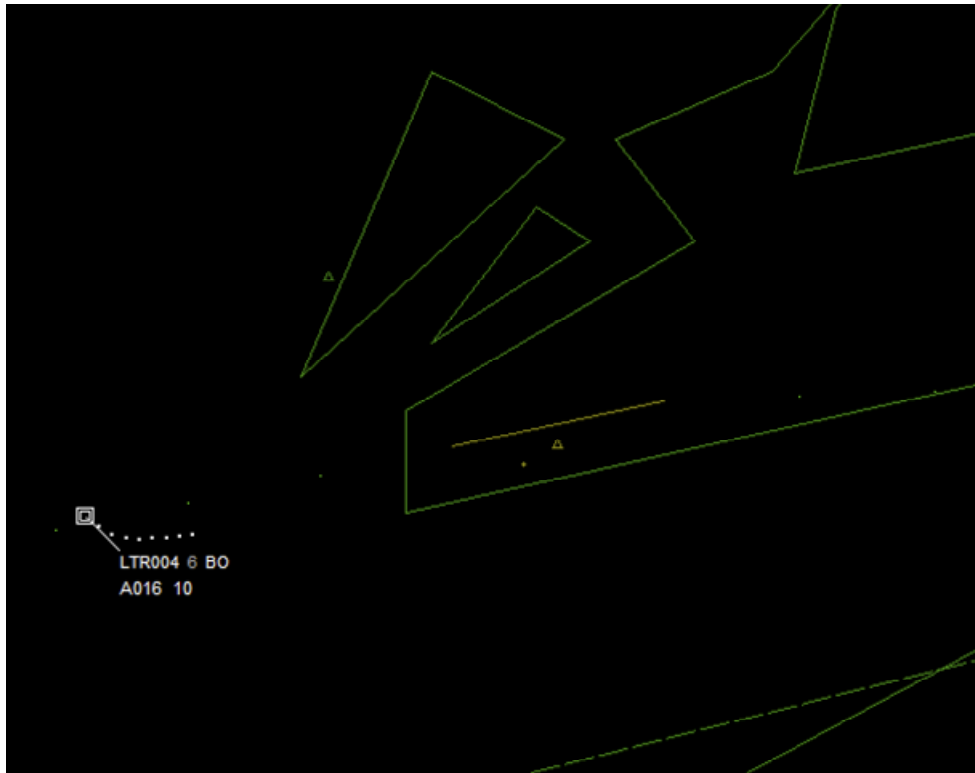
Radar print-out at 14:41:45Z. Position approx. 4 nm NM west of runway 07 threshold, altitude 1 600 ft, ground speed 100 KGS in approx. 30 kt of tailwind, course north-west through Localizer.
