SL 2011/20

## REPORT ON SERIOUS AIRCRAFT INCIDENT 2-3 NM NORTH OF RYGGE, NORWAY ON 2 JULY 2005 WITH DIAMOND DA40-D, LN-NEX

Aircraft: Diamond Aircraft Industries GmbH, DA40-D  
Nationality and registration: Norwegian, LN-NEX  
Owner: Oslo Flyveklubb, Norway  
User: Same as owner  
Crew/commander: Male, 26 years old  
Passengers: None  
Incident site: 2 – 3 nm north of Rygge Air Force Base (ENRY)  
Date and time of the incident: Saturday 2 July 2005 at 1158 hours

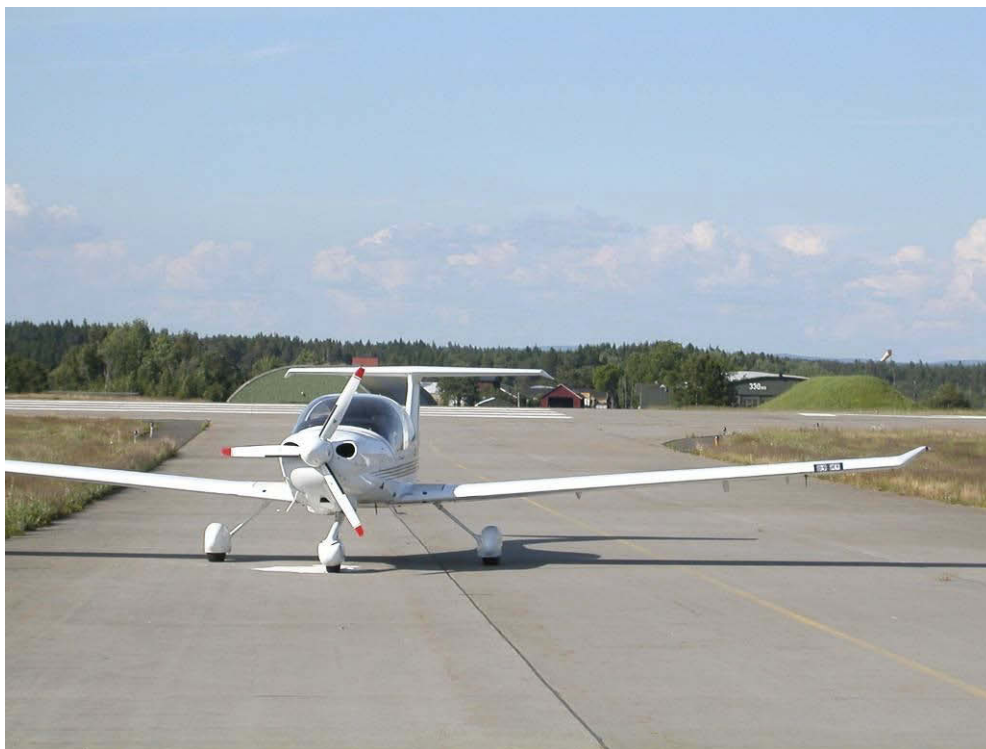
Figure 2: Picture taken shortly after the landing. The aircraft approached over the two hangars in the background.

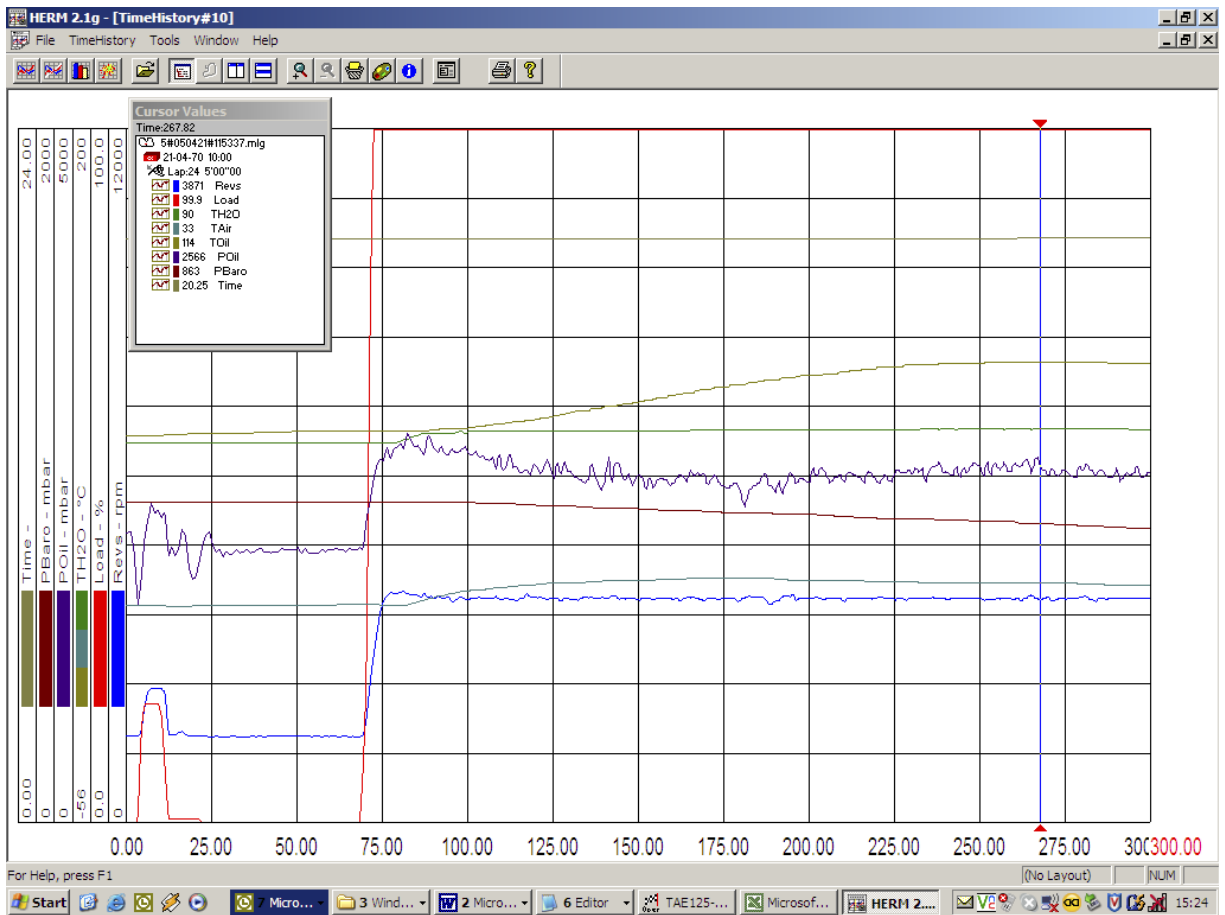
1.11.3 The data log shows that the oil pressure after departure from Fagernes on 19 April was approximately 2.5 bar, but that it dropped slowly to 2.3 bar approximately 25 minutes into the flight. . During the approach to Kjeller, approximately 36 minutes after departure, the oil pressure had dropped to 2.1 bar. This emerges from the printouts from the data logs below.

Figure 3: The FADEC data log printout shows that the oil pressure (dark blue graph) was approximately 2.5 bar during the departure from Fagernes on 19 April 2005.

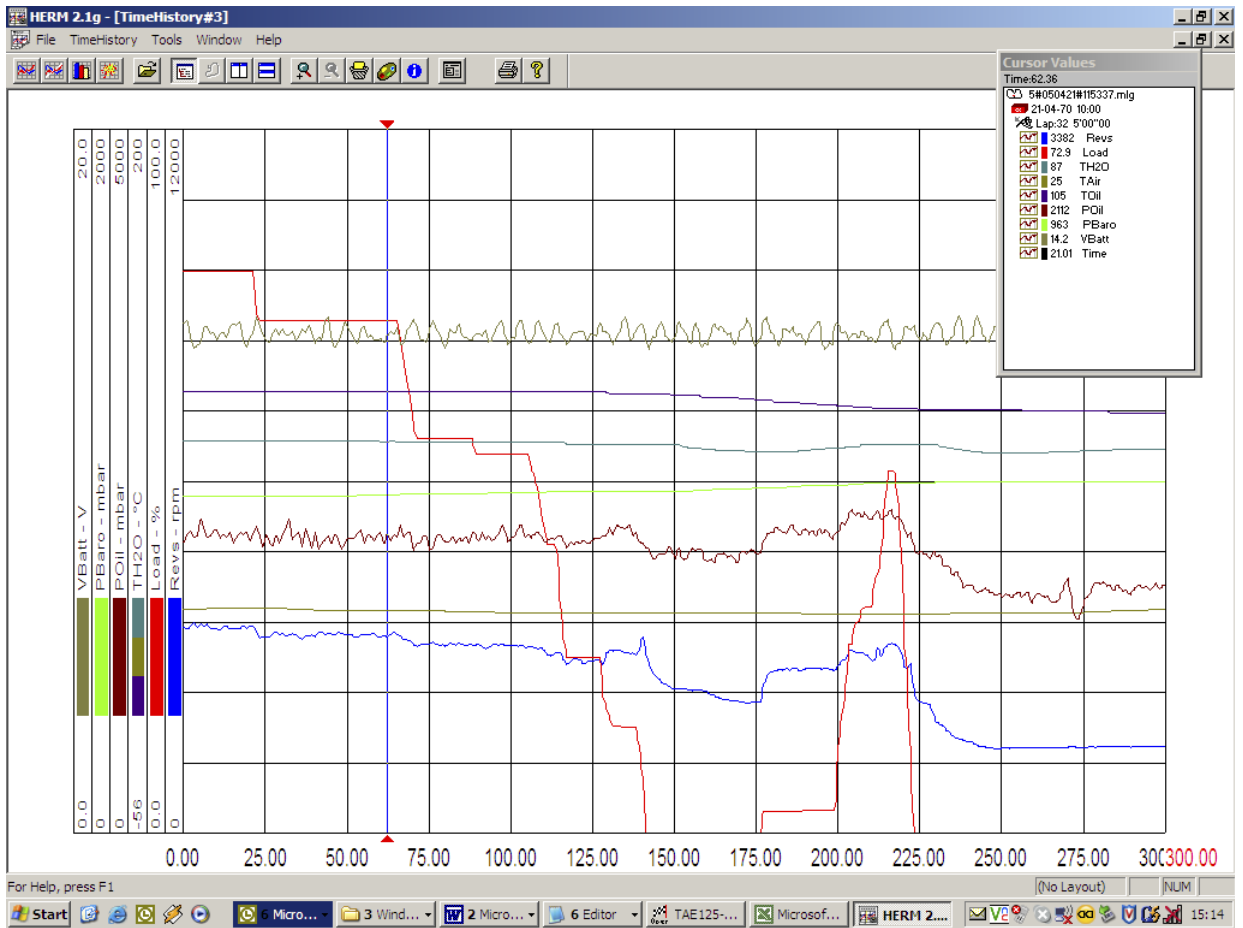
Figure 4: Printout from the FADEC data log showing that the oil pressure (brown graph) was approx. 2.1 bar during the approach to Kjeller on 19 April 2005.

- j) For a brief period on 19 April 2005, the engine flew with an insufficient oil level and an oil pressure of 2.1 bar. Even though the pressure was well above the minimum stated by the engine manufacturer it is probable that this, in combination with the low level, caused overheating in the engine which in turn led to the engine failure.

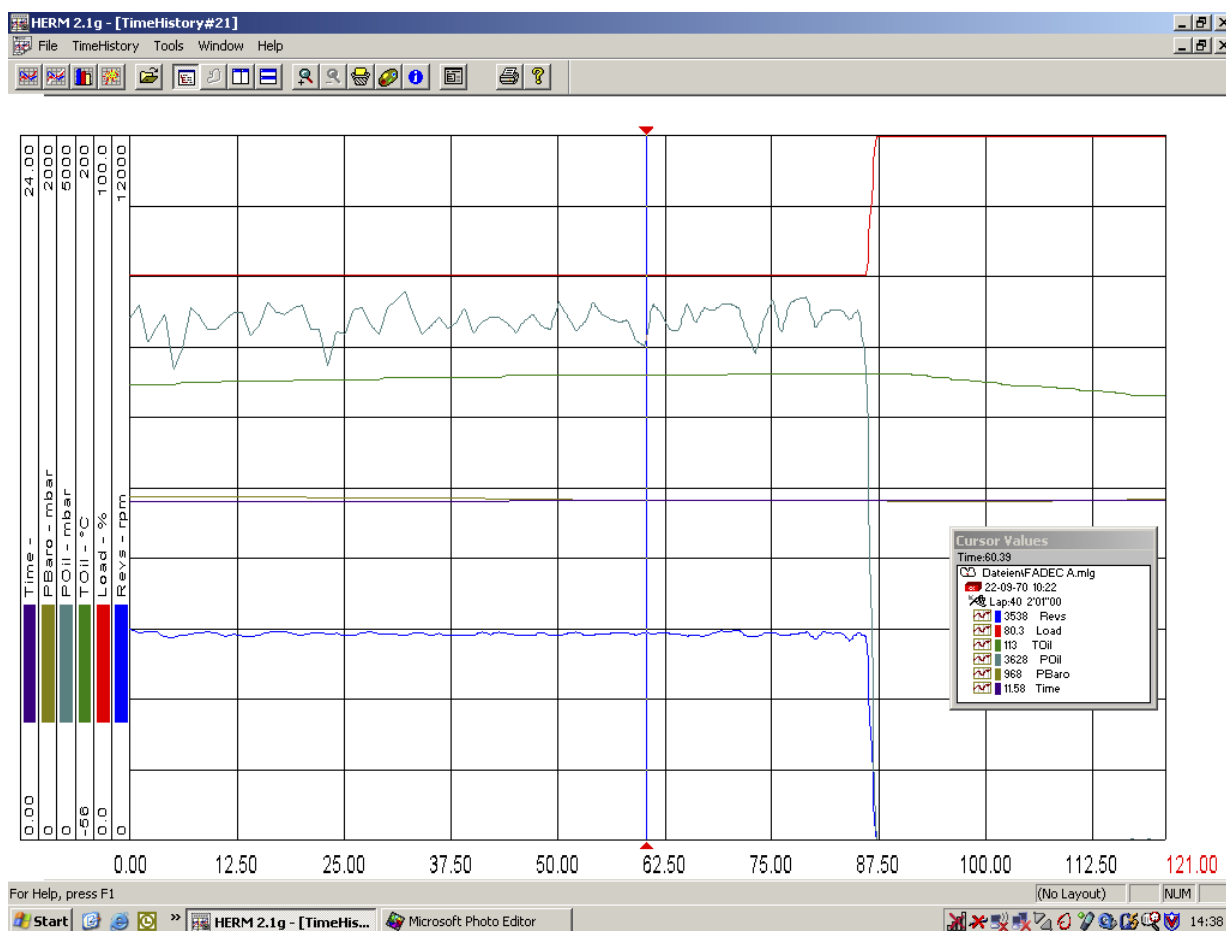
Figure 5: Printout from the FADEC data log showing that the oil pressure (turquoise graph) was 3.6 bar before the engine suddenly stopped.

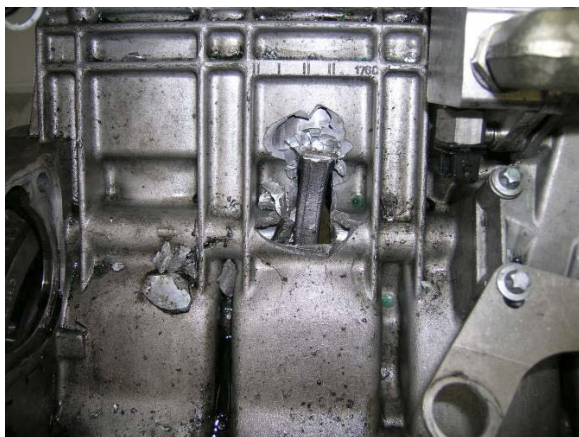
- 1.12.1 The investigation conducted at the site of the emergency landing confirmed that there was a hole on the lower right-hand side of the engine where the crankshaft was visible, and a hole on the left side where parts of a connecting rod were sticking out. Furthermore, there was engine oil and cooling fluid leakage in the engine compartment. It was decided that the aircraft should be transported to the Accident Investigation Board's premises in Lillestrøm so that the engine could be removed and sent to the engine manufacturer Thielert in Germany for closer inspection (see chapter 1.16).
- 1.12.2 During the removal, approximately 3 liters of engine oil level were drained from the engine.

Figure 6: The left-hand side of the engine with the connecting rod sticking out.

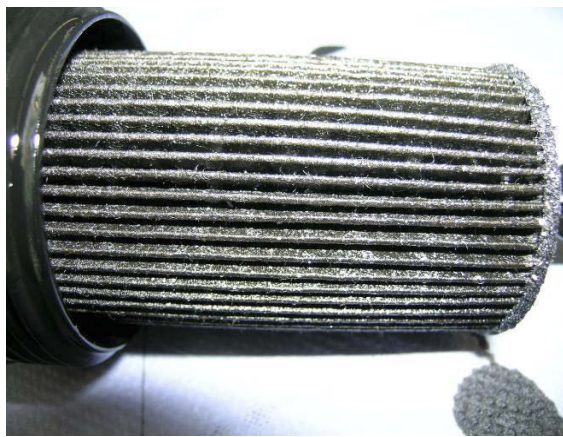
Figure 7: The engine oil filter contaminated by metal particles.

- The engine's primary oil pump was intact and showed little sign of wear and tear. However, there were small grooves on the cog wheels indicating that the oil had been contaminated by metal particles.

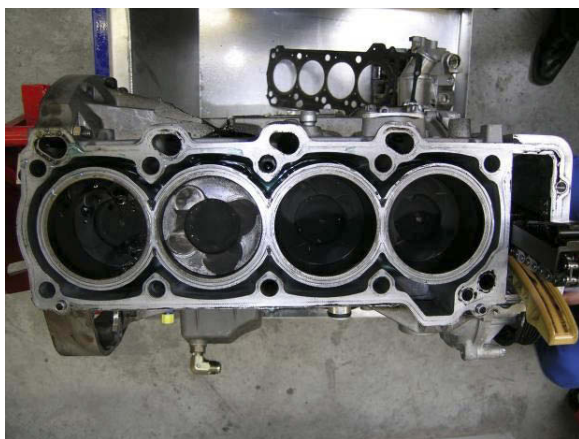
Figure 8: Picture viewing down into the cylinders. The piston in cylinder no. 3 (no. 2 from the left) was slightly damaged as a result of the impact with the cylinder head.

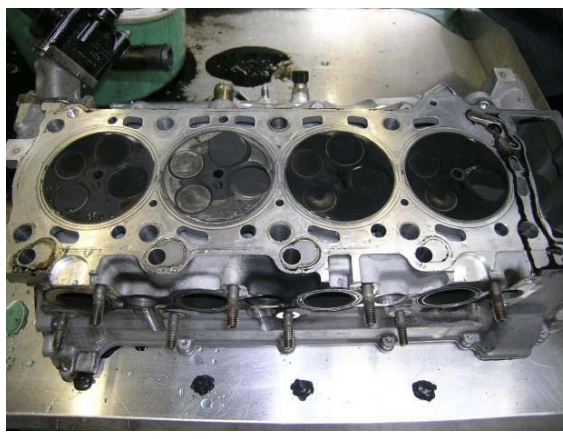
Figure 9: Corresponding damage to the cylinder head in cylinder 3.

- The bearings and the cams on the camshafts were in good condition.
- The cylinder head was in good condition, but there were clear evidence from impact between the piston and the cylinder head with associated valves in cylinder no. 3. There was some carbon on the cylinder head of the other cylinders, but this had nearly disappeared due to the impact with the piston in cylinder no. 3.

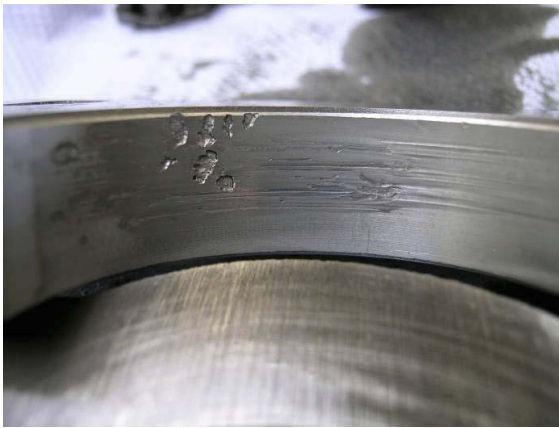
Figure 10: Damage to the crankshaft's journal bearing no. 1.

- The crankshaft bearings were in good condition and showed little sign of wear and tear. However, the journal bearing liners of bearing no. 1 and 2 (opposite end of the gear box) had small areas where there were depressions in the bearing material (see figure 10).

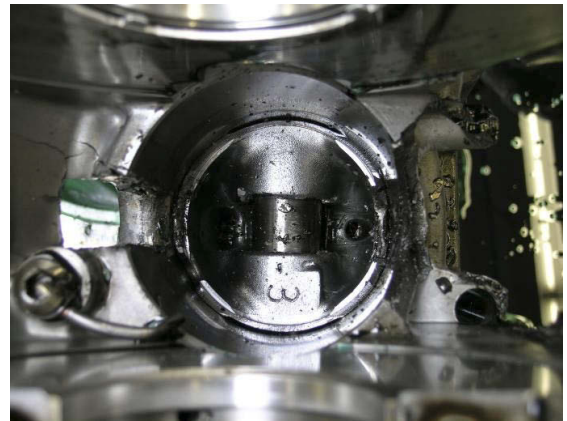
Figure 11: Cylinders and piston no. 3 after the crankshaft and the connecting rod had been removed.

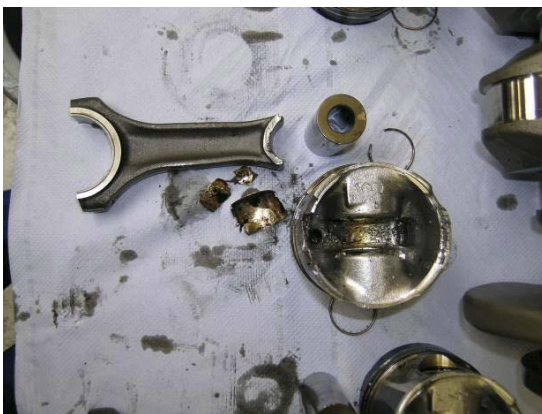
Figure 12: The connecting rod and the piston from cylinder no. 3.

- Rod no. 3 was without the upper half of the small end bearing. The connection rod was slightly bent and the fracture surfaces and the surface of the small end bearing were completely deformed.

- 2.3.3 When the small end bearing split, the piston disconnected and became stationary. Later, it was struck by the rod on its way up the cylinder. This has most likely resulted in the piston striking the valves with such force that one of the valve rocker arms broke. How many times the loose connecting rod has travelled up and down inside the cylinder cannot be established. At one time, however, it came below the edge of the cylinder skirt. On its way up again it pushed through the cylinder wall, through the water jacket and all the way to the outside of the engine. This resulted in the engine going from practically normal rotational speed to full stop in the course of less than half a rotation. The hole in the crankcase on the engine's right-hand side was most likely caused by the loose rod at one time also having broken through the wall of the crankcase.

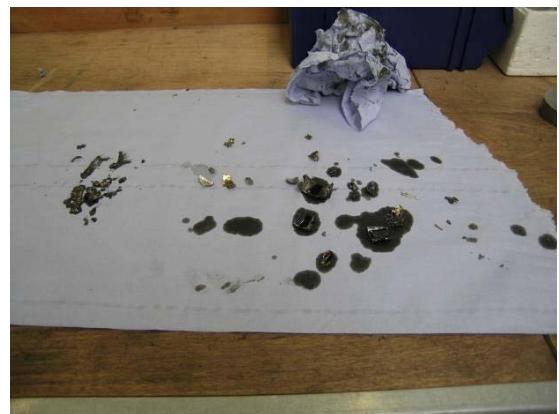
Figure 13: Small and large metal debris were discovered in the oil pan and oil filter unit.

- There was a lot of burnt carbon on the inlet valves.
- The oil sump contained large amounts of ground-up bearing materials, parts of the upper end of connection rod no. 3 and several crankcase bits.

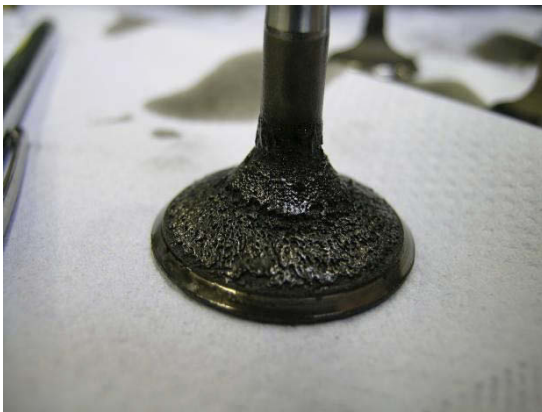
Figure 14: Burnt carbon deposits on the inlet valve.

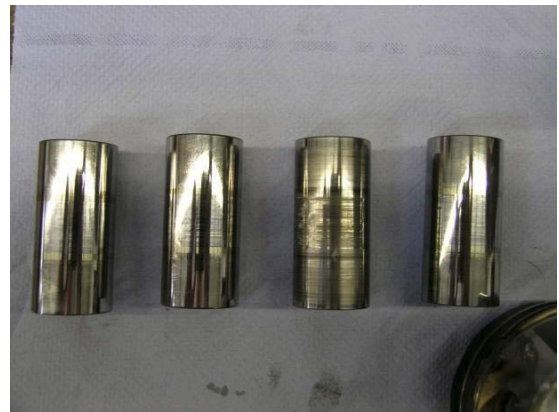
Figure 15: The colors on the gudgeon pins indicate overheating.

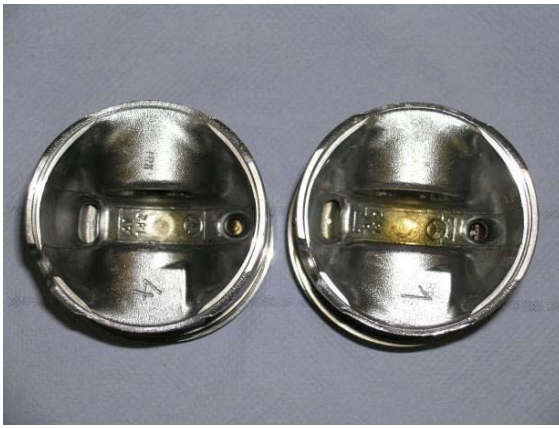
Figure 16: Color difference. Piston which has run for 1000 hours (reference piston) to the left and piston no. 1 from LN-NEX to the right.

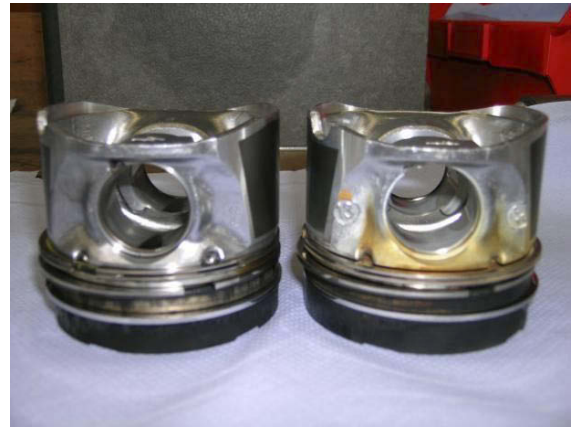
Figure 17: Color difference. Piston which has run for 1000 hours (reference piston) to the left and piston no. 1 from LN-NEX to the right.

- 2.3.2 The color differences on the pistons indicate that they have been considerably hotter than the reference piston (see Figure 17). The color differences on the gudgeon pins also indicate a high temperature. The small end bearing is normally one of the most heavily strained bearings in a piston engine. The small end bearing in the connecting rod may have failed because the steel alloy in the connecting rod was impaired as a result of high temperatures. Due to mechanical damage in the fracture surface it has not been possible to retrieve information based on the fracture surface itself. It is also possible that the high temperature caused deterioration in the small end bearing and thus abnormal strain on the connecting rod.
