SL 2013/17

## REPORT CONCERNING AIR INCIDENT DURING APPROACH TO OSLO AIRPORT GARDERMOEN ON 19 DECEMBER 2008 WITH AIRBUS A320-214, VP-BWH

Date of  
submission: 11.06.2013  
SL Report: 2013/17

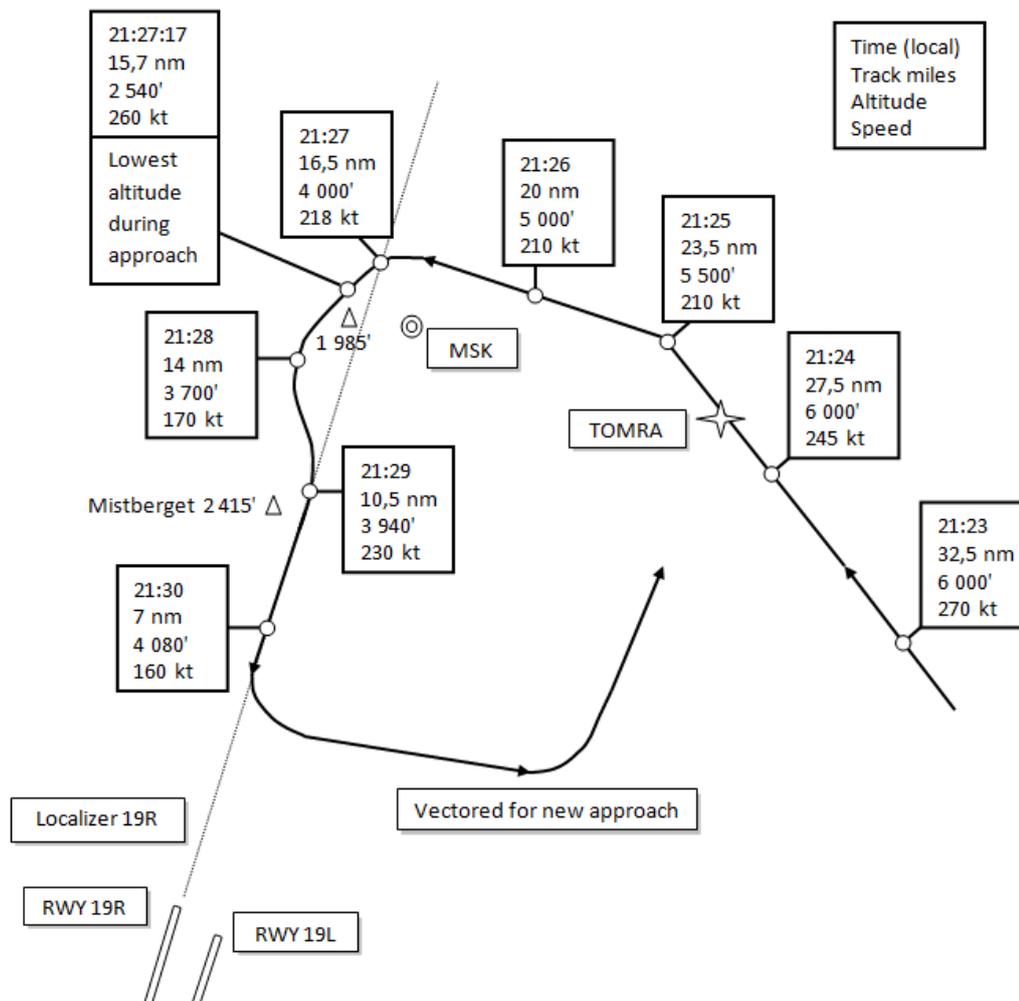
Figure 2: The estimated flight path based on radar data and flight data recorder.

At 21:25:14 hrs, DIR repeated that runway 19R had to be used for landing and that the change was due to weather conditions at the airport. At 21:25:50 hrs, AFL211 acknowledged that they had understood the new instructions. AFL211 then had about 20 NM left to fly before landing at Gardermoen. The aircraft's position was approximately 4 NM from localiser 19R. This means that the crew had about one minute to go before the aircraft would turn onto the final approach (see Figure 2 at 2126 hrs). The aircraft was configured with "Flaps 1" and had a speed of 210 kt. Maximum speed for the configuration is 230 kt.

The commander has explained that he did not feel comfortable with the situation and that he considered requesting vectors for a new approach. Due to a lot of traffic on the radio, and the fact that the aircraft was quickly approaching “capture” on localiser 19L, a situation with time pressure arose. The commander therefore decided to reprogram FMGS to follow the approach to the cleared runway 19R.

Air traffic control's clearance to approach 19R was issued without giving AFL211 an intercept heading. When the commander activated “approach mode”, the aircraft was so close to the localiser that “capture” happened almost immediately. When AFL211 captured the localiser, the aircraft flew through the LOC at an angle of about 90 degrees, and as a result the autopilot intensively banked the plane to the left with some sideslip to capture the localiser beam. When the commander raised his head, after having made inputs to the FMGS control panel, he got an illusion of aggressive aircraft pitch up instead of bank. Instinctively he deactivated the autopilot and pushed the sidestick down to counteract the fictitious aircraft pitch up motion. According to his own description of the situation, the commander was disoriented at the time and therefore aborted the approach. He deactivated the autopilot and autothrottle in an attempt to regain control and situational awareness. After the incident the commander explained that he most likely was exposed to spatial disorientation.<sup>1</sup> The Australian Transport Safety Bureau (ATSB) has issued a safety study: “*An overview of spatial disorientation as a factor in aviation accidents and incidents*” ([B2007/0063](#)) describing and analysing the phenomena.

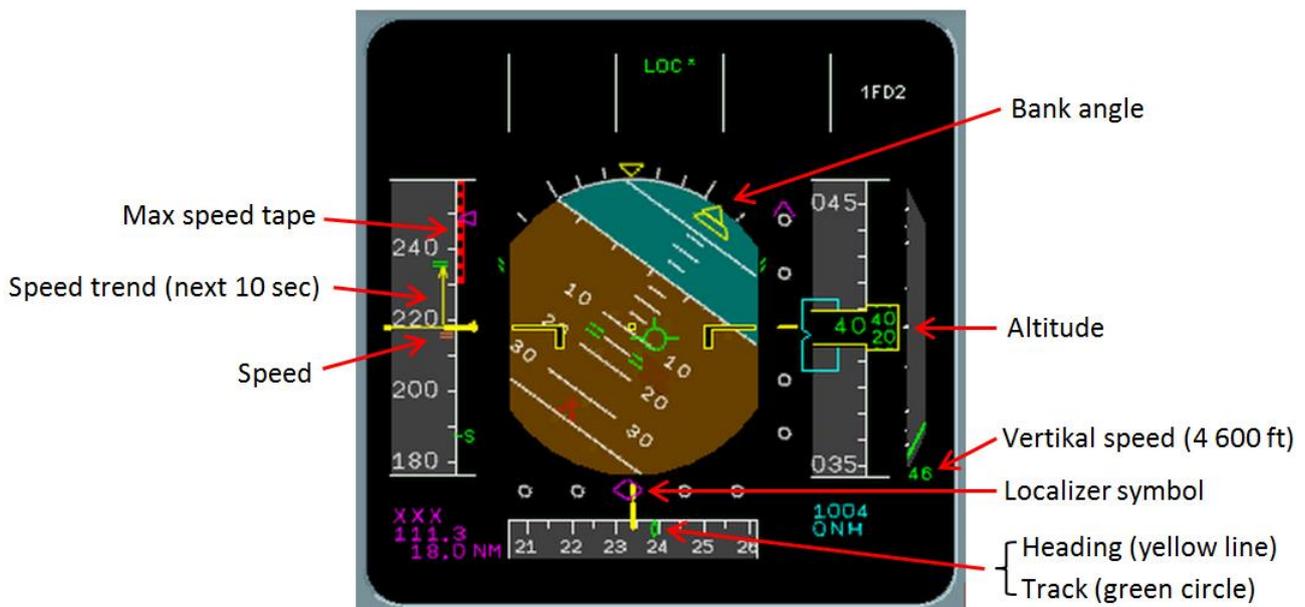
Figure 3: Still picture from animation based on data from the flight data recorder (FDR).

When the commander deactivated the autopilot, the aircraft was at 4 380 ft with a 30° bank to the left and a descent rate of 2 200 ft/min. When the aircraft passed 4 000 ft a few seconds later, the bank was approximately 35° and the descent rate had increased to 4 600 ft/min (see Figure 3). At the same time, the aircraft was flying through the localiser with a heading of approximately 240°, still in a left turn to follow the localiser which has an inbound approach course of 195°.

The aircraft continued with a descent rate which maxed out at 5 800 ft/min before the commander made corrections which reduced the rate. The speed increased due to the high descent rate, and the first officer has explained that he reacted by calling out “speed-speed” to notify the commander that the speed was approaching maximum permitted speed limit. He did not recognise the absence of the commanders’ response as a sign of incapacitation and therefore did not intervene by taking controls. However flight data recorder shows that the co-pilot on two occasions briefly introduced back stick force during the pullout. The EGPWS<sup>2</sup> terrain warning system was activated: “TERRAIN AHEAD – TERRAIN AHEAD”.

The aircraft was maneuvered to wings level and after a while the commander was able to recover the aircraft back to the cleared altitude of 4 000 ft. The altimeter showed that the aircraft had been down to 2 540 ft at the lowest before it started climbing again. The radar altimeter showed that the lowest altitude above the terrain during the incident was 2 030 ft. About 17 seconds elapsed from when the aircraft passed the cleared altitude of 4 000 ft and until it reached the lowest altitude of 2 540 ft. During this time, the speed increased to 260 kt which is 30 kt higher than the maximum permitted for the configuration with “flaps 1”.
