REPORT

SL 2013/18

REPORT ON AIR ACCIDENT AT BRANNSLETTA IN NESSEBY IN FINNMARK COUNTY NORWAY ON 26 NOVEMBER 2009 WITH EUROCOPTER AS 350 B3, LN-OML OPERATED BY HELITRANS AS

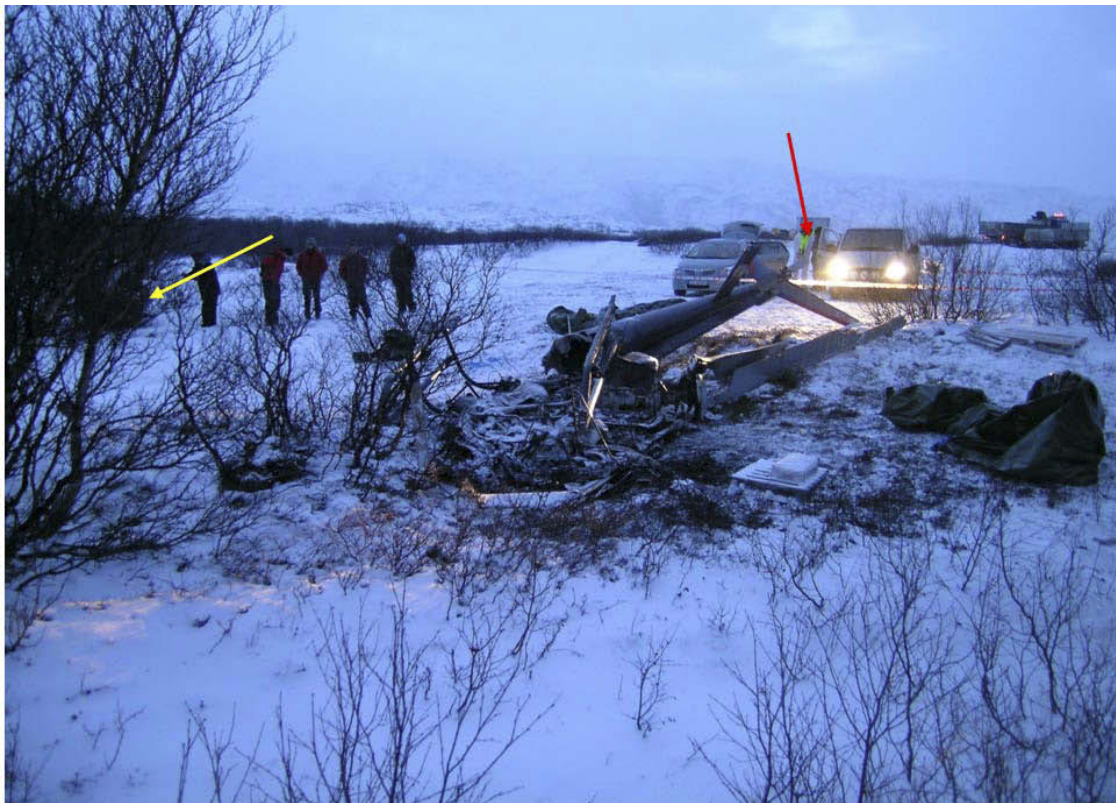
burned-out wreckage ended up approx. 55 m west of where the cargo was supposed to be put down. The excavator with the longline attached ended up approx. 13 m south of the helicopter wreckage.

Figure 4: The helicopter wreckage seen towards the southwest. The plan was to put the excavator part down in front of the container (red arrow). The excavator ended up next to some trees by the persons in the picture (yellow arrow). Photo: AIBN

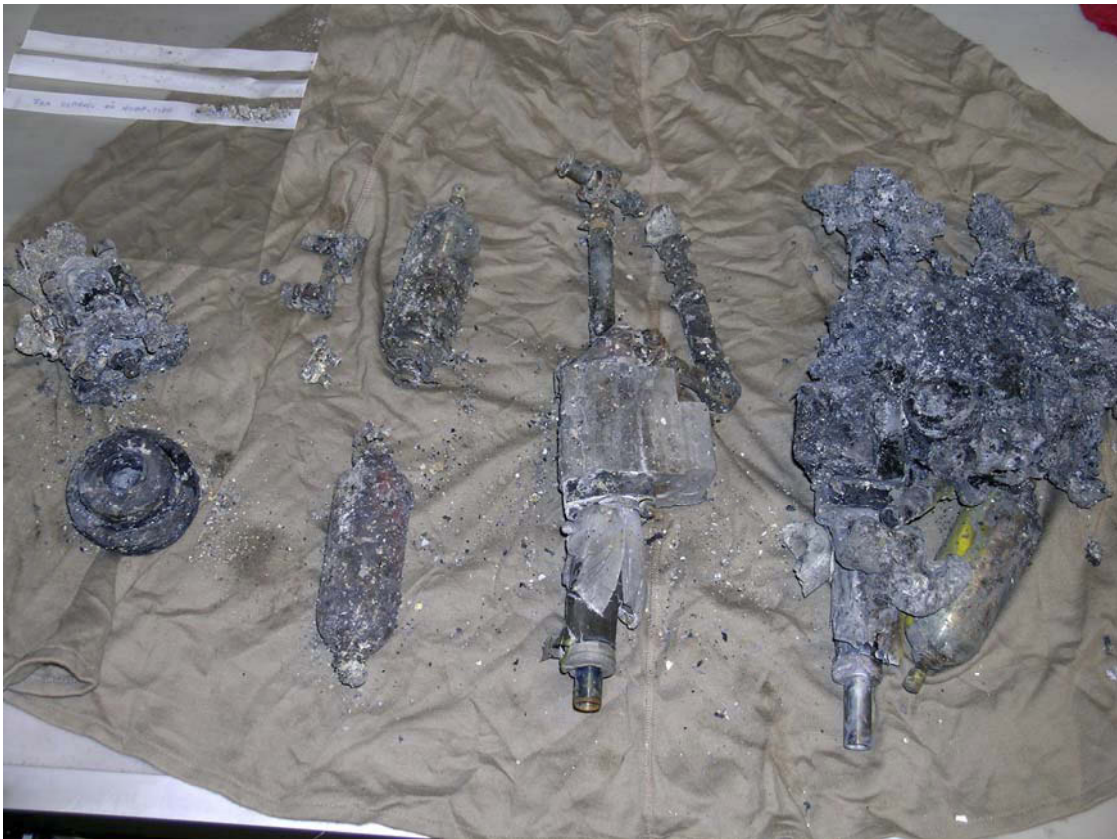
- 1.12.2.1 The helicopter ended up in one piece. The wreckage burned up, with the exception of the tail, parts of the main rotor and the engine. In addition to the abovementioned parts, the wreckage consisted mainly of ash, melted aluminum and steel parts. Some parts containing a high proportion of steel or aluminum could be identified. It was therefore possible to find the hydraulic pump and the associated steel parts. The steel parts had no obvious breakages or damage. The grooves in the hydraulic pump's driving wheel were partly filled with a charred substance. It was also possible to identify parts of the servos.

Figure 5: From left to right: hydraulic pump with driving wheel, two accumulators, servo without accumulator and complete servo with accumulator. Photo: AIBN

- 2.4.2 Only limited remains of the hydraulic pump were left, but what was possible to study showed no signs of failure. Charred material in the grooves of the driving wheel indicates that the drive belt was in place before the fire started. Leaks in hoses or components in the hydraulic system may explain why the pressure dropped, but it has not been possible to find traces of such leaks.

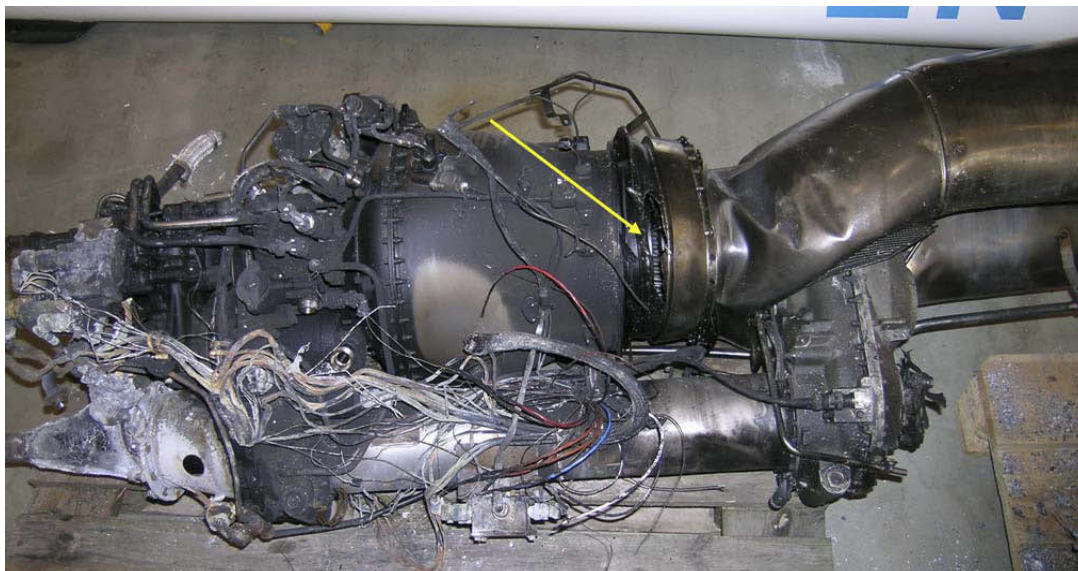
- 1.12.2.3 The engine was found to be intact, protected by the firewalls and partially hidden under a burned-up engine cover. In addition to soot and minor fire damage, the power turbine had lost all its blades. These had pushed forward through the turbine housing with great force just ahead of the turbine's protection ring. Seen from behind, the blades had gone in a direction corresponding to 45° down to the left. In the area around the power turbine, the turbine housing and the exhaust pipe had sustained significant deformation. The engine was partially covered by soot, in particular in front of the power turbine (see Figure 6).

Figure 6: Engine with soot marks. Yellow arrow pointing to the tear where the turbine blades exited. The protection ring is directly to the right of the tear. Photo: AIBN
