REPORT

SL 2013/25

REPORT ON SERIOUS INCIDENT AT OSLO AIRPORT GARDERMOEN ON 31 OCTOBER 2012, AIRCRAFT PROXIMITY (AIRPROX) BETWEEN LN-DYC (NAX741) AND LN-NOM (NAX740), BOTH OPERATED BY NORWEGIAN AIR SHUTTLE ASA

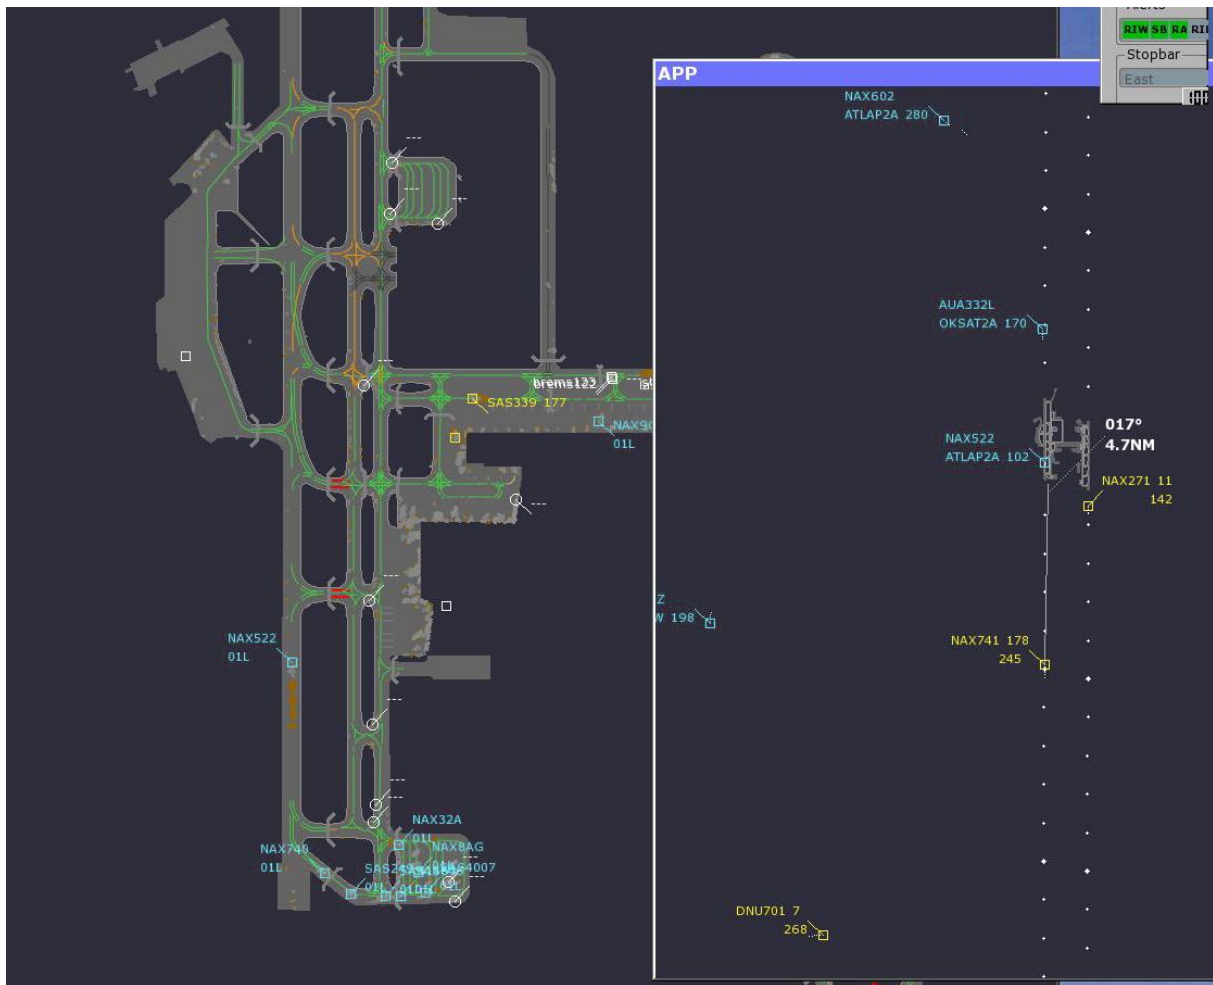
Appendix C: Situation Image from the Traffic Surveillance System

Playback from the ground surveillance system at time 07:33:22 shows the aircrafts' positions relative to each other approximately one minute before NAX741 reported a missed approach.

NAX740 was cleared for takeoff at time 07:33:50. NAX741 reported a "go-around" 40 seconds later. Minimum horizontal distance between the aircraft was registered at time 07:35:28 using FDR data; see Appendix D.

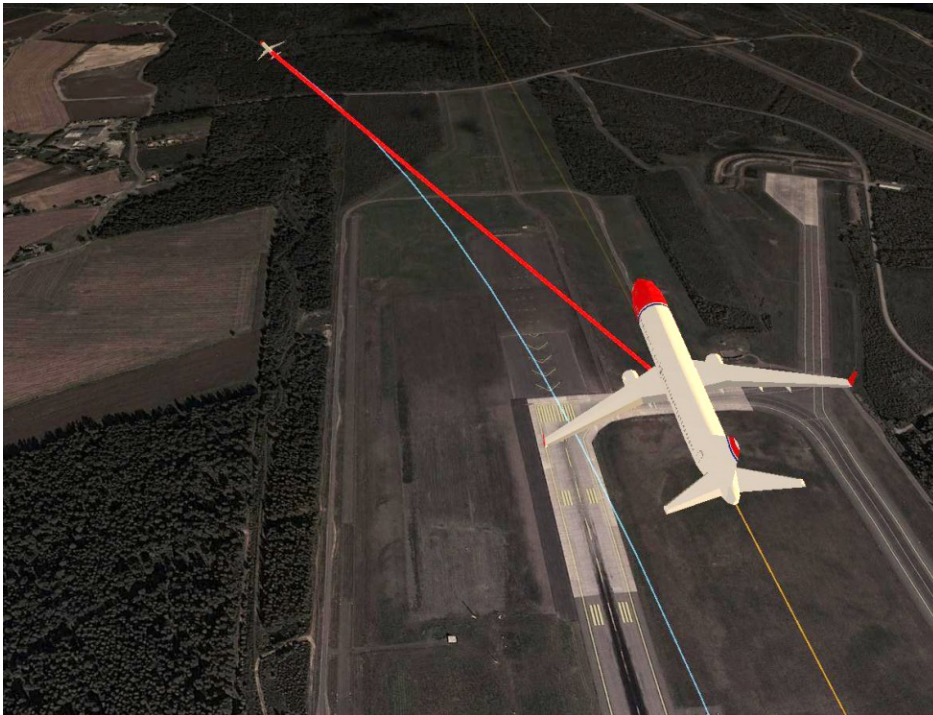
Figure D 1): At time 07:35:28. Correlation of FDR data shows that the minimum distance between the two aircraft was 0.17 NM horizontally and 500 ft vertically. Both aircraft were in clouds at this time, which is not depicted in the image.

Slant range (the red line) is 352 m (0.19 NM), altitude difference was 152 m (500 ft), i.e. the distance between the two aircraft, projected onto the line was 317 m (0.17 NM). Rounded to 0.2 NM.

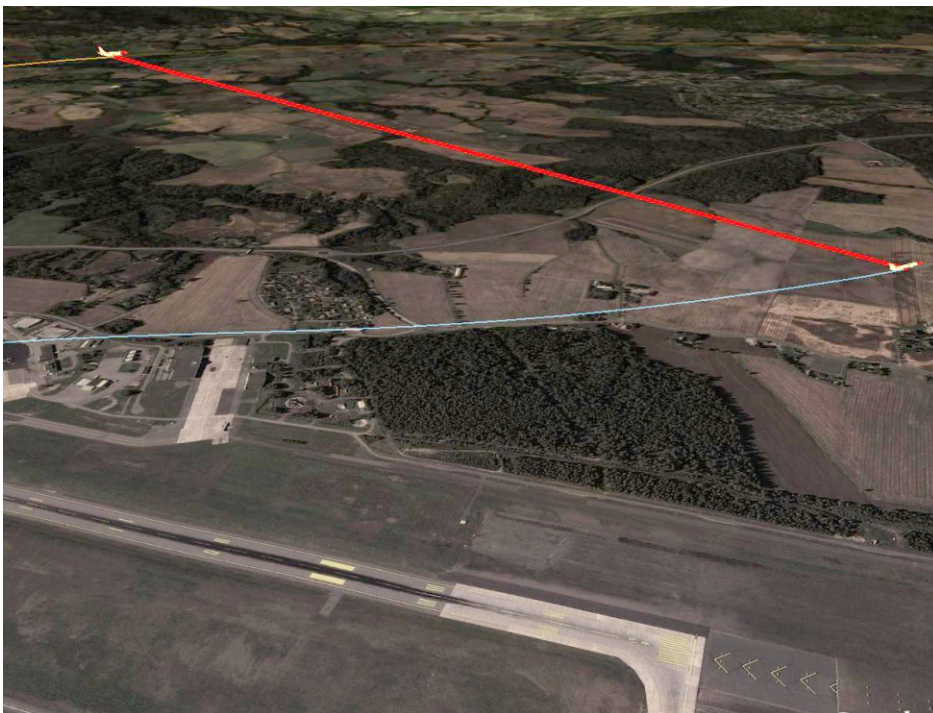
Figure D 2): The same time as in figure D 1, but looking west.
The animation images in the figures were produced at Norwegian Air Shuttle based on FDR data from both aircraft.
