# REPORT

SL 2013/30

## REPORT ON AIR ACCIDENT SOUTHEAST OF MOSJØEN NORWAY 11 JANUARY 2012 WITH ROBINSON HELICOPTER R44, SE-JPZ, OPERATED BY JÄMTLANDS FLYG AB

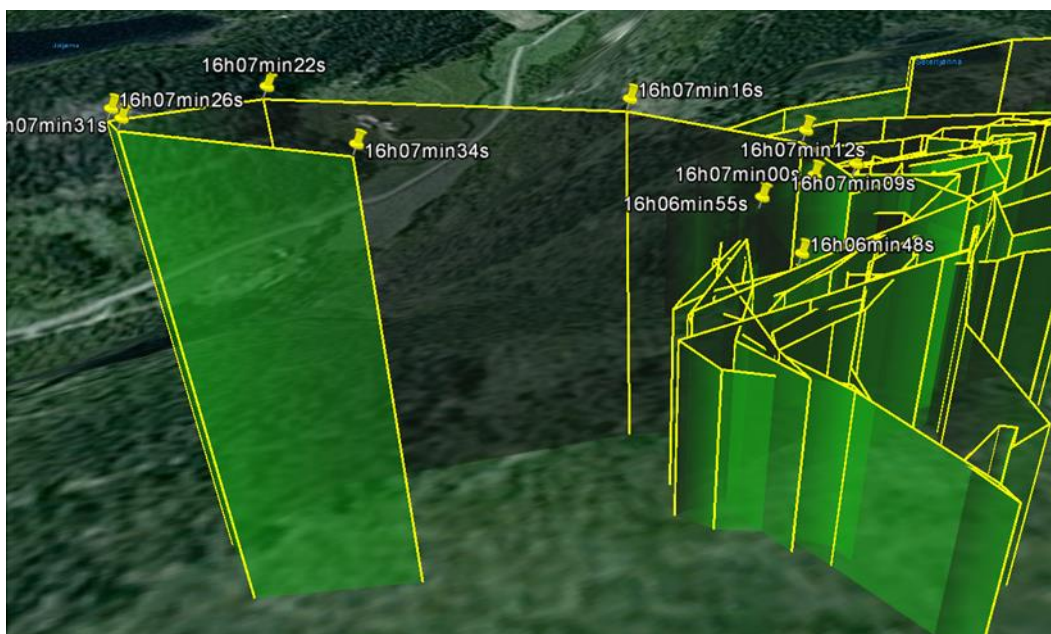
1.11.2 The helicopter was equipped with a Garmin 296 GPS. Data obtained from the tracker in the unit has shown the following (see also Figure 4):

- The helicopter was on the ground for a brief period between 1657 and 1703 hours
- The last registration was at 17:07:34 hours. The helicopter was then approx. 230 feet (70 m) above ground with a heading of approx. 020°.
- In the last 20 seconds before the crash, the helicopter rose 318 feet (97 metres), initially almost vertically.
- 8 seconds before the last registration, the helicopter rose by 625 ft/min, but this became a descent of 260 ft/min over the last three registered seconds.
- Over the last 22 registered seconds, the helicopter turned from a heading of approx. 216° to 020°.
- Over the last 22 registered seconds, the ground speed of the helicopter was 49 kt on average.
- Over the last three registered seconds, the ground speed was 58 kt on average.
- The last registered position was 65° 46' 42.53" N 013° 18' 17.10" E.

Figure 4: The last waypoints from the flight were registered by the helicopter's GPS and entered in a Google Earth map. The time (UTC) is given for the last ten points. The map is oriented to the west and the E6 highway can be seen in the background. The pattern from some of the flight before the crash can be seen on the right.

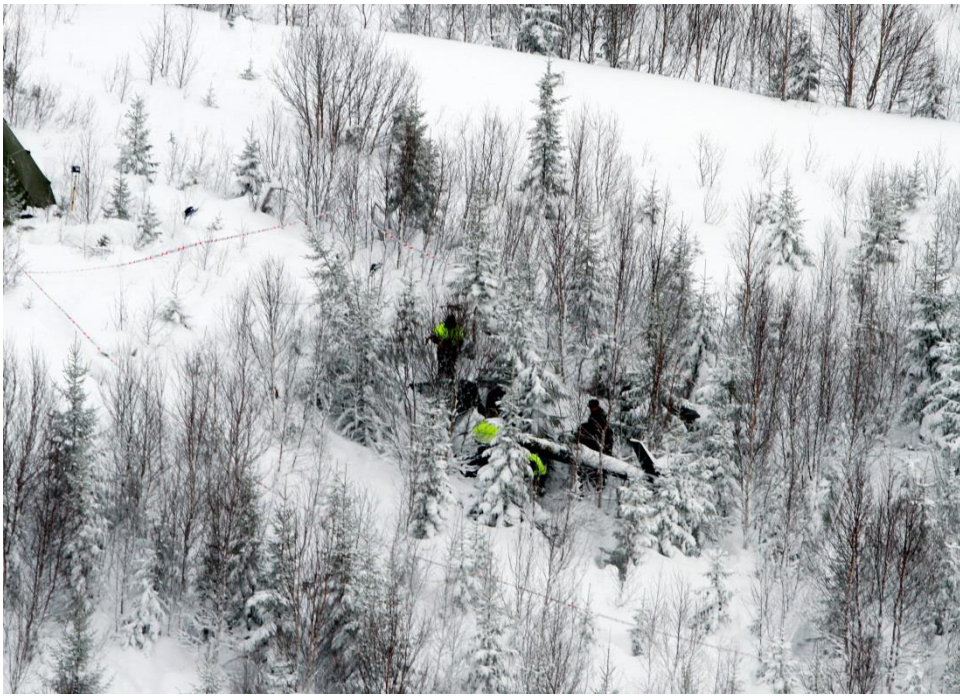
- 1.12.1.1 The helicopter crashed in sloping terrain covered by low young growth. The wreckage ended up between several 4–5 metre high birch and fir trees. Only the top of one tree had been cut off. A small tree just next to the wreckage had been snapped off. Small branches and bark had been scraped off a few other trees, but there was otherwise little damage to the trees. There was an estimated 50 – 70 cm of snow in the area. Before the Accident Investigation Board arrived at the crash site, another 10 cm of snow fell.
- 1.12.1.2 The crash site was approx. 410 metres (1 345 ft) above the sea. The crash site was approx. 800 metres east of the E6 highway and approx. 4.2 km east of Mosjøen airport Kjærstad.

*Figure 5: The crash site seen against the east. The helicopter tail boom can be clearly seen between two of the people in the picture. Photo: Per Vikan, Helgeland Arbeiderblad*

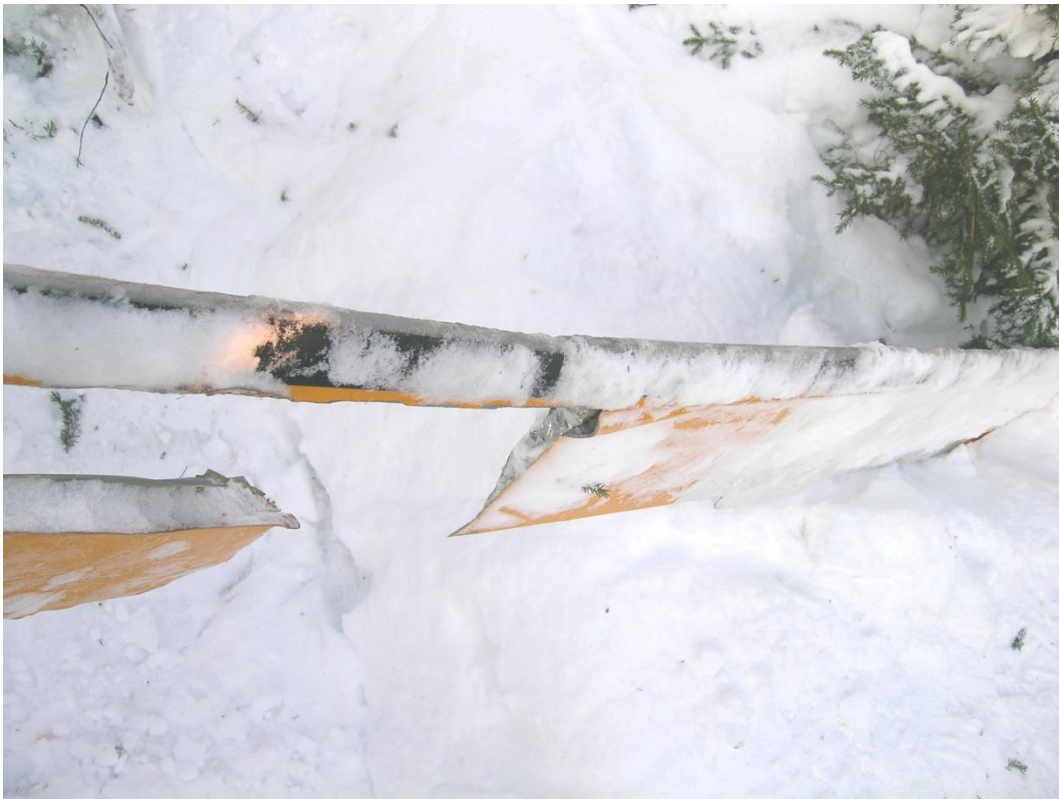
- Snow/ice had frozen on the leading edge of both blades. This was particularly the case for the leading edge of the outer part of blade A (see Figure 6).

*Figure 6: The upper side and leading edge of main rotor blade A with frozen snow/ice. The spar has partially separated from the rest of the blade. Photo: AIBN*

- 2.5.2 The engine of SE-JPZ was equipped with fuel injection and only ices under extreme conditions, which was not the case on the day of the accident. During icing conditions, ice can also form on the rotor blades. This may lead to vibrations and reduced aerodynamic effect. At the extremes of the blades, ice will not normally form due to the heating from aerodynamic friction. The outer part of one of the main rotor blades on SE-JPZ had frozen snow and ice along the leading edge (see Figure 6), indicating that this part of the main rotor was warm and free of ice when it ended up in the cold snow after the crash. Some of the snow then melted and the water later froze onto the blade.

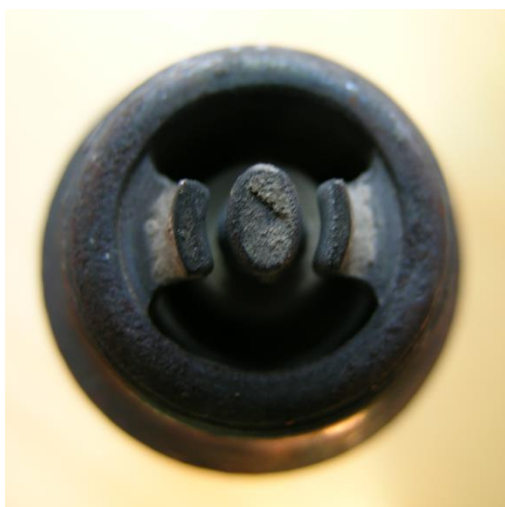
- All 12 spark plugs were worn with an electrode opening of 0.022” or more.
- The engine oil filter was not visibly contaminated and there were no metal chips on the magnet plug in the engine's oil sump.

Figure 7: Examples of worn spark plugs.  
Photo AIBN

1.16.3 To better test the condition of the spark plugs under realistic loads, they were installed in the engine of an R44. When running the engine and hovering at low altitude, there was no sign of failure in the performance of the engine.

- 2.4.3 All spark plugs in the engine were worn and had a spark gap requiring adjustments before further usage. Although the spark plugs would not have met the requirements for further flight unless adjusted, the test in a similar helicopter engine showed that they yielded the expected engine power. Similarly, a deviation of 3° in ignition timing does not yield a significant output loss. As a result, the Accident Investigation Board has not uncovered faults which would necessitate an immediate emergency landing.

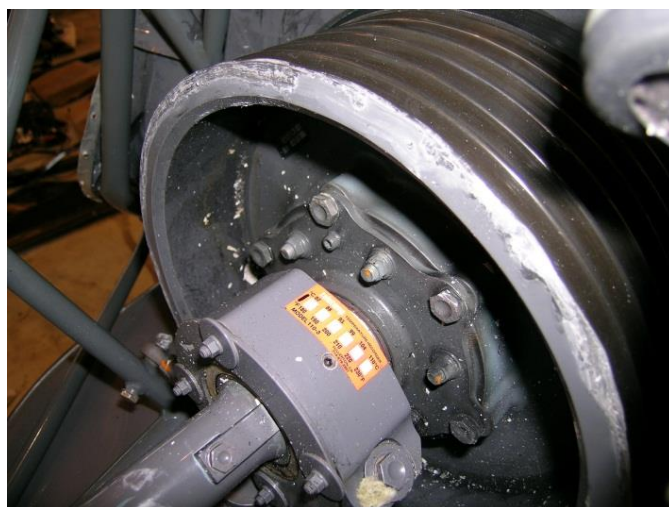
Figure 8: Scratch marks on the upper belt pulley. Photo: AIBN

- 2.4.1 No technical faults in the helicopter were found to explain the loss of control. All significant functions relating to the flight controls and rotors were intact when the helicopter hit the ground. Scratch marks on the starter ring gear and belt pulleys indicate that both the engine and the rotor were turning when the helicopter hit the ground. Overall, this describes a helicopter that was intact and controllable before the accident.
