RAPPORT

SL 2014/04

RAPPORT OM LUFTFARTSULYKKE VED HOGGARVATNET, ROGALAND 9. OKTOBER 2009 MED EUROCOPTER AS 350 B2, LN-ODU

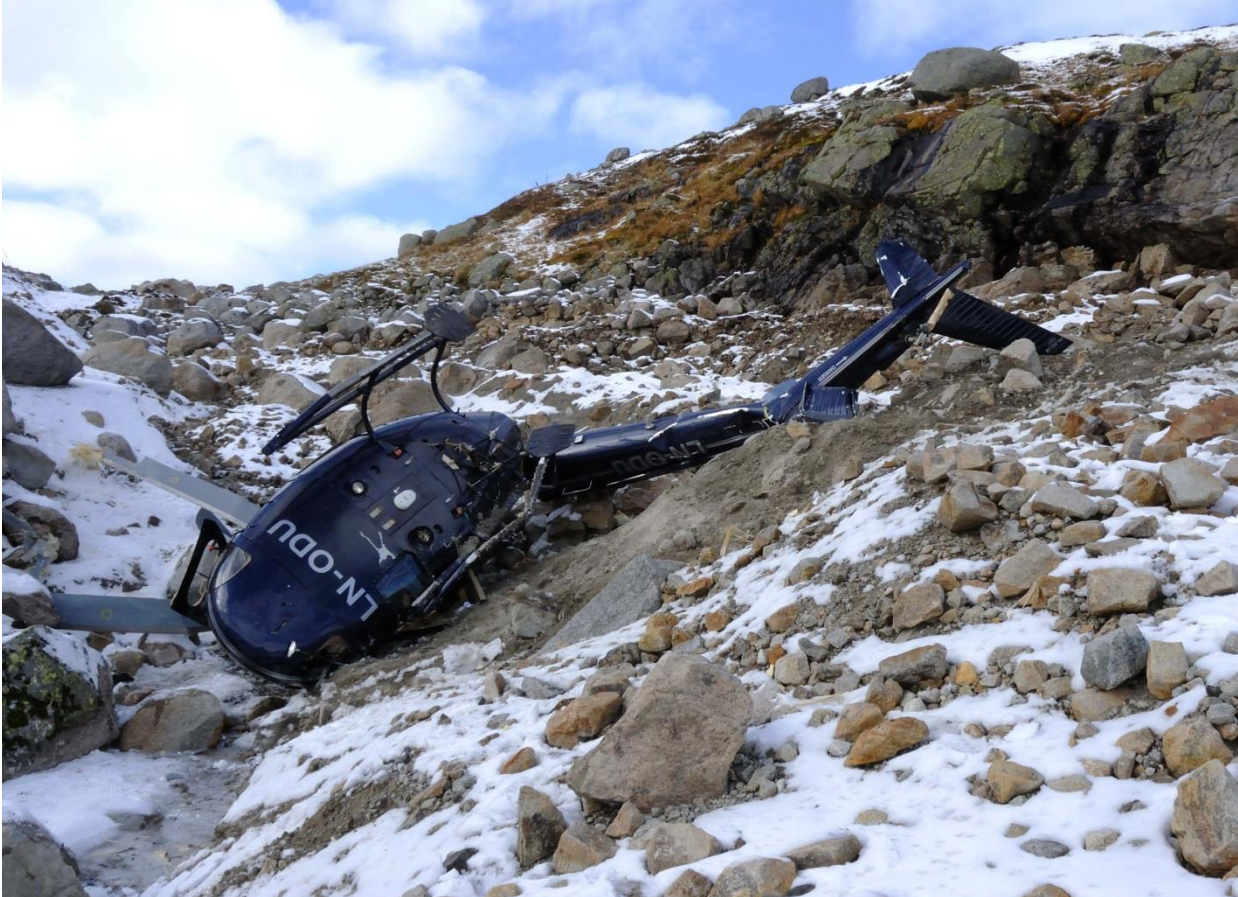
Figur 2: Helikopteret slik det ble liggende etter ulykken. Bildet er tatt i samme retning som innflygingsretningen. Foto: SHT

Betydelige skader på skrog og halebom, hovedrotorbladene brukket.

Helikopteret kom til ro i et tørt elveleie, liggende på høyre side med nesa mer enn 90 grader til venstre for innflygingsretningen. (se figur 2)

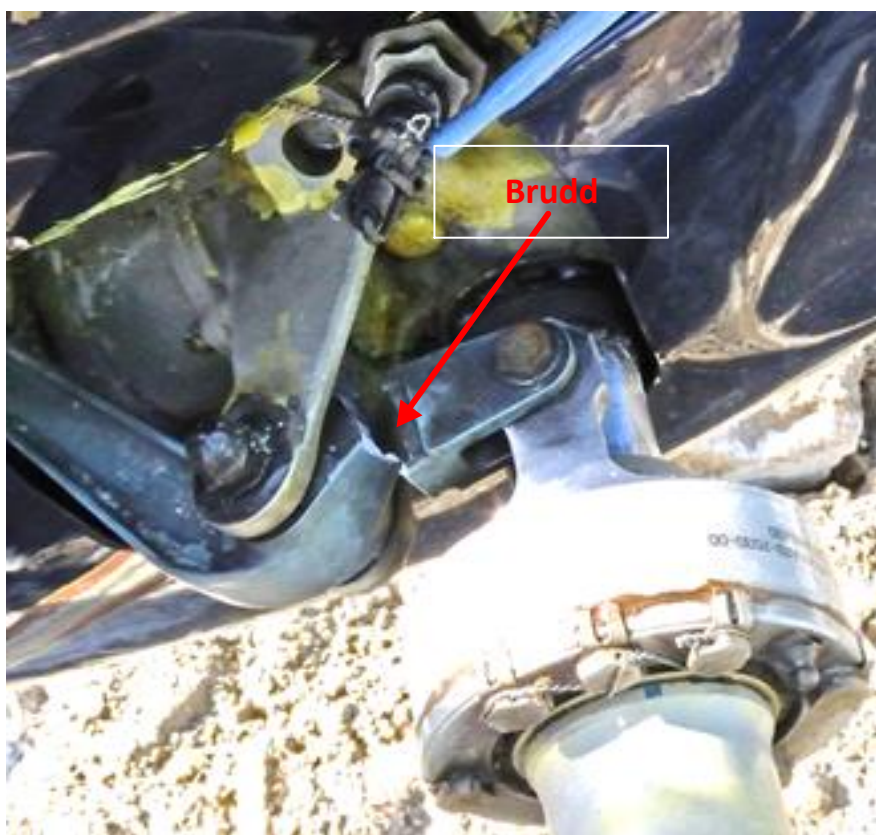
Figur 3: Bruddet i kontrollarmen slik det ble funnet Foto: SHT

Ved undersøkelse på havaristedet ble det klart at det var et brudd i kontrollarmen som regulerer vridning på halerotorbladene. Se figur 3.

En foreløpig undersøkelse viste at det meste av bruddflatene var misfarget/anløpt, mens den siste tredjedelen av bruddet så ferskt ut.

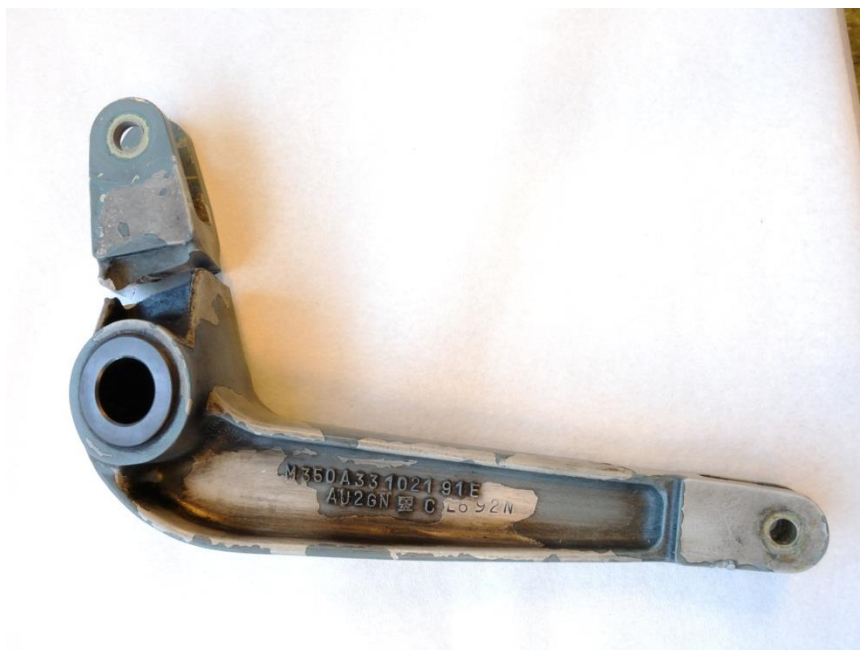
Figur 4: Kontrollarm for halerotor. Foto: SHT

Figur 4 viser den defekte kontrollarmen avmontert. Eurocopter's benevnelse på delen er "Blade horn".

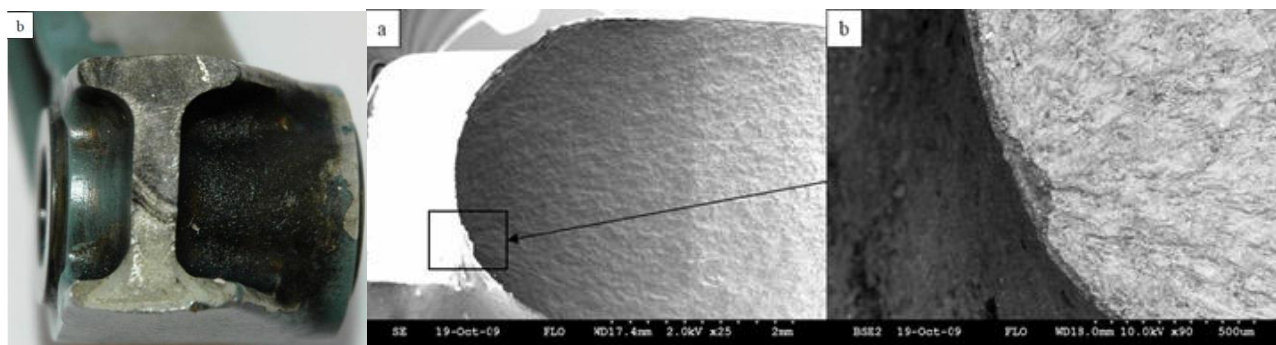
Figur 5: Bilder fra metallurgisk undersøkelse som viser bruddflater og startpunkt. Foto: Forsvarets metalllaboratorium

Kontrollarmen ble sendt til metallurgisk undersøkelse hos Forsvarets metalllaboratorium. Rapporten etter denne undersøkelsen konkluderte med at dette var et utmattingsbrudd, som hadde utviklet seg over tid. Se figur 5.

Sprekken ser ut til å ha startet ved en uregelmessighet i overflaten. Uregelmessigheten stammer mest sannsynlig fra produksjonen av delen.

Den 29. oktober iverksatte fabrikanten tiltak gjennom å utstede "Safety Information Notice No. 2106-S-65, Tail rotor Gearbox: Check of blade horn installation on the TGB." Se vedlegg A.

Videre har EASA (vedlegg B) utstedt direktiv (AD 2011-0038-E) som omhandler problemet i form av endrede inspeksjonsrutiner, bearbeidelse av berørte varianter av kontrollarmen og alternativt utskifting av delen til en forsterket variant.

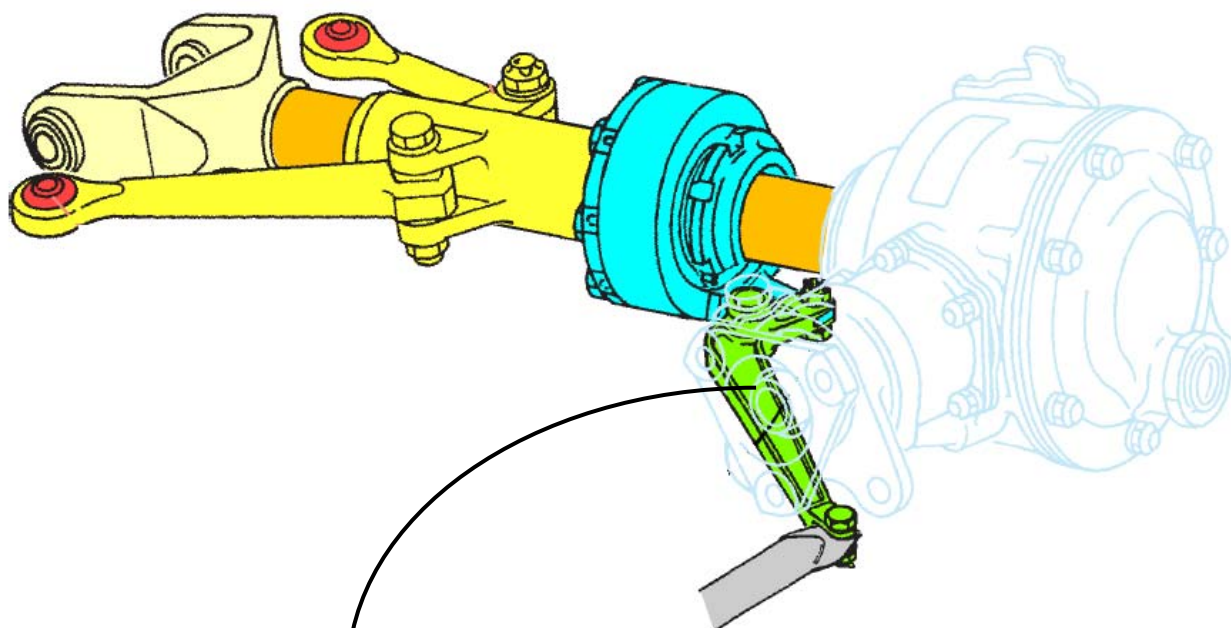
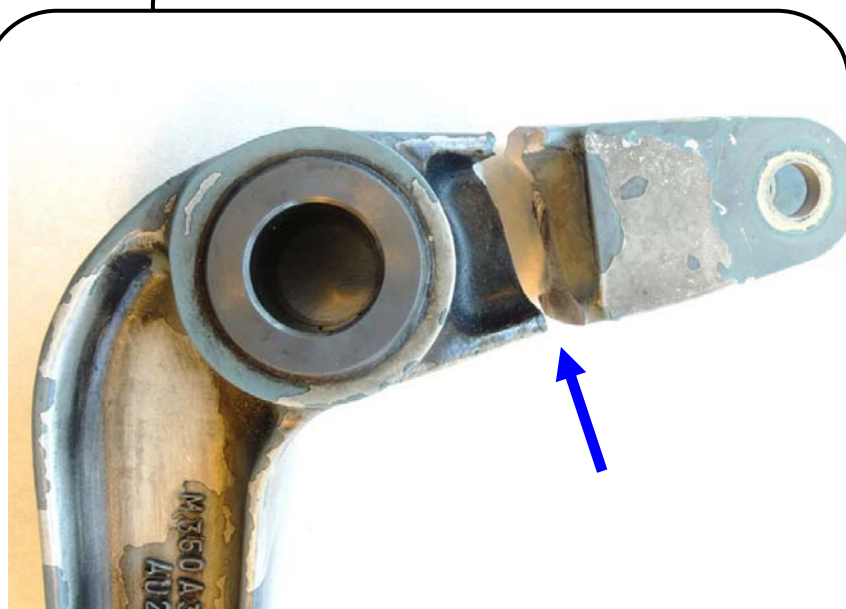
PHOTO OF THE FAILURE AREA

Initial investigations show that the area of failure of this blade horn (see appended photo) is similar to that of the case encountered previously, where the inquiry concluded that it was due to non-compliant installation.

Without predicting the conclusions of the board of inquiry, EUROCOPTER is issuing this Safety Information Notice to remind you of the installation procedure for this blade horn and of the instructions concerning the checks to be carried out after installation of this blade horn, defined in AS350/AS355 MET Work Card 65.20.00.401 and summarized below:

- 1- Before installing the expansible bolt, check the position of the components, in particular the position of the spring washers and the retaining ring (Fig. 3 of Work Card 65.20.00.401).
- 2- When installing the expansible bolt, make sure that the spring washers are effectively in contact with the pivot yoke of the TGB casing.
- 3- After installing the bolt and the blade horn:
 - a. Manually check that the bolt does not turn by trying to turn its head.
 - b. Check that there is play between the blade horn and the yoke (at least 0.4 mm on both sides of the lever).
 - c. Make sure that the blade horn slides freely on the bolt and check that there are no friction points when the blade horn pivots.
