SL 2014/13

## REPORT ON SERIOUS AVIATION INCIDENT SOUTH OF SANDEFJORD AIRPORT TORP (ENTO) 22 MAY 2014, AIRPROX BETWEEN SOCATA TBM850 (N97RN) AND DIAMOND DA 42 NG (LN-FTL)

Date: 17.12.2014  
SL Report: 2014/13

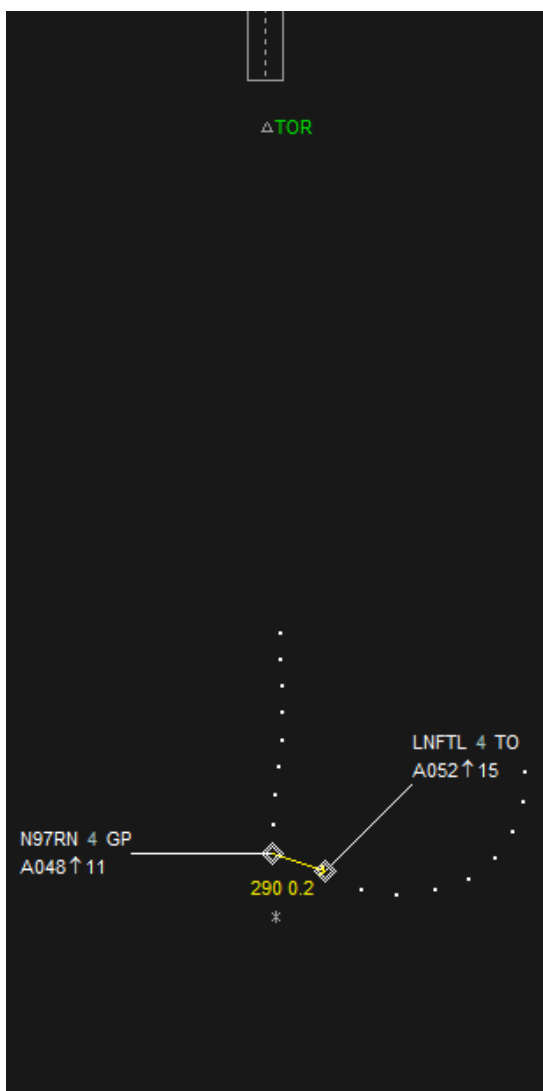
The radar playback showed that the minimum distance between the aircraft, immediately before they passed each other, was approximately 400 ft vertically and 0.2 NM (370 m) horizontally (see figure 1). The playback also showed that the trainer aircraft climbed from 5 000 ft to 5 250 ft in few seconds, simultaneously increasing its turn rate. N97RN made a minor heading adjustment before the airprox, and continued to climb while maintaining a steady ground speed of 100-110 kt.

Figure 1: At time 16:20:34. Radar playback from Mode-C information with accuracy of up to 100 ft, shows that N97RN was at 4,800 ft, climbing, southbound with a ground speed of 110 kt. LN-FTL was at 5,200 ft, climbing, northwest bound, with a ground speed of 150 kt. The distance between the two aircraft was approximately 400 ft vertically and 0.2 NM (370 m) horizontally. The image also shows the location of Torp VOR (TOR). Source: AVINOR

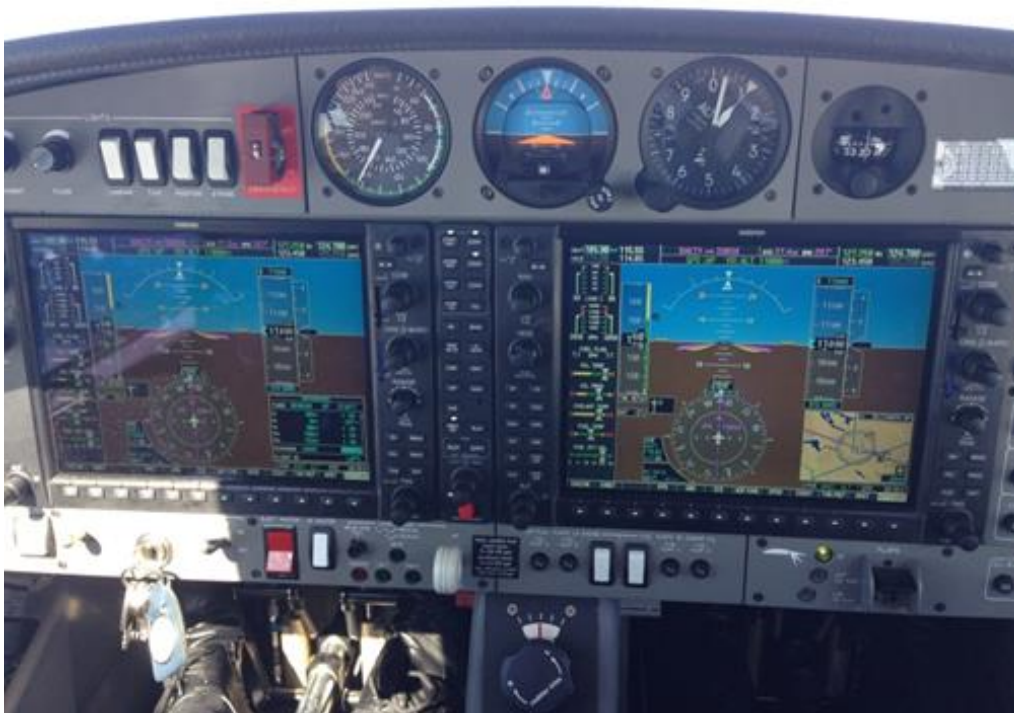
It was the aircraft's Traffic Advisory System (TAS, see figures 4 and 5) which first drew the trainer aircraft crew's attention to the fact that they were in a conflict situation and made them aware of the whereabouts of the other aircraft relative to their own position. The student, who was sitting in the left seat, was piloting the aircraft manually. Both he and the instructor saw and heard the alert that was activated immediately after they had initiated a right turn in towards Torp VOR. The Commander of LN-FTL has stated that everything happened very quickly. On his traffic screen he saw that another aircraft, represented by a yellow circle, was very close to them to their right. At the same time they heard a voice alert, which the Commander afterwards recalled as saying: "Traffic 12 o'clock, less than one mile, same altitude". Based on what he observed on the traffic screen, the Commander looked out through his window, down to his right. He then immediately caught sight of the other aircraft, which was climbing straight ahead. At that moment he thought that they were

Figure 4: LN-FTL cockpit with Garmin G1000 Integrated Flight Deck System. The image related to the Traffic Advisory System (TAS) is in the lower right hand corner of the right hand screen (MFD). See close-up image in figure 5. Photo: LN-FTL Commander

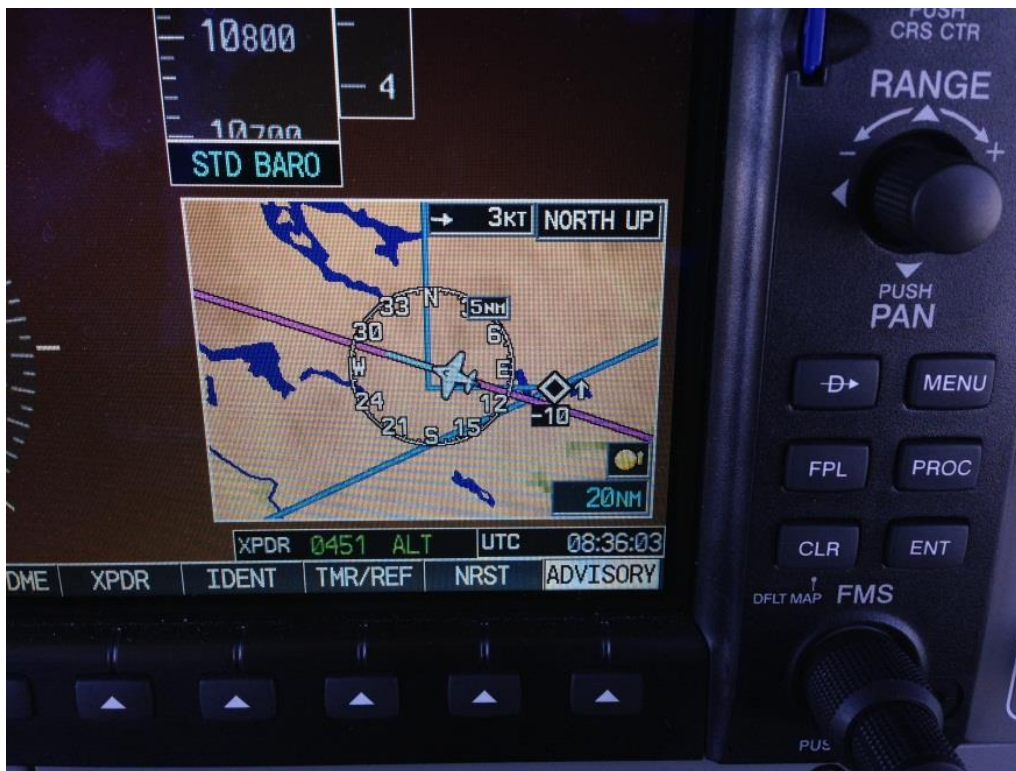
Figure 5: Detail from figure 4 displaying the traffic situation (TAS). The aircraft was not in a conflict situation when this photo was taken. The image shows own aircraft in the middle, and another aircraft climbing 1 000 ft below. If it had been a conflict, the other aircraft would have been represented by a filled yellow circle. Photo: LN-FTL Commander.

Both aircraft had systems onboard that displayed close traffic and thus contributed to improve the pilots' perception of the current situation. It was TAS that first made the LN-FTL crew aware that they were in conflict with another flight, and which caused them to initiate an evasive manoeuvre. Such systems are not compulsory for this category of light aircraft, but in this case they proved their value as an extra safety net when the established safety barriers failed.
