REPORT

SL 2015/01

REPORT ON THE SERIOUS AIRCRAFT INCIDENT DURING APPROACH TO KITTILÄ AIRPORT IN FINLAND (EFKT) ON 26 DECEMBER 2012 WITH A BOEING 737-800, LN-DYM, OPERATED BY NORWEGIAN AIR SHUTTLE ASA

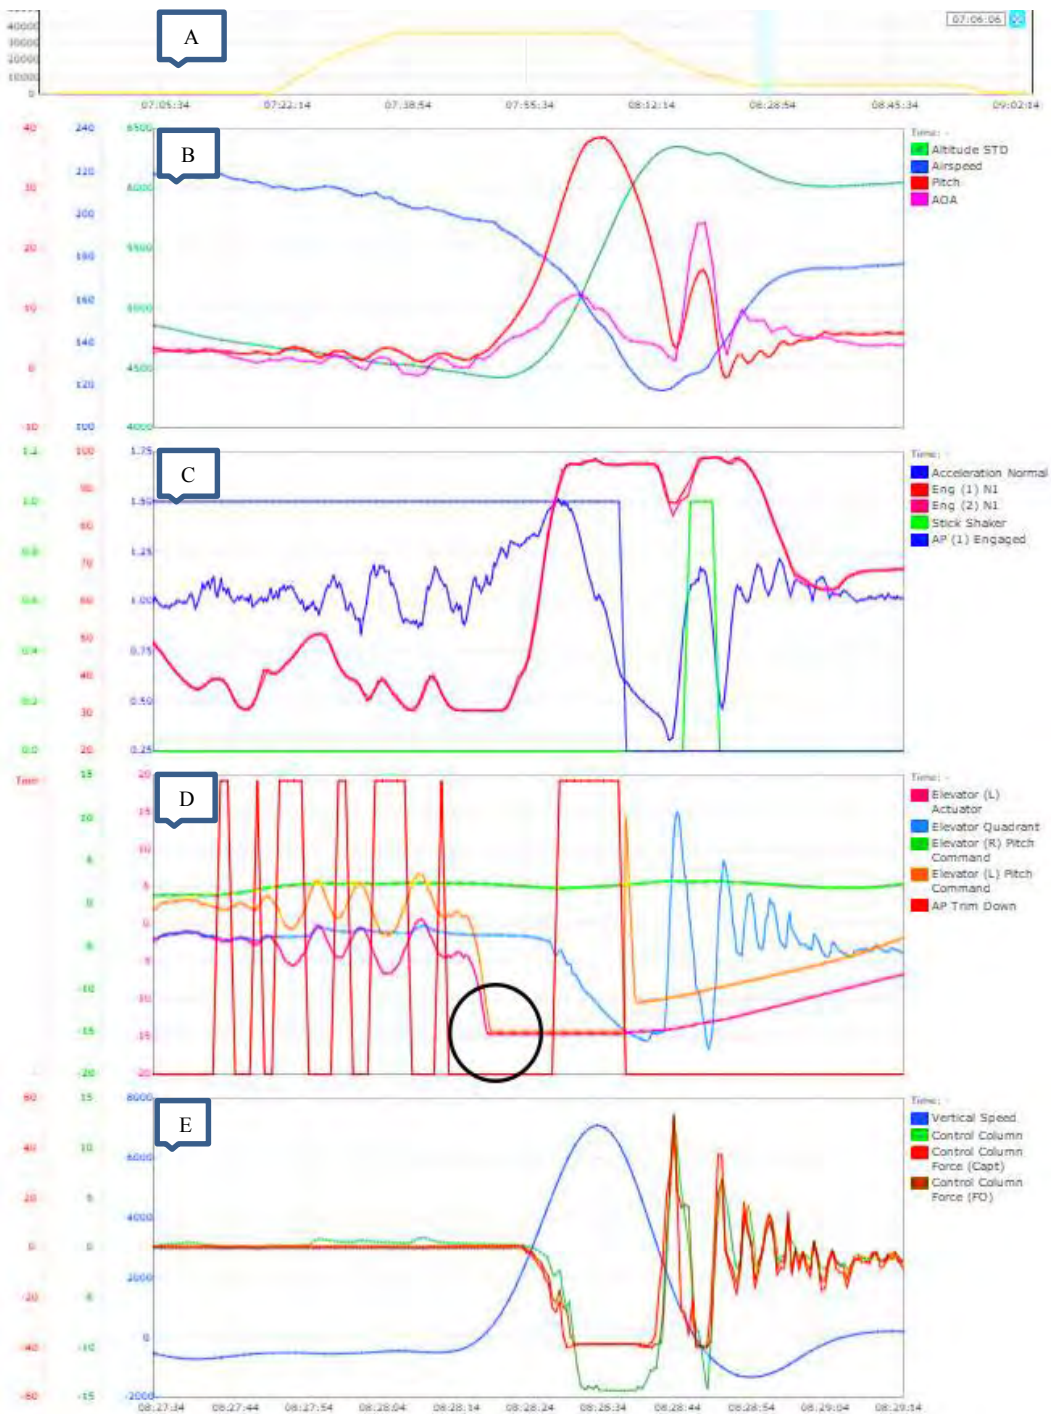
with associated further loss of airspeed. Figure 1 shows an excerpt from the aircraft's flight data recorder in connection with the incident.

Figure 1: Excerpt from flight data recorder during the incident.

- 1.6.3.12 Based on the fact that the flight data recorder proved that blockage of the Power Control Unit had prevented the aircraft's normal elevator function (see Figure 1 and Chapter 1.11.1), AIBN has investigated what may have caused the blockage. These investigations are described in Chapter 1.16.

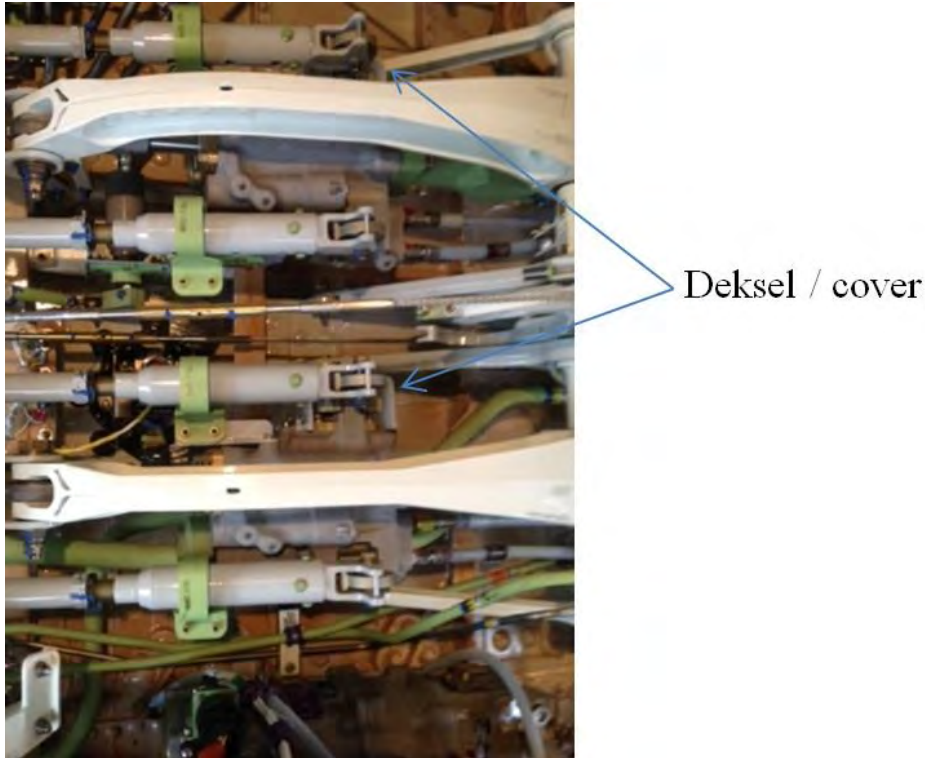
- 1.6.3.9 In AIBN's understanding, the PCUs are equipped with a cover because the same type of PCU is also used to control the ailerons on Boeing 737. The two aileron PCUs are installed in the wheel well with the input cranks horizontal and are therefore more exposed to foreign objects. In order to help prevent any foreign objects from falling down and blocking the Input cranks on the aileron PCUs, they are equipped with a cover over the top Input crank. See Figure 5.

Figure 5: Photo from a Boeing 737-800 wheel well taken in the aircraft's direction of travel. The photo shows that each PCU have a cover over the Secondary Input crank. Photo: AIBN

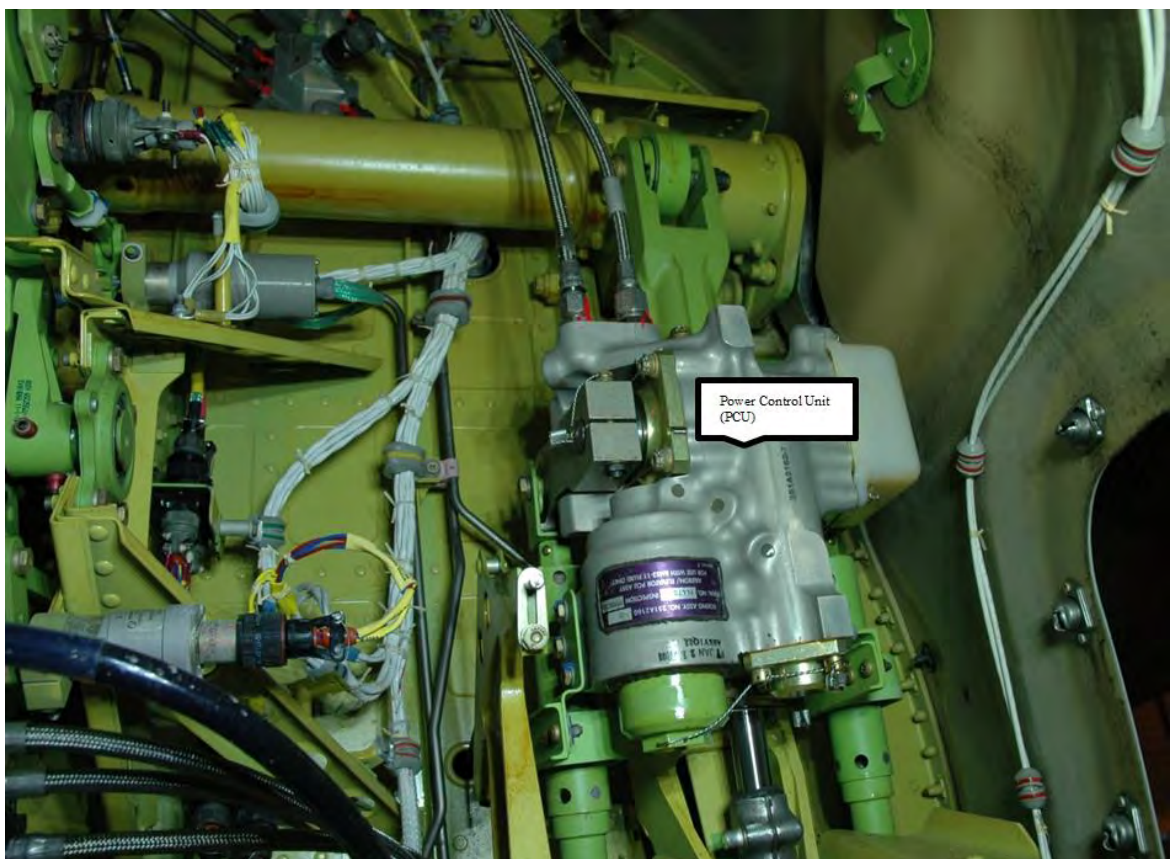
Figure 7: Photo taken inside the Tail Cone Compartment which shows the back of the right PCU on LN-DYM (31 January 2013). Photo: AIBN

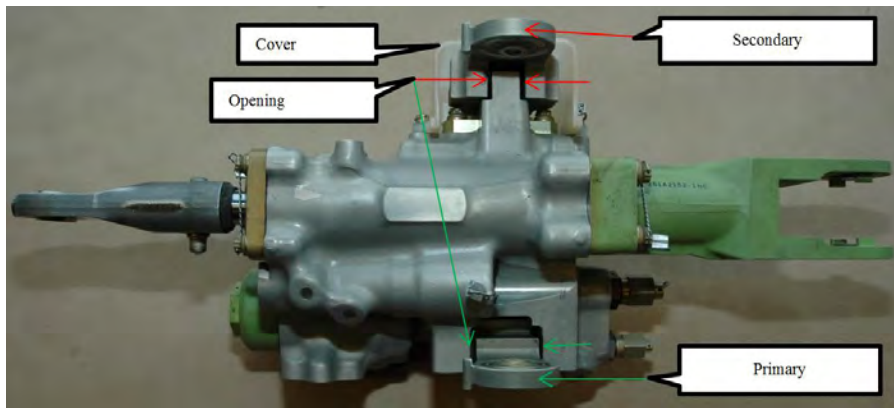
Figure 8: Shows the front of a PCU. Note the narrow gap (“opening”) where a foreign object/ice could block movement of the Primary and Secondary Input cranks and thus prevent normal movement on the PCU (actuator) Photo: AIBN

- 1.6.3.11 AIBN has measured the gap opening on a Power Control Unit to be approximately 1.9 mm (0.075 inch) (marked “opening” in Figure 8). This means that the Input cranks need not move far from the neutral position where the elevator remains in its current position, in order to signal the PCU to move the elevator in the up or down direction. This means that, if a foreign object/ice blocks the gap opening, this will affect normal elevator control.

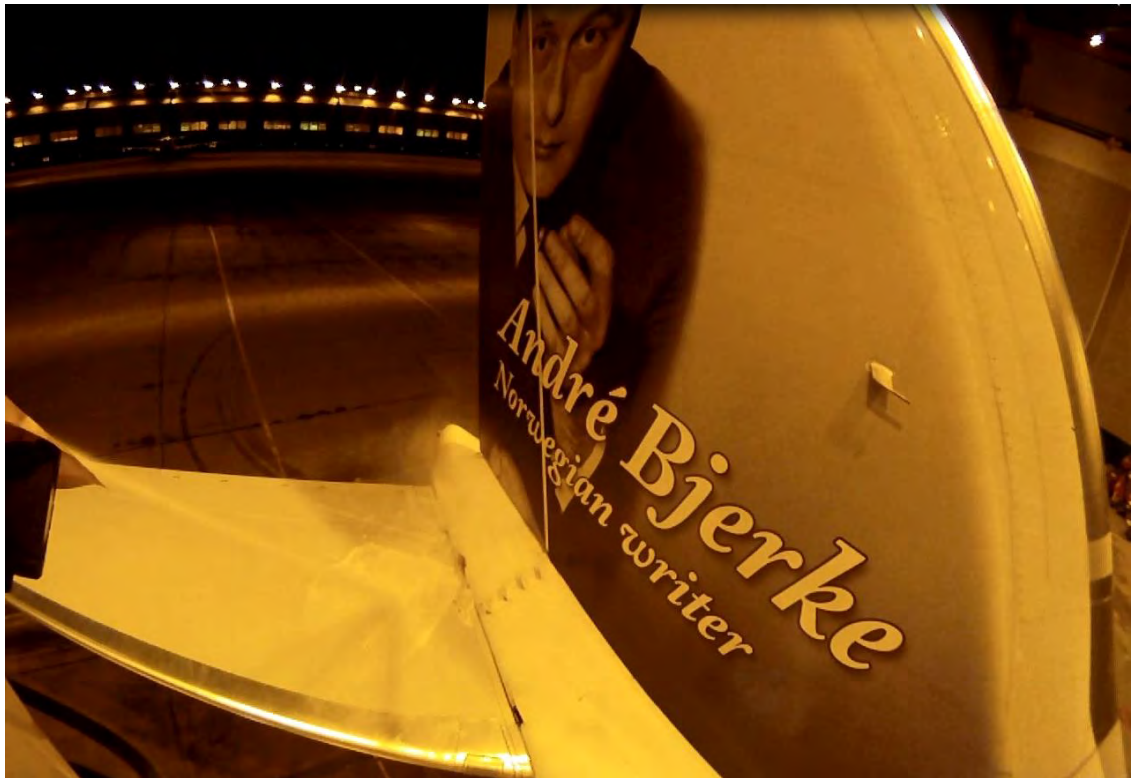
Figure10: "Spray testing" at different marked angles on LN-DYM's horizontal stabiliser and elevator. Photo: AIBN

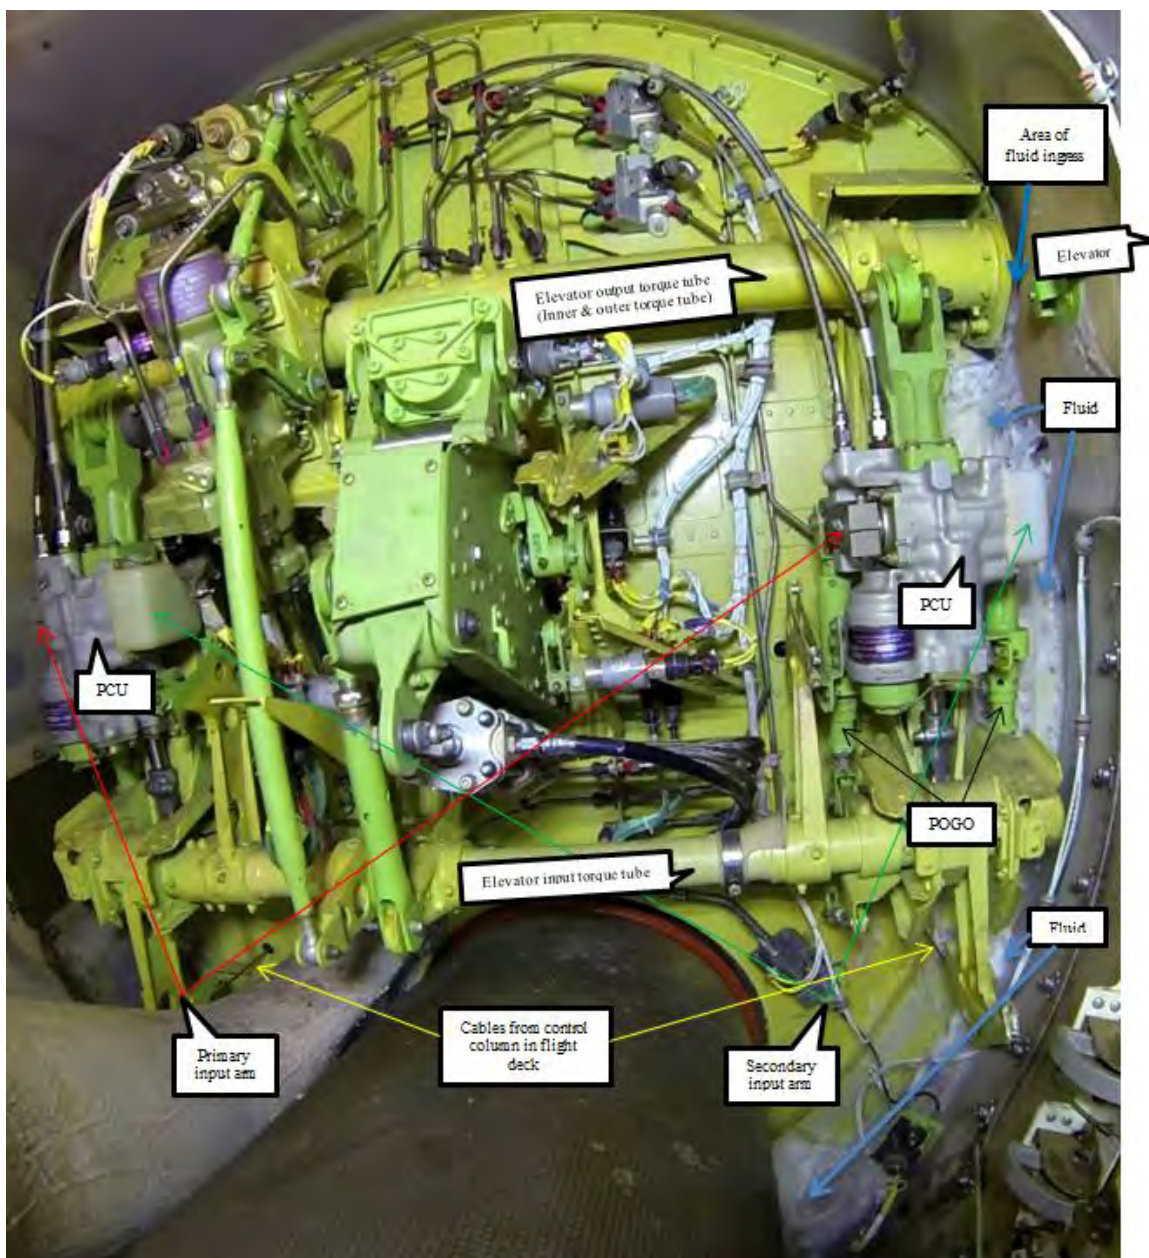
- 1.16.8.7 While investigating the Tail Cone Compartment, AIBN found that the clearance around the penetrations on both the left and right sides of the fuselage are wide enough for fluid to enter the compartment. When fluid enters the compartment, it is possible for this fluid to splash on the PCUs as are located below and near the mentioned openings in the fuselage. Since the de-icing fluid is warm, steam from the fluid will condense on cold surfaces.

Figure 11: Shows fluid penetration and spray potential toward the Input cranks on the PCUs. (Photo taken in the aircraft's direction of travel in connection with simulated de-icing of the aircraft's right side). The pipe at the bottom of the photo is the exhaust pipe from the aircraft's Auxiliary Power Unit (APU). Photo: AIBN

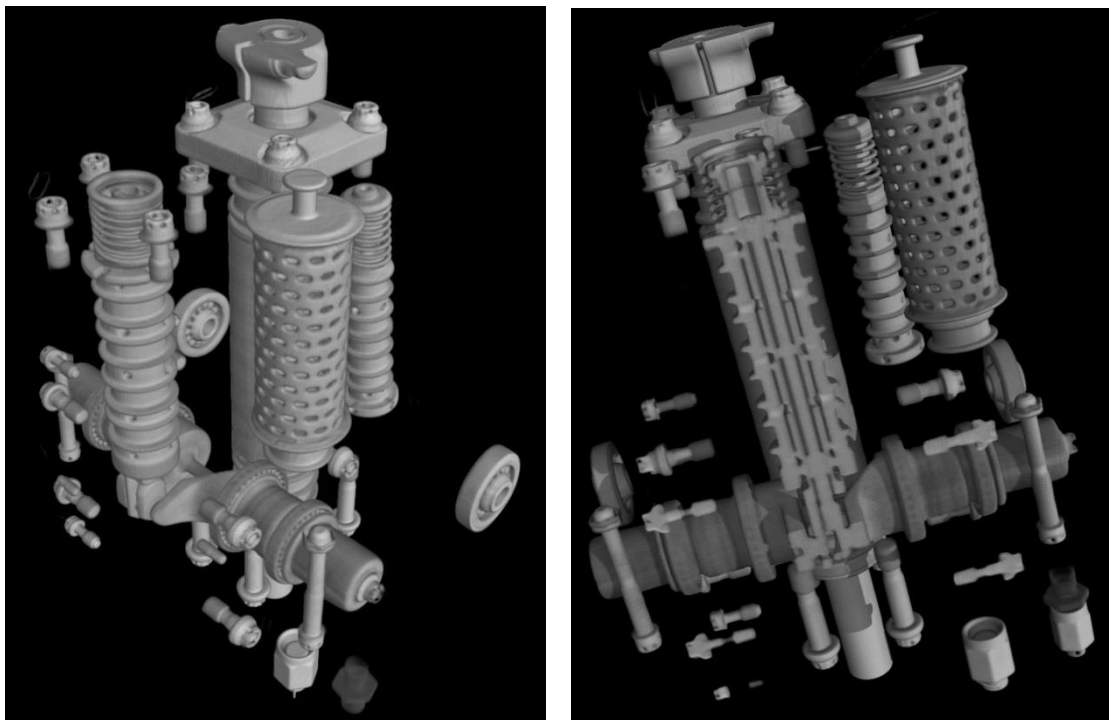
In order to investigate whether any foreign objects inside the PCUs may have caused a blockage, AIBN, in cooperation with the NTSB, requisitioned an advanced CT scan of both units in the US. The CT scans indicated the presence of a small Foreign Object Debris (FOD) inside one PCU, but no foreign object was later found when the unit was opened. This FOD indication is considered to be an artefact from the CT scan from the machined flat feature of the bypass spool. See also Chapter 1.19 for additional information.

Figure 19: Example images from the CT scan. Photo: NTSB

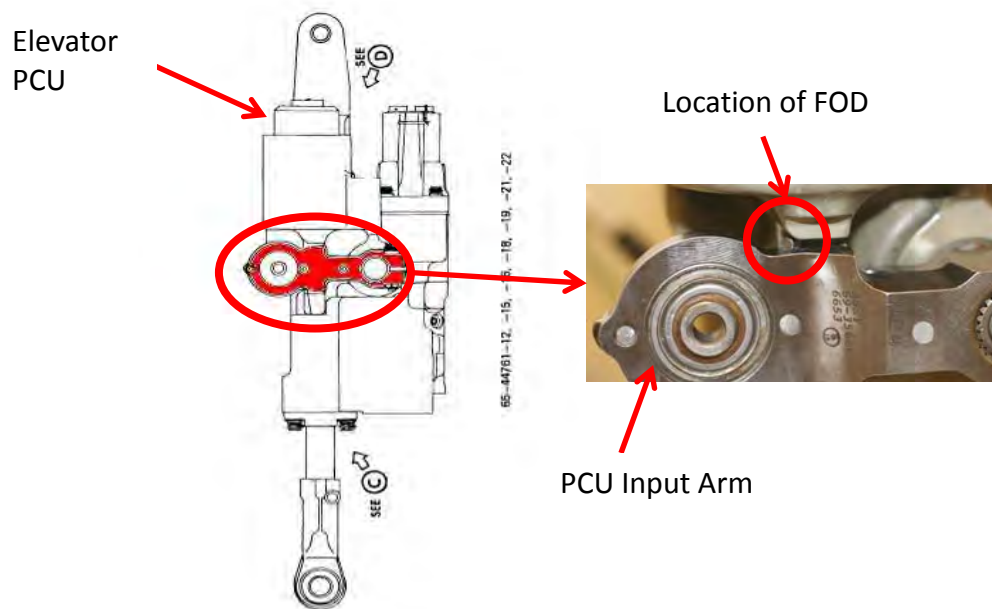
Figure. Location of FOD.

Once Boeing has developed a method to protect the elevator power control unit input arm assembly on 737-300 through -500 series airplanes from foreign object debris as requested in Safety Recommendation A-11-7, require operators to modify their airplanes with this method of protection. (A-11-8)
