REPORT

SL 2015/05

REPORT CONCERNING THE SERIOUS AIRCRAFT INCIDENT ON 18 MAY 2014 NORTHEAST OF BJØRKELANGEN WITH APEX AIRCRAFT CAP 10C, LN-KAP

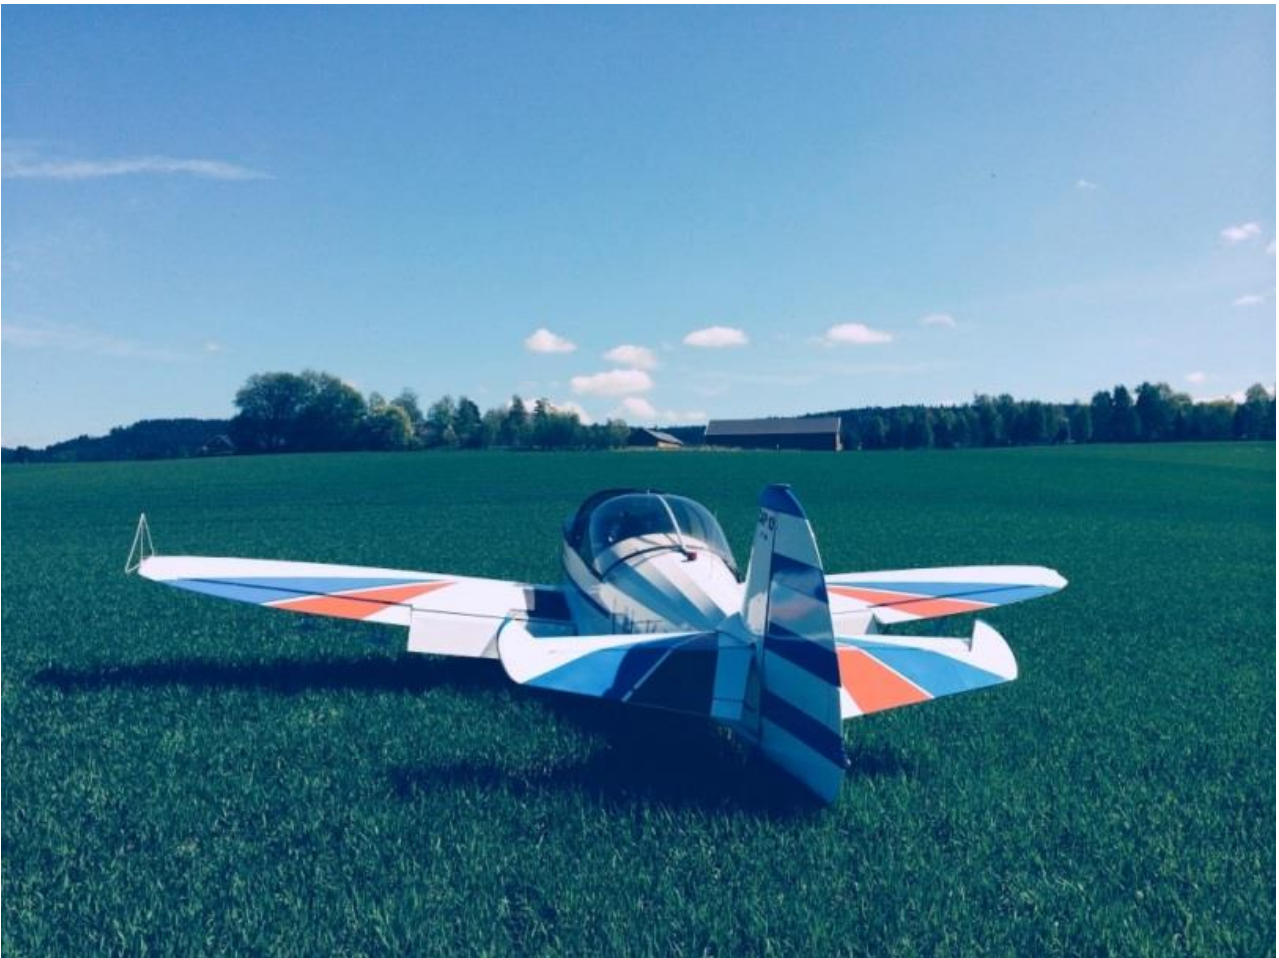
The commander described the unpowered flight and landing as undramatic. After landing in the field, the aircraft came to rest at about 1210 hours, four minutes after the propeller disappeared (Figure 2).

Figure 2: LN-KAP at the crash site. Photo: Private

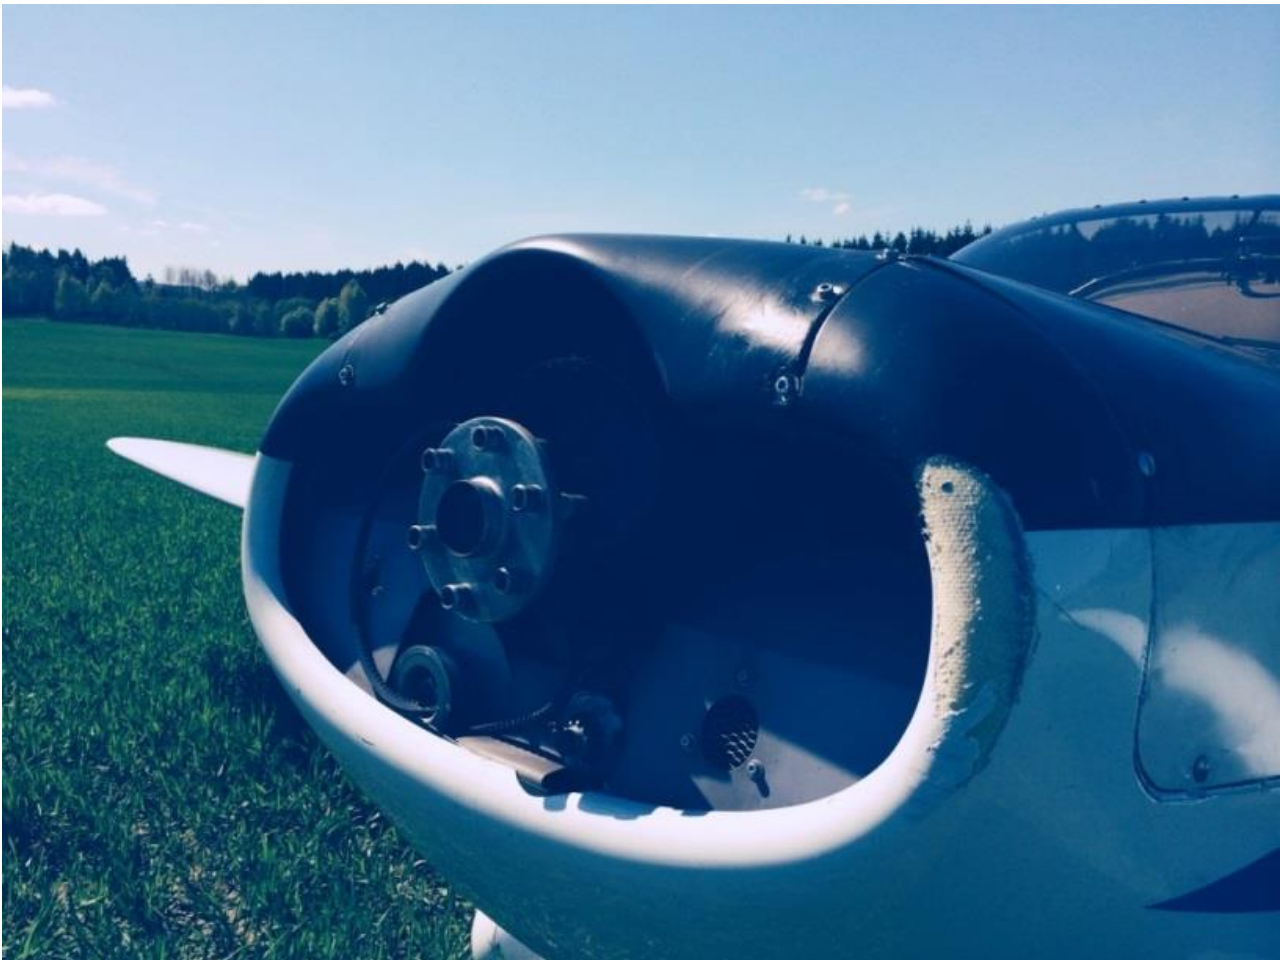
After landing, it was observed that the propeller, spinner, spinner bulkhead and starter ring gear had disappeared. The starter ring gear also drives the aircraft's generator using a transmission belt. The transmission belt was still in the nose compartment. There was also minor damage on the front left side of the cowling (Figure 3).

Figure 3: Aircraft nose compartment after landing. Photo: Private

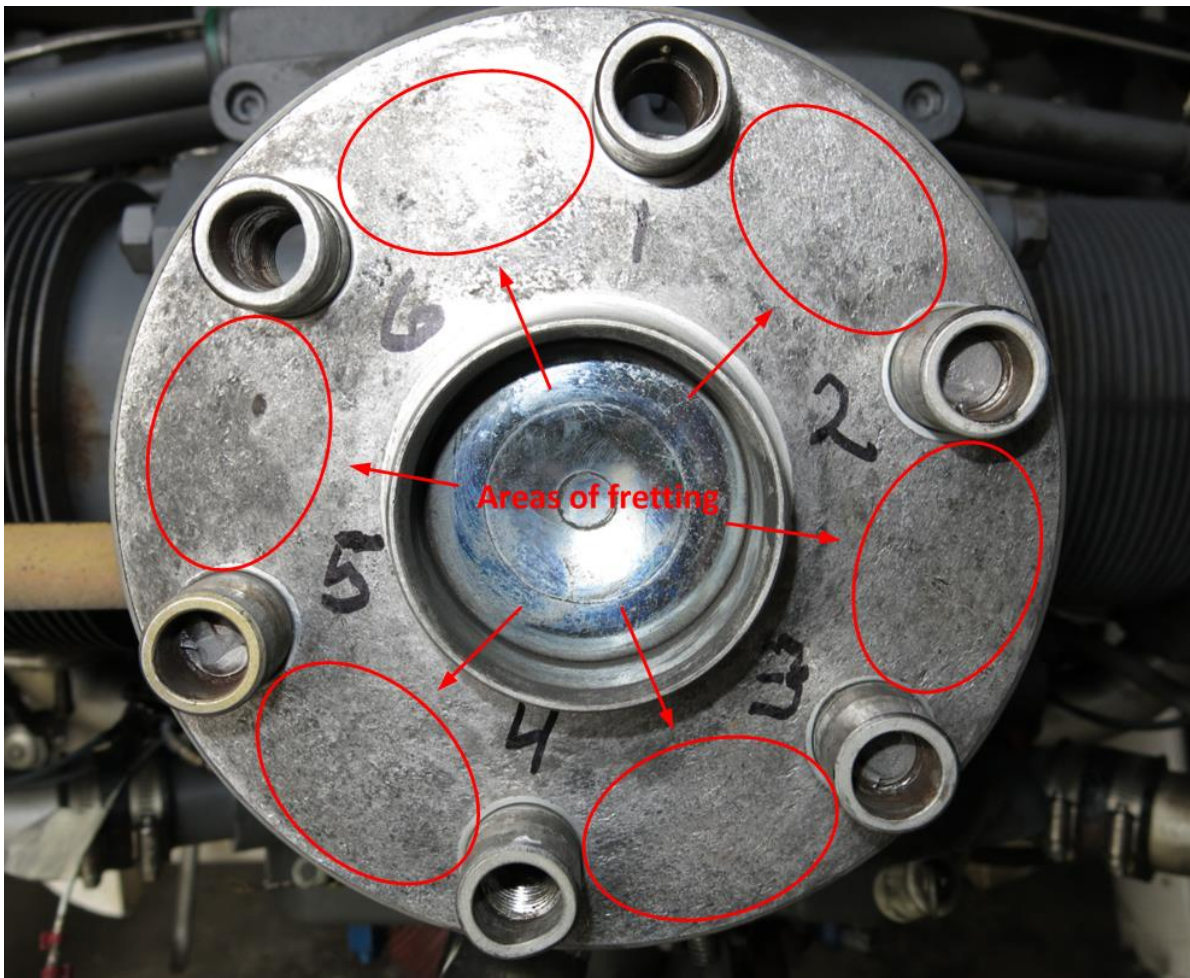
The investigation of the propeller flange on the engine crankshaft showed that three of the six propeller bolts were missing in their entirety. The other three had broken, and remaining parts were still in the bushings. There were signs of fretting¹ on the contact face of the propeller flange, which indicates that the propeller and starter ring gear had moved in relation to the crankshaft (Figure 4).

This wear indicates that the propeller bolts were not holding the propeller tightly enough against the starter ring gear and propeller flange. The friction between the propeller flange and starter ring gear/propeller was not sufficient to absorb power pulses from the engine. The propeller flange has 6 threaded bushings for fastening the propeller bolts. These bushings are not designed to absorb such strain. Thread residue from the propeller bolts was found in three of the bushings.

Figure 4: Areas with fretting on the crankshaft flange. Photo: AIBN

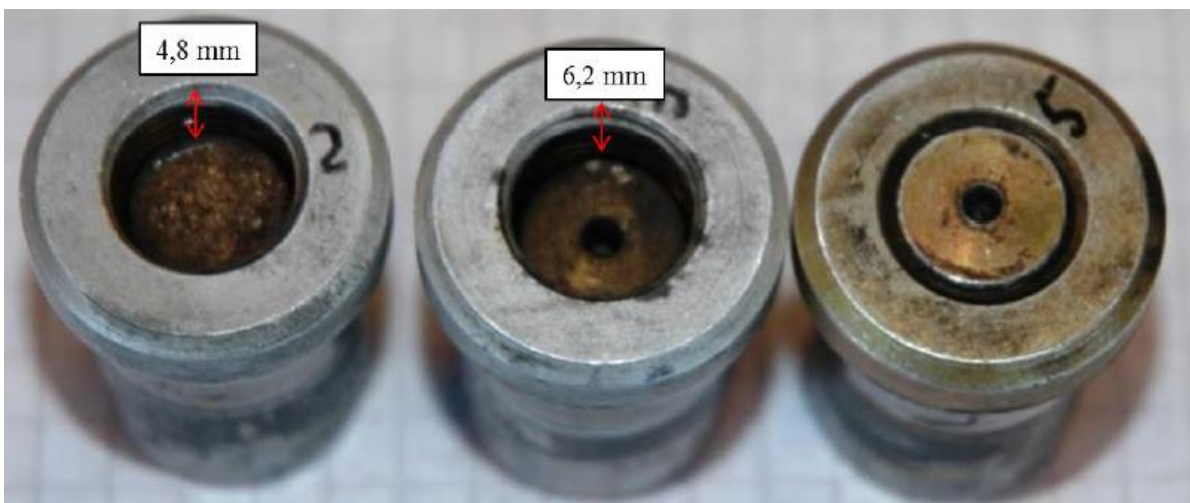
All bushings were removed from the propeller flange and sent to the Armed Forces' FLO materials laboratory for further analysis. Bolt pieces were found in three of the bushings. Two of the remaining bolt pieces were in a position in the bushings indicating that the bolts had partially unscrewed themselves before they broke. The last one (no. 5 in Figure 5) was still in correct position.

Figure 5: Bolt pieces screwed into bushings to varying degrees seen from the engine side. Photo: FLO materials lab

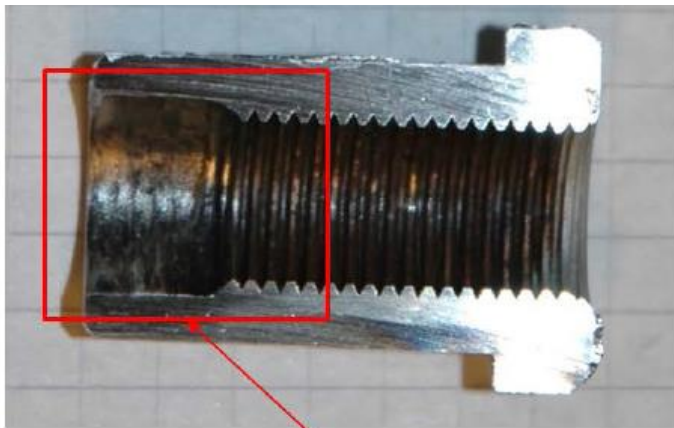
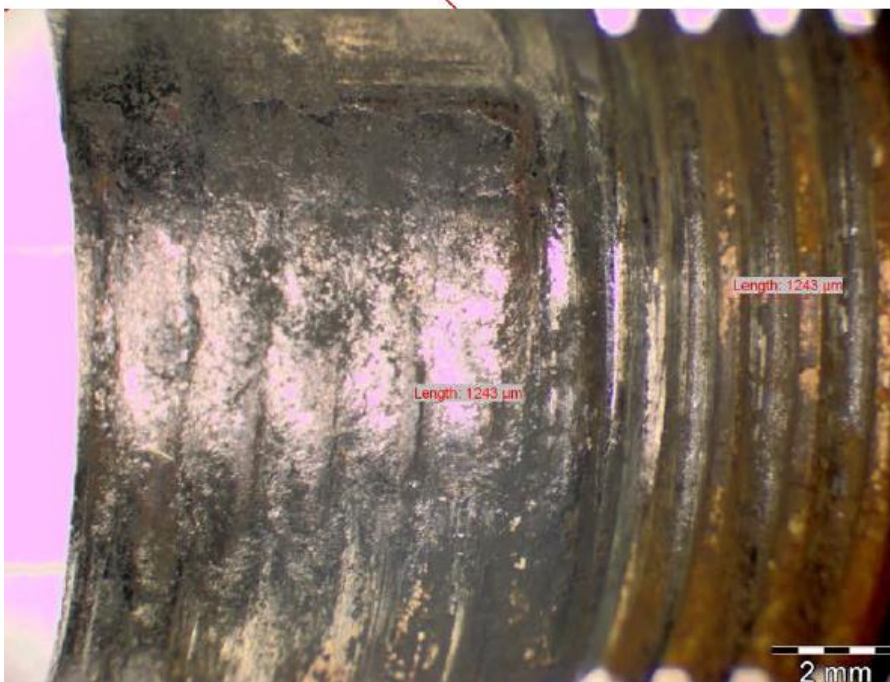
In the three bushings where no bolt pieces were found, the bolts have most likely unscrewed themselves entirely. This is evident as traces of the bolt threads in the part of the bushings without threading (Figure 6).

Figure 6: Traces of bolt threads in bushing. Photo: FLO materials lab

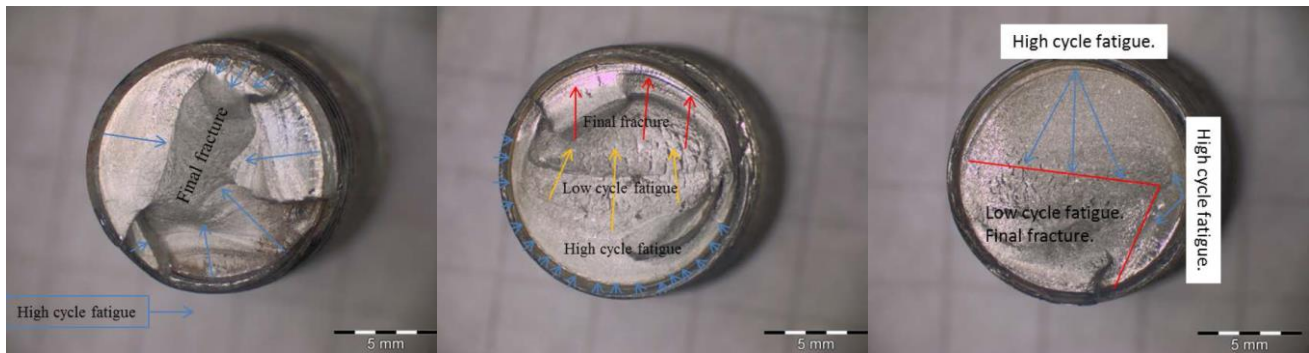
The bolt pieces' fracture surfaces showed fatigue fractures with subsequent ductile final fracture (Figure 7).

Figure 7: Fracture surfaces on bolt pieces. Photo: FLO materials lab

Traces of corrosion were observed on parts of the bolts where the cadmium plating had worn off. This wear is presumed to be caused by movement between bolts and bushings. The corrosion indicates that this process has been under way for some time.
