SL 2016/02

REPORT ON SERIOUS INCIDENT NEAR KLANTEN AIRFIELD, NORWAY ON 26 MAY 2015 WITH ALEXANDER SCHLEICHER GMBH & CO SEGELFLUGZEUGBAU ASK 21 MI, LN-GMI

Date of submission: 23.02.2016
SL Report: 2016/02

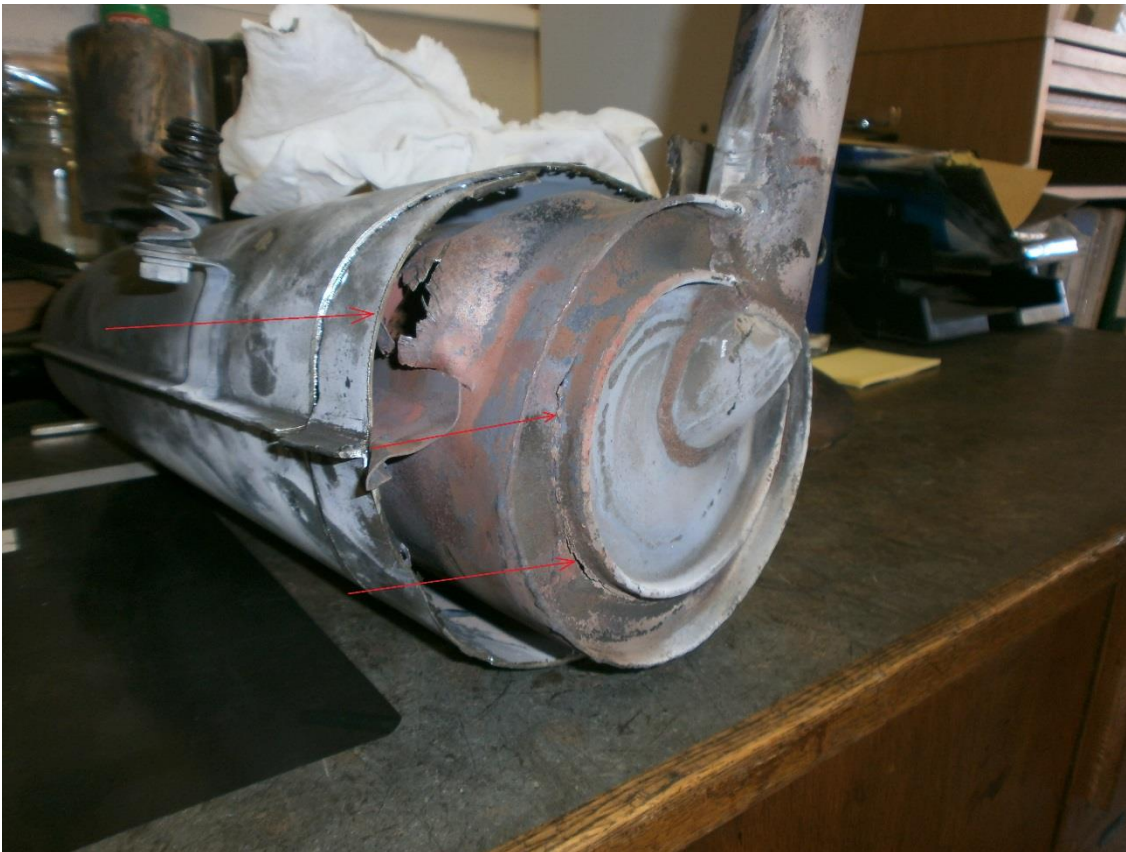
- The air filter (see Figure 5) had been damaged by fire/overheating.
- The oil tank bore marks of having been exposed to high temperatures. The oil tank level sensor had been exposed to temperatures high enough to melt the epoxy holding it in place and cause an oil leak.
- The rear engine mount (see Figure 6) had been damaged by fire/overheating. The composite material in the glider fuselage had disintegrated due to the heat, causing the engine to come loose from the rear engine mount.
- The temperature in the oil tank area had been high, causing heat damage to various wires.
- Several details in connection with the exhaust silencer had been red-hot, or showed other signs of having been exposed to high temperatures.
- The exhaust silencer was cut open, and cracks and holes between the inner exhaust system and the surrounding cooling air were found (see Figure 4).

Figure 4: The exhaust silencer partially cut open. The external heat shield was first dismantled. The picture clearly shows the surrounding space where the cooling air passes through. The arrows indicate the cracks in the innermost element. Photo: S/NLF

The Accident Investigation Board Norway believes that the heat damage in the engine installation originated in the cracks that formed in the exhaust silencer. During the last flight, the heat in the area became intense enough to melt the epoxy holding the oil tank level sensor in place, causing the oil leak. At some time, a contained fire started, melting the wire insulation and damaging the air filter for the engine's cooling air. The high temperature in the area also caused the composite material in the rear engine mount to disintegrate.

The Accident Investigation Board Norway therefore recommends that Alexander Schleicher GmbH & Co Segelflugzeugbau makes public relevant information so that users of ASK 21 Mi can be advised on how to detect leaks in the exhaust silencer at an early stage.

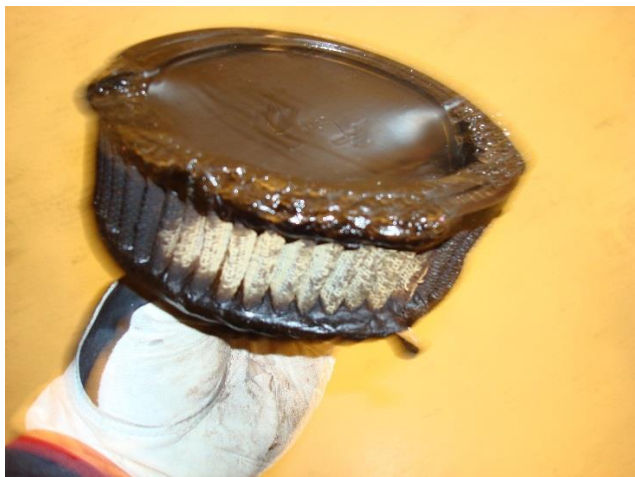
Figure 5: Fire/heat damage on the air filter. The end wall of the filter has a concave deformation.
Photo: S/NLF

- The air filter for the engine's internal cooling had melted and suffered a permanent concave deformation of the end wall. This indicates that the cooling fan had sucked air through the filter while the air filter had been hot. In such a situation, it is natural to assume that the cooling air is very hot before reaching the engine, and that the warning for high ICAOut will

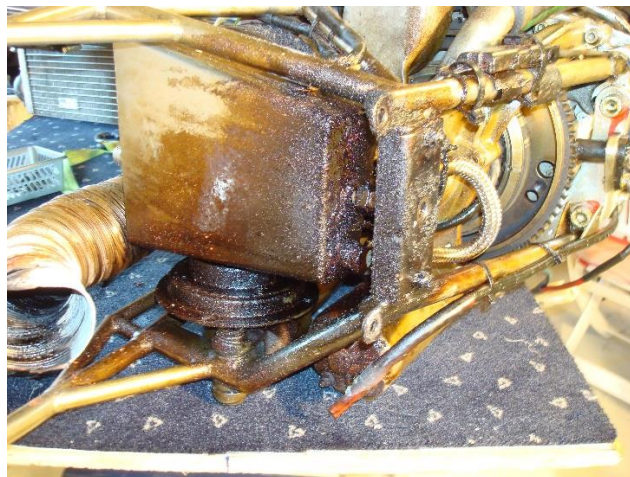
Figure 6: Fire/heat damage to the oil tank and the area near the rear engine mount. Photo: S/NLF

The glider mechanic believed that a temperature sensor on the oil tank would provide additional safety against a recurrence. Such a sensor will therefore be installed on LN-GMI.
