REPORT

SL 2016/11

REPORT ON SERIOUS AVIATION INCIDENT AT SVOLVÆR AIRPORT HELLE ON 2 DECEMBER 2010 INVOLVING BOMBARDIER DHC-8-103, LN-WIU, OPERATED BY WIDERØE'S FLYVESELSKAP AS

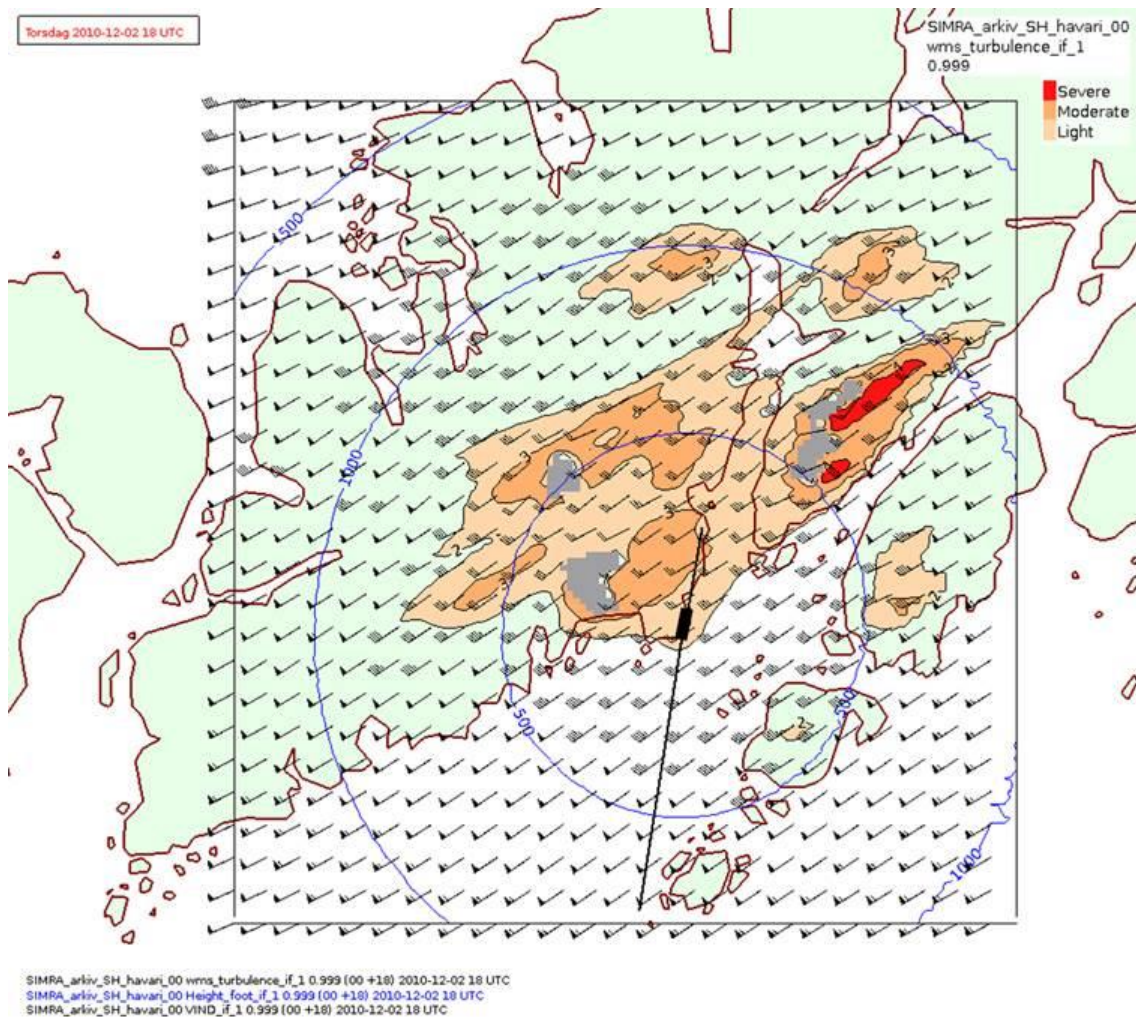
Figure 4: Horizontal section showing the modelled turbulence picture approximately 45 minutes after the incident. Supplementary explanations of the model are available at www.ippc.no. Source: The Norwegian Meteorological Institute

- 1.7.4.2 The figure below (Figure 4) illustrates the turbulence conditions using the same template as used at Avinor IPPC (Internet Pilot Planning Centre). The chart shows the height of a funnel-shaped flat area with the runway at the bottom (thick black line). The grey areas made up of squares indicate where the mountains in the model protrude through the funnel-shaped flat area.

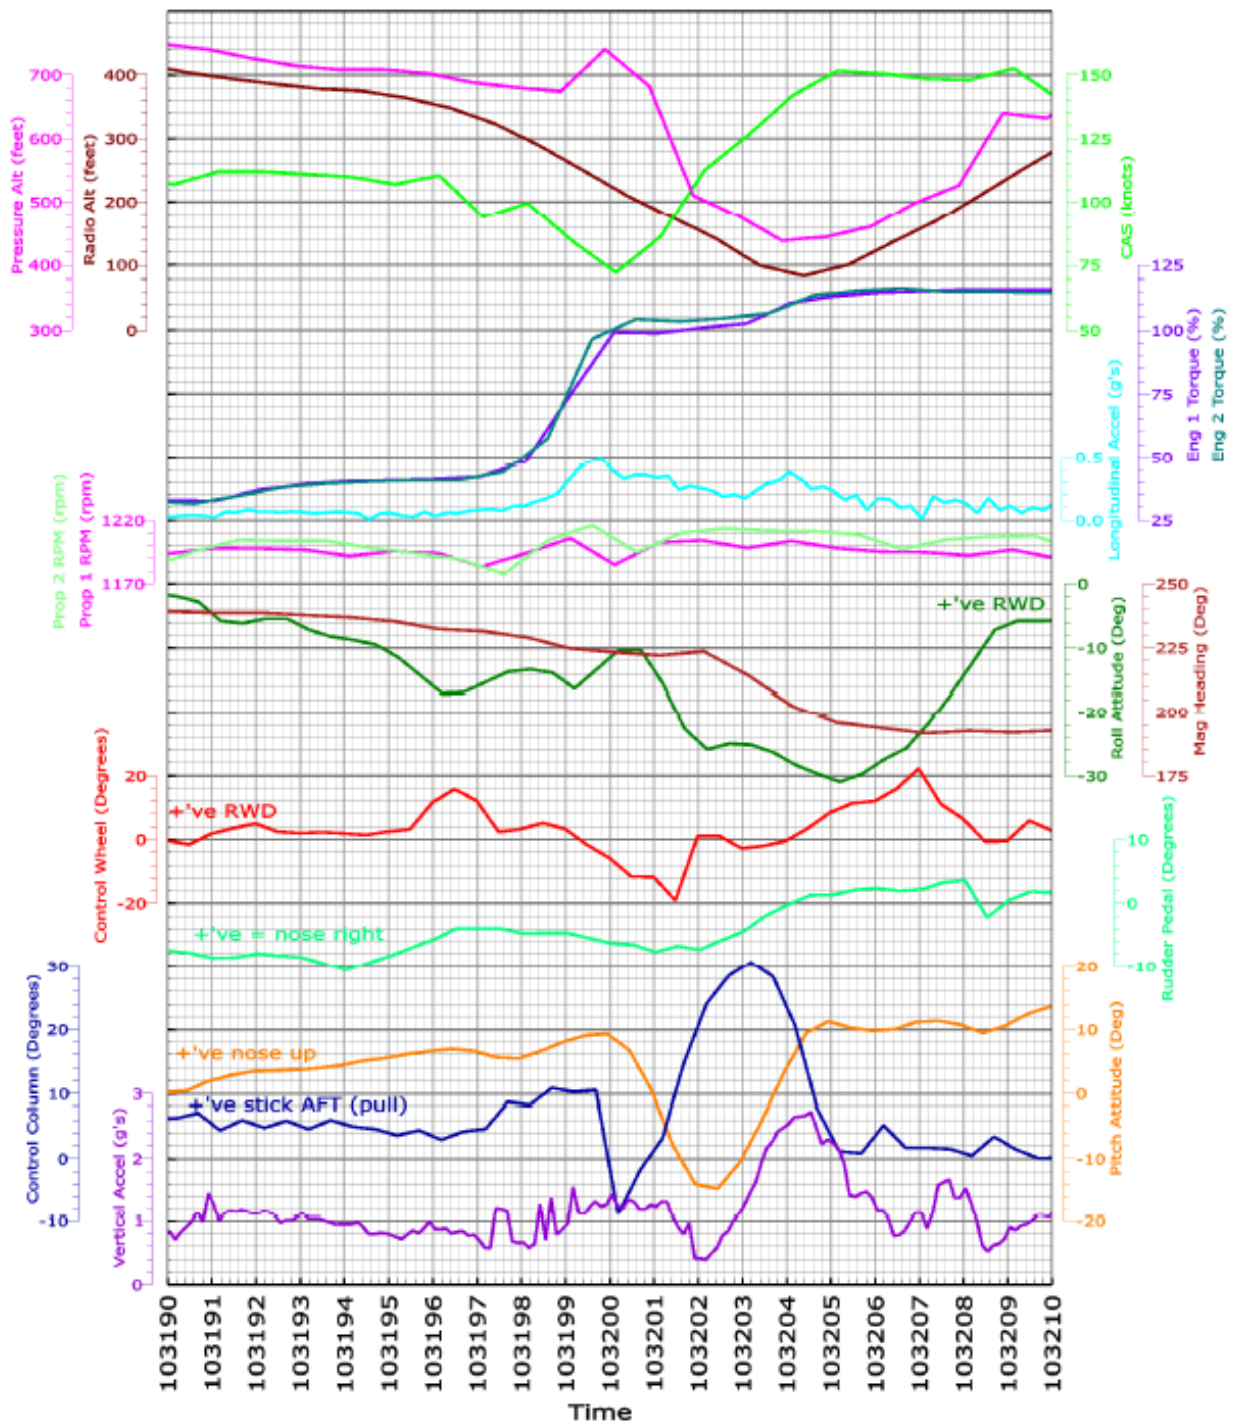
Figure 8: Overview of relevant FDR parameters from a few seconds prior to the critical phase starting, and until the situation was under control again. The timeline in the figure covers a total of 20 seconds. Source: Bombardier

- (16) *Between sample time 103204.4 and 103208.4, radio altitude increases from 83 to 212 ft at an average calculated rate of climb of 1935 ft/min. Airspeed settles at around 150 KCAS beginning at 103205.1 and the pitch attitude reaches 11.3° nose up and settles. The left and right elevator deflections settle at 3.9° and 0.7°, respectively, beginning at 103205.3, varying no more than 2° for the remainder of the analysis.*

corrected for wind) for relevant mass¹². The critical phase the flight crew has described, from a perceived normal situation via an acute hazardous situation with recovery which ended up in a very low altitude above the sea and until the situation was under control, unfolded over the course of approx. 10 seconds (cf. Figure 8, FDR time 103196–103205).

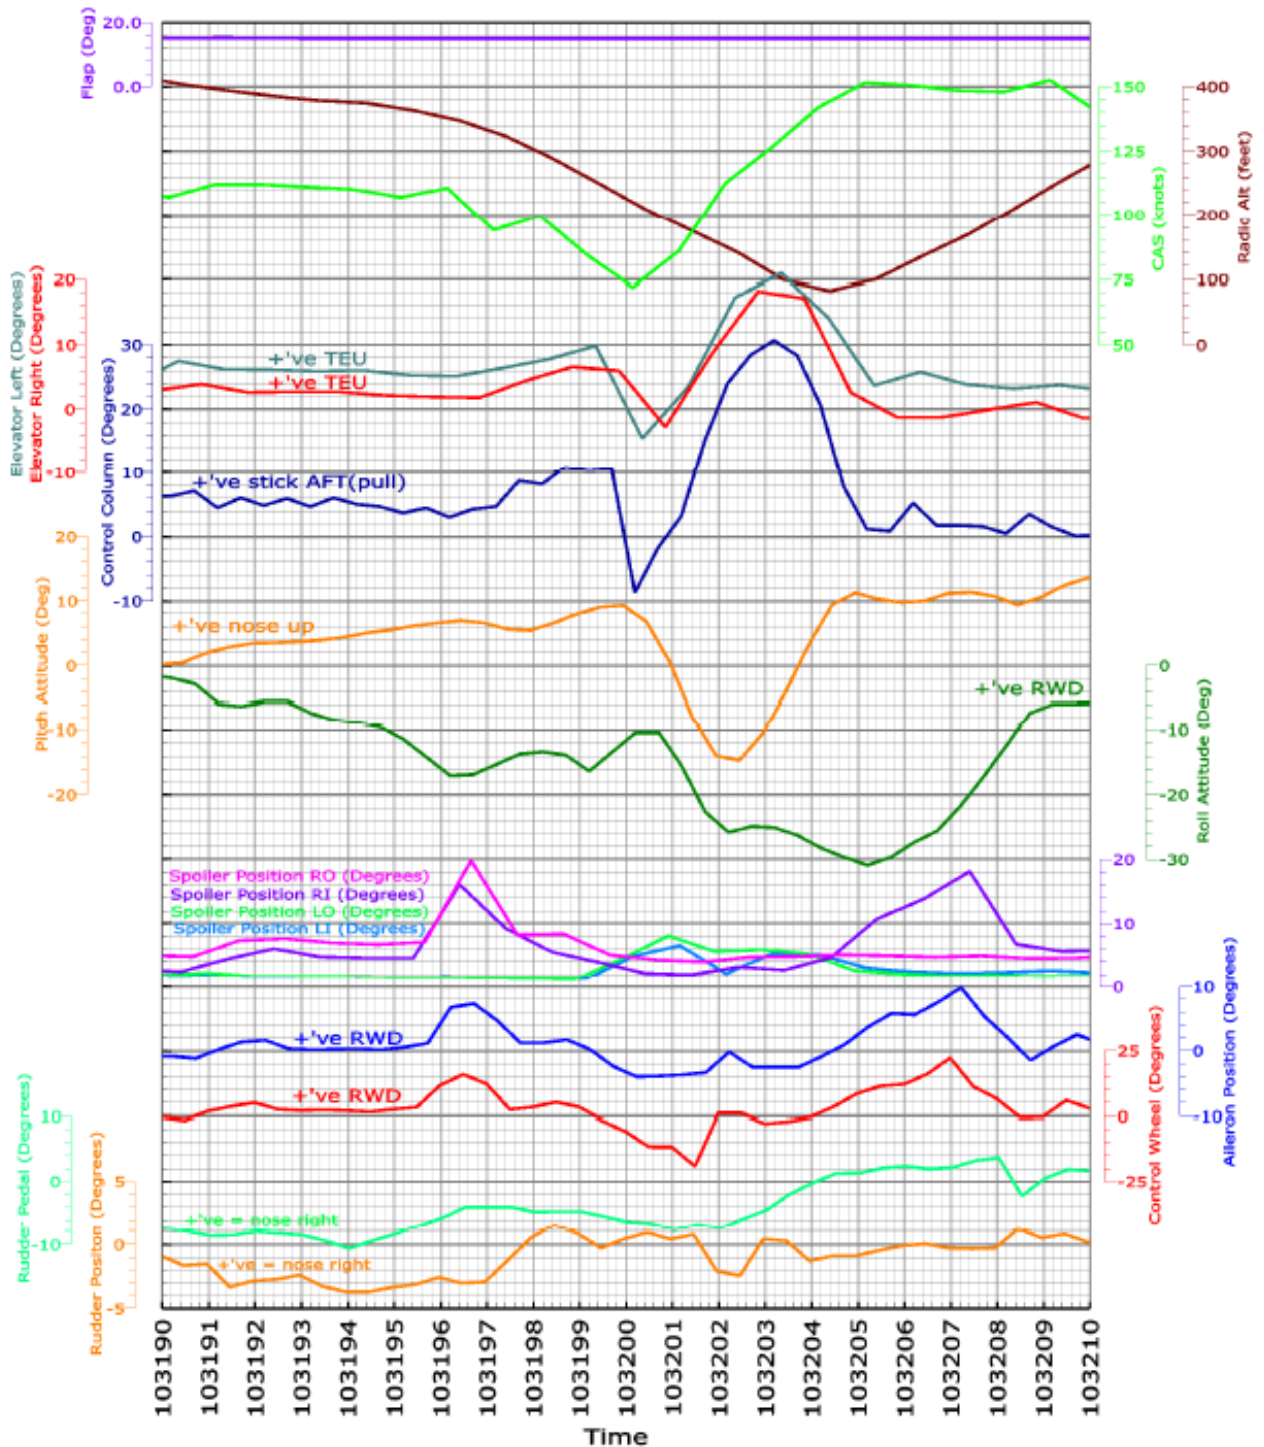
Figure 9: FDR parameters related to flight attitude and flight control positions in the same 20-second period as Figure 8. Source: Bombardier

Briefly summarized and expressed in a less precise manner than the account provided above, data from FDR show that the aircraft was in the transition between "base" and "final" (heading approx. 230 degrees) when the problems started (cf. Time 103196). The altitude was then approx. 350 ft (radio altimeter), engine power was approx. 41%, condition levers max and airspeed approx. 108 kt, which was the correct value (not

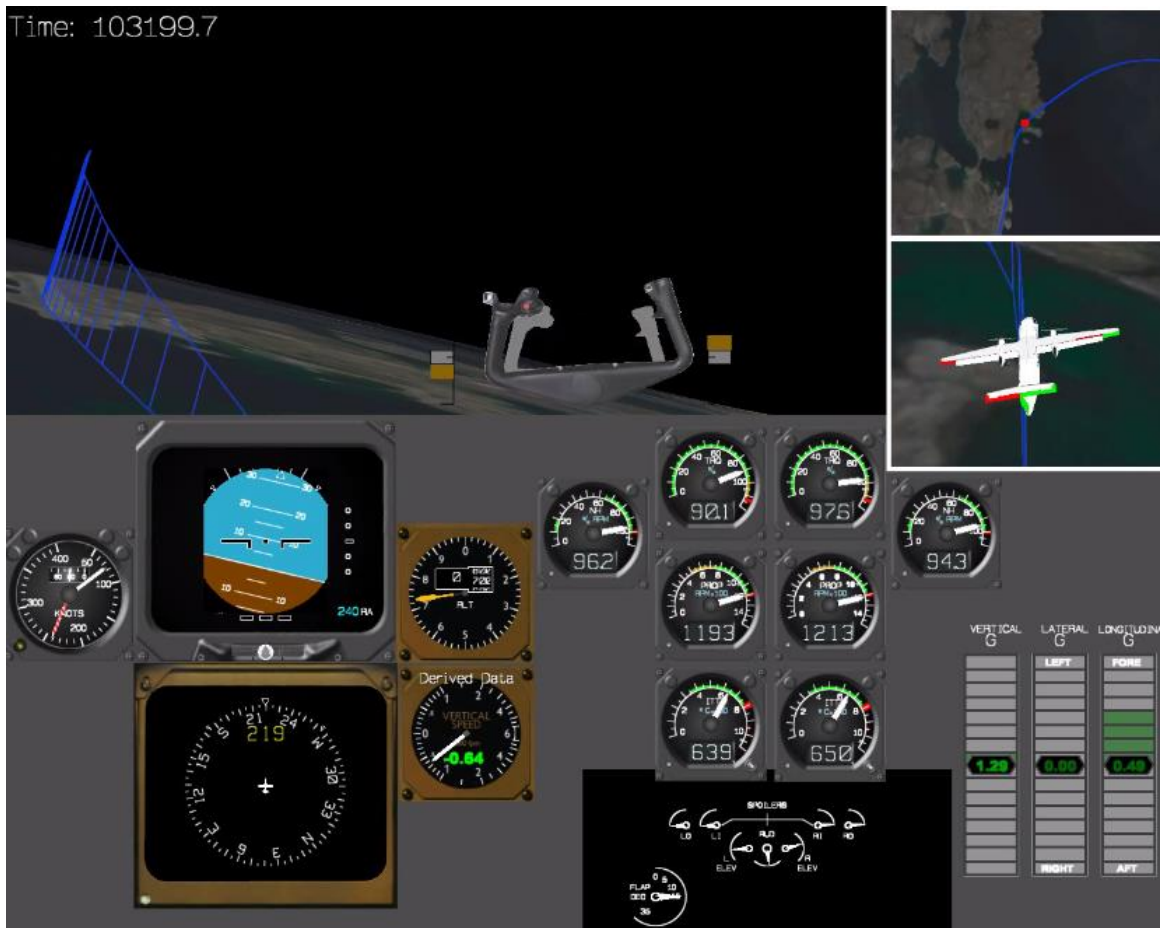
- 1.11.5.2 Despite inherent weaknesses in this, AIBN has determined that it is correct to publish the animation along with this report. The animation gives a good impression of how quickly things happened, a factor which is essential for understanding the sequence of events and the pilots' reactions and actions. The crew members and flight operations management in Widerøe have seen the animation, and have been given an opportunity to provide input. The animation can be downloaded from AIBN's website at <https://www.aibn.no/Aviation/Published-reports/2016-11-eng>.

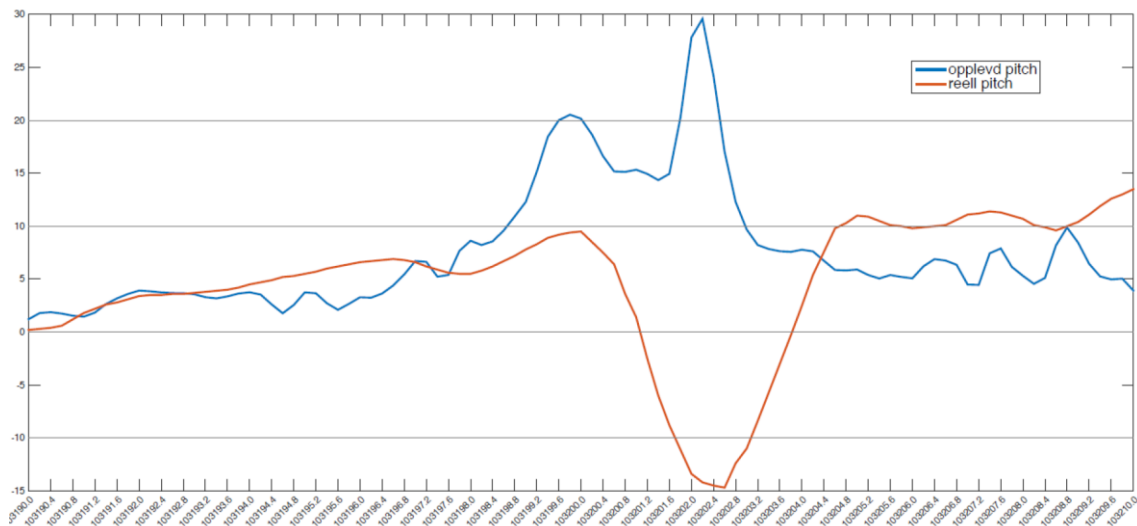
Figure 12: Sliding average (Fourier curve): Orange line, actual pitch (nose position) versus blue line, perceived pitch (resultant force) in degrees of deviation from the horizon (0). Source: FMI

FMI has discovered that the forces that can create a somatogravisk illusjon were present in the critical phase of the approach to Svolvær during the relevant time period. The following figure illustrates the result of the calculations made by FMI based on the FDR data from LN-WIU during the incident:

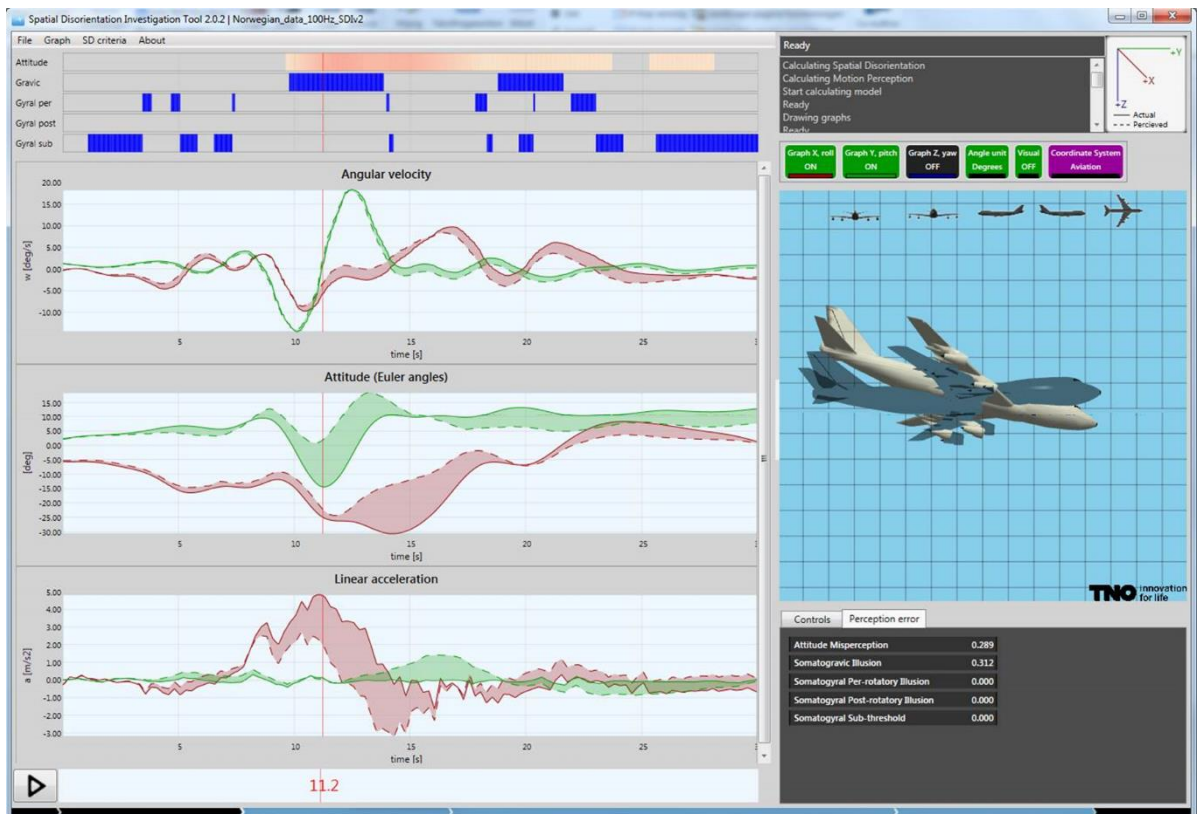
The figure below is a snapshot from SDiT. The recording has been paused when the nose was at the lowest point. The vertical red line shows the Time 11.2, corresponding to an FDR Time of approx. 103202 in Figure 8. In this situation, a deviation of approximately 17 degrees between actual and perceived pitch is shown:

TNO found that the conditions were conducive to sensory illusions also for a short period after the situation had been resolved. This is considered insignificant and will not be discussed in more detail here. The conclusion in the TNO report as regards the critical seconds largely coincides with FMI's findings.

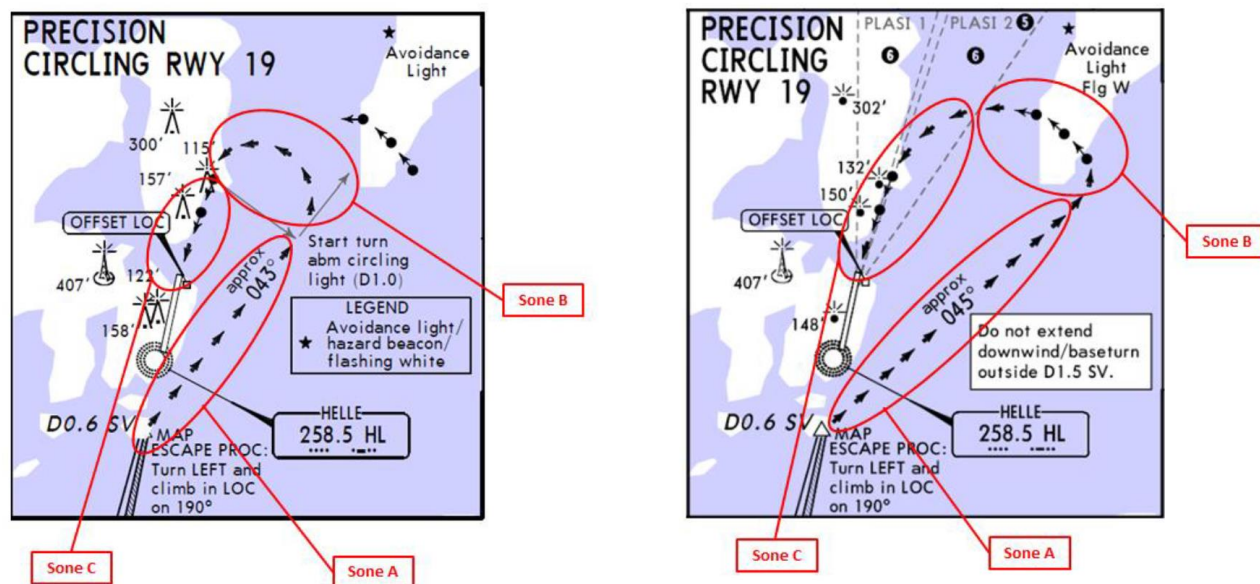
Figure 14: Comparison between Widerøe's chart dated 11 Feb. 2011 and 20 Feb. 2015.
Source: FMI

1.16.2.3 As described in Chap. 1.18.1, the lighting, PLASI, circling pattern, etc. at the airport were changed during the period in question. FMI divided the approach route into three zones and compared the hazards then and now:

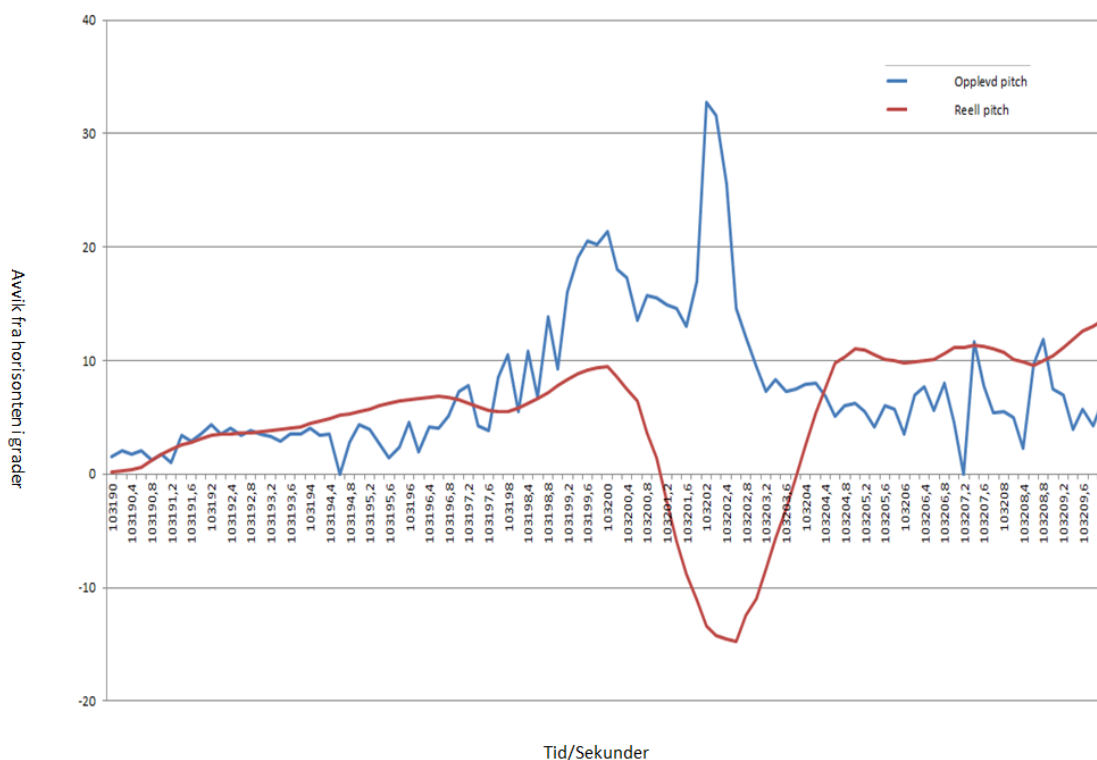
Figur 2: Reell pitch (nesestilling) versus opplevd pitch (resultantkraften) i grader avvik fra horisonten (0).

Figur 2 viser WIF814s reelle nesestilling, hentet fra FDR-data, (rød linje) sammen med den beregnede resultantkraften (blå linje) (se figur 1). Resultantkraften kan kalles opplevd *pitch*, altså hvordan pilotene kan ha opplevd flyets nesestilling basert på de krefter det var utsatt for.

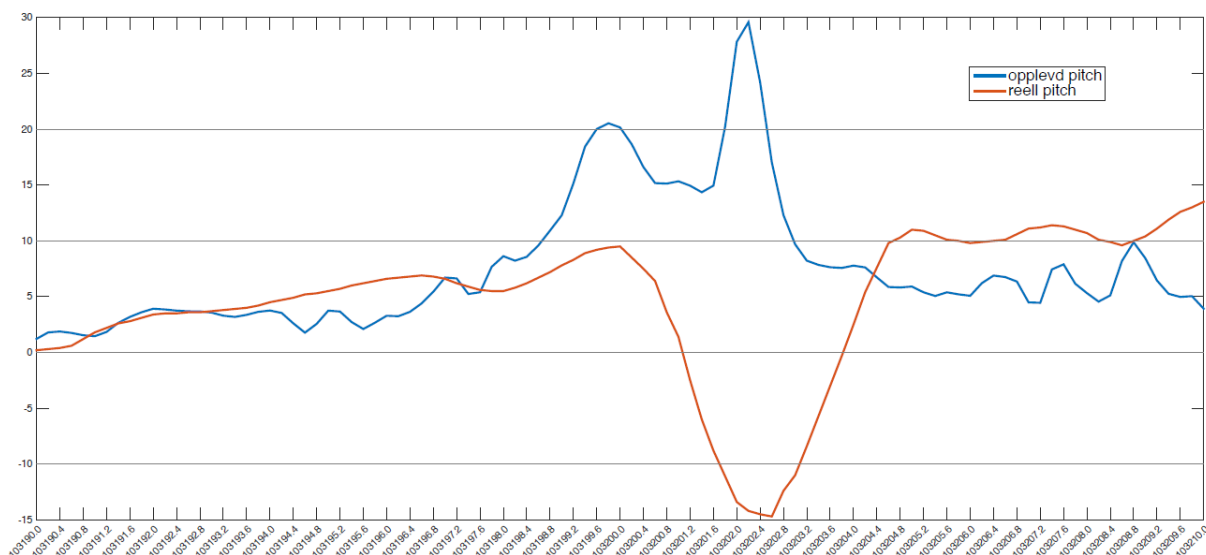
Figur 3: Glidende gjennomsnitt (Fourier-kurve): reell pitch (nesestilling) versus opplevd pitch (resultantkraften) i grader avvik fra horisonten (0).

I figur 2 og 3 ser vi at den beregnede resultantkraften viser opplevd nesestilling opp under hele hendelsen, med en økning i opplevd nesestilling opp like før, og spesielt mens, flyets nese faktisk vendte nedover. Flyets reelle nesestilling sank fra like etter øyeblikket hvor flyets stikke ble beveget forover (sekund 103199), og var på det laveste på ca. $-14,5^\circ$. Samtidig økte resultantkraften til nese opp med ca. $29,9^\circ$ på det høyeste (sekund 103202).

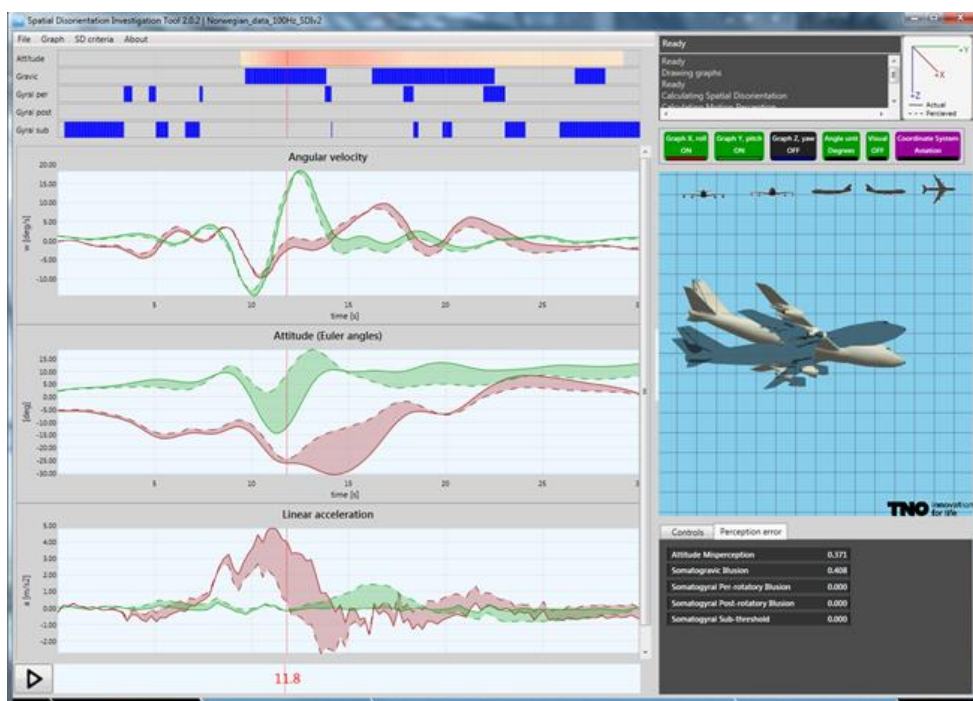
Figure 1. Screenshot of incident analysis with the SDiT. **Upper panel:** SD tracks showing the identified vestibular illusions. Attitude=attitude misperception; Gravic=somatogravic illusion; Gyrals per=somatogyral illusion during turn; Gyrals post=somatogyral illusion after turn; Gyrals sub=sub-threshold rotation. **Bottom panel:** time histories of actual (solid lines) and perceived (dashed lines) aircraft attitude (upper) and linear acceleration (lower). The shaded areas indicate the perceptual mismatch. Red: motions in the x-axis (roll rotation resp. longitudinal acceleration); Green: motions in the y-axis (pitch rotation resp. lateral acceleration). Motions in z-axis (yaw rotation and vertical acceleration) are not shown.

The blue and orange SD tracks in the upper panel of Figure 1 show various SD events. The three tracks labelled with “Gyrals” indicate that the aircraft’s angular motion was not always being perceived at all (“Gyrals sub”), or alternatively, the perceived angular rate was below the actual rate due to the dynamics of the semicircular canals (“Gyrals per”). Looking at the shaded areas in the time history of angular velocity, the error in the perception of angular velocity was only minor. Therefore it is likely that the somatogyral effects were not an issue in this case.
