SL 2017/05

REPORT ON SERIOUS INCIDENT AT BERGEN AIRPORT FLESLAND, NORWAY ON 31 AUGUST 2015 WITH PIPER PA-28-161, LN-BGQ

Date of submission: 18.04.2017
SL Report: 2017/05

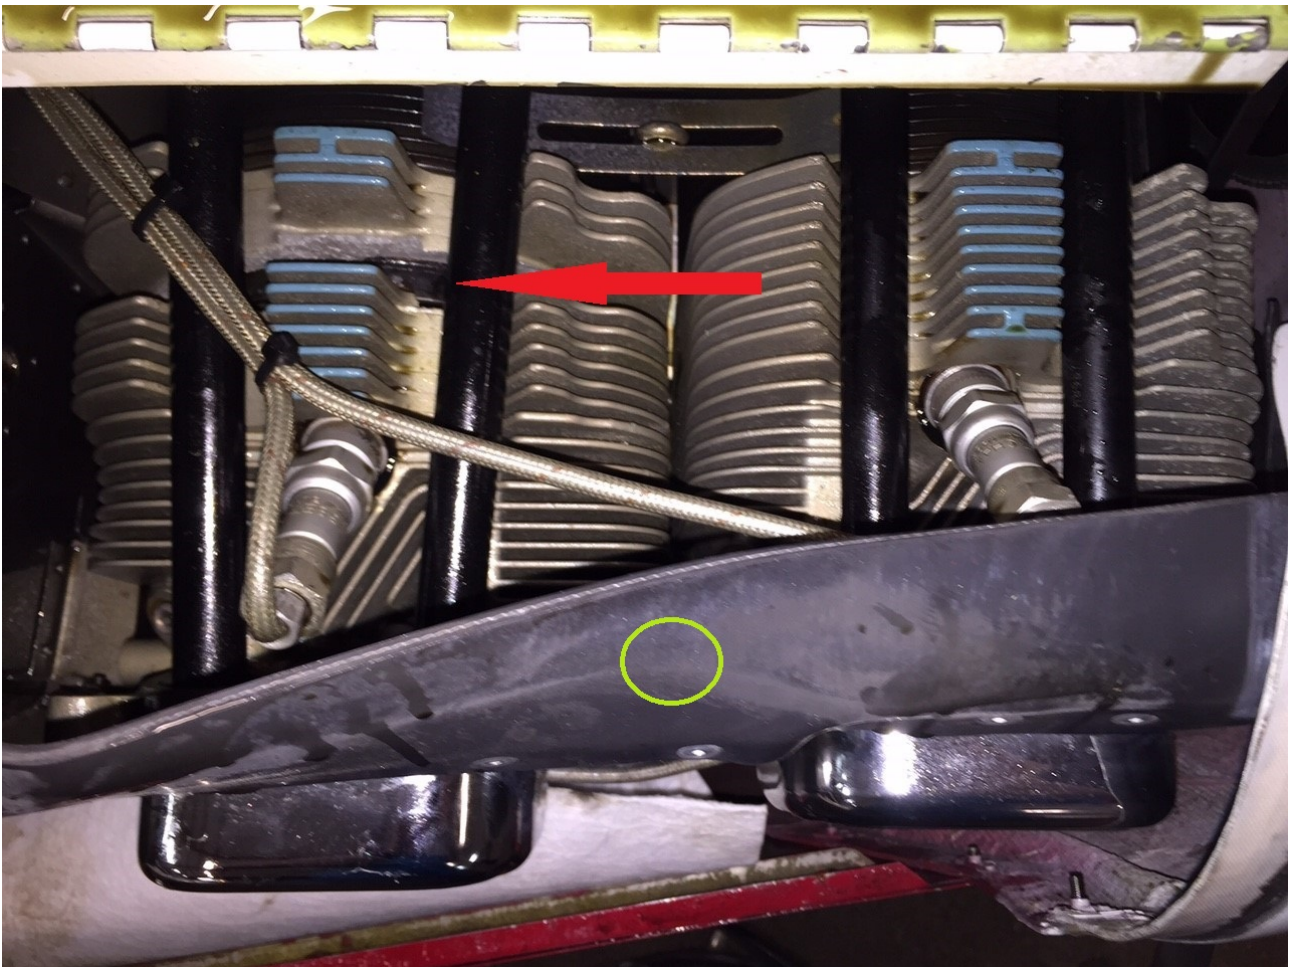
It soon became clear that the engine trouble was due to the cylinder head on cylinder no. 3 fracturing and coming loose. Cylinder no. 3 was consequently dismantled and sent to the Accident Investigation Board (AIBN) for closer examination.

Figure 1: Fracture in cylinder no. 3 before the cylinder was dismantled. A screw was wedged between the cylinder heads in the area underneath the black rubber seal, indicated with a green circle. Photo: Private

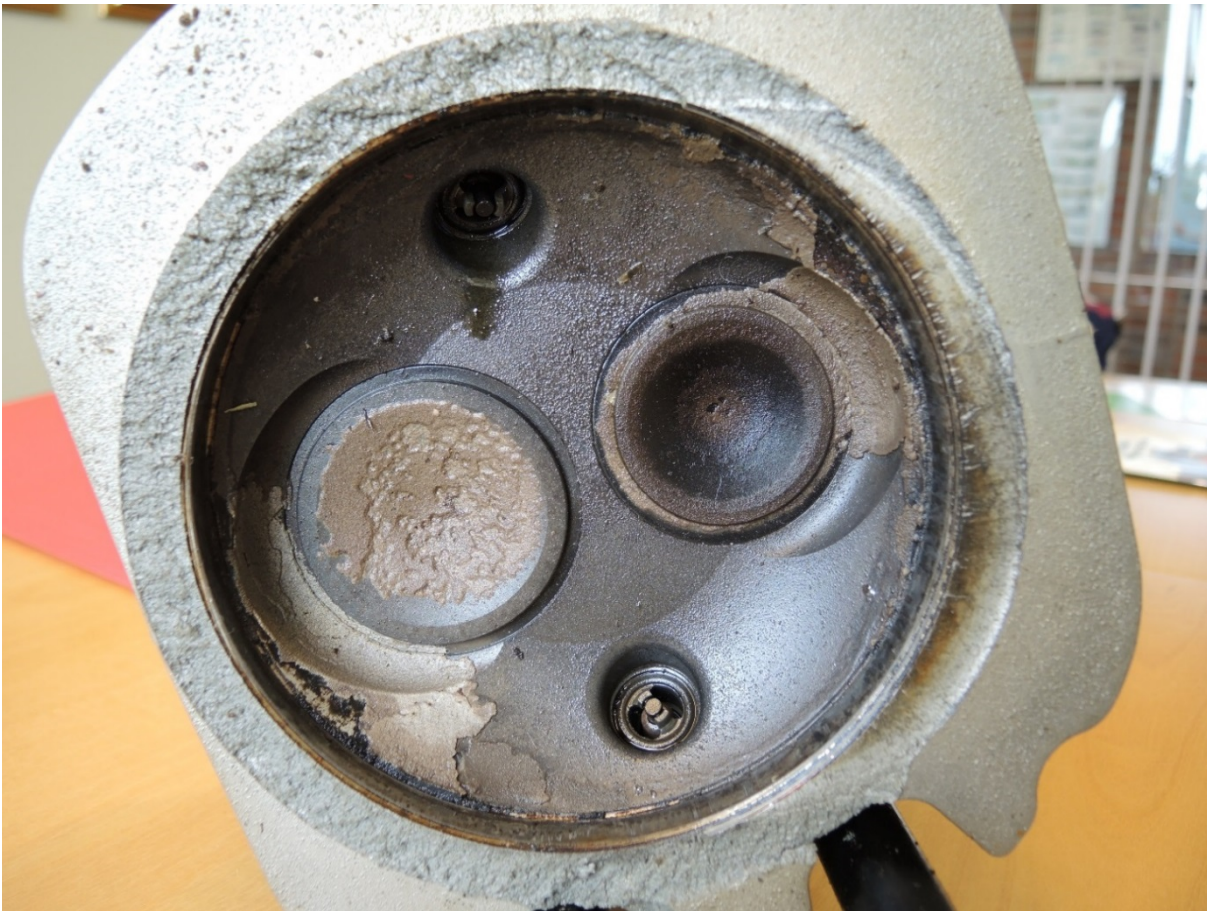
Figure 2: Fracture after the cylinder head was removed. The fracture started on the right side of the photo. Soot colour in the right side of the fracture surface shows that the fracture has been open in this area for a while. Photo: AIBN

The cylinder head was sent to the Norwegian Armed Forces Laboratories at Kjeller (FLO/VEDL/FOLAT) for closer examination, where it was discovered that the fracture was due to fatigue. They were unable to find obvious flaws in the material or identify what initiated the fatigue crack.

Soot on the fracture surfaces supports the theory that an open fracture has existed over a certain number of flight hours. However, the fracture was so small that only a thorough inspection immediately prior to the incident could have discovered the fault.

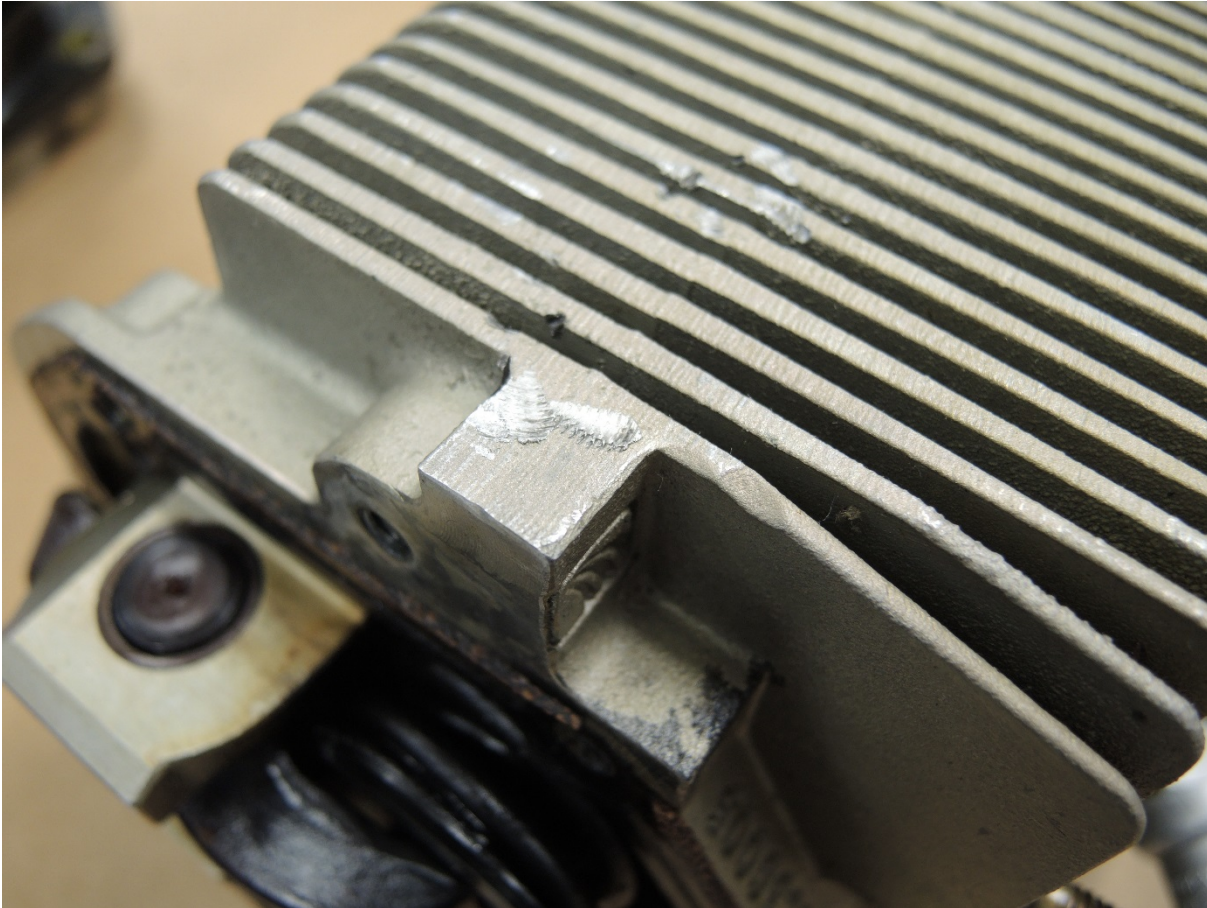
In connection with the investigation in the US, it was noted that the cylinder head had indentations from a screw-like object in the area facing cylinder no. 1 (see Figure 3). A 1/4" screw with 28 threads per inch fit right into the indentation. The area where the indentation was identified was on the same side where the fatigue fracture started.

Figure 3: Marks from a screw-like object on the surface of the cylinder head (cylinder no. 3) facing cylinder no. 1. Photo: AIBN

The distance between the cylinders in the relevant location may allow a screw of the type in question to wedge itself in. The indentations indicate that at least one screw had been wedged in the opening between cylinders 1 and 3. Temperature changes and the cylinders' work cycle have led to small relative movements between the two cylinders. These movements have likely allowed the screw to wedge itself between the cylinders, and it has then been forced into the cylinder head. This has most likely caused abnormal strain on the cylinder as well as a lateral force which the cylinder head could not withstand, over time.

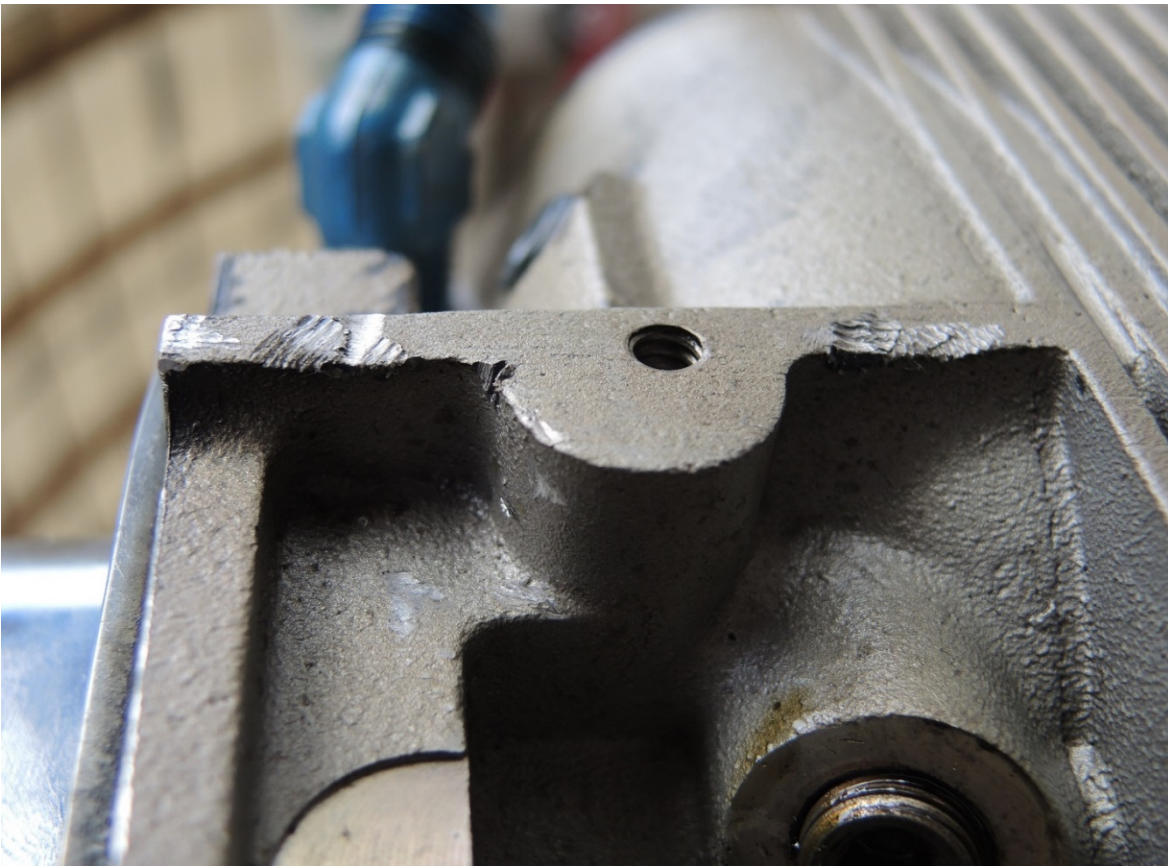
Upon closer inspection of cylinder no. 1, an equivalent indentation was discovered directly opposite the indentations found on cylinder no. 3 (see Figure 4).

Figure 4: Equivalent indentations on cylinder no. 1. Photo: AIBN

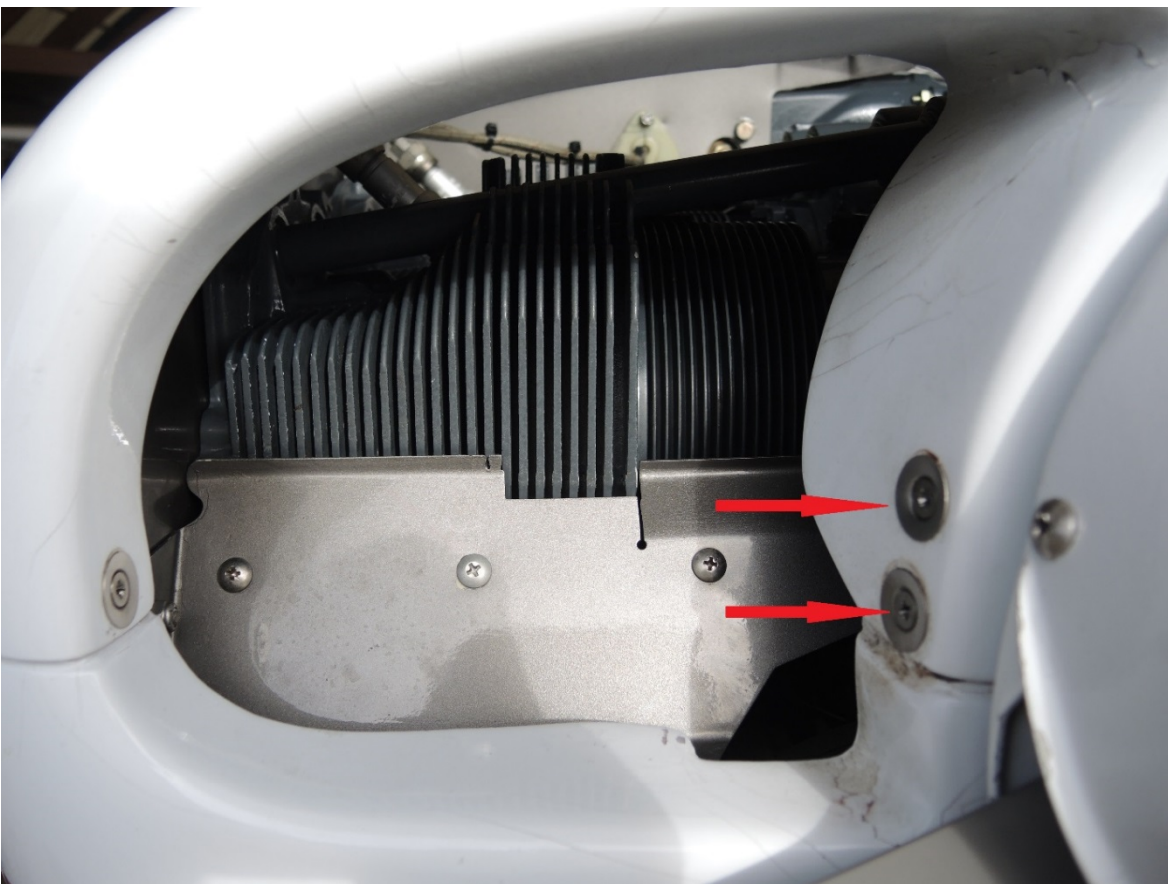
The actual screw dimensions were 1/4" with 28 threads per inch.

Figure 5: Arrows point at the screws in question. Photo: AIBN
