SL 2018/04

SUMMARY REPORT ON THE AIR ACCIDENT NEAR TURØY, ØYGARDEN MUNICIPALITY, HORDALAND COUNTY, NORWAY 29 APRIL 2016 WITH AIRBUS HELICOPTERS EC 225 LP, LN-OJF, OPERATED BY CHC HELIKOPTER SERVICE AS

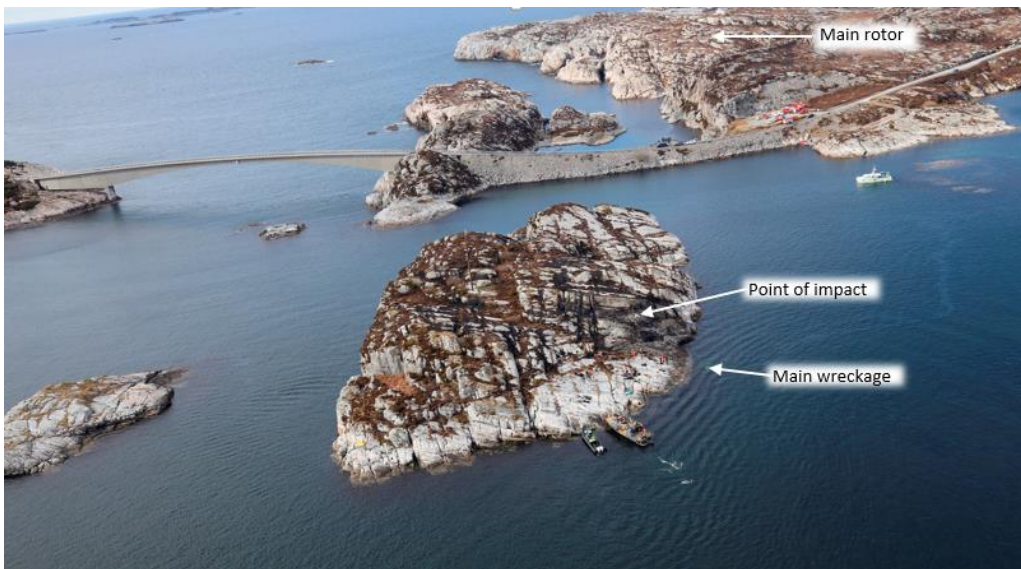
Figure 1: Photo of the accident area taken at 1500 hours 29 April 2016. View from south. Photo: Kriplos

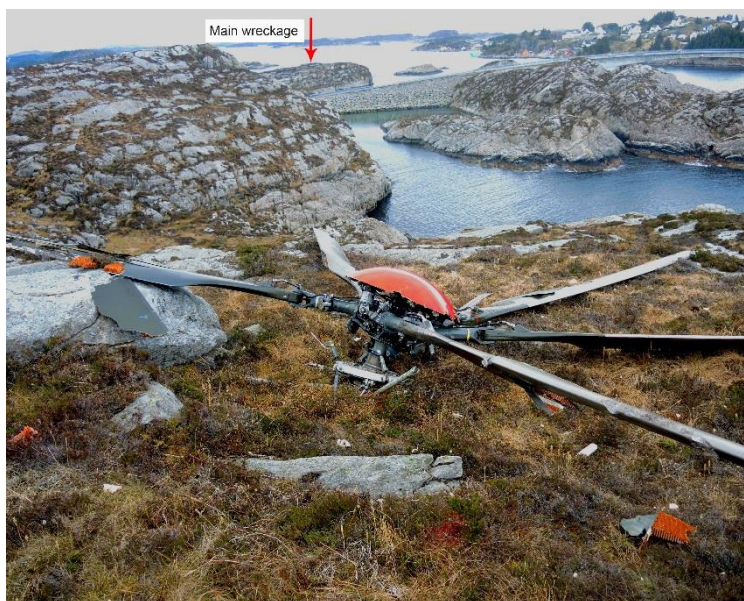
Figure 2: The main rotor as found on the island Storskora. Photo: AIBN

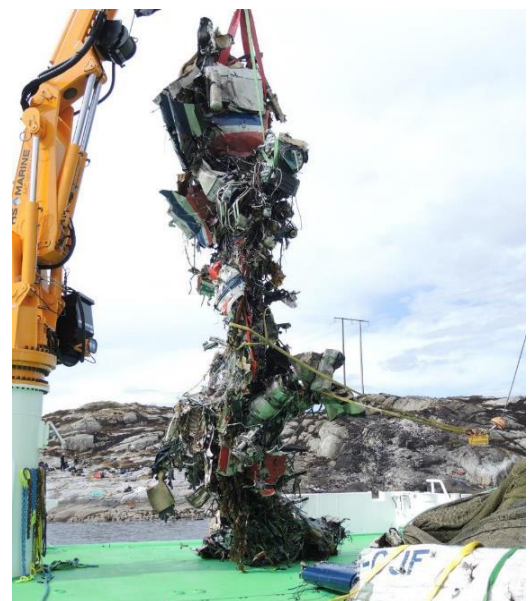
Figure 3: The main wreckage during recovery. The tail boom at the lower right. Photo: AIBN

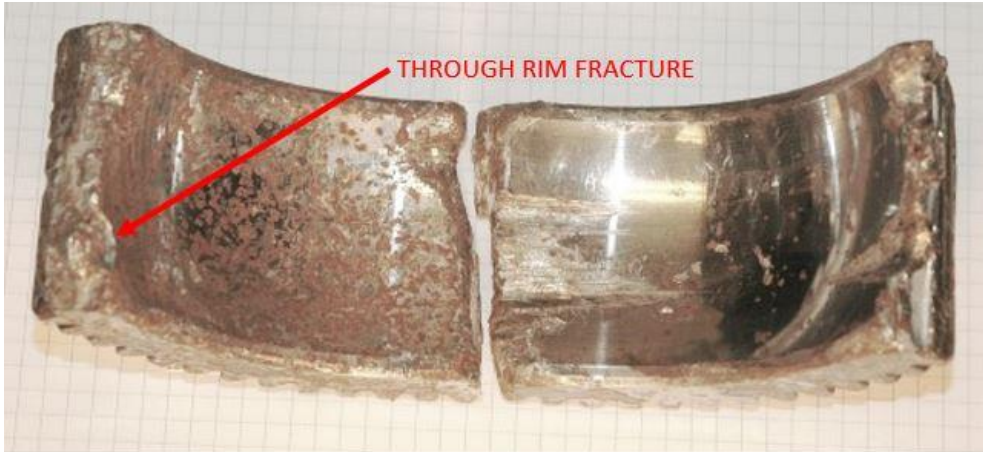
Figure 6: The two segments of the fractured second stage planet gear. The fatigue fracture through the rim (through-thickness fracture) started in the outer upper race of the planet gear wheel, where the red arrow is pointing. Photo: AIBN/NDL

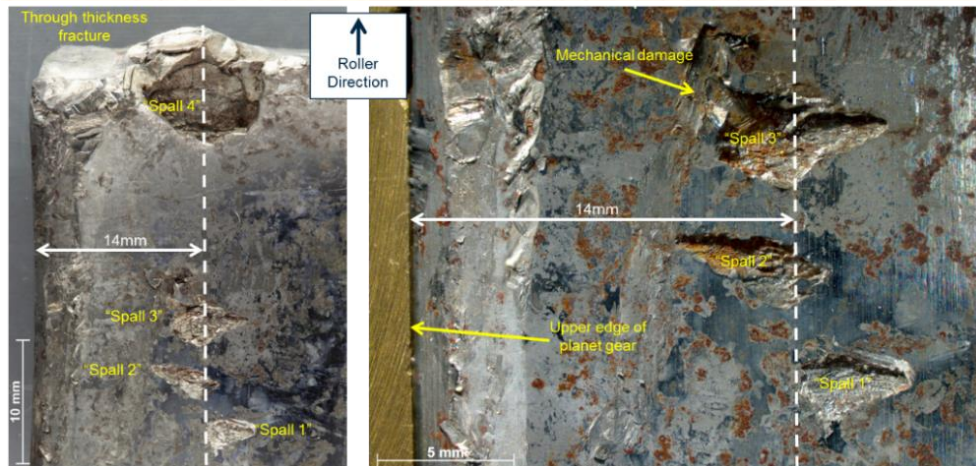
Figure 7: Spalls 1, 2, 3 and 4 together with the max Hertzian stress line. Photo: AIBN/QinetiQ

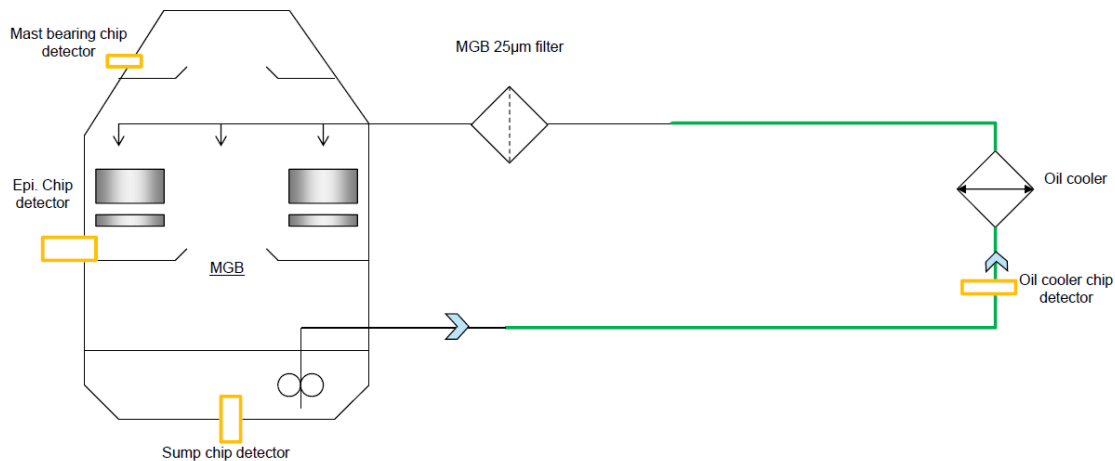
Figure 8: Chip detection system overview. Source: Airbus Helicopters

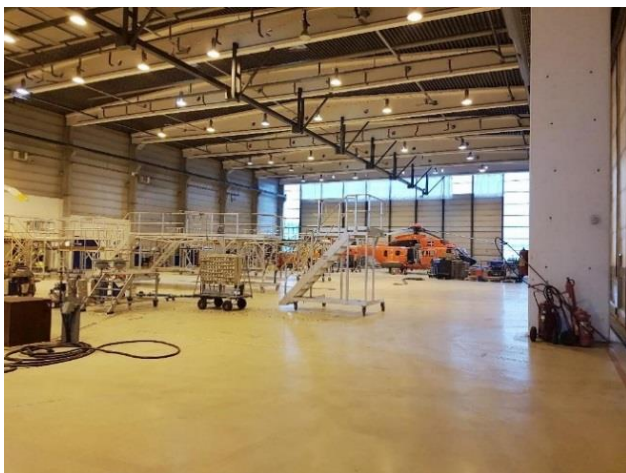
Figure 11: The CHC Helicopter Service maintenance hangar in Bergen. Photo: CHC Helicopter Service

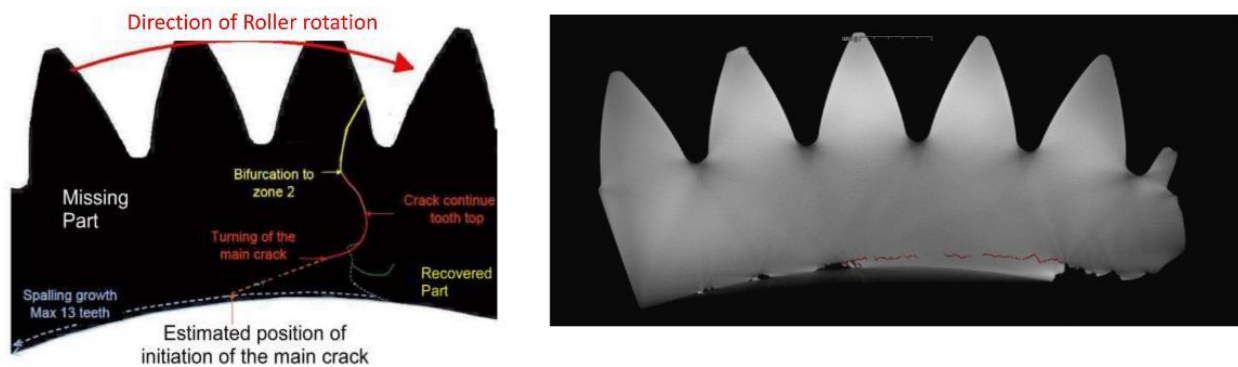
Figure 13: Stress model estimation of crack growth from the G-REDL to the left (Source: Airbus Helicopters) compared with the CT scan from the LN-OJF gear with the crack in red (Photo: CT-scan from AIBN/Southampton University).
