## PRELIMINARY REPORT 1 JUNE 2016

### ACCIDENT AT TURØY, NEAR BERGEN, NORWAY ON 29 APRIL 2016, INVOLVING AIRBUS HELICOPTERS H225, LN-OJF OPERATED BY CHC HELIKOPTER SERVICE AS

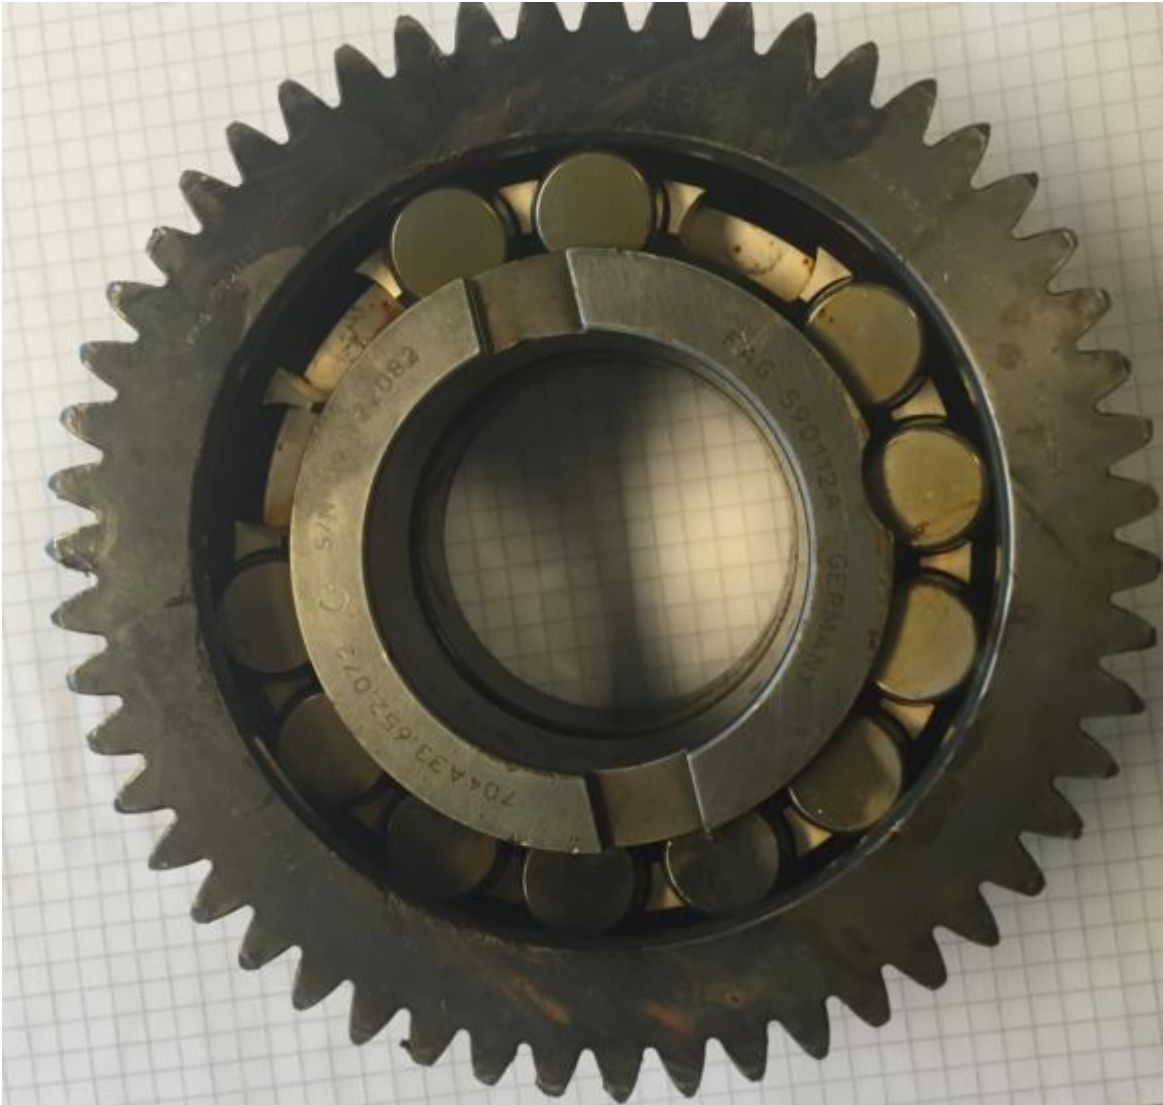
Detailed metallurgical examinations have been ongoing since 19 May. Several parts from the second stage epicyclic module were retrieved from the accident site. The epicyclic module planet gears are designed as a combined gear and bearing assembly. Figure 1 shows one of eight second stage planet gears.

Figure 1: Second stage planet gear (as found with three rollers missing). Photo: AIBN
