UPDATE TO PRELIMINARY REPORT ON ACCIDENT AT TURØY, NEAR BERGEN, NORWAY ON 29 APRIL 2016, INVOLVING AIRBUS HELICOPTERS H225, LN-OJF OPERATED BY CHC HELIKOPTER SERVICE AS

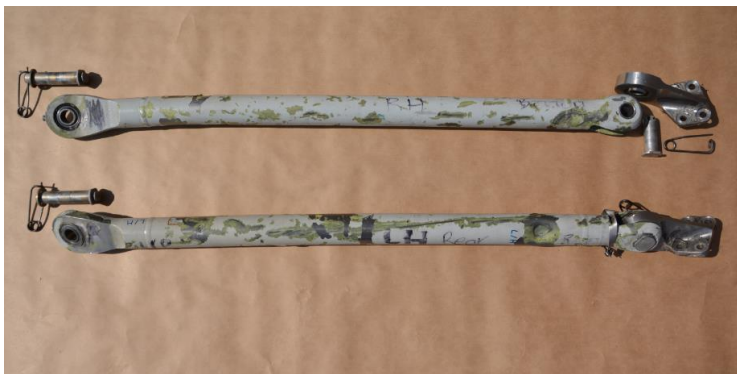
Figure 3: MGB Right and left hand aft suspension bars with attachment fittings. Photo: AIBN

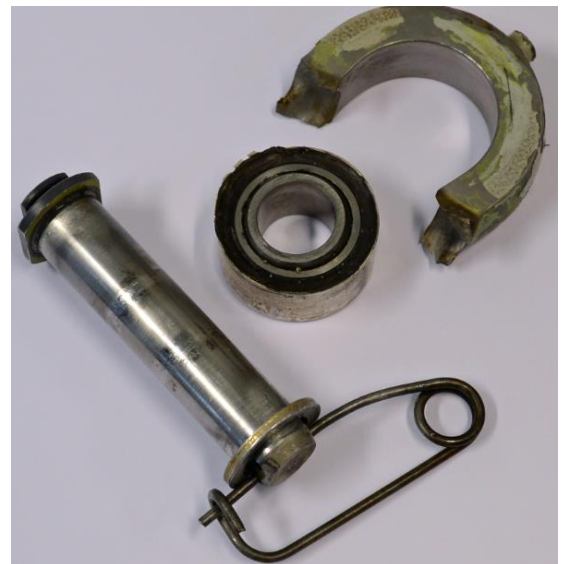
Figure 4: Upper forward suspension bar fitting. Photo: AIBN

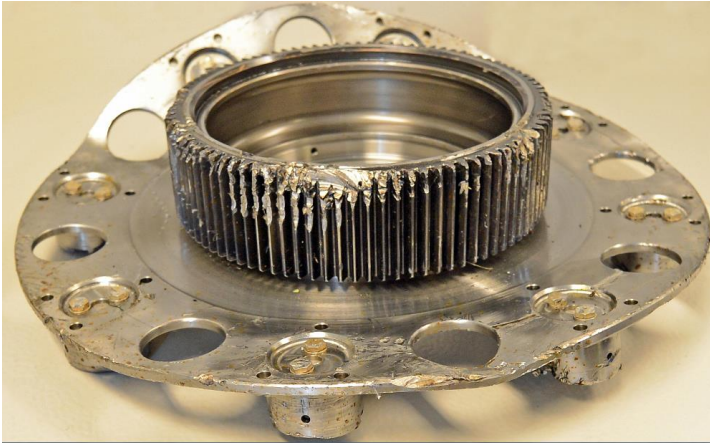
Figure 5: MGB first stage planetary gear carrier. Photo: AIBN

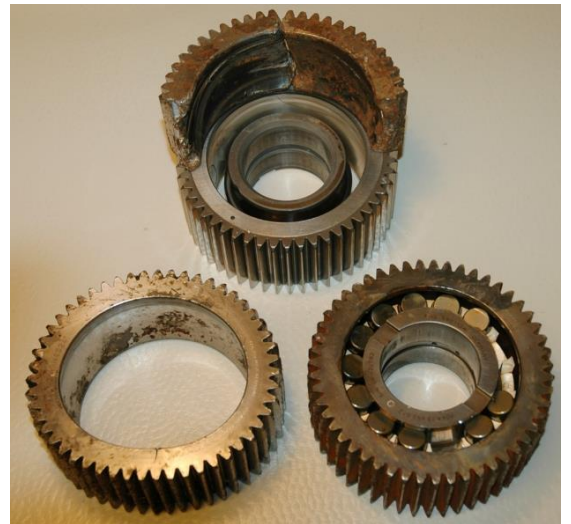
Figure 6: Parts from second stage planet gear. (The fractured gear is placed on top of a sample gear that was not involved in the accident.)
Photo: AIBN

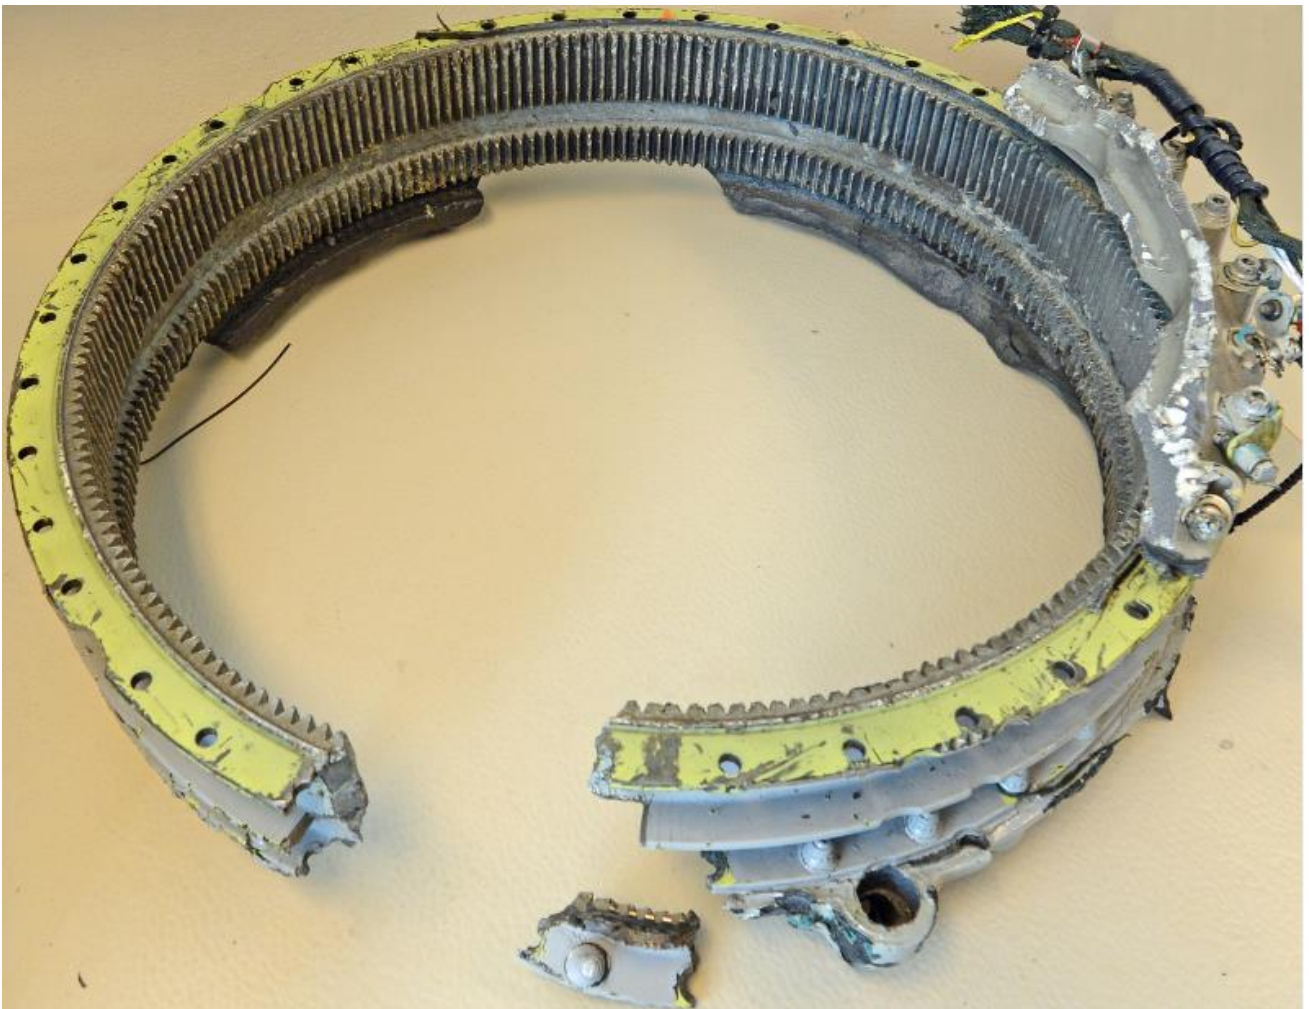
Figure 7: Ring Gear. Photo: AIBN

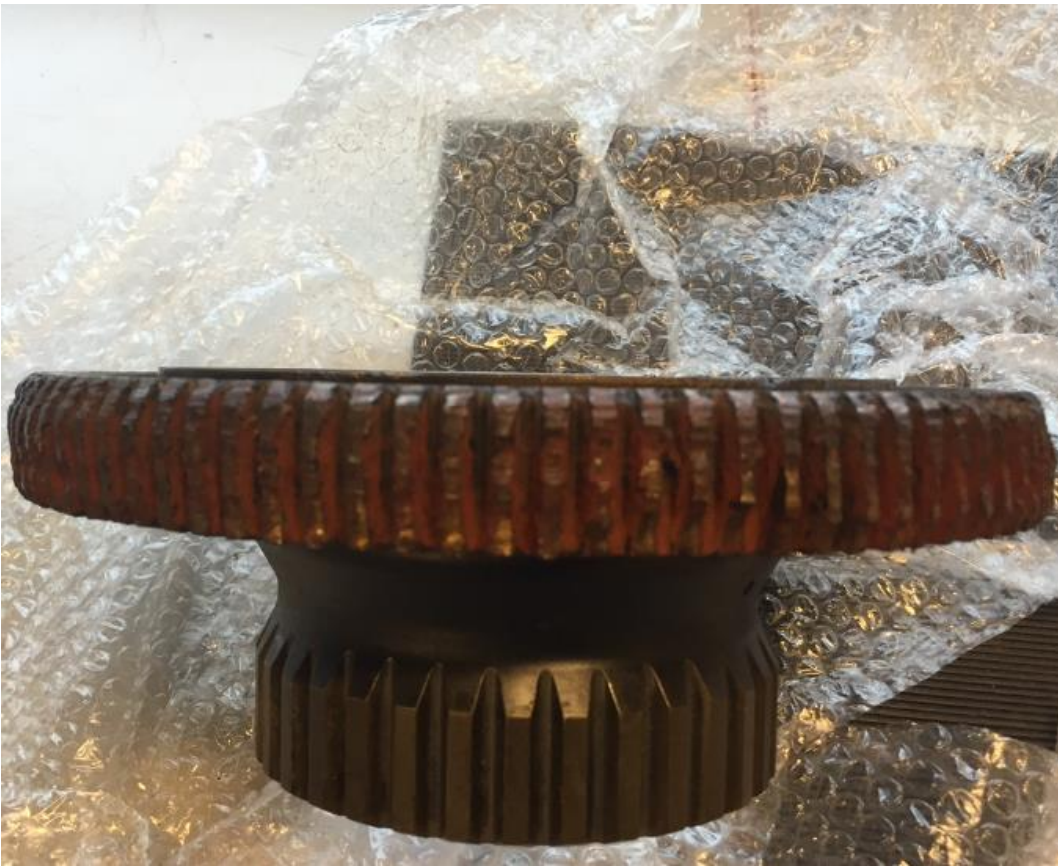
Figure 8: First stage Sun Gear. Photo: AIBN

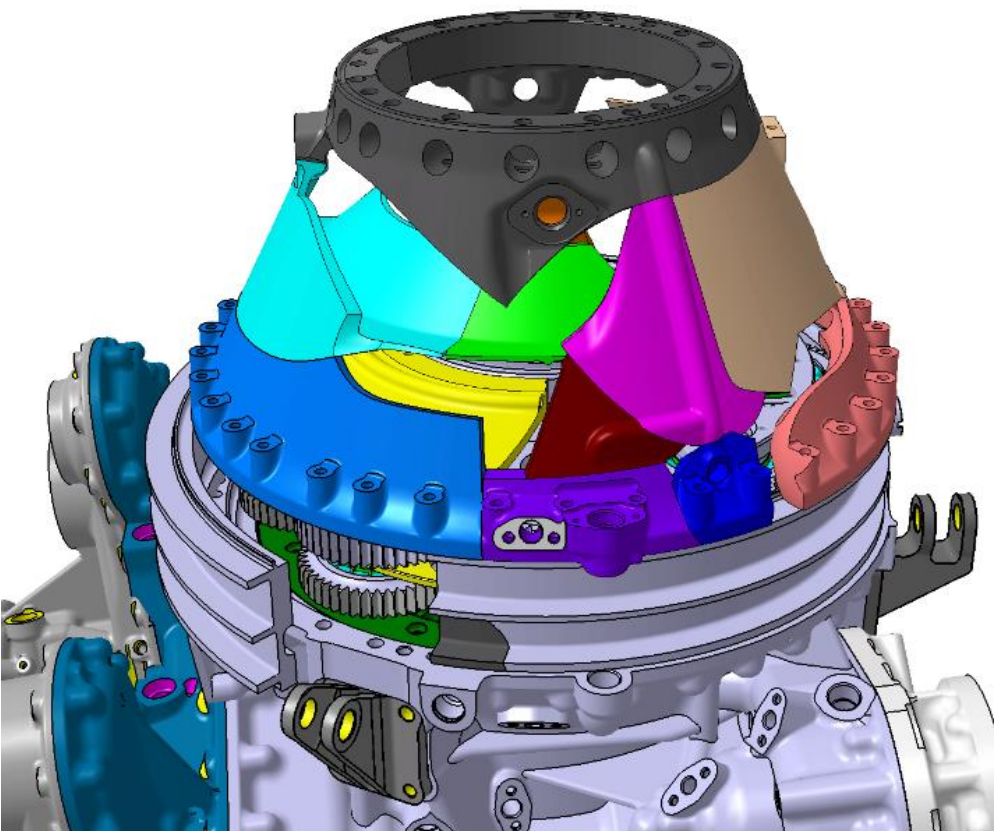
Figure 9: Illustration of how the retrieved fragments of the Conical Housing are pieced together in order to look for break-up sequence/mechanism. Illustration: Airbus Helicopters

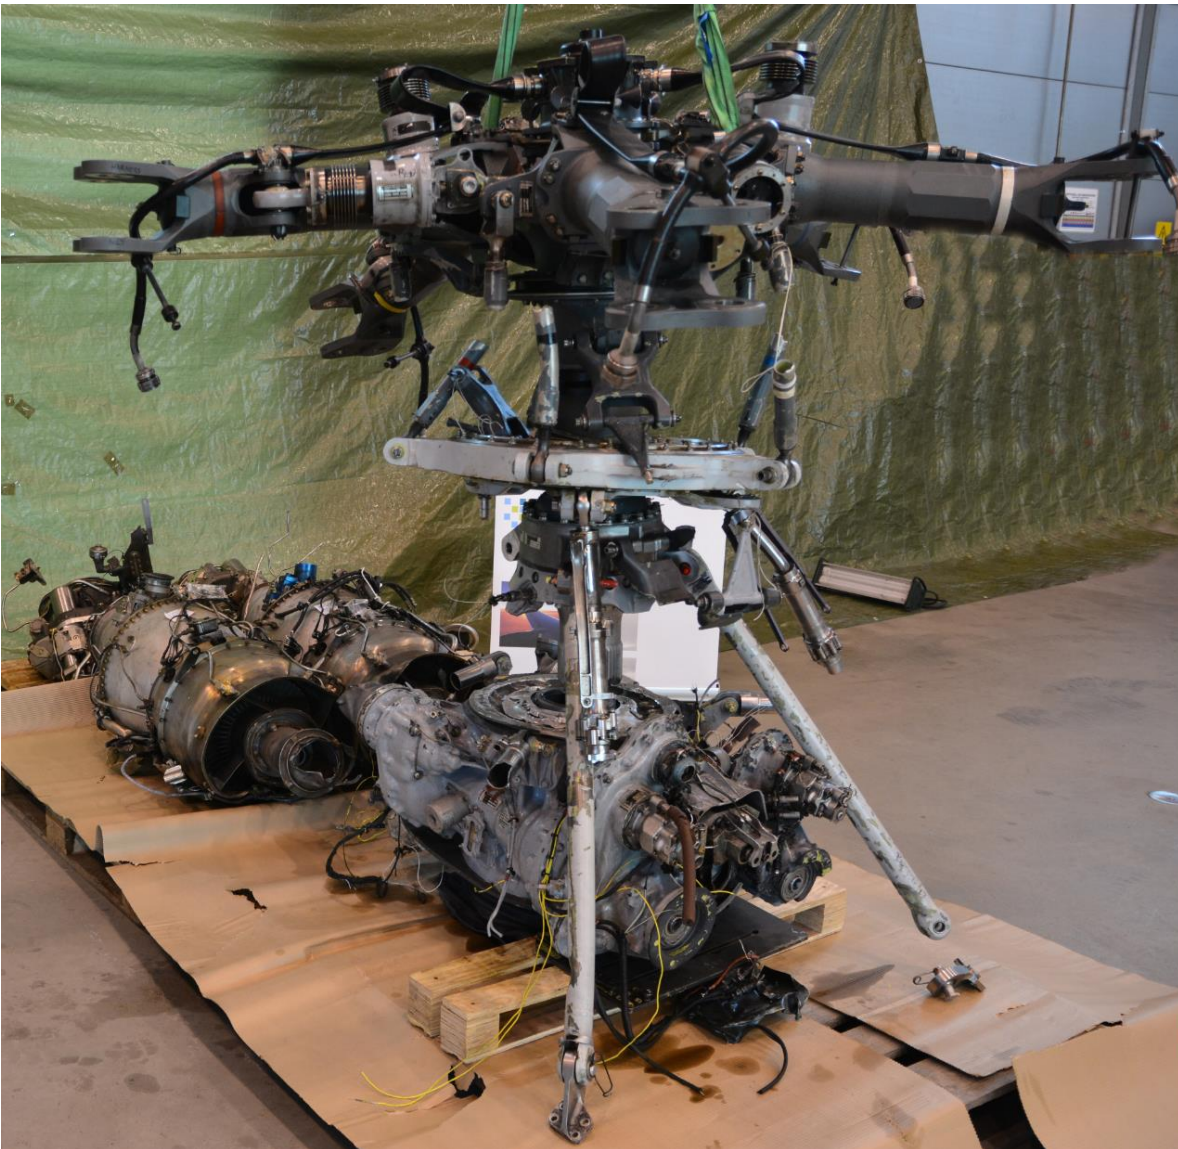
Figure 10: Main rotor head with rotor mast with aft suspension bars and power plants. Photo: AIBN
