**PRELIMINARY REPORT ON THE AIR ACCIDENT NEAR TURØY, ØYGARDEN  
MUNICIPALITY, HORDALAND COUNTY, NORWAY 29 APRIL 2016 WITH AIRBUS  
HELICOPTERS EC 225 LP, LN-OJF, OPERATED BY CHC HELIKOPTER SERVICE AS**

28 April 2017

## AIR ACCIDENT PRELIMINARY REPORT

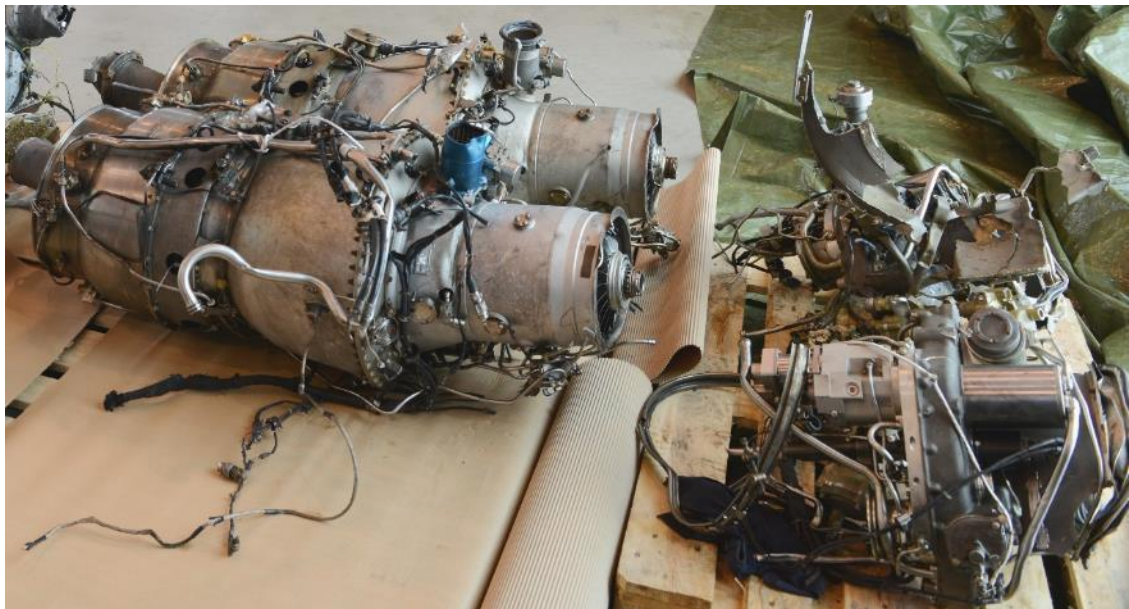
Figure 23: The engines at the AIBN hangar. They had similar damages to a large extent. Both intake sections (Module M01) which had separated from the front part of the engines can be seen to the right of the photo. Photo: AIBN

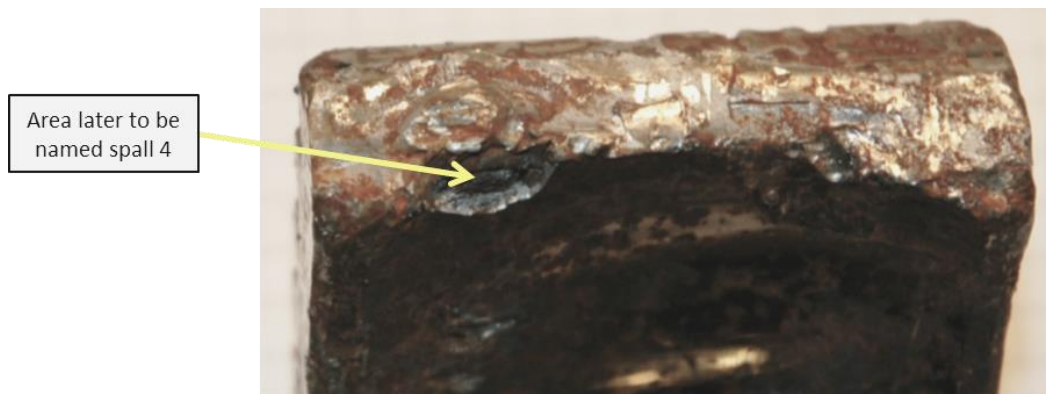
Figure 28: The fracture surface to the left in Figure 27, in general other surfaces appeared to be ductile overload, however, this surface indicated by the yellow arrow was of particular interest. Photo: AIBN/NDL

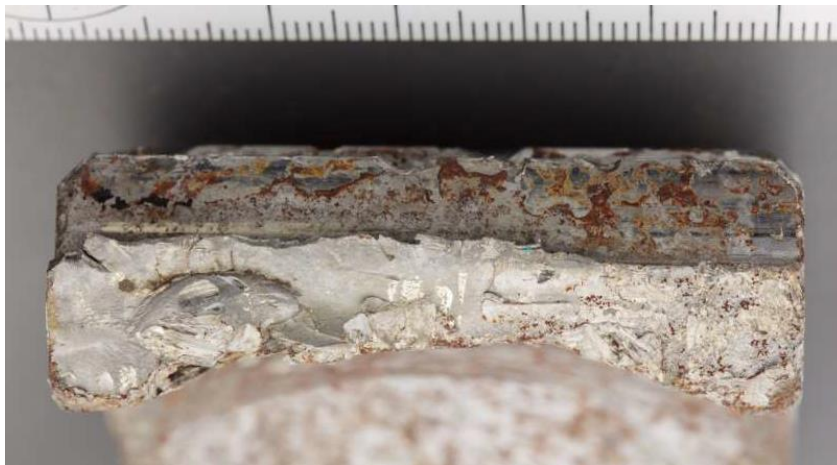
Figure 31: The cleaned through-thickness fracture surface. The cleaning was performed using a combination of acetate replica stripping and inhibited HCl solution with ultrasonic agitation. Macro marks (beach marks) are visible towards the upper edge of the gear (left hand side in photograph). Photo: AIBN/QinetiQ

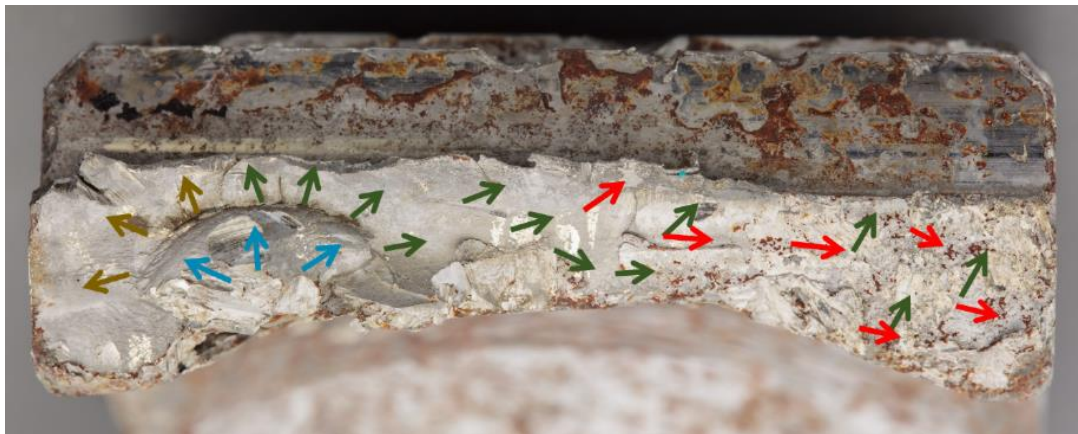
Figure 33: Crack propagation directions concluded from macro mark orientations in zones A (blue), B (brown) and C (green). Propagation in zone C concluded from striation and micro crack orientations is shown by the red arrows. Photo: AIBN/QinetiQ

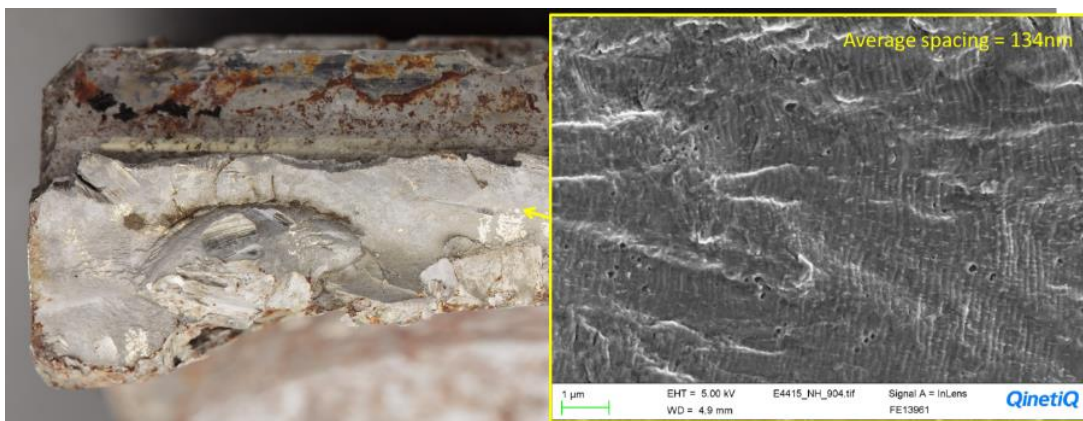
Figure 34: Fatigue crack progression marks – striations. Average spacing between the striations in this area are 134 nm. Photo: AIBN/QinetiQ

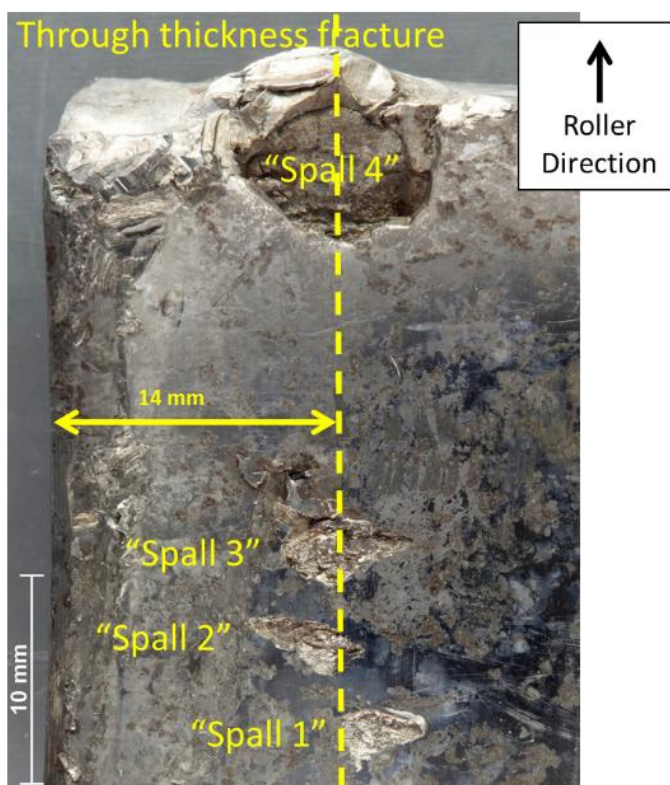
Figure 35: Showing spall one, two, three and four together with the max Hertzian stress line of 14 mm. Photo: AIBN/QinetiQ

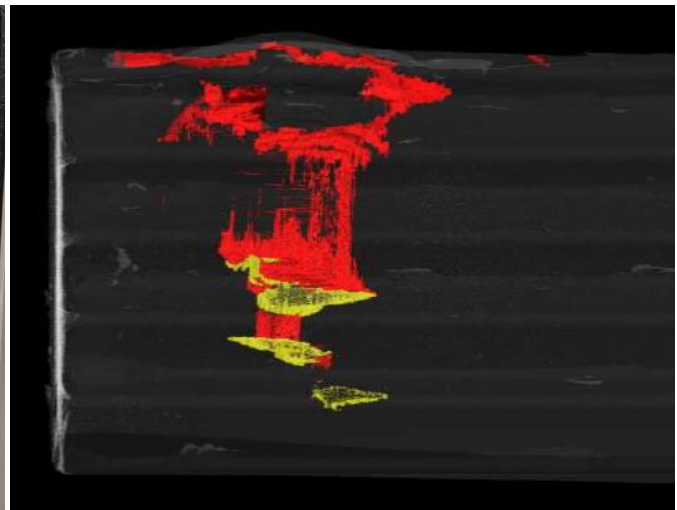
Figure 38: CT-scan of the specimen in Figure 35. The yellow areas are spall one, two and three. The red area indicates a sub-surface crack. Photo: Threshold CT-scan image from AIBN/Southampton University

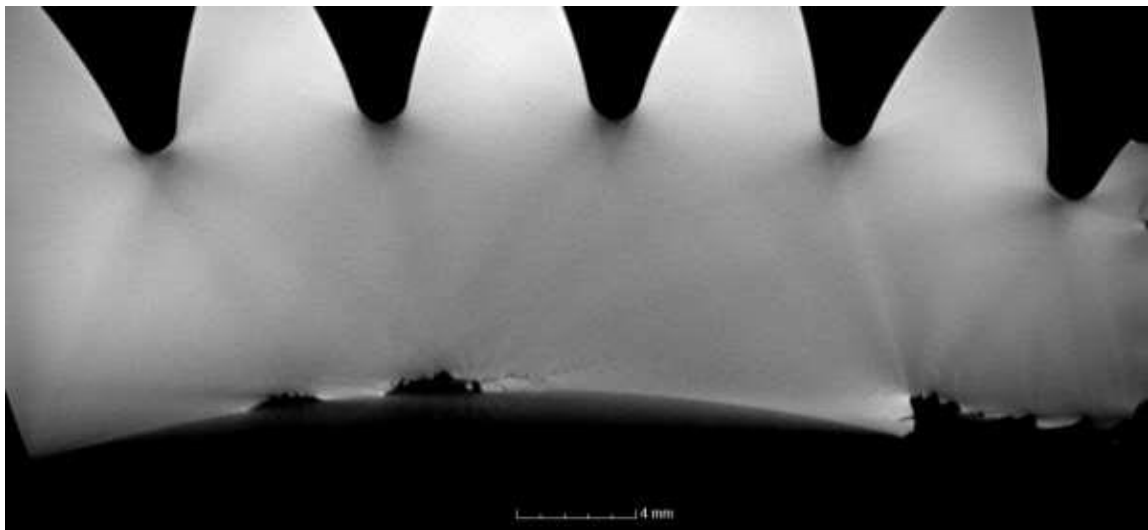
Figure 39: Longitudinal slice from CT-scan showing several cracks below the surface of the outer race. One crack runs below the surface between spalls (areas of surface damage). Photo: CT-scan from AIBN/Southampton University

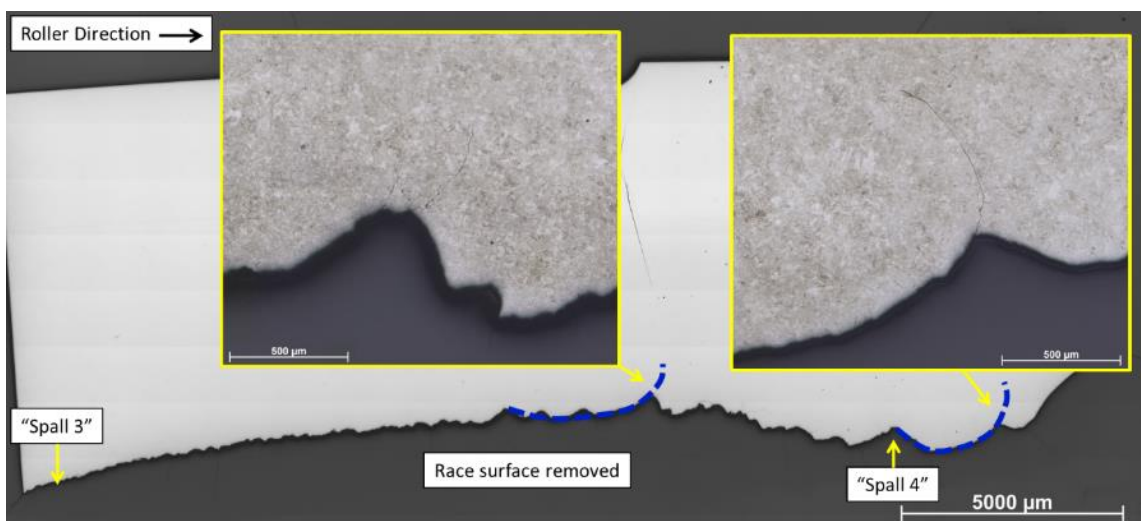
Figure 44: Sample FE13961 (see Figure 40). The microsection shows a close up of deviations towards the gear teeth roots. Photo: AIBN/QinetiQ

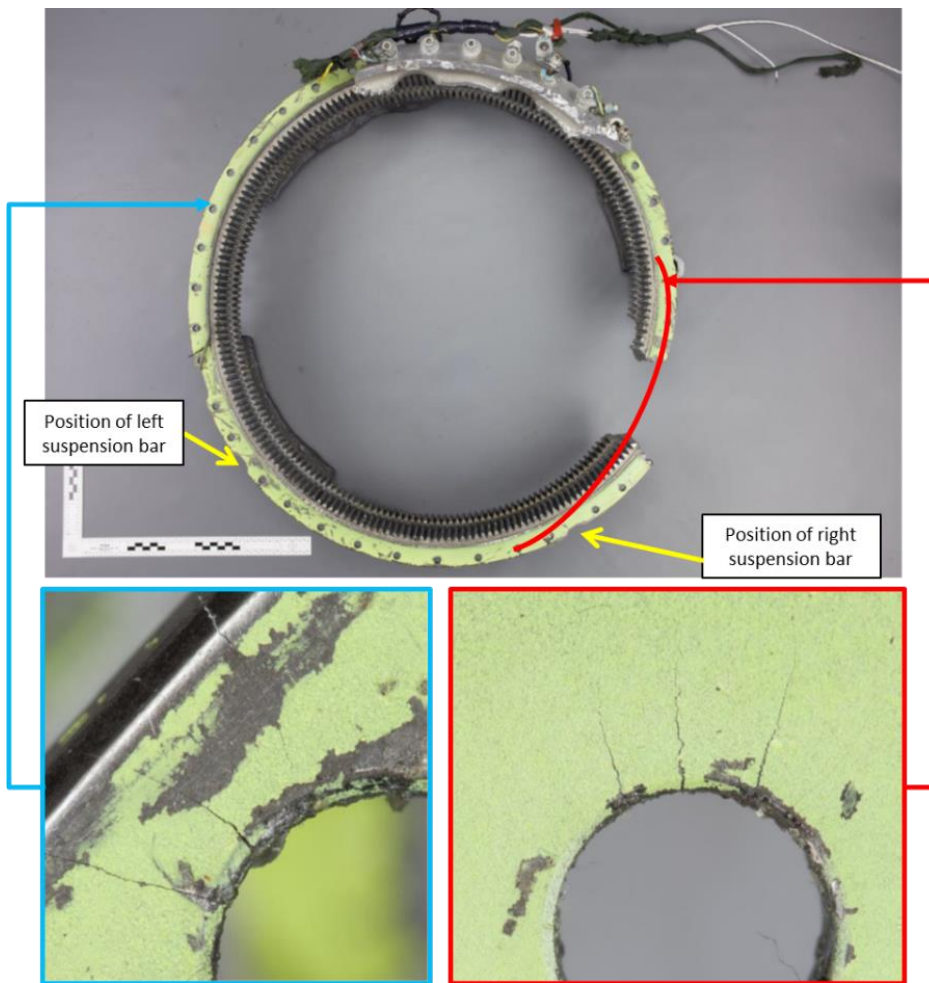
Figure 52: Epicyclic ring gear. Cracks at fastener holes suggests flange of conical housing were intact when fixed ring split and moved outwards. Photo: AIBN/QinetiQ

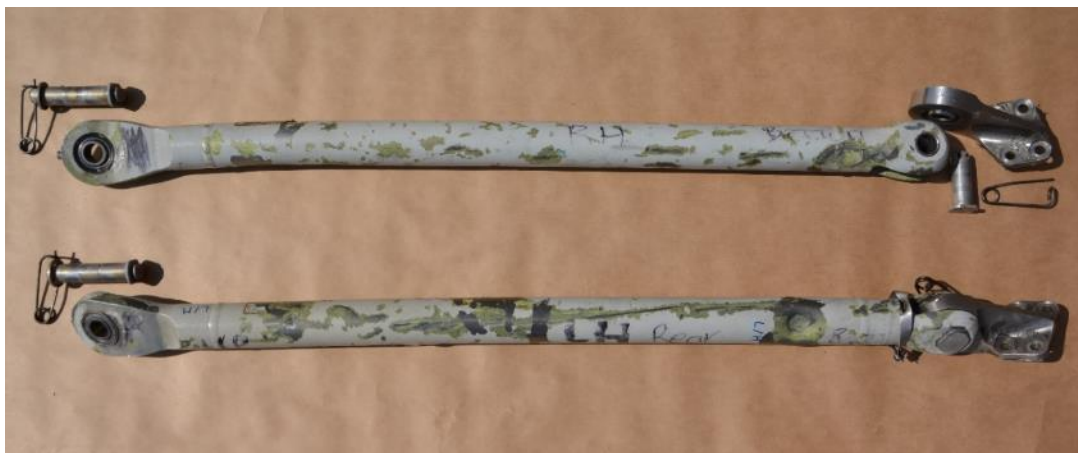
Figure 54: Left and right aft suspension bars with clevis pins, safety pins (only one shown in each position) and fuselage fittings. Both suspension bars have indentations from gear teeth.  
Photo: AIBN

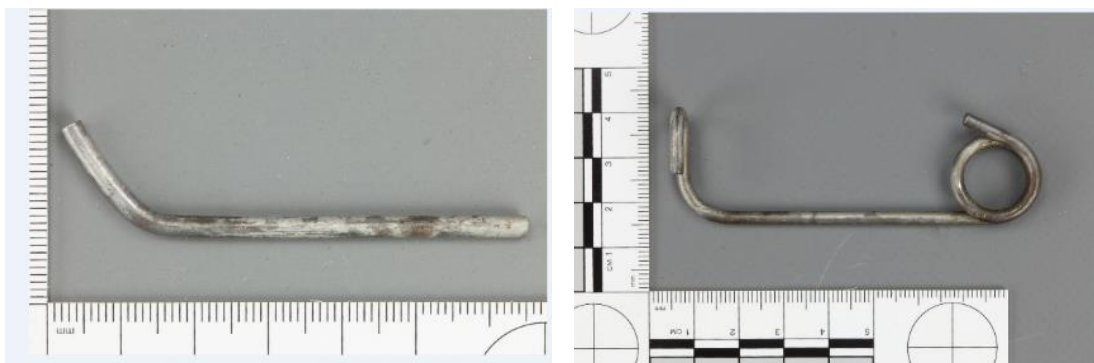
Figure 55: Two segments of safety pins found near the rotor mast. Metallurgical examination proved these to be from two different pins. Photo: AIBN/QinetiQ

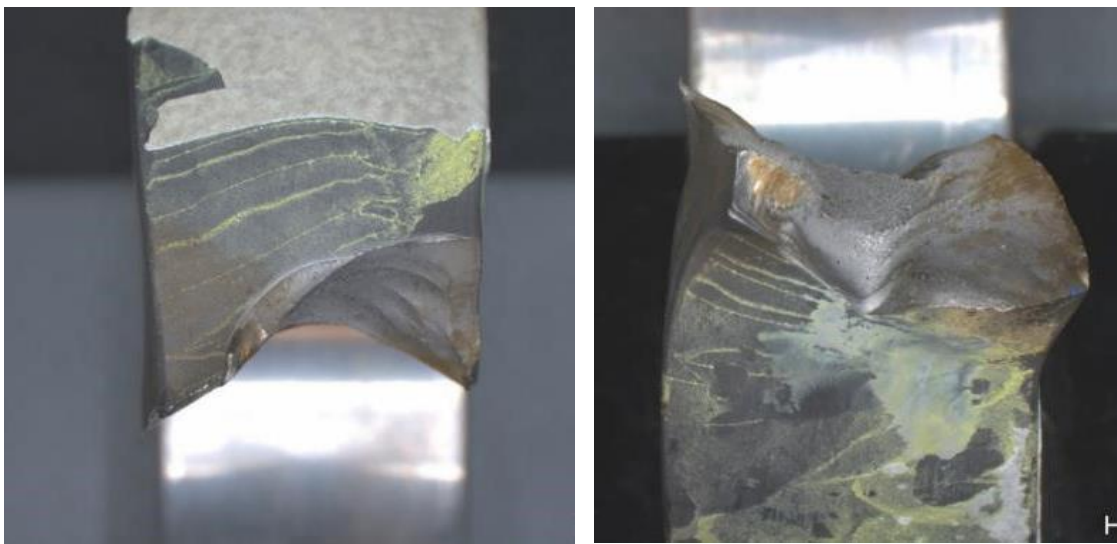
Figure 57: Upper forward suspension bar, mounting lug. Top fracture viewed from above (left photo). Bottom fracture viewed from below (right photo). Photo: AIBN/QinetiQ

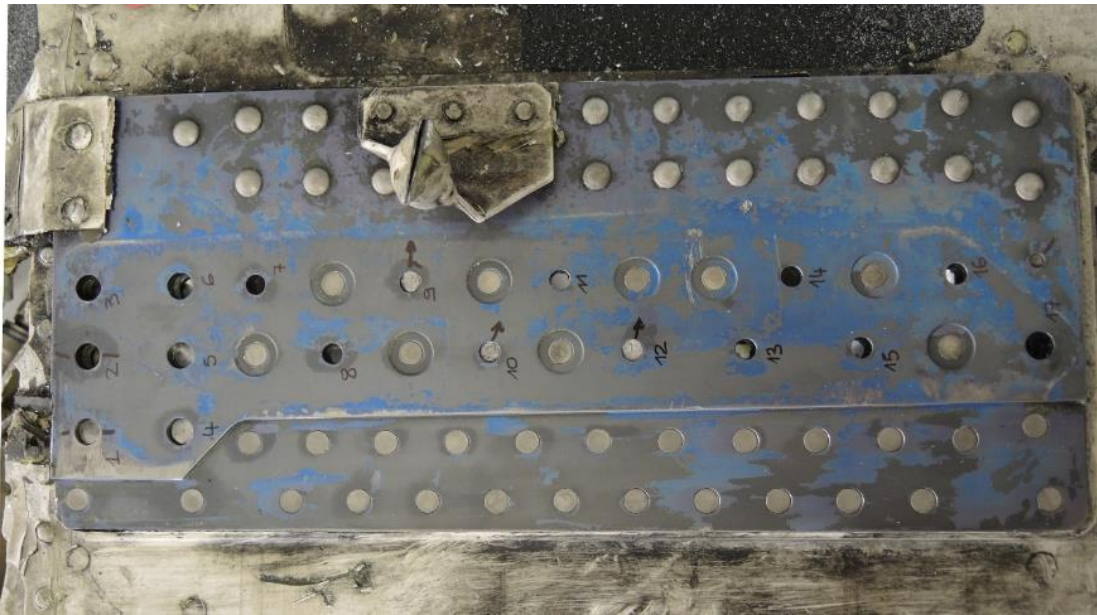
Figure 59: The flexible plate aft attachment had detached from the fuselage plate. 9 out of 17 bolts were still in place. Arrows indicating direction of overload in shear (towards the left relevant to the helicopter direction of flight). Photo: AIBN

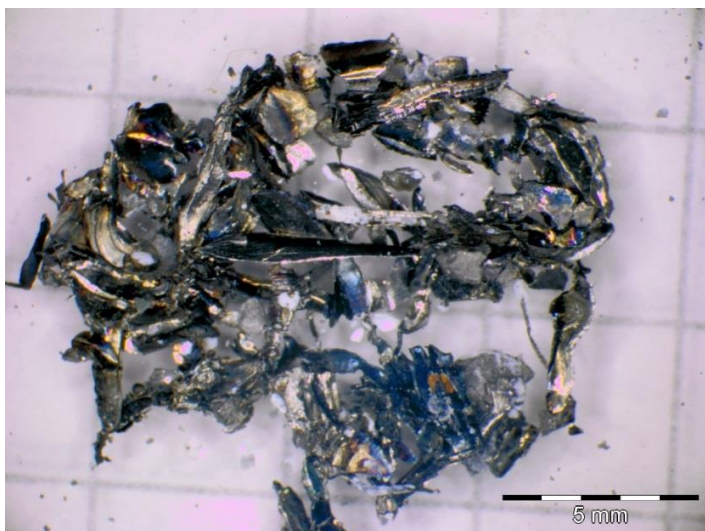
Figure 60: Metal particles from the MGB magnetic plug. Photo: AIBN/NDL
