## PRELIMINARY REPORT 28 JUNE 2016

### ACCIDENT AT TURØY, NEAR BERGEN, NORWAY ON 29 APRIL 2016, INVOLVING AIRBUS HELICOPTERS H225, LN-OJF OPERATED BY CHC HELIKOPTER SERVICE AS

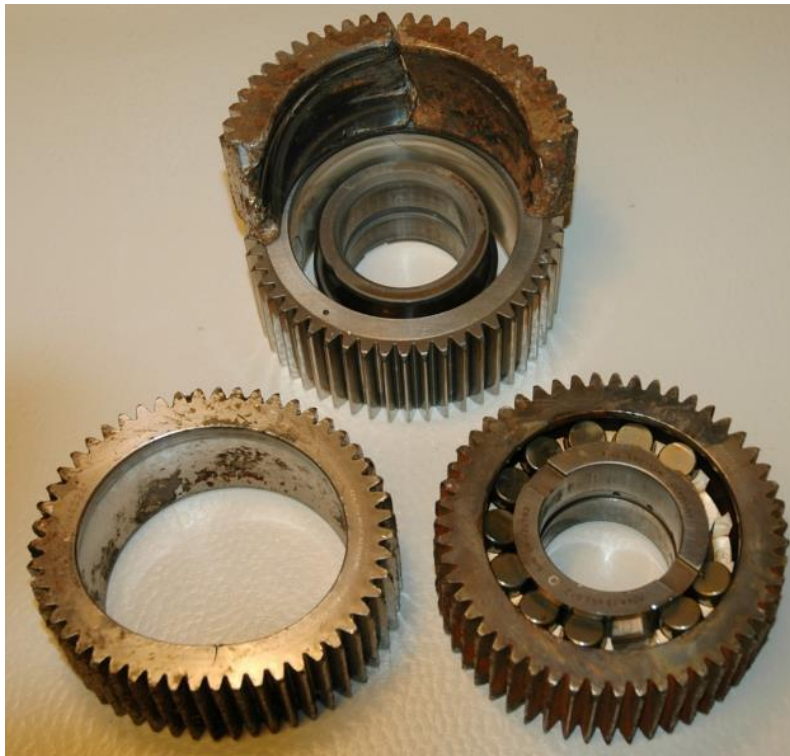
*Figure 2: Planet gear parts from second stage epicyclic reduction gear module. (The fractured gear is on top of a sample gear that was not involved in the accident.) Photo: AIBN*

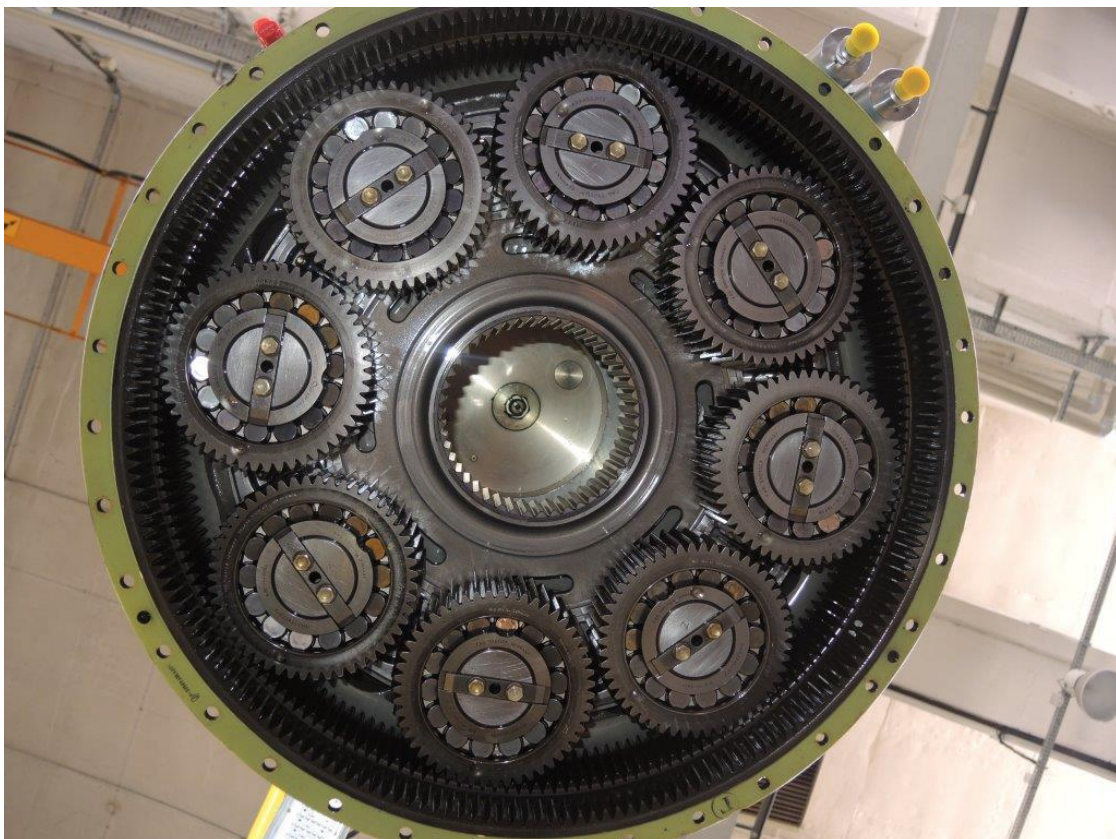
*Figure 3: Eight second stage planet gears as fitted on the carrier inside the ring gear, seen from below (first stage gears and carrier is not shown). Photo: AIBN*

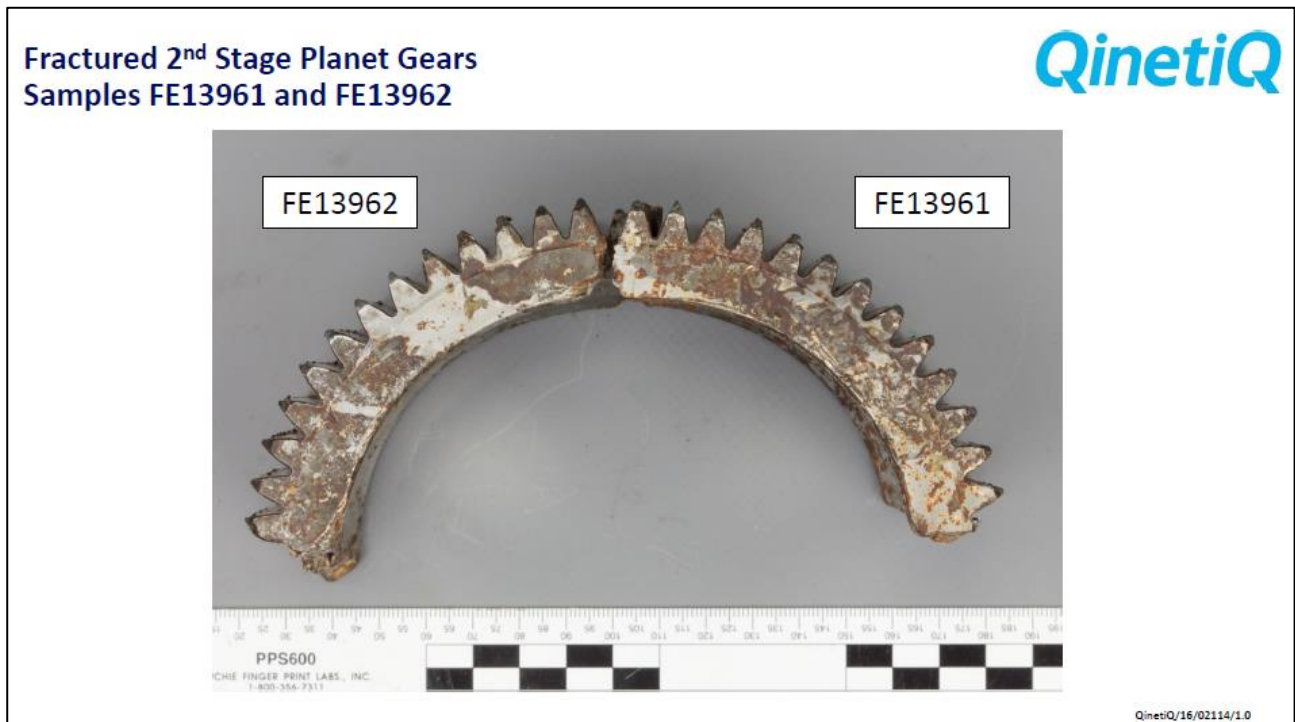
Figure 4: The two pieces of the second stage planet gear prepared for metallurgical examinations. The fracture surface with fatigue is to the right in the figure. Photo: QinetiQ

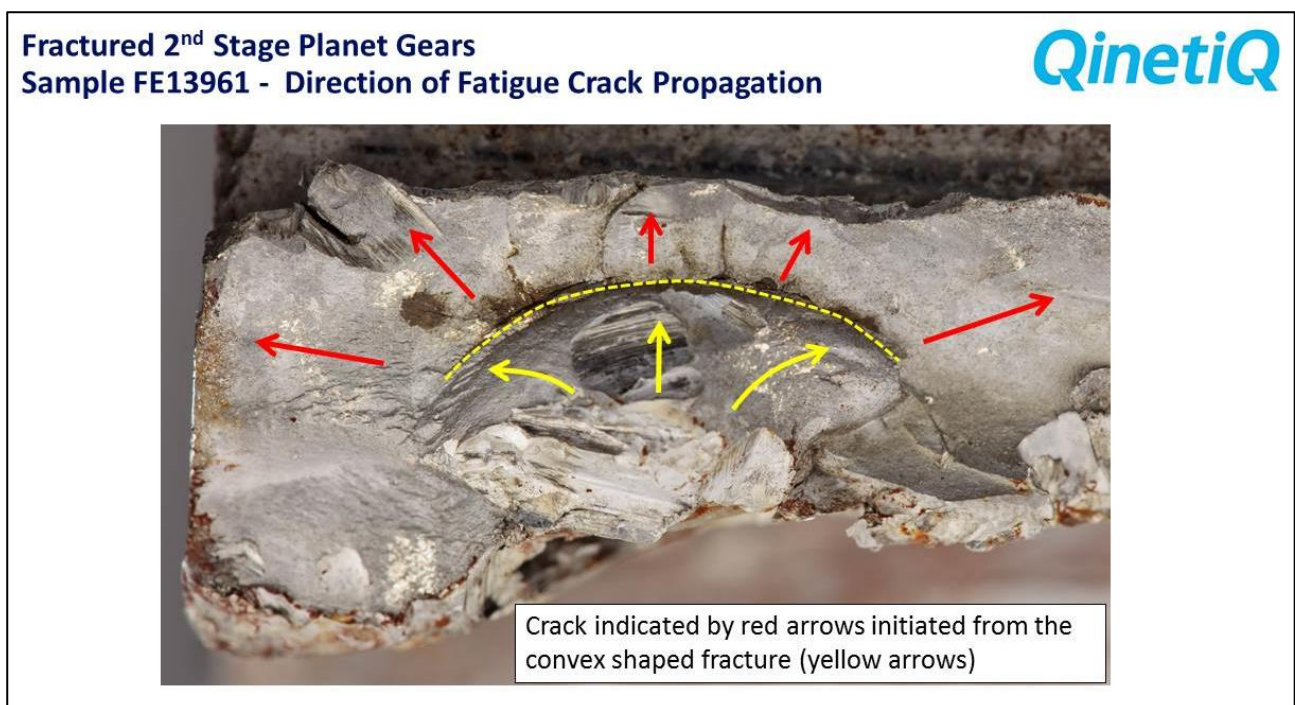
Figure 5: Close-up of the fracture surface initiated on the inner surface (outer race). Multiple cracks propagating from major crack around convex fracture surface. Photo: QinetiQ

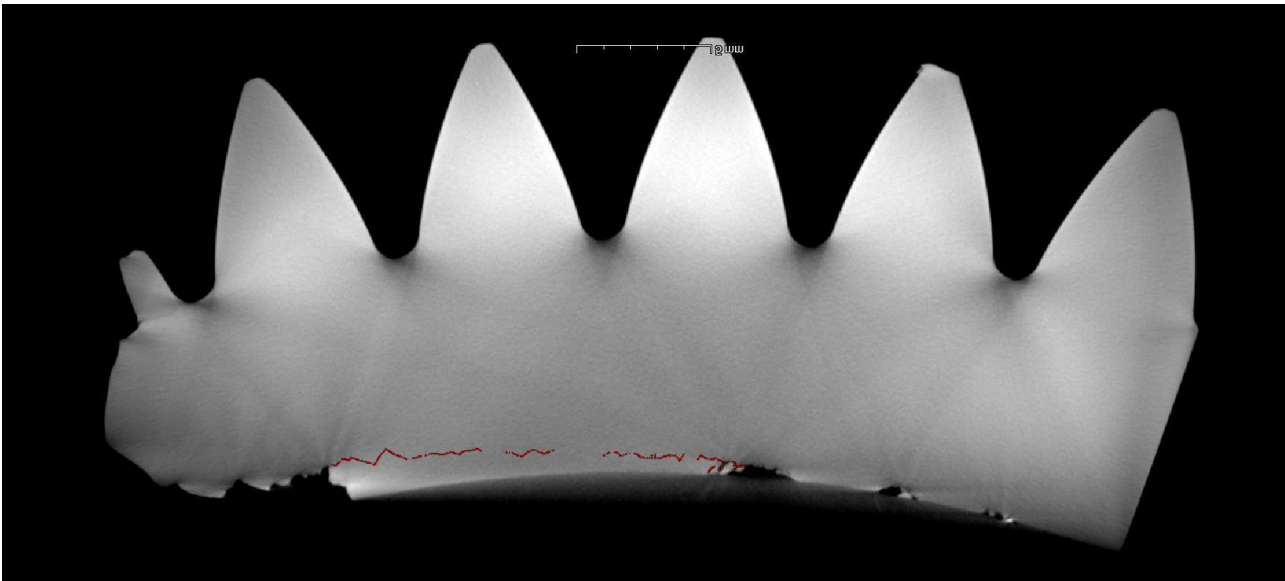
*Figure 6: An example from the CT scan showing a subsurface crack propagating from the right hand spalling all the way to the left. The red colour is a frame-by-frame mapping performed by hand to highlight the crack. Photo: University of Southampton*
