SL 2018/10

REPORT ON AIR ACCIDENT AT HØYLAND, HÅ MUNICIPALITY IN ROGALAND 30 APRIL 2016 INVOLVING AIRBUS HELICOPTERS AS 350 B3, LN-OSG

Date of submission: 13.11.2018
SL Report: 2018/10

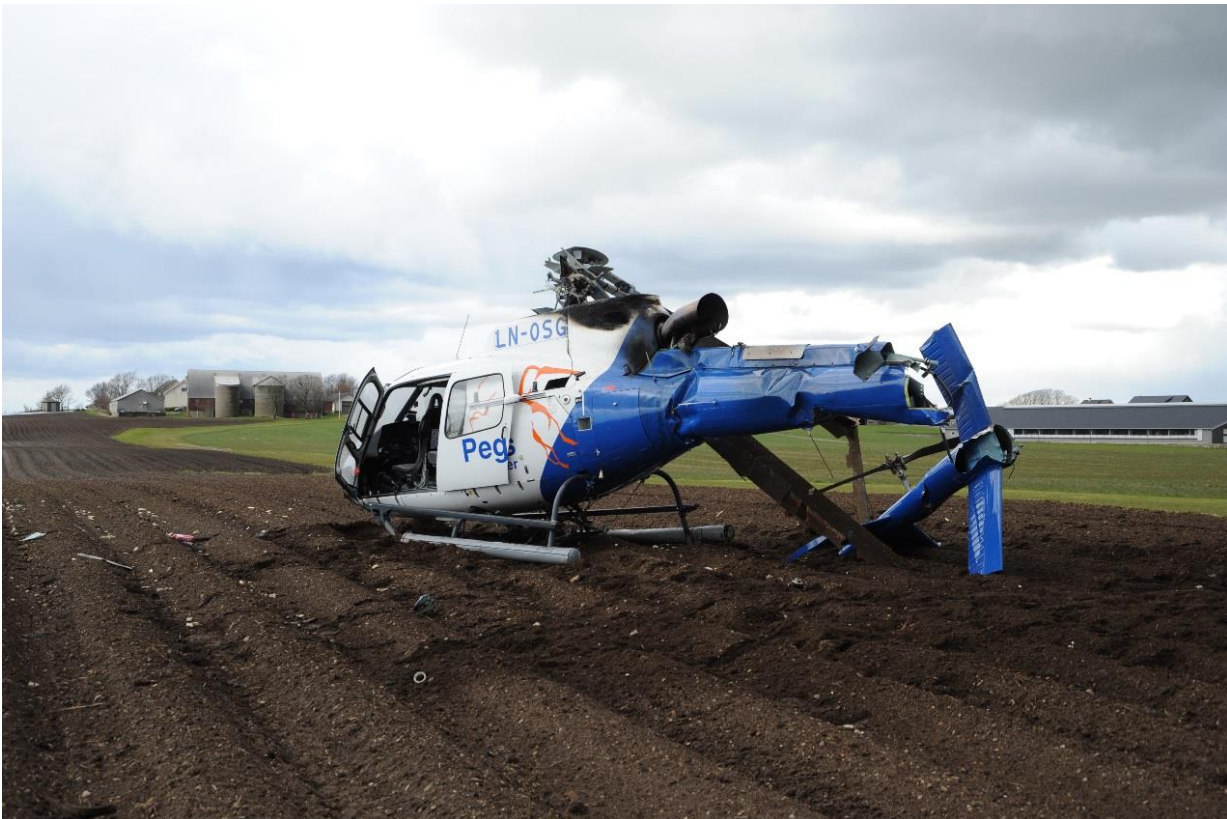
Three of the main gear box's four suspension bars were torn off when the rotor blades hit the ground. The main rotor blades broke and the aft part of the tail boom was torn off. The main gear box and engine were displaced to the right (see Figure 1).

Figure 1: Scope of damage. Photo: The Police

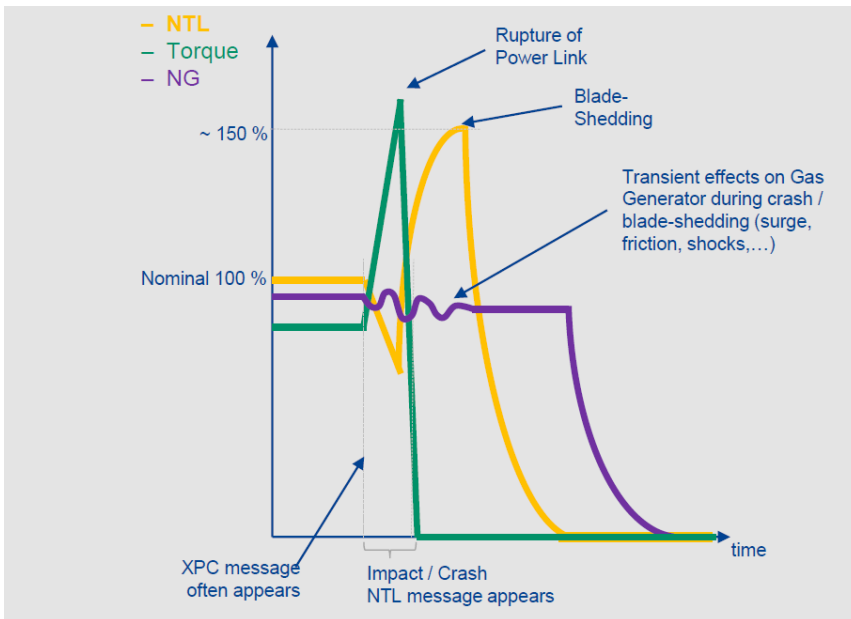
The drive shaft between the engine and main gearbox was twisted off and ruptured due to the shock load that occurred when the rotor blades hit the ground. The engine's module 5, the reduction gearbox, ruptured as a result of the accident sequence. The free turbine, which now had no mechanical connection to the drivetrain, quickly accelerated to an RPM where the turbine blades are designed to separate from the blade root, which is where the turbine blade is attached to the turbine disc (see Figure 4). This happens at approx. 150% of the free turbine's RPM (NTL). Figure 2 shows a generic sequence of events when the drive shaft between the engine and main gearbox decouples.

Figure 2: Generic sequence of events when the free turbine disconnects. Source: Safran Helicopter Engines

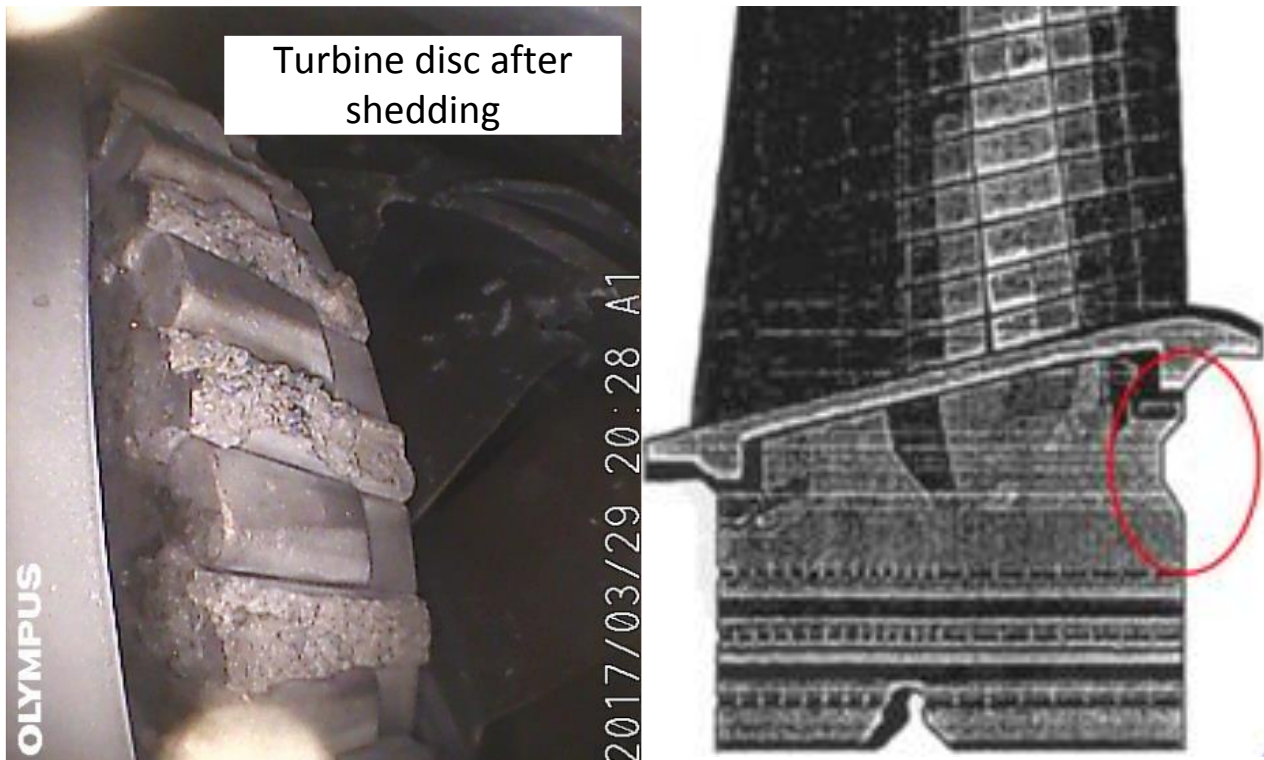
The turbine blades on the free turbine are designed to break off at the blade roots at approx. 150% RPM from the turbine disc and thereby separate from the free turbine wheel (see Figure 4).

Figure 4: Turbine disc after shedding and turbine blade with designed break point. Photo: Safran Helicopter Engines

The objective of this design is to ensure that the free turbine does not reach an RPM of approx. 170%, which would have resulted in rupture of the turbine disc and causing significantly greater damage due to ejected shrapnel from the turbine wheel. The turbine blade fragments were caught by the engine's "containment shield". Even though the "containment shield" caught the turbine blade fragments, the kinetic energy in the turbine blades caused the turbine casing to deform. This allowed combustion gases at high temperature to escape the engine and enter the engine compartment (see Figure 5).

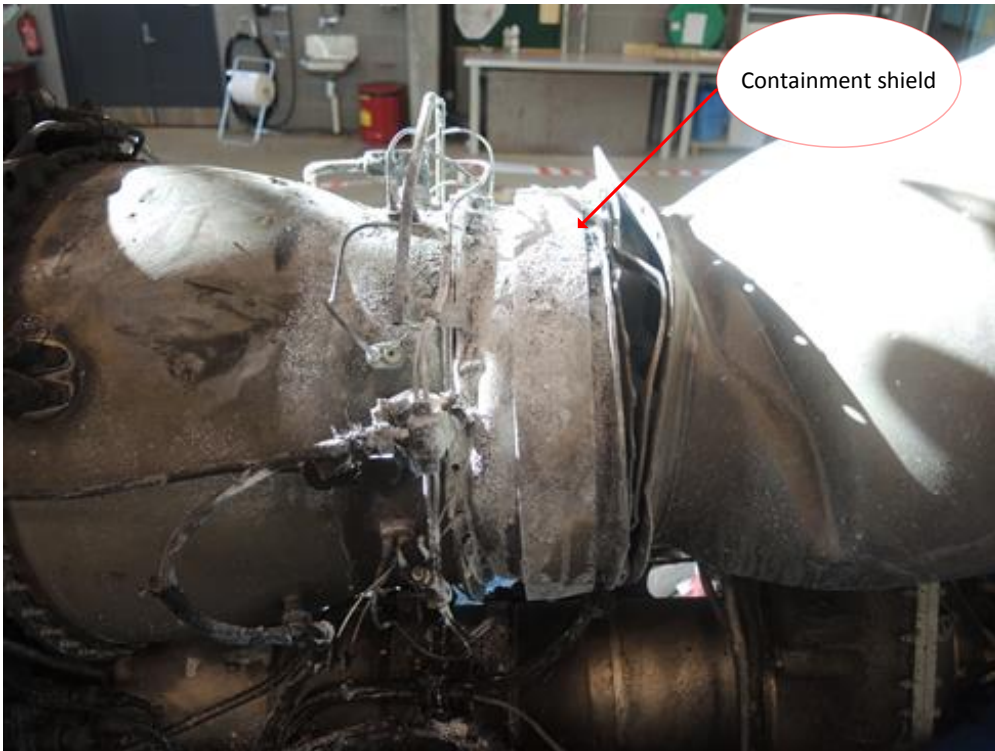
The consequential damage sustained by the engine due to the free turbine blades separation caused hot combustion gases to enter the engine compartment from the still running gas generator, which continued to run after the DECU froze the fuel flow and with the EBCAU trying to maintain 100% NTL.

Figure 5: The "containment shield" and deformed turbine casing. Photo: AIBN

Airbus Helicopters/Safran Helicopter Engines are requested to study and propose technical solutions with the purpose of reducing the risk of fire in situations where engine is still running after the free turbine has separated and the NTL signal is lost.

In case the manufacturers proposes any modifications with the purpose of reducing this risk, EASA is requested to follow up and make such modifications mandatory.

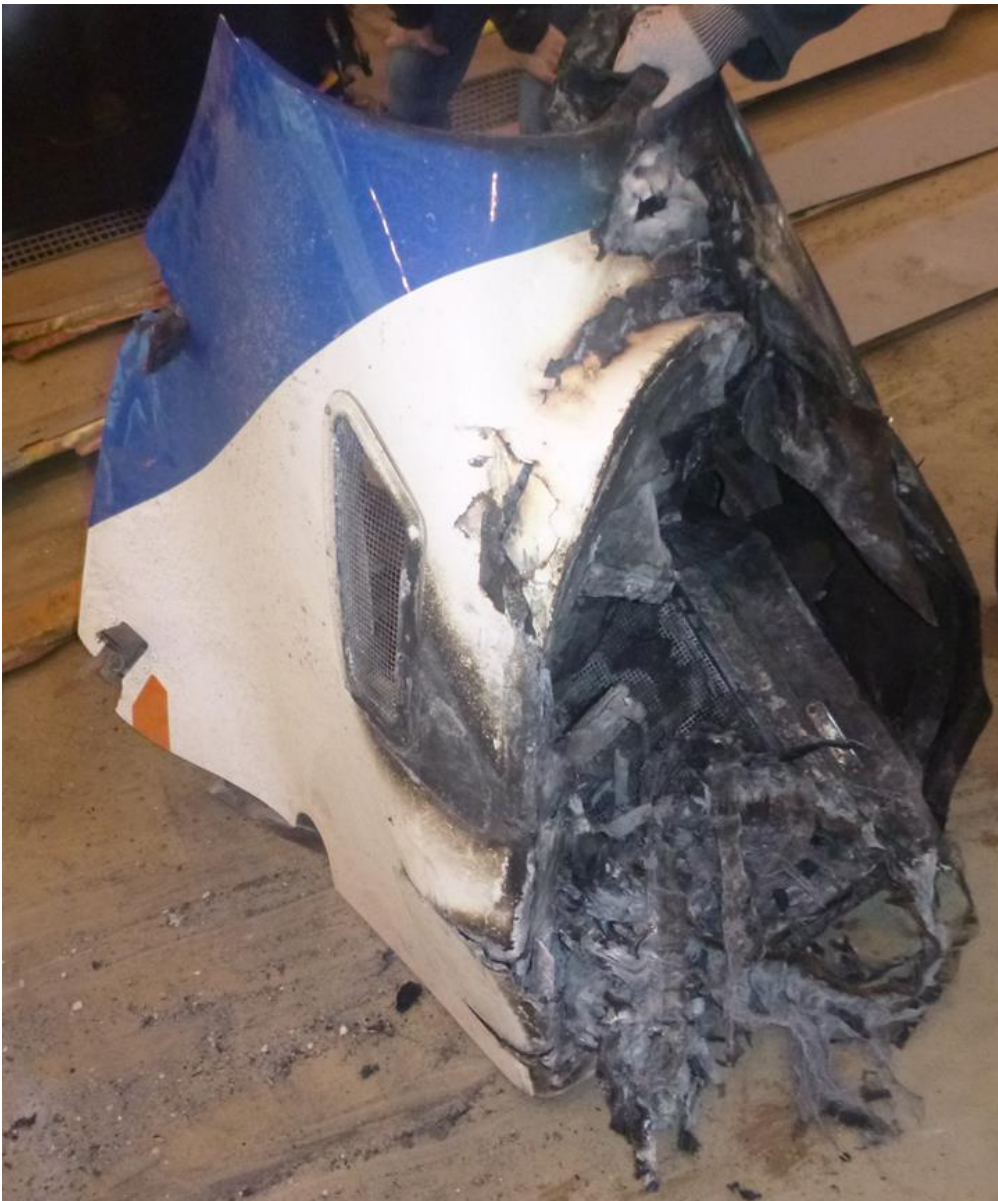
The fire that broke out in the engine compartment involved the engine's air intake, which was equipped with an air filter (see Figure 6). The filter material was by design impregnated with oil, and was intended to prevent small particles from accompanying the air stream into the engine. The air intake filter was completely burnt (see Figure 7). The engine itself and its accessories had only minor thermal damage.

Figure 7: Engine cowling with incinerated air intake filter. Photo: AIBN

The Accident Investigation Board Norway recommends Airbus Helicopters, in cooperation with Safran Helicopter Engines to study technical solutions for AS 350 helicopters equipped with Arriel 2 engines, as well as other Airbus helicopter types with similar Arriel engine installations. The purpose of this study should be to find ways of reducing the risk of fire following accidents where the free turbine blades have shedded.

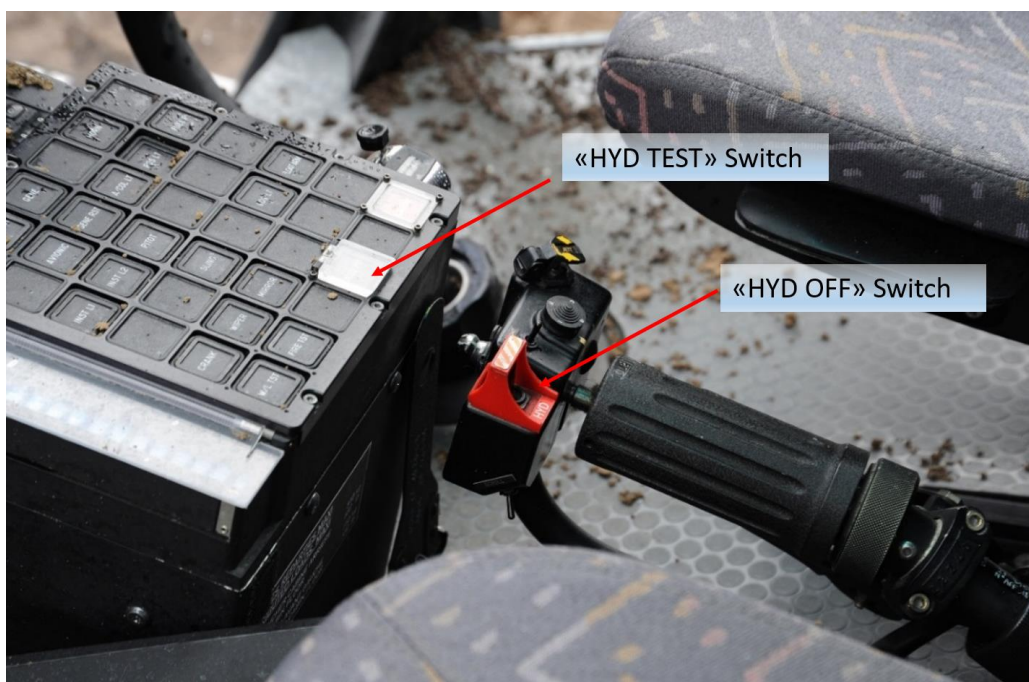
Figure 8: HYD TEST switch on pedestal, and HYD OFF switch with cover on the collective. Photo: AIBN

When the examiner activated the "HYD TEST" pushbutton, and the commander then immediately activated the "HYD OFF" switch, a sequence of events occurred in the helicopter's hydraulic system:

The fact that this occurred in hover meant that the margins for correcting the situation were too small. With the "HYD TEST" pushbutton activated, returning the "HYD OFF" switch on the commander's collective to the normal position had no effect. With the "HYD TEST" pushbutton activated, oil from the hydraulic pump was returned to the tank regardless of the position of the "HYD OFF" switch.
