SL 2019/04

REPORT ON AVIATION ACCIDENT AT ÅNGARDSVATNET IN OPPDAL MUNICIPALITY 26 FEBRUARY 2017 INVOLVING DYN AERO MCR 4S, LN-DLH

Date filed: 22.03.2019
SL Report: 2019/04

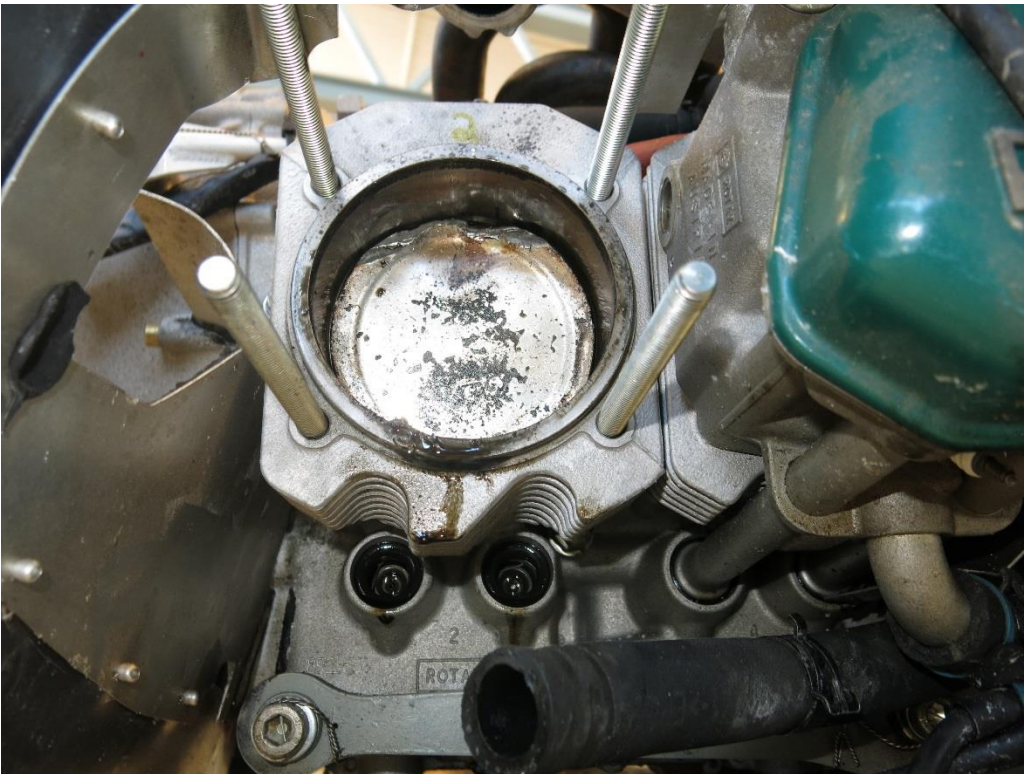
An initial examination of the engine was done at the maintenance facility at Eggemoen. Damage was found and documented. In cylinder no. 2 the connecting rod was bent and broken off, and the piston skirt had broken off on one side of the piston. Due to the missing piston skirt on one side of the piston, it had rotated around the piston pin and was jammed at an angle in the cylinder, with a deformed piston crown and ring zone (see Figure 5 and Figure 6). Further disassembly of the engine was done at EdgePerformance's workshop where necessary special tooling was available. The dismantled engine was transported to AIBN's facilities for further examination.

Figure 5: Piston in cylinder no. 2. Photo: AIBN

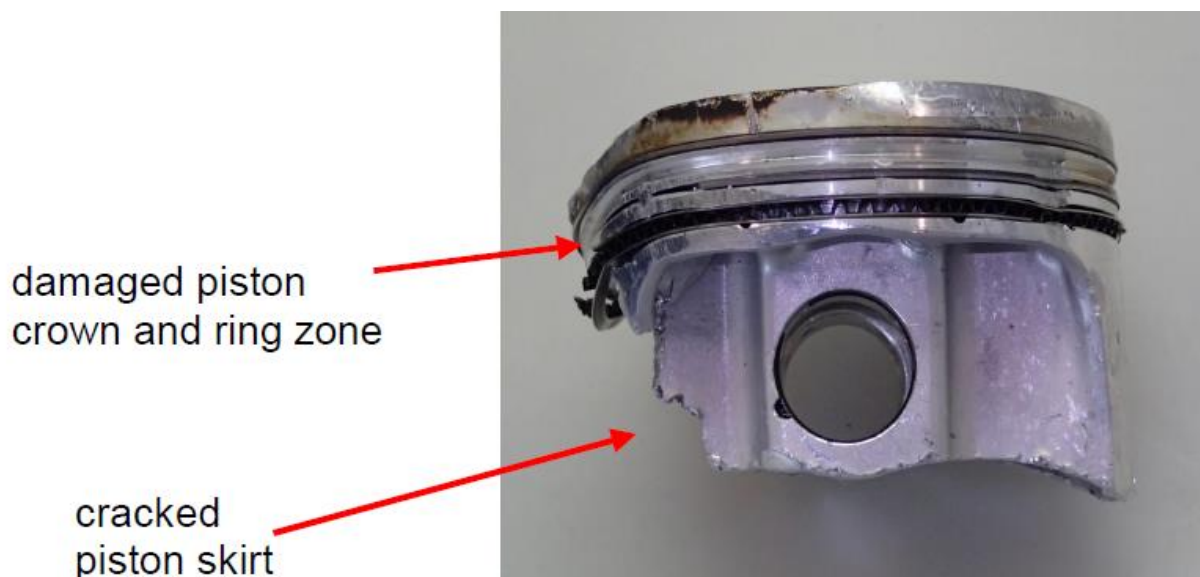
The piston rings and the piston ring grooves on piston no. 2 had not been subject to abnormally high temperatures. The circumference of the piston crown was polished due to the contact the tilted piston had with the cylinder walls after the piston skirt had broken off.

Figure 6: Damages on piston no. 2. Source: Rotax

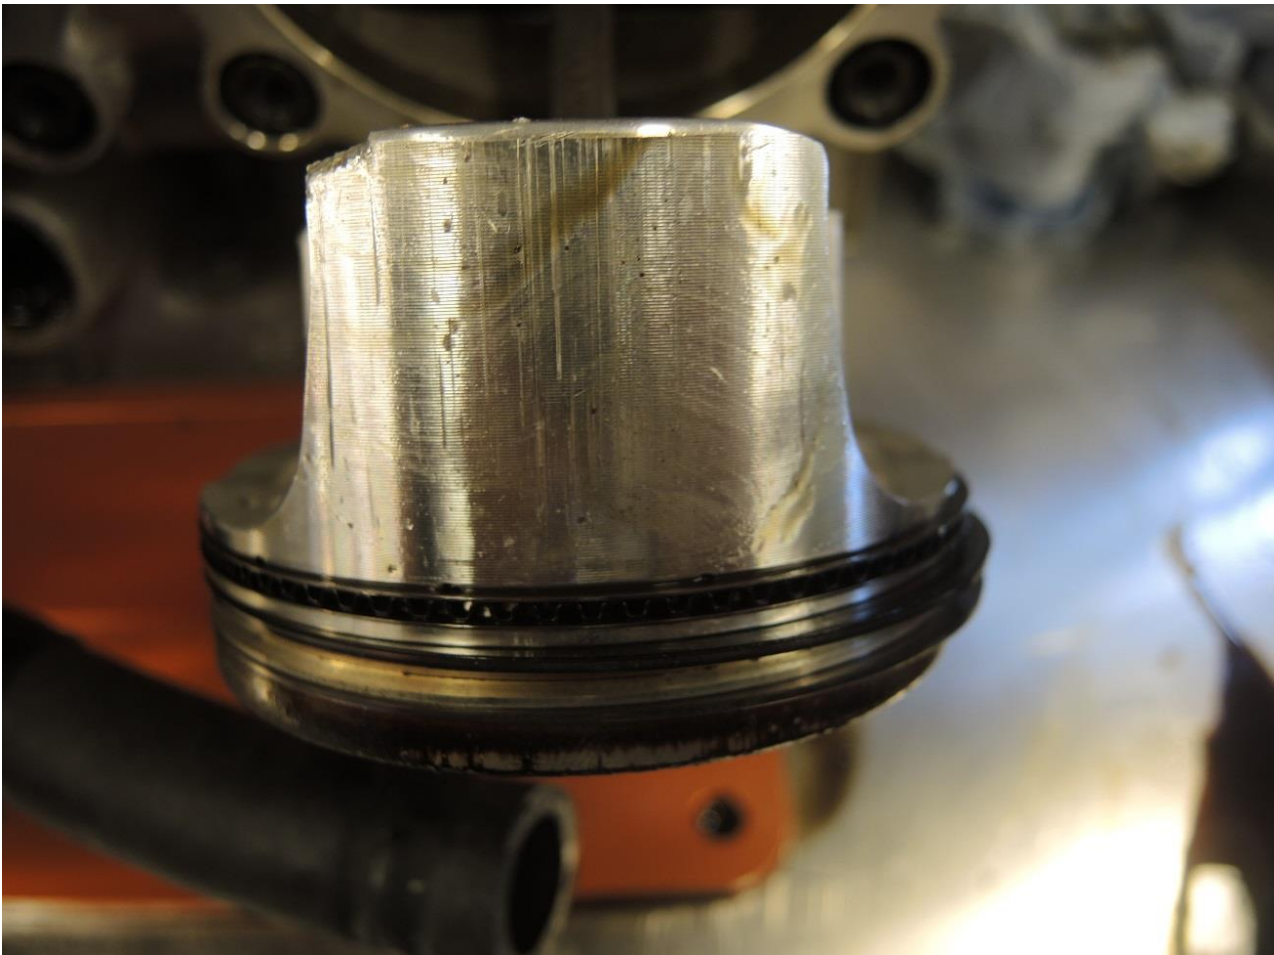
There were scratches on the piston skirts on all four pistons. The extent of scratches indicates that they were caused by metal debris that was created when the no. 2 connecting rod broke off (see Figure 7).

Figure 7: Scratches on the piston skirts on one of the pistons. Photo: AIBN

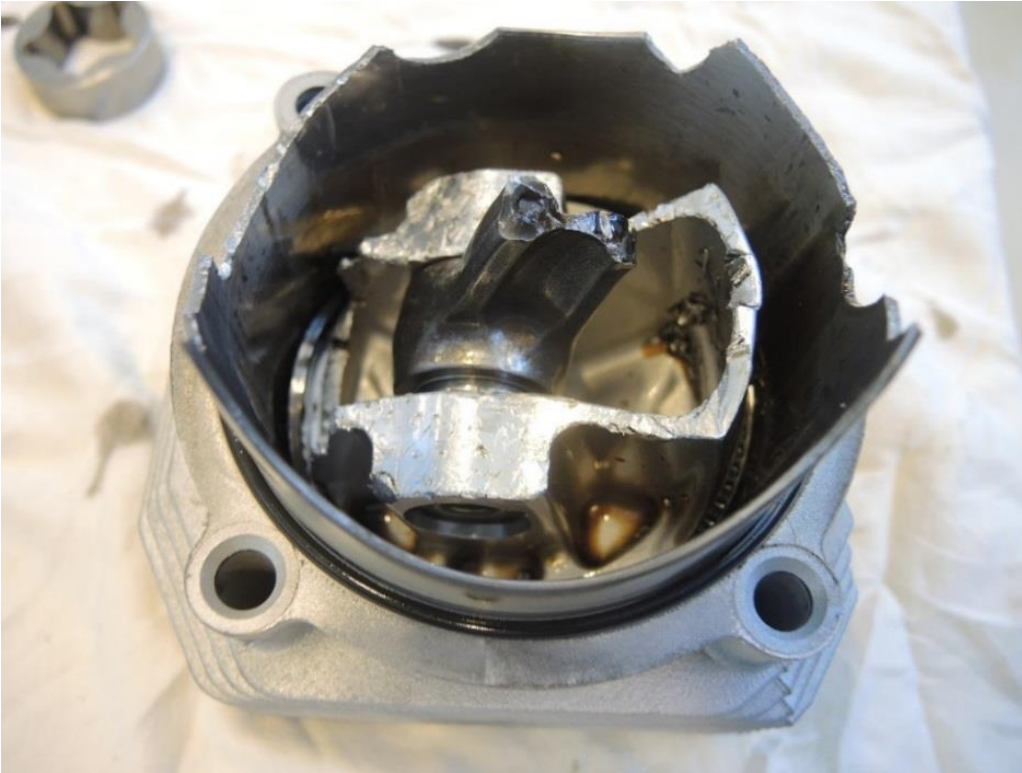
Cylinders, cylinder heads, pistons, crankshaft with connecting rods, and camshaft were later brought to the Rotax engine manufacturer for further examinations. These examinations showed that the fractured connecting rod had impact marks in the fracture zone, indicating that the engine had been running on three cylinders for a while after the piston in cylinder no. 2 had jammed. The lower section of cylinders 1 and 2 had had bits of the bottom part of the cylinder wall chipped off. These were secondary damages that occurred after the connecting rod in cylinder no. 2 broke off (see Figure 8). Metal debris was spread around in the crankcase.

Figure 8: Cylinder no. 2 with piston and upper part of connecting rod. Photo: AIBN

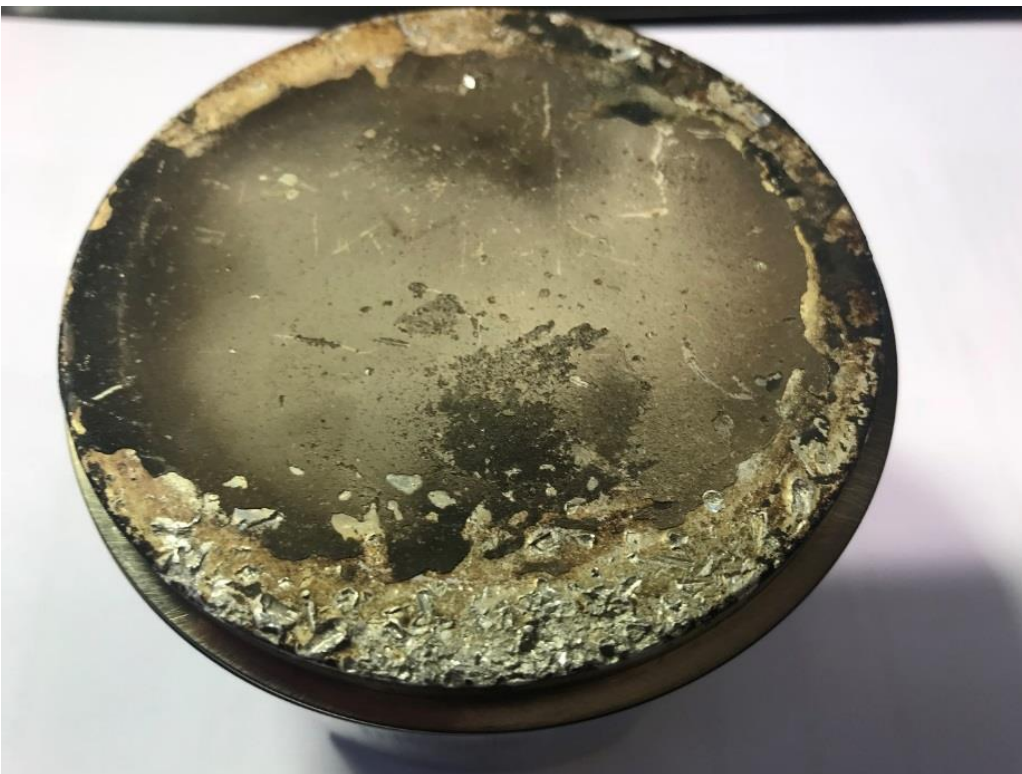
There were marks on piston heads and cylinder heads that could indicate either that there had been detonations in the cylinders, or that foreign objects had entered the cylinders. Closer examination revealed that foreign objects had entered the cylinders while the engine was running. Particularly piston no. 4 had pronounced damages (see Figure 9 and Figure 10).

Figure 9: Damages to the piston crown of piston no. 4. Photo: AIBN

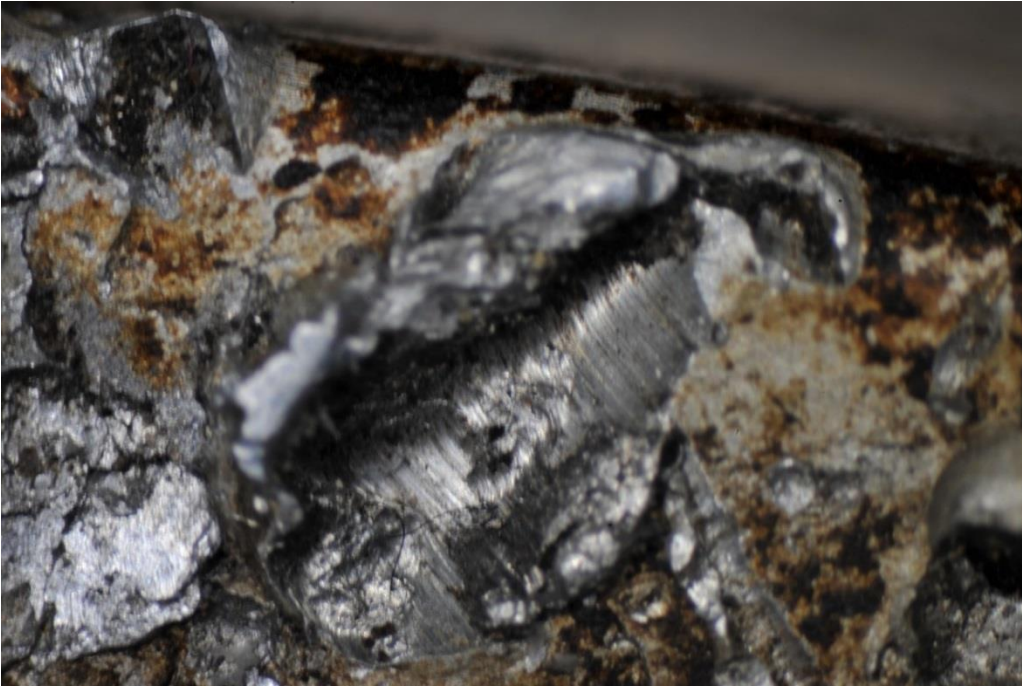
Figure 10: Traces of foreign objects on piston crown on piston no. 4. Photo: AIBN/NDLO

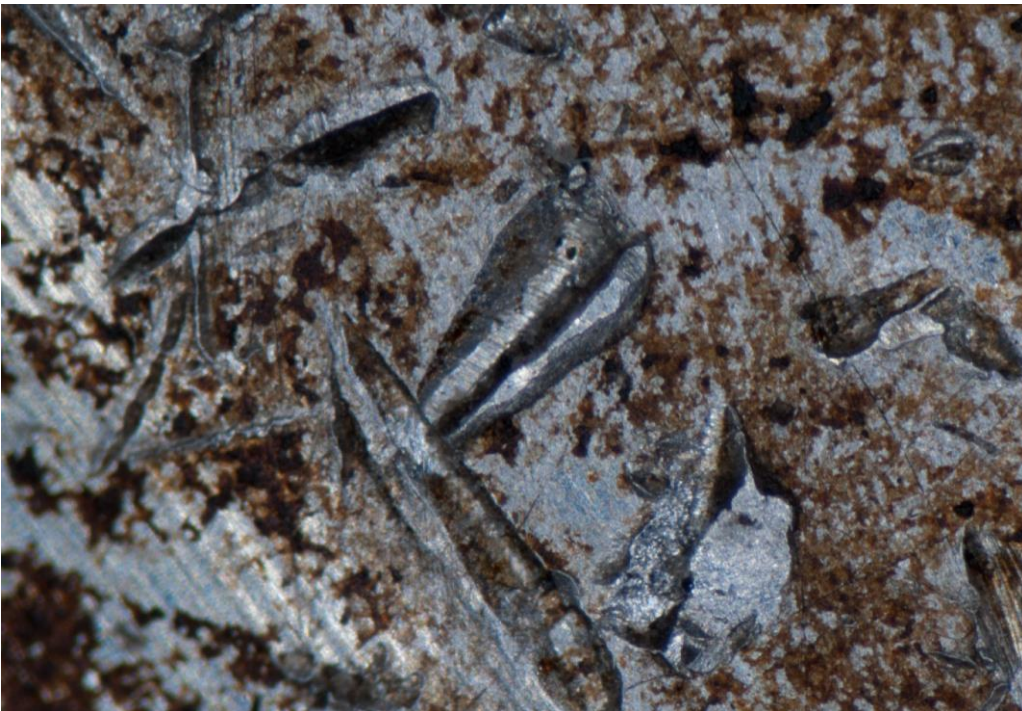
EDS¹ analysis by SEM² microscopy showed that the fragments found imprinted in the most damaged piston crown (piston no. 4) mainly consisted of iron (see Figure 12). It has not been possible to establish what caused these fragments to enter the cylinders. Similar damages were found on piston no. 2 (see Figure 11).

Figure 11: Damages on piston crown on piston no. 2. Photo: AIBN

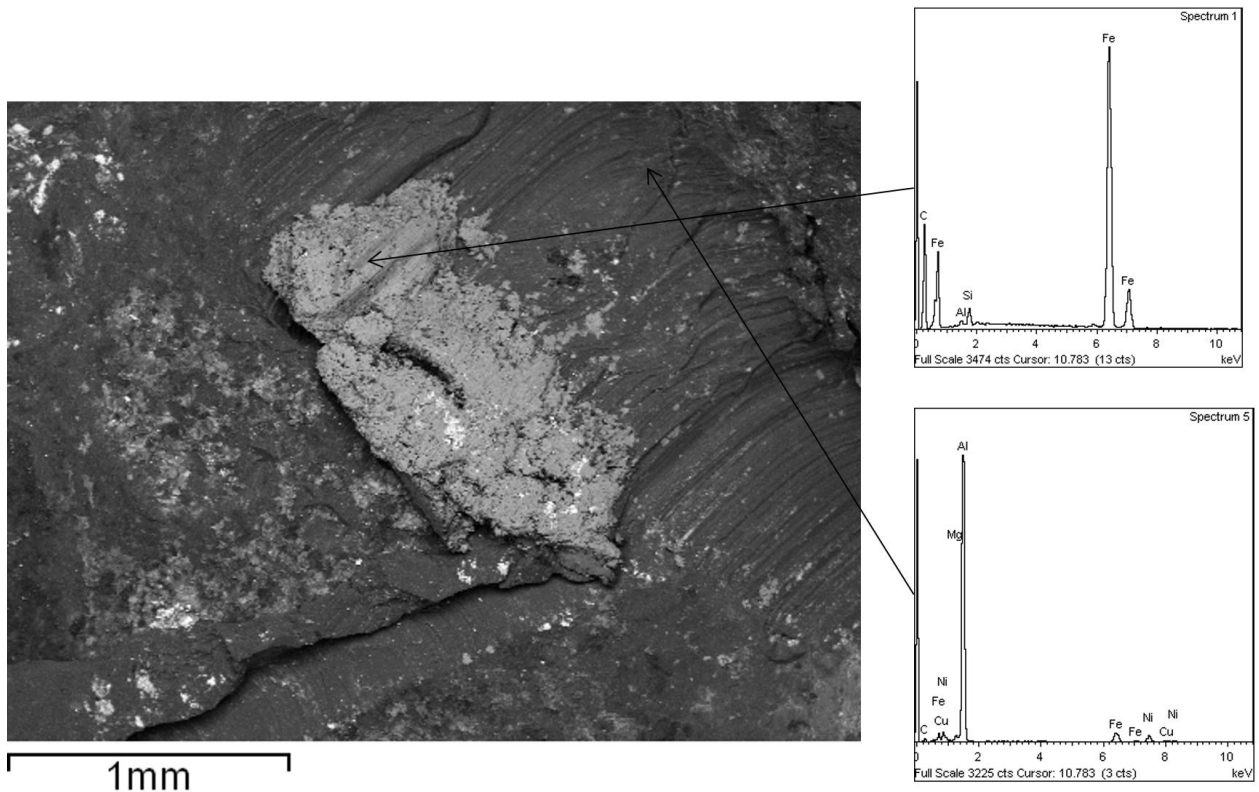
Figure 12: SEM microscopy and EDS spectrum of particles on piston crown on piston no. 4.
 Photo/illustration: AIBN/NDLO

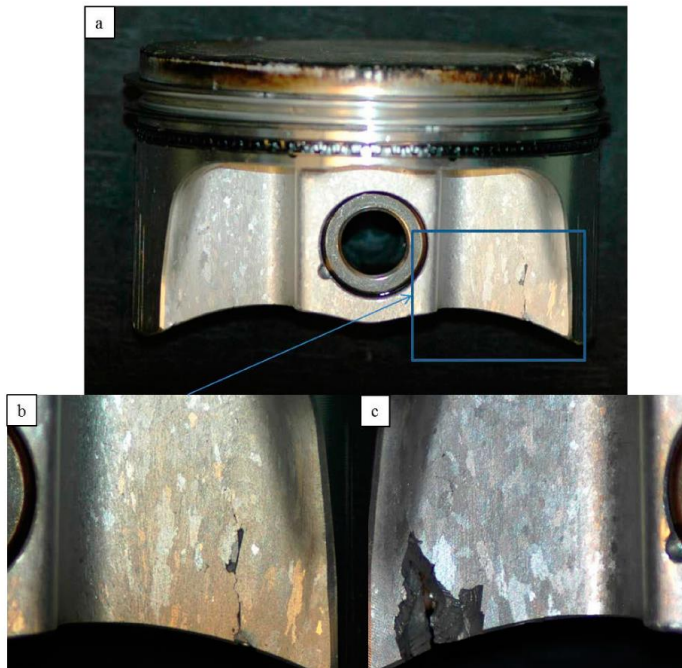
Cracks were found in the reinforcements that support the piston skirts on all four pistons. The piston pin holes in the pistons were asymmetrically offset with approximately 1 mm. These cracks had appeared on the same side on all four pistons (see Figure 13). It was checked if the pistons had been installed the wrong way compared to similar asymmetry as on the original Rotax pistons. On the original Rotax pistons, an arrow stamped on the piston crown indicates direction of installation. The Big Bore pistons were installed the same way as the original Rotax pistons.

Figure 13: Cracks in piston skirt support structure in one of the pistons. Source: AIBN/NDLO

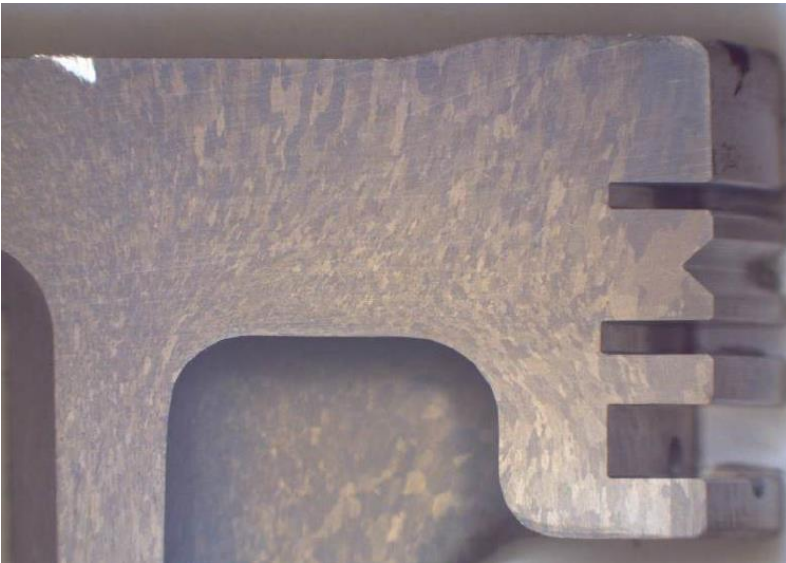
A metallurgical examination performed by NDLO, revealed a coarse, granular structure in the piston. Such a structure appears in this material at a temperature of more than 300 °C. The pistons

were forged and consisted of AA2618 alloy. According to Rotax, the operational temperature in this area of the piston will not exceed 170 °C. According to NDLO, it is likely that the coarse, granular structure occurred in the material during the manufacturing process (see Figure 17). This was also confirmed by the company that produced the pistons for EdgePerformance.

Figure 17: Coarse granular structure in pistons. Photo: Rotax

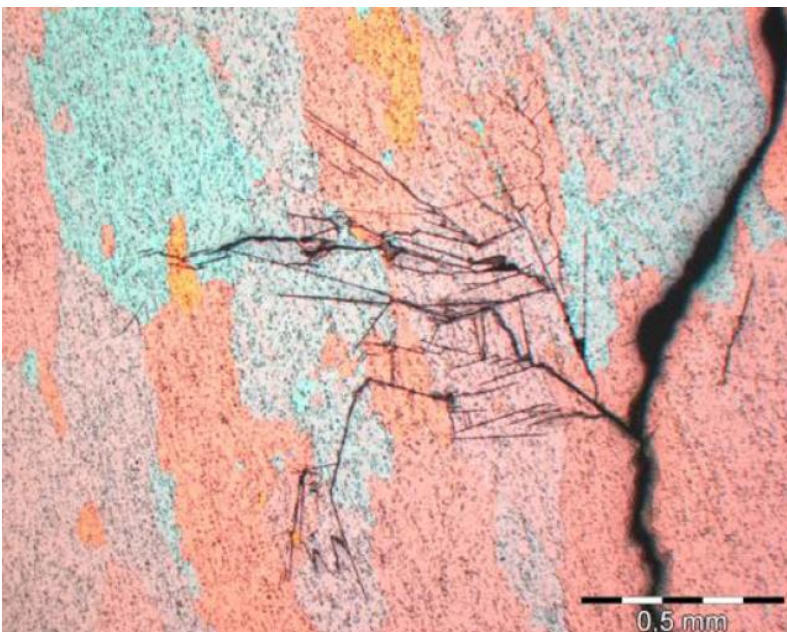
This structure will weaken the mechanical properties of the material. Intergranular fractures were in the same location on all four pistons. In addition, transgranular crushing damage also occurred in the material, which indicates that the structure near the fracture surfaces has been subjected to compressive forces (see Figure 18).

Figure 18: Transgranular crushing in the piston material. Photo: AIBN/NDLO

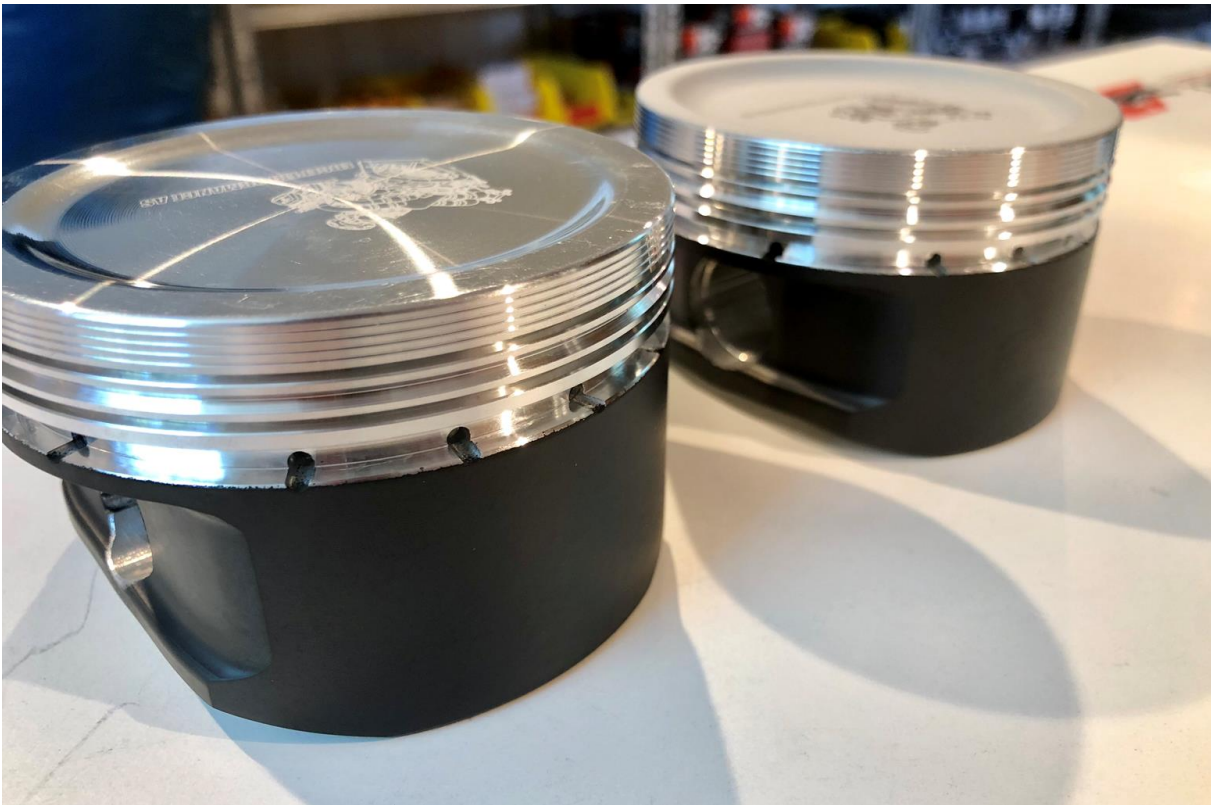
Figure 19: New design of «Big Bore» pistons. Photo: EdgePerformance

A new design now exists on the pistons that EdgePerformance delivers. The piston skirt is now larger in area and has thicker walls, and the pistons are covered with Teflon and ceramic coating below the piston rings (see Figure 19) to reduce the friction between the piston skirts and the cylinder walls. This design, as AIBN considers it, is intended to be better to absorb the forces generated by the lateral movements of the pistons in the cylinders.
