# REPORT

SL 2019/10

## REPORT ON AIR ACCIDENT AT SVOLVÆR AIRPORT HELLE, NORWAY ON 11 FEBRUARY 2018 INVOLVING PIPER PA-28-161, LN-TOS

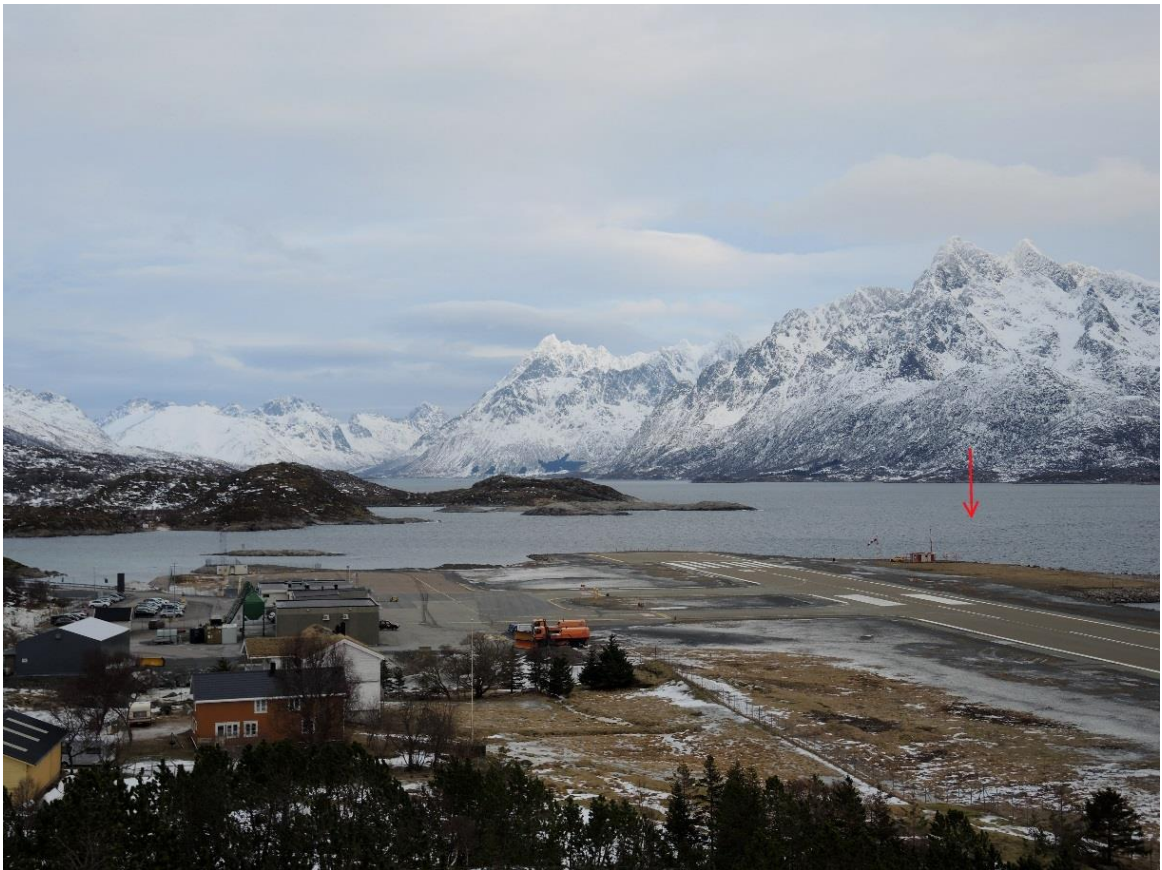
Figure 2: Photo taken from tower at the airport. The arrow points to the location where the wreckage was found. Photo: AIBN

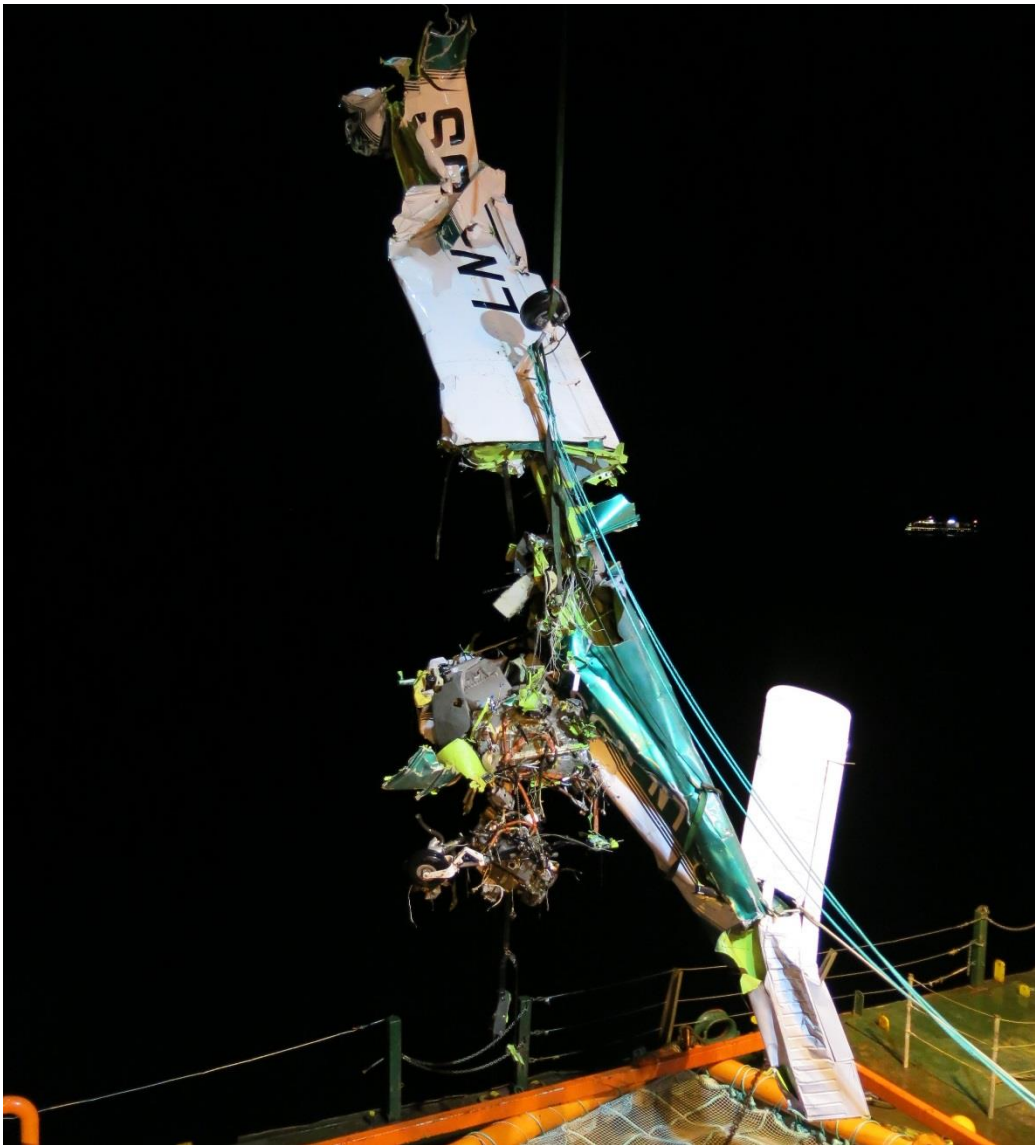
Figure 4: Main wreckage after being raised from the ocean. Photo: AIBN

The fuselage had sustained substantial damage from the front and all the way back to the seat back in the back seat. Behind the luggage compartment, the fuselage was bent sharply to the right. At the transition to the tail fin, the tail was bent to the left correspondingly.

The engine and nosewheel had been knocked loose and were only connected to the fuselage by hoses, cables and wires. The firewall between the engine and cabin was connected to the instrument panel and parts of the flight controls. Engine cowlings, windows, the door and most of the cabin structure were missing.

- 2.3.1 The damage to the aircraft shows that it impacted the ocean with substantial force with the front and right wing first. Damage to the outer right wing indicates that the wing hit the water at an angle of approx. 45°. The fact that the wing was ripped off the fuselage and that the main wheel leg was torn off indicates that the speed, and thus the force, was significant in the impact with the ocean.

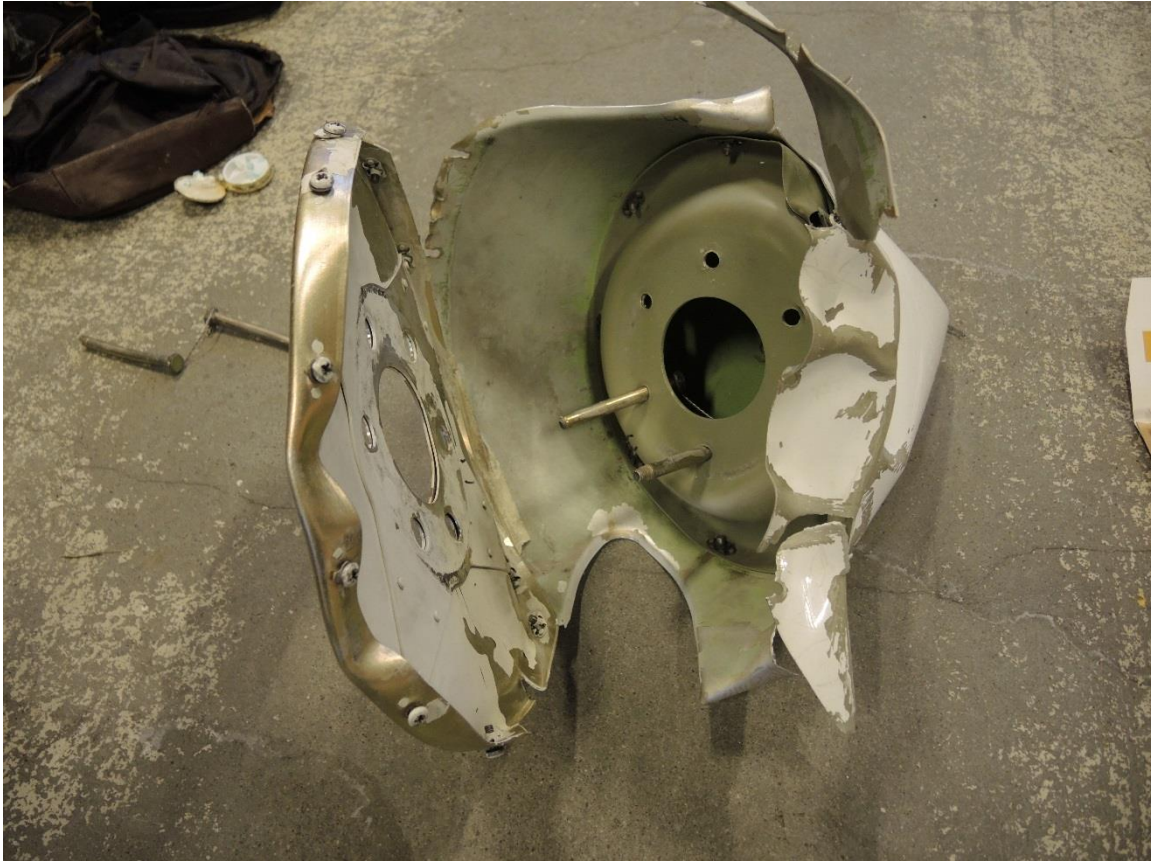
Immediately after the accident occurred, a number of items were found floating in the ocean. Some items were also later found along the shoreline. This included the private belongings of the two pilots, the plane's *Aircraft Journey Log Book*, floor mats, pieces of insulation, a petrol funnel, one litre of motor oil, various emergency equipment, the content of the aircraft's first aid kit, the cabin's fire extinguisher and the propeller spinner (see Figure 5).

Figure 5: Spinner, complete with attachment bolts and backplate. Photo: AIBN

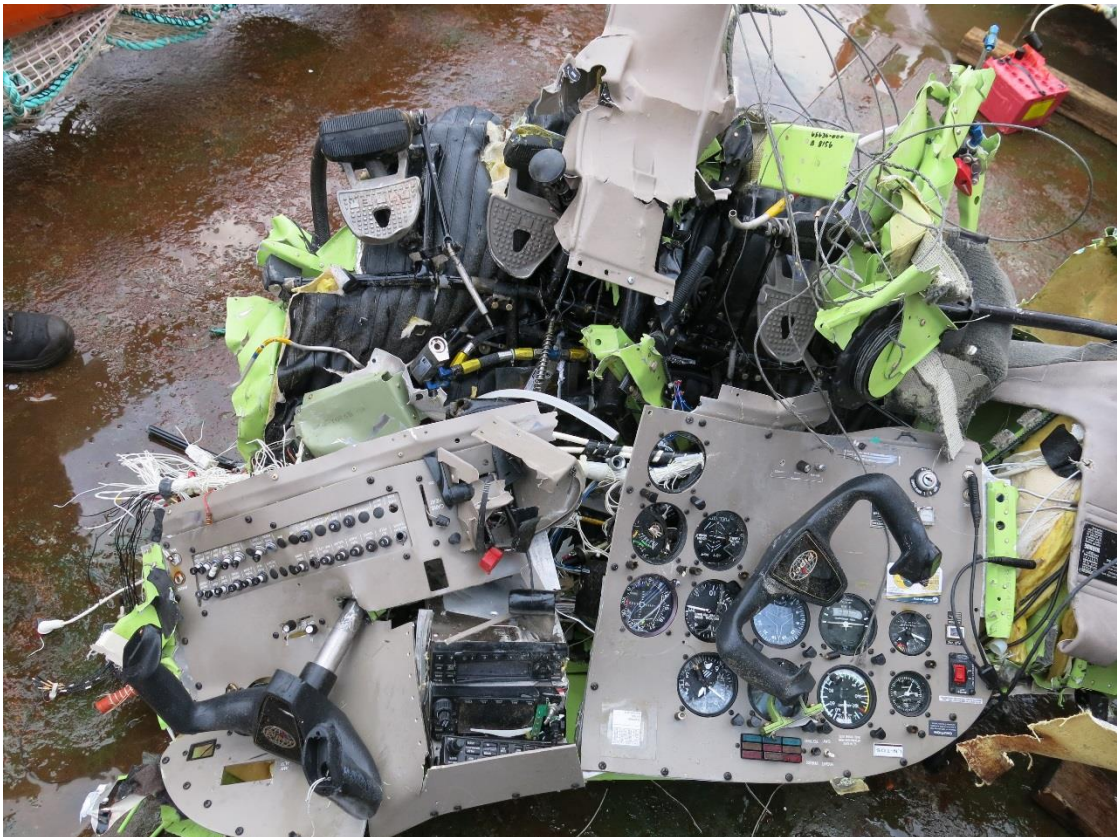
The instrument panel was found to be relatively complete (see Figure 6). The following is noted:

- The artificial horizon was still in the instrument panel and was relatively undamaged. It indicated that the aircraft's right wing was pointing 45° down (roll to right) and that the aircraft's nose was pointing approx. 5° up. Faults and damage found during disassembly of the instrument are all compatible with damage that may have occurred in a powerful impact with the ocean and subsequent damage following the incursion of saltwater. Saltwater damage to bearings made it impossible to test the instrument.

- The airspeed gauge showed 0.
- The altimeter was found set to 1001 hPa (29.55 inHg).
- The vertical speed indicator showed the maximum negative reading, i.e. -20,000 ft/min.

- The turn and bank indicator indicated that the wings were horizontal.
- The engine's RPM indicator was broken and had come loose from the instrument panel. An examination of the instrument face with a view of finding impact marks from the indicator needle, was fruitless.

- The three switches for instrument lighting exhibited varying levels of damage. The switch for SWITCH was partially broken. The switch for PANEL was found with panel lighting turned up approx. 1/3. The switch for AVIONICS was knocked completely out of the panel and missing.

- The switches for exterior lights were knocked loose from the instrument panel and were partially destroyed. These switch positions were deemed not to provide reliable information.

Figure 6: The instrument panel and flight controls after being raised from the seabed and placed on the recovery barge deck. Photo: AIBN

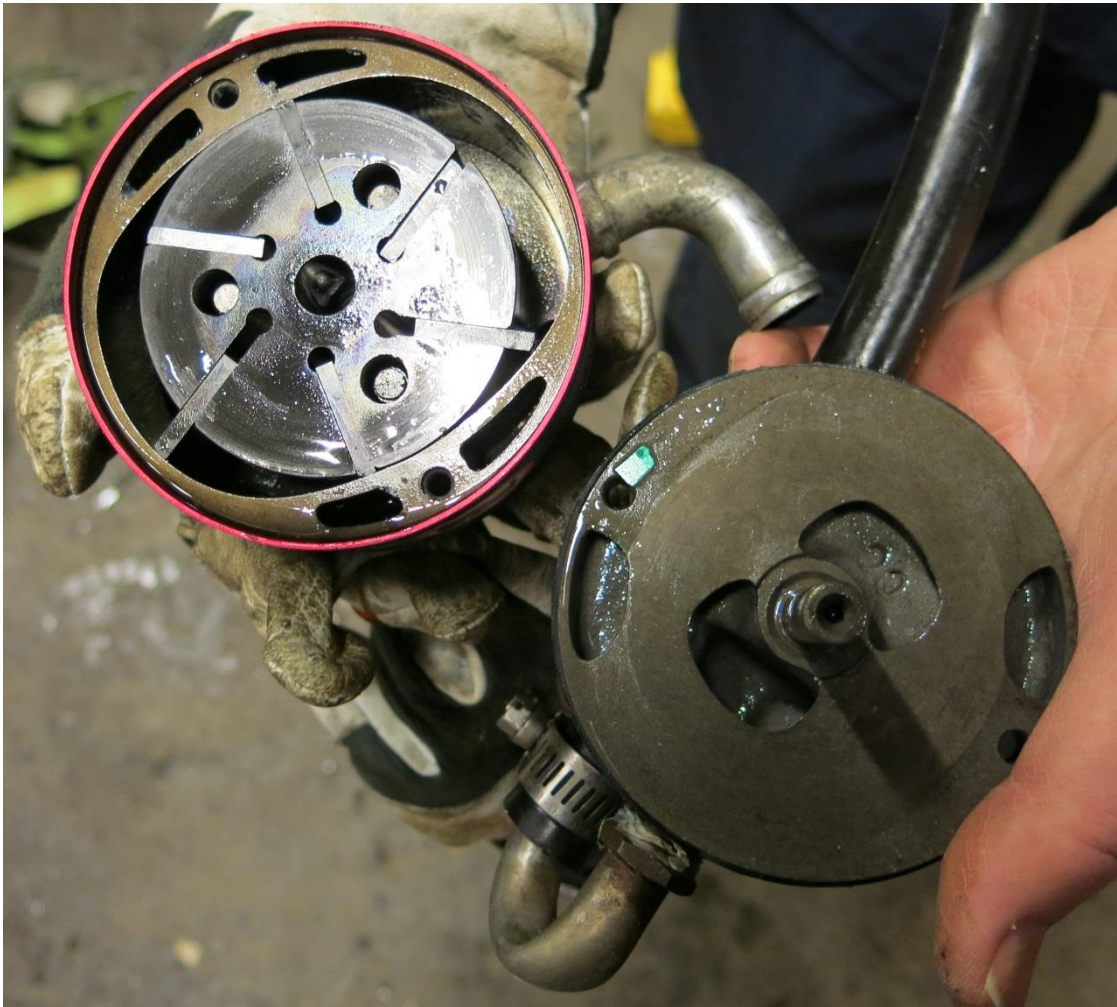
- The carburettor had been crushed and parts of it were missing.
- The fuel pump was disassembled and correct function was verified.
- The vacuum pump was disassembled and correct function was verified (see Figure 7).

Figure 7: The vacuum pump after being opened up. Photo: AIBN

- 2.3.6 The aircraft's vacuum pump was found to be functional. The artificial horizon cannot function without it. This, along with the discoveries mentioned above, makes it highly likely that the artificial horizon was functioning as intended during the flight.

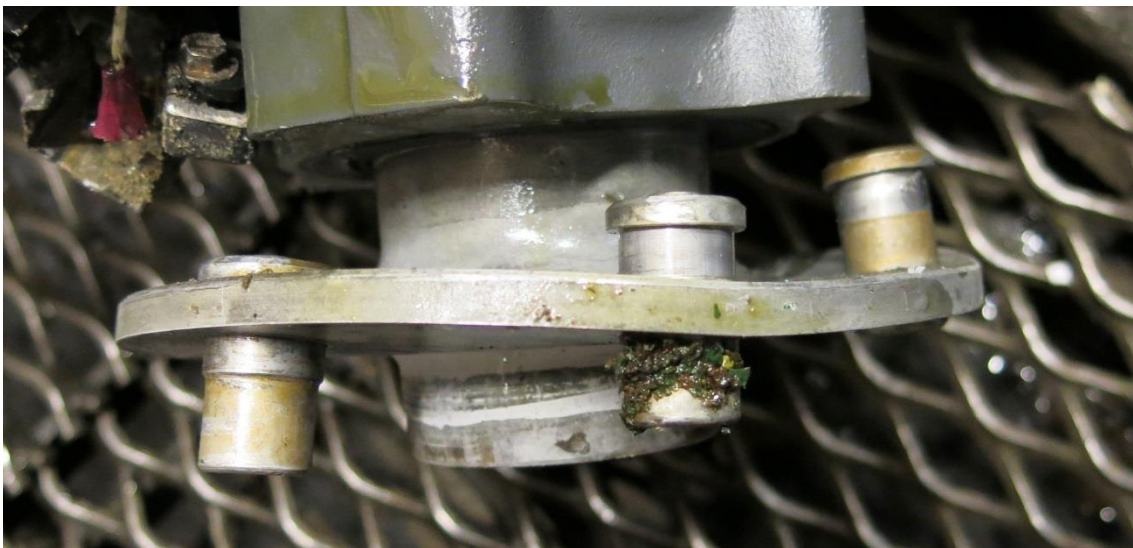
- The propeller flange was bent into an S shape. Two of the bushings (nuts) for the propeller's bolts were missing. Three bushings had been partially pushed in and one

bushing was in the right position. Parts of the propeller bolts were found in the four remaining bushings (see Figure 8).

Figure 8: The propeller flange on the engine. Photo: AIBN

- 2.3.4 The propeller flange showed clear signs of the propeller being driven by the engine when it separated. The overloading of all six propeller bolts and the fact that only one of the propeller bolt bushings (nuts) was still in the right position confirm that an excessive torque was transmitted before the propeller disappeared. The fact that the propeller was not found in the search area could indicate that it was spinning at a high RPM and that it was flung far away once it separated. The conclusion is that the AIBN finds no basis to believe a lack of engine power may have been a cause of the accident. The statement from the witness who heard an engine revving up supports this conclusion.
