REPORT

SL 2020/03

REPORT ON AIR ACCIDENT AT OSLO AIRPORT GARDERMOEN ON 11 JANUARY 2017 WITH CESSNA AIRCRAFT COMPANY 560 ENCORE, LN-IDB, OPERATED BY HESNES AIR AS

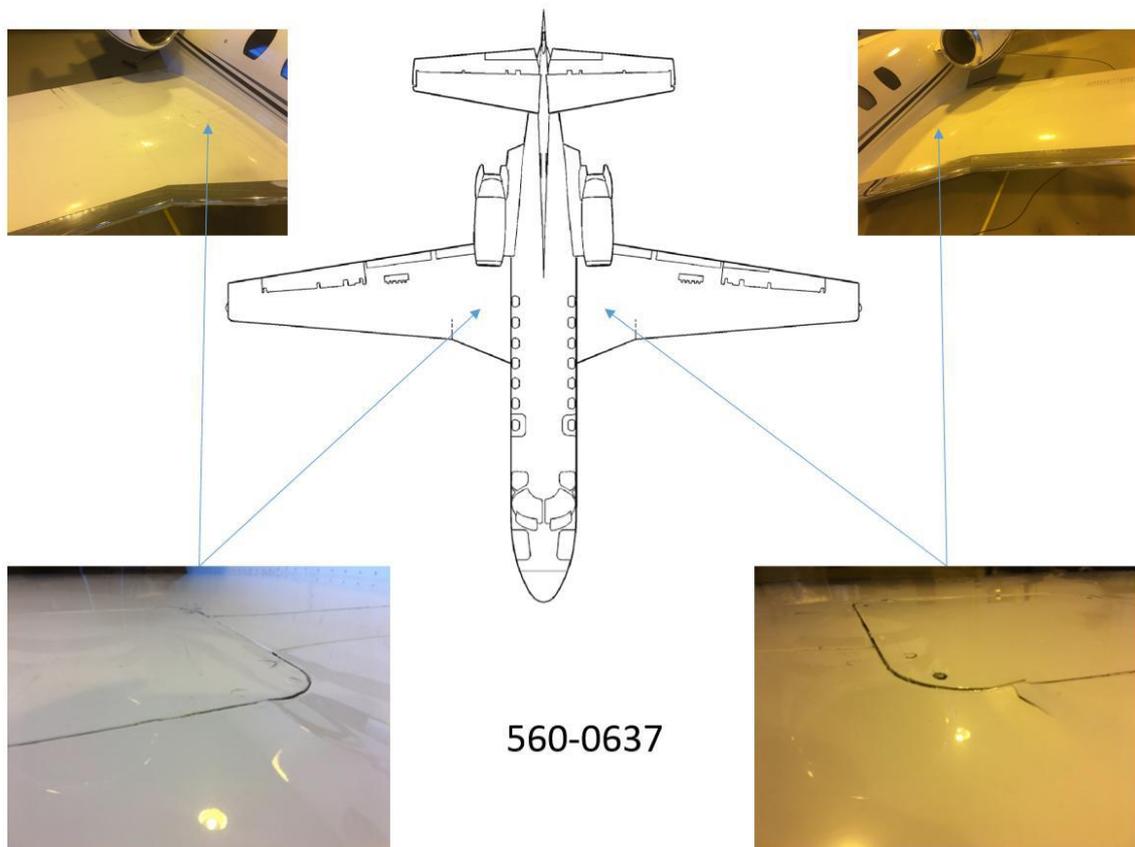
- 1.12.2.1 Due to the high G loads to which the aircraft was exposed, deformations occurred in multiple places on the top side of both wings. Deformations also occurred on engine nacelles and on the fuselage over the wings (see Figure 11 and Appendix B for details). The aircraft was so damaged that it was not found economically viable to repair it.

Figure 11: Visible damage to the top of the wings. Source: Hesnes Air AS

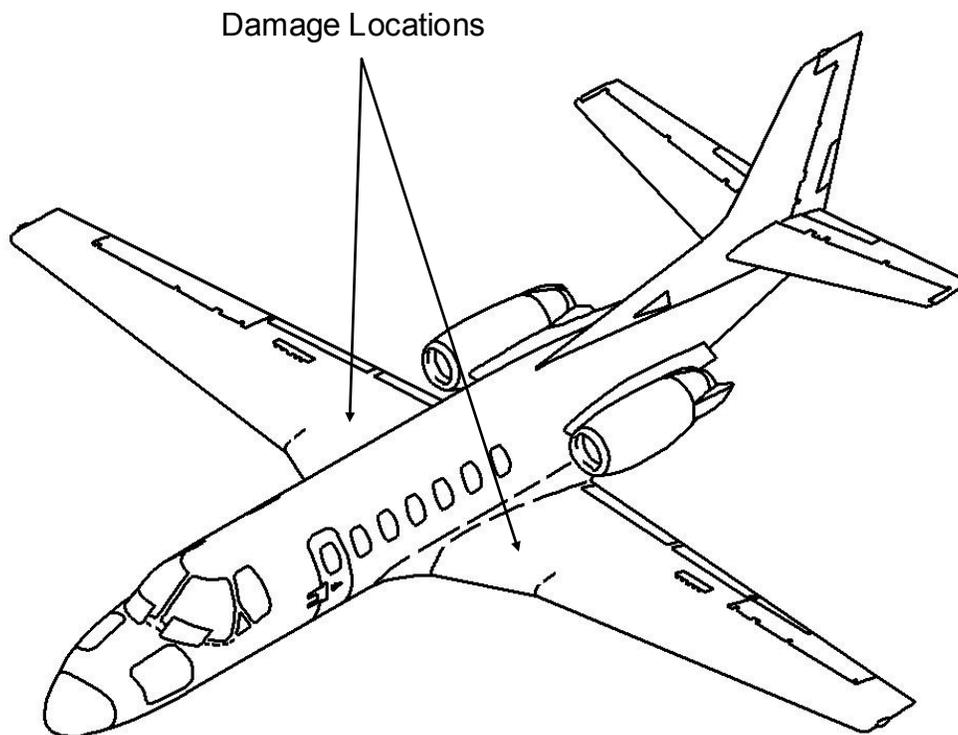
Figure 1.0 Major Damage Locations on the Model 560

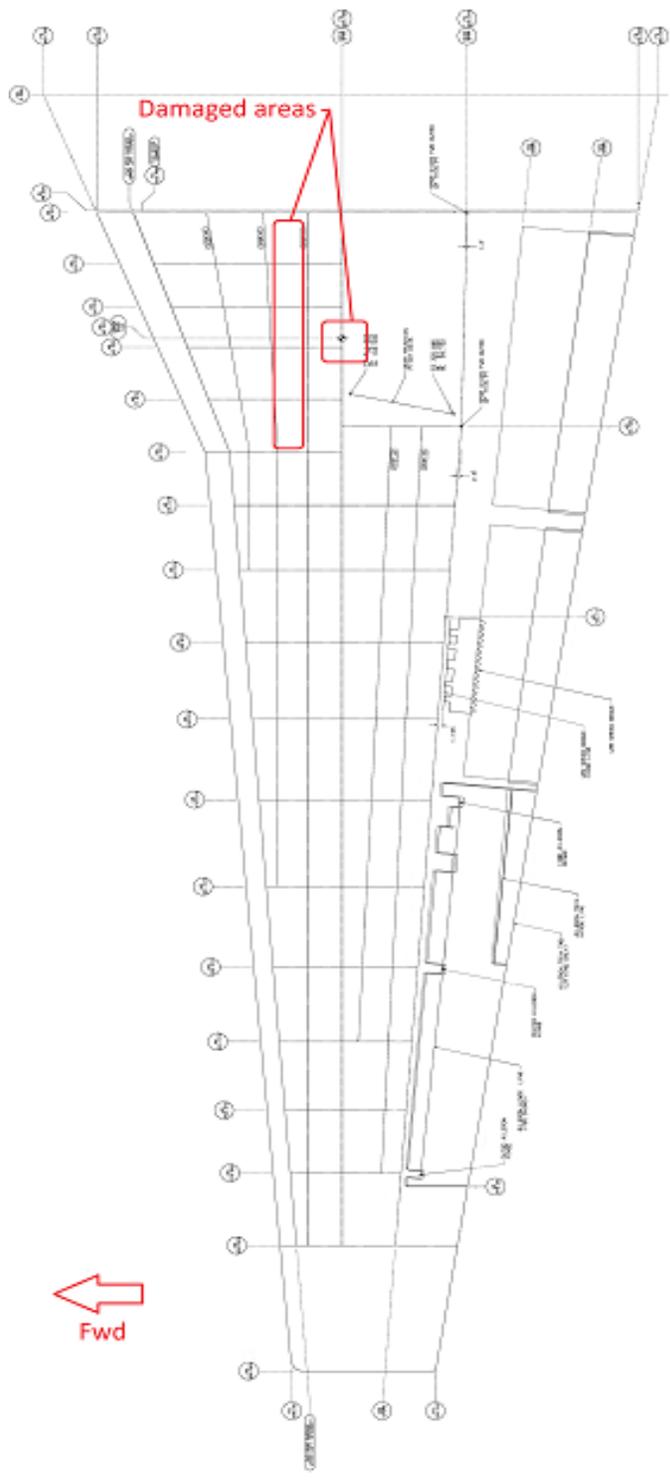
Figure 1.3 LH Wing Damage Locations

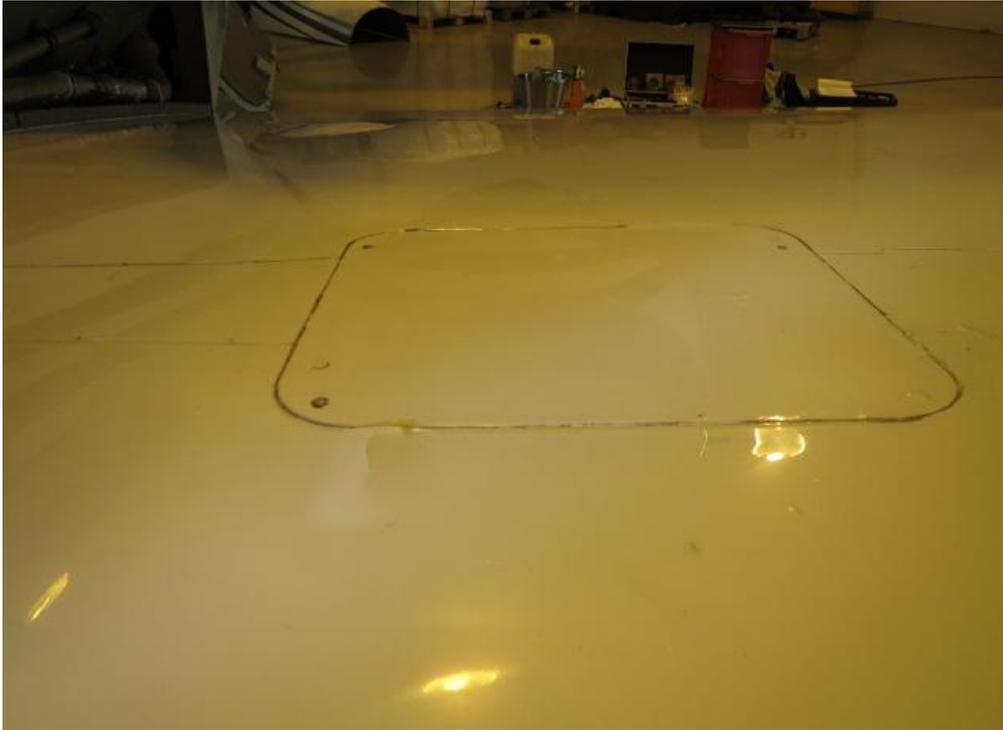
1.4 Crease in LH Upper Stub Wing Skin - WS 60.50

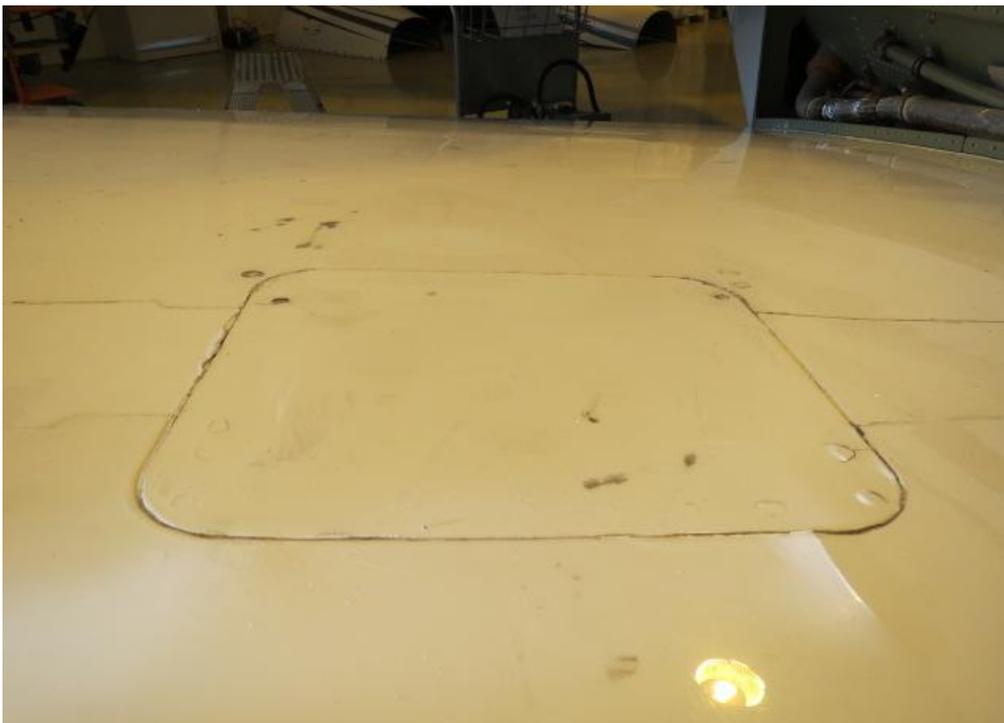
1.5 Crease in RH Upper Stub Wing Skin - WS 60.50

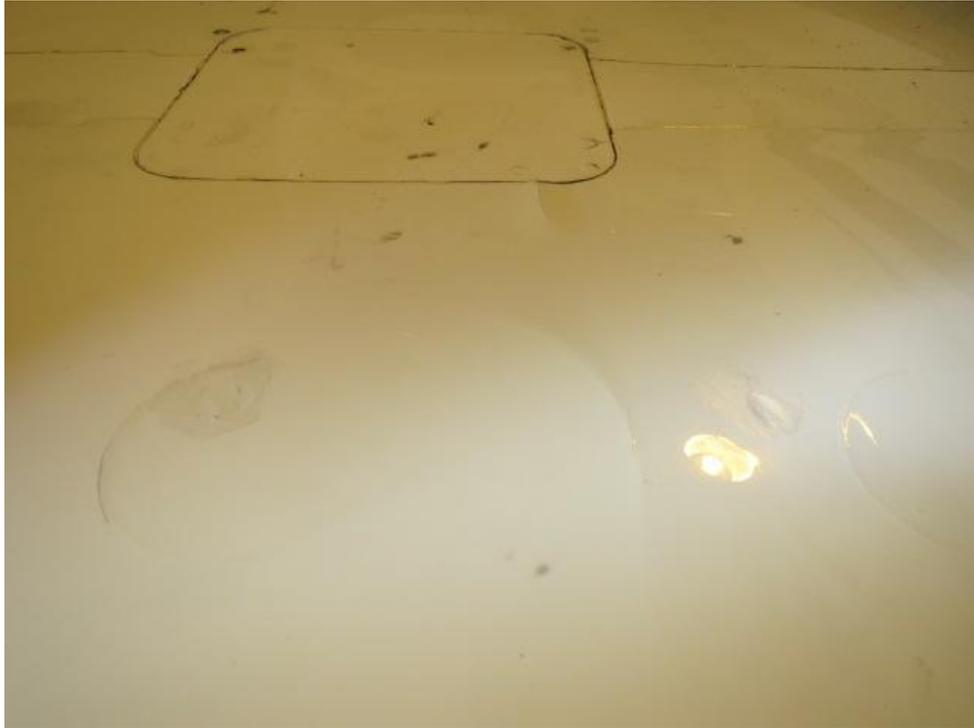
Figure 1.6 Raised Areas on RH Upper Stub Wing Skin

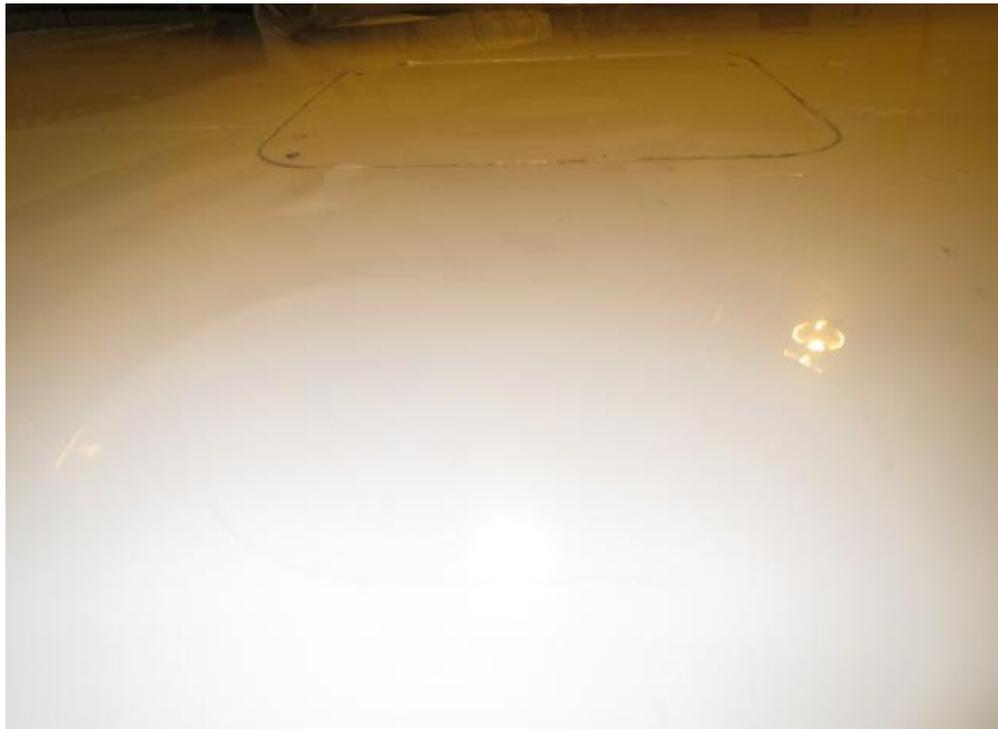
Figure 1.7 Raised Areas on LH Upper Stub Wing Skin

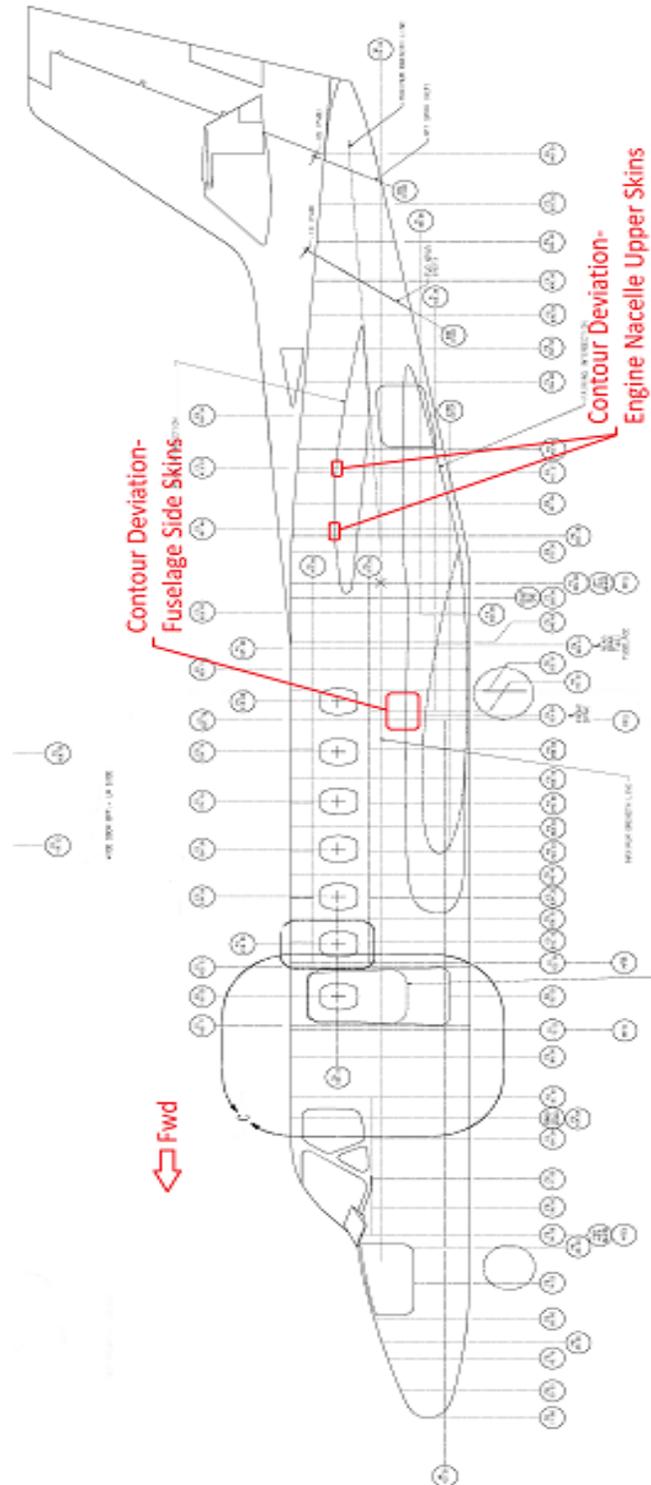
Figure 1.8 Contour Deviations – LH & RH Fuselage Side Skin and Engine Nacelle Upper Skins

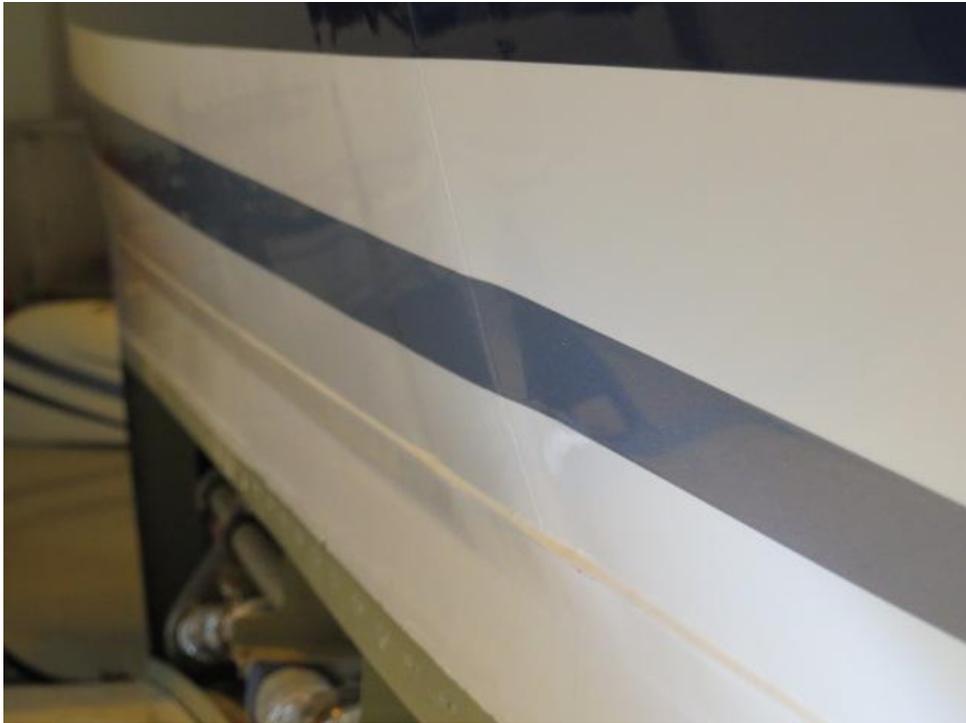
Fig 1.9 RH Fuselage Side Skin Contour Deviation – FS 309.90

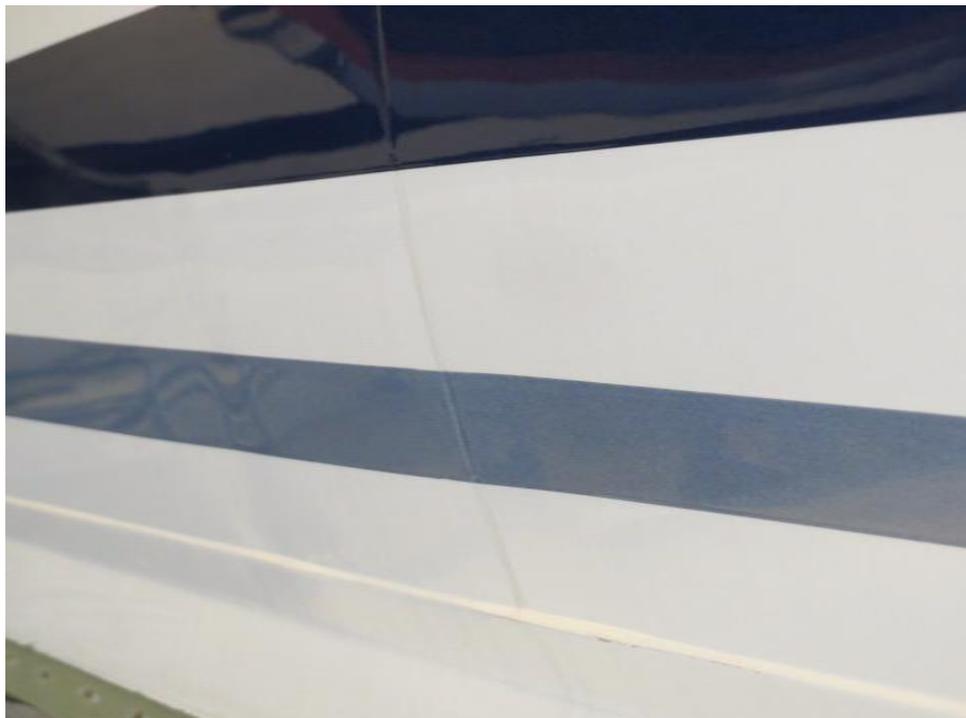
Fig 1.10 LH Fuselage Side Skin Contour Deviation FS 309.90

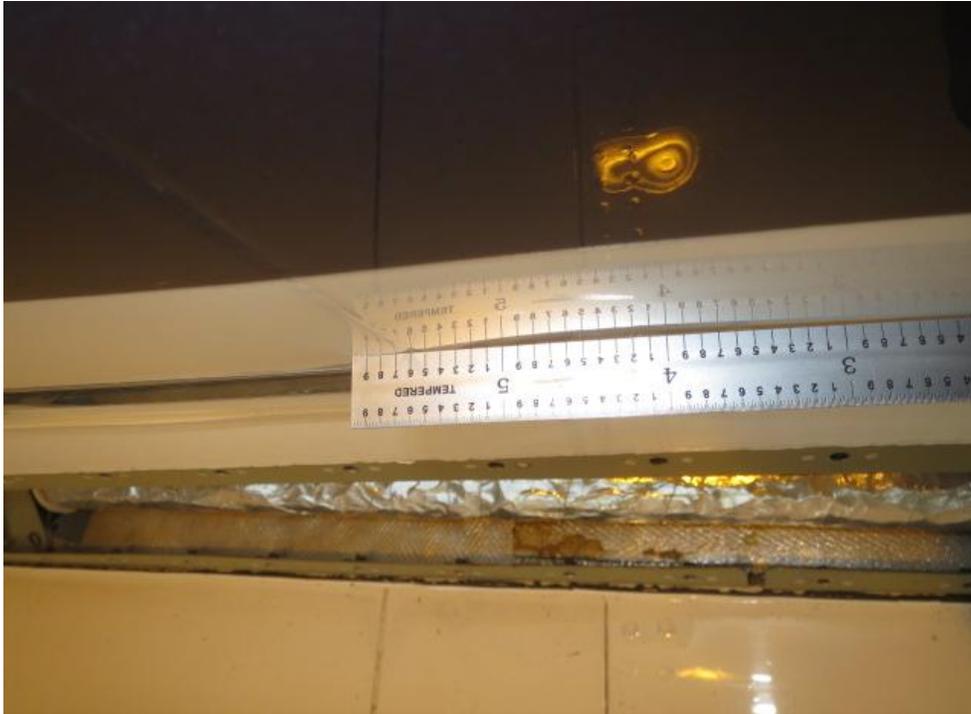
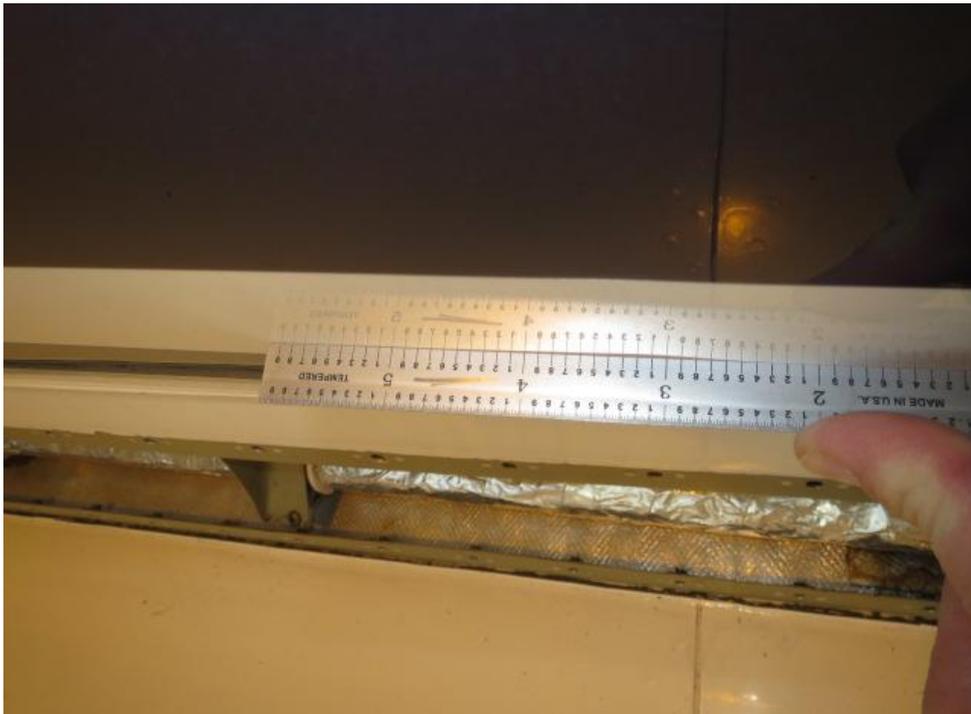
Figure 1.11 Fuselage Side Skin Contour Deviation FS 309.90

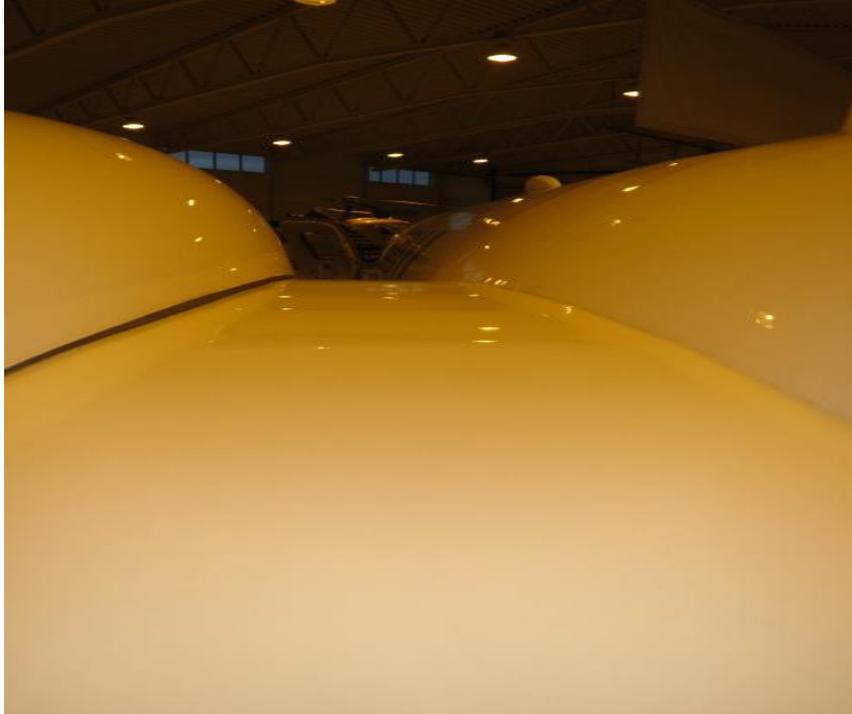
Figure 1.12 LH Engine Nacelle Upper Skin Deviations – FS 387.48 & FS 413.07

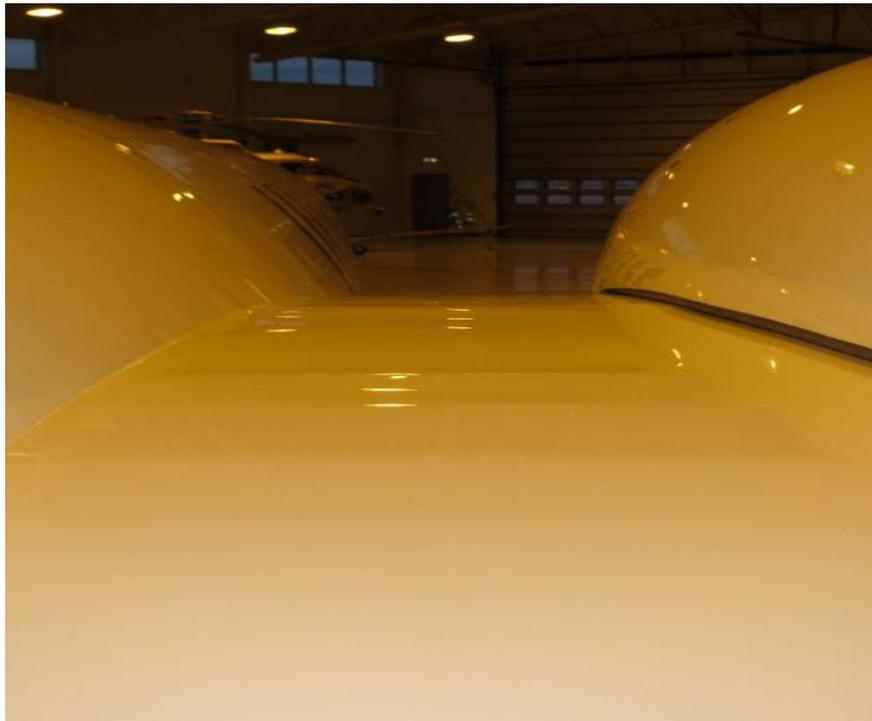
Figure 1.13 RH Engine Nacelle Upper Skin Deviations – FS 387.48 & FS 413.07
