REPORT

SL 2020/04

REPORT ON AVIATION ACCIDENT IN ISFJORDEN ON SVALBARD, NEAR BARENTSBURG, 26 OKTOBER 2017, WITH Mil Mi 8AMT, RA-22312 OPERATED BY CONVERS AVIA AIRLINES JSC

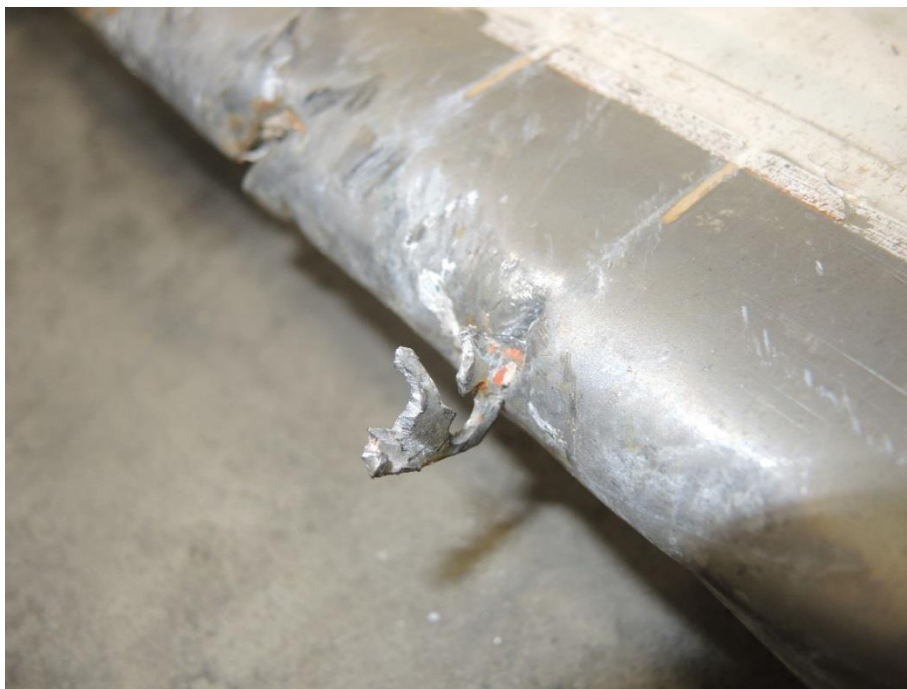
- 1.11.2.2 The Flight Data Recorder was hit by a main rotor blade during the sequence of the accident, and it was struck loose from its mounting in the pod underneath the tail boom (see Figure 6).

Figure 6: Fragment of FDR casing stuck in the leading edge of a main rotor blade. Photo: AIBN

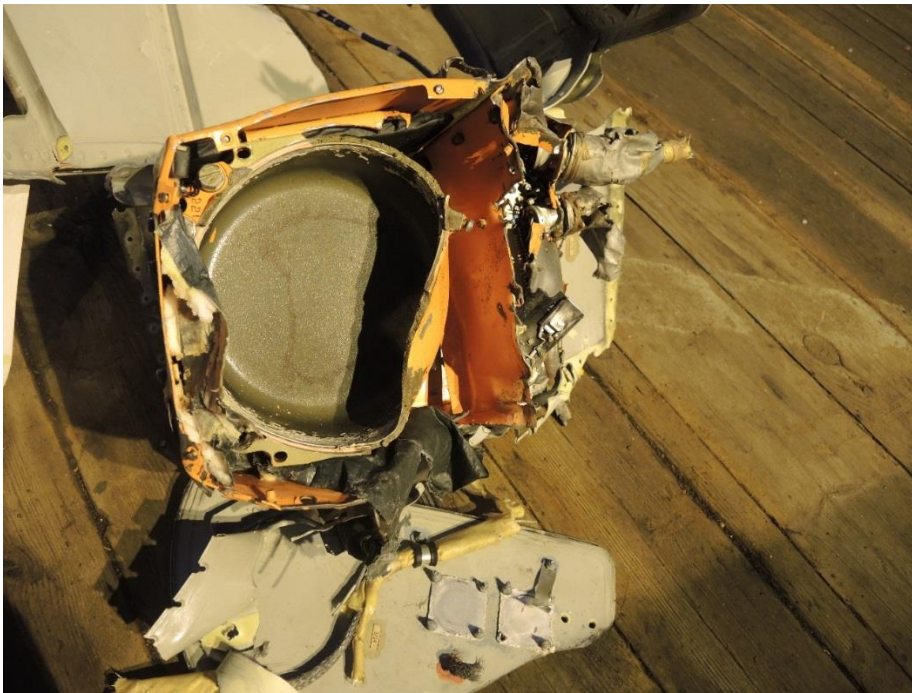
- 1.11.2.3 One day after the helicopter was lifted from the seabed, fragments of the flight data recorder was found at the sea bottom at a distance of 80 to 90 meters from where the helicopter fuselage had been on the seabed. The casing of the protected memory unit (i.e. Crash-Survival Memory Unit, CSMU) and the top covering lid of the CSMU were found approximately 40 meters from each other. The internal memory module was not found (see Figure 7). Analysis of registered data from the FDR was therefore not possible.

Figure 7: Destroyed BUR-3-2 FDR with empty CSMU casing. Photo: AIBN

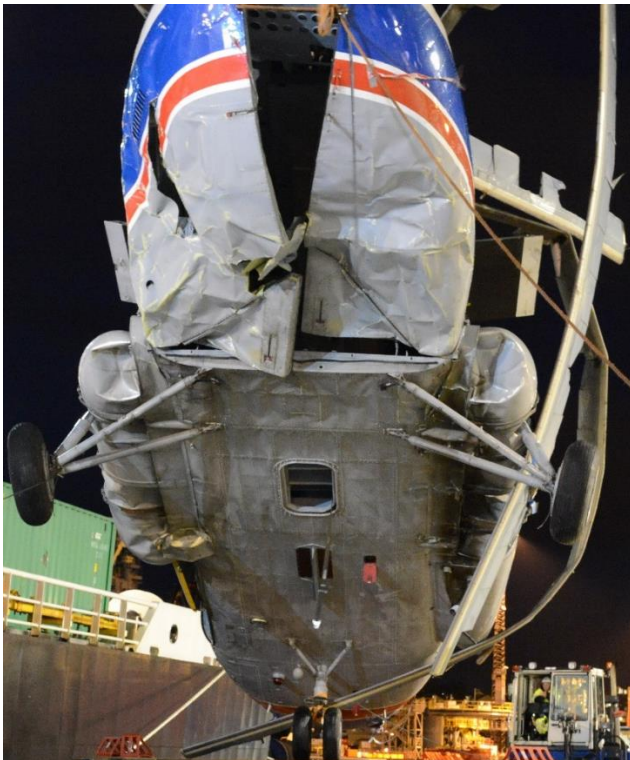
- 1.12.3.1 The main fuselage was intact, whereas the aft part of the tail boom was found by its side. Damages to the underside of the helicopter indicate that it hit the water with the aft part of the main fuselage (Figure 15).

Figure 15: Damages to the underside of the helicopter. Photo: AIBN

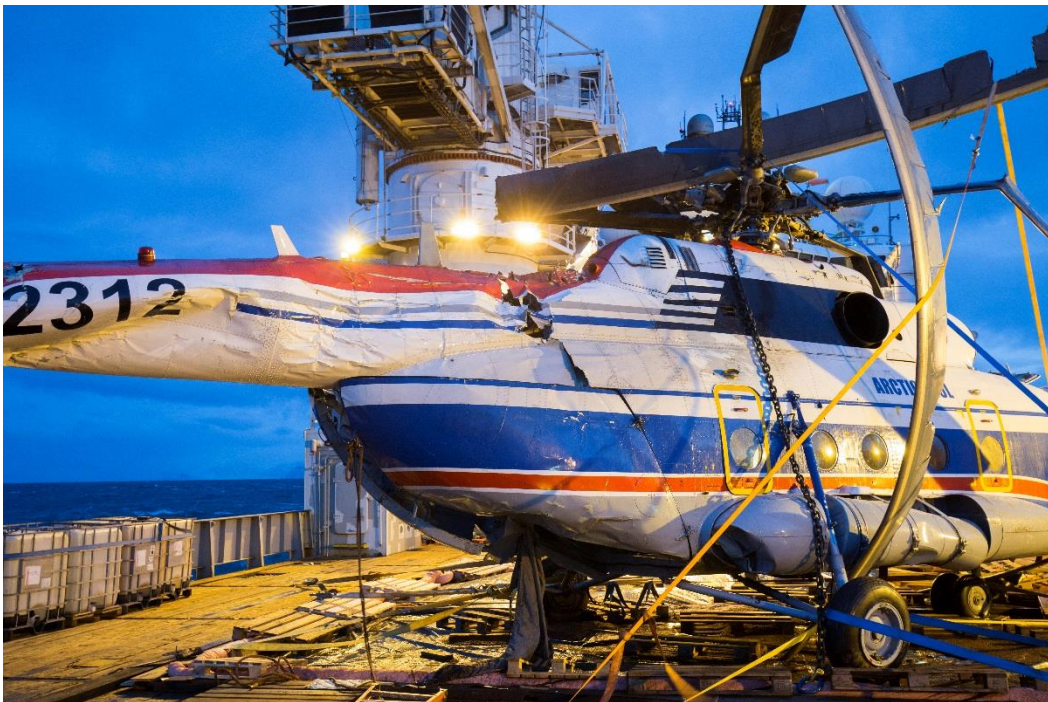
- 1.12.3.2 The aft part of the central fuselage section had damages that probably occurred when the helicopter first hit the water surface, and when it later hit the sea bottom. The damages that occurred is shown in Figure 15, Figure 16 and Figure 17.

Figure 16: Structural damage on the fuselage on the right hand side. Photo: AIBN

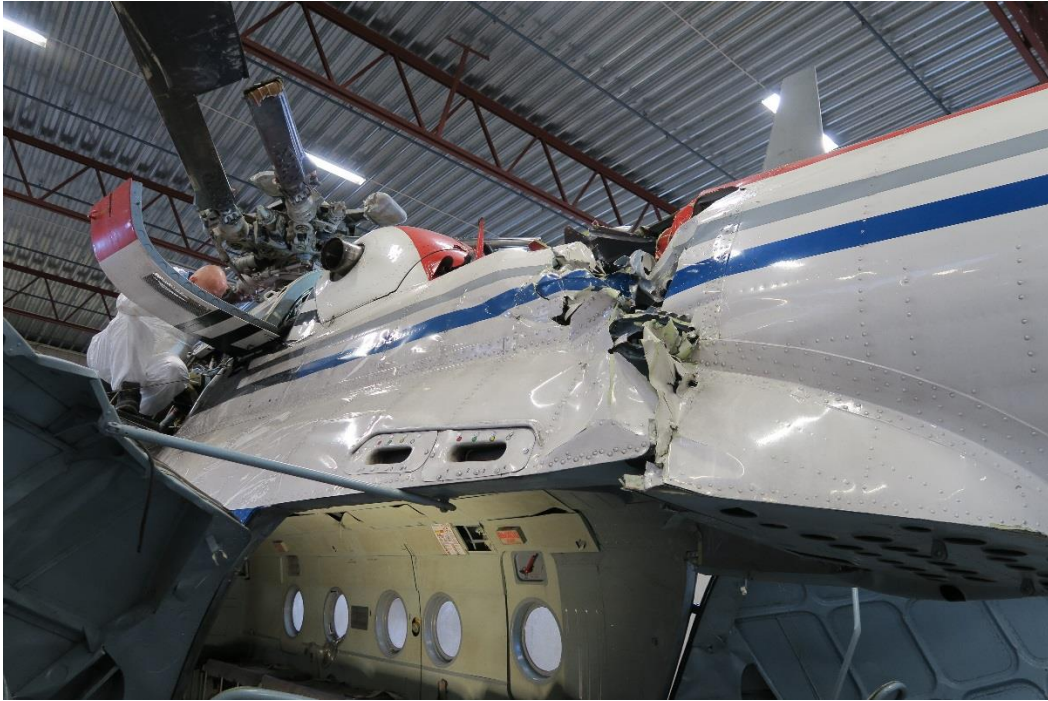
Figure 17: Structural damage on the left hand side between the main fuselage and the tail boom. Photo: AIBN

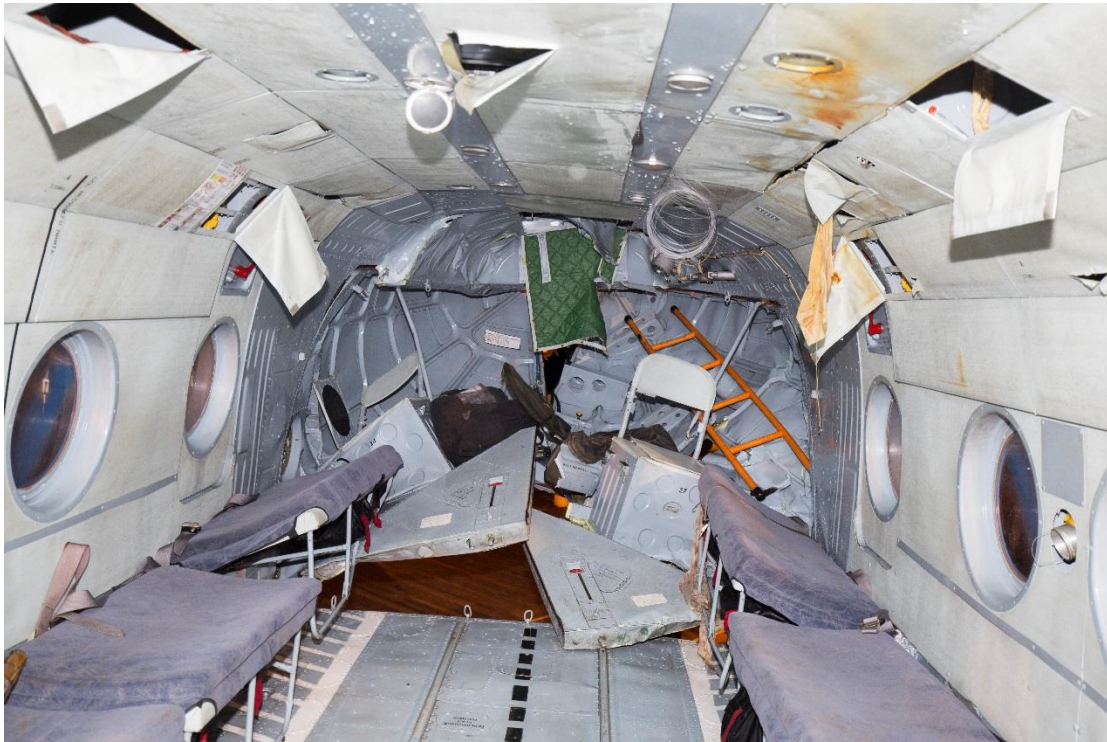
opening in the floor as well. The cabin could thus fill up with water quickly (see Figure 23). Because of the weight of engines, main gearbox and main rotor, the center of gravity is so high that a helicopter without emergency flotation gear or sponsons is unstable and will easily capsize.

Figure 23: Deformed cargo doors due to impact with the water surface. The picture is taken looking towards the aft of the cabin and the cargo doors. Photo: The police

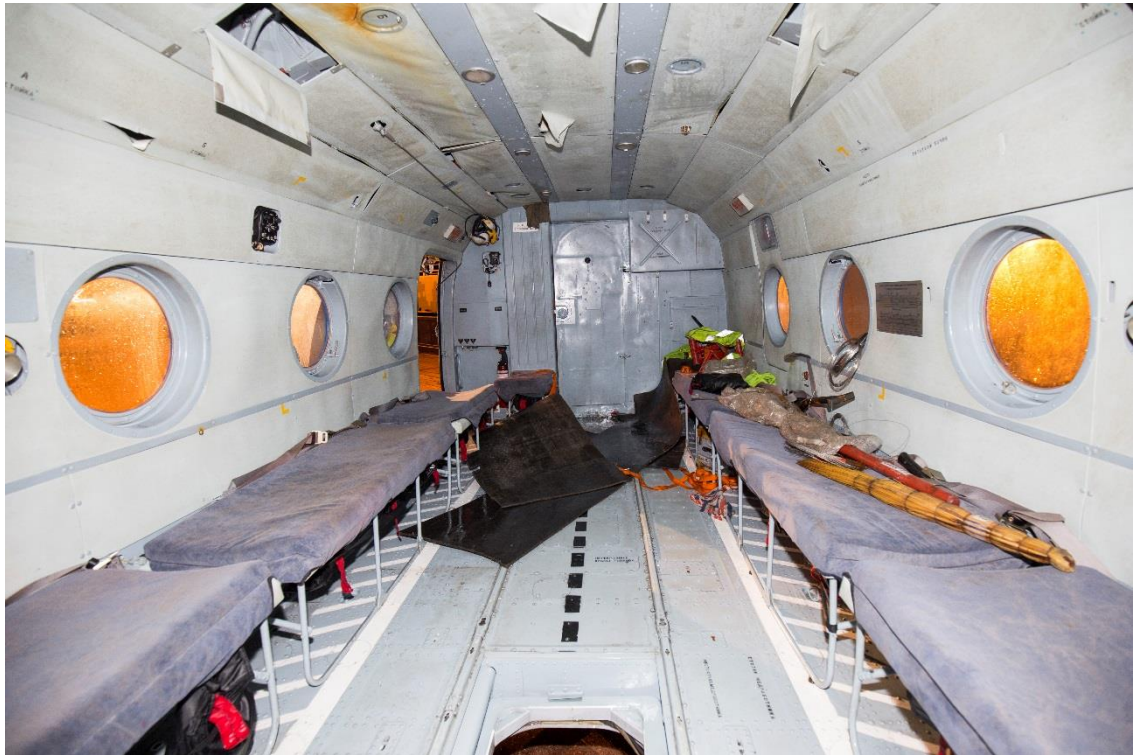
- 1.15.2.8 After the wreck was lifted on board, large loose rubber mats were found inside the cabin. According to the information AIBN was given, the mats were there to protect the cabin

floor. These rubber mats were unknown to the company's engineering department at the head office in Tver in Russia (see Figure).

Figure 24: Black rubber mats in the helicopter cabin. The picture was taken facing forwards in the cabin. Photo: The police
