REPORT

SL 2020/07

REPORT ON THE AIR ACCIDENT NEAR ØIAN AIRFIELD IN MERÅKER IN THE COUNTY OF TRØNDELAG, NORWAY ON 7 NOVEMBER 2018 WITH VAN'S AIRCRAFT INC (EX) RV-6, LN-AAL

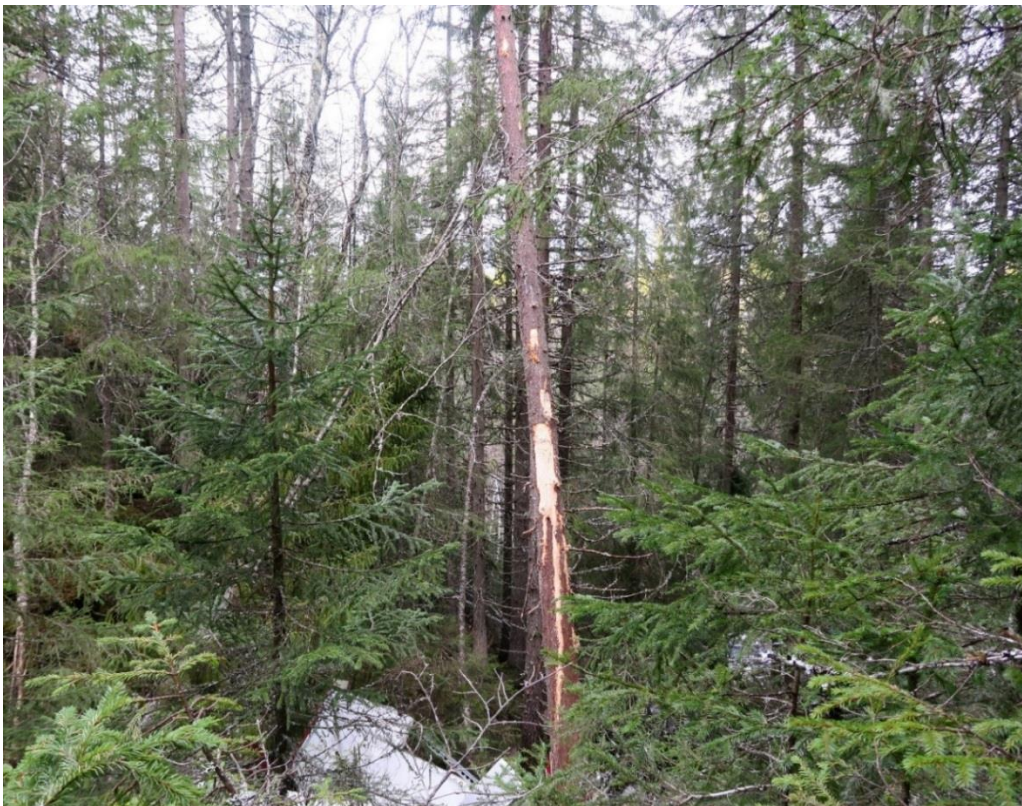
- 1.12.1.3 At the accident site itself, the aircraft had struck two spruce trees, located about 30 cm from each other. The thickest of the two trees was to the right and was 35 cm diameter at the base. This tree was struck 9 meters above the ground. In some places, the bark was stripped off. At the top of the tree, the damage was on the south side, but the furrows on the tree turned westward further down the trunk. There were no branches left below the point of impact on the south and west side of the tree. The force of the impact had uprooted the tree, causing it to tilt about 10° north. The tree had also been broken in two approximately 12 meters above the ground and the top of the tree had fallen to the ground. The other tree was thinner, approximately 15 cm in diameter at the base. It had been splintered and divided in two about a meter above the ground. There were no indications of propeller impact on either of the trees (see Figure 12 and Figure 13).

Figure 12: Photo taken facing north. The top of the photo shows the point of impact 9 meters up on the tree, which was tilted by the impact. The aircraft's right wing is visible to the left of the tree. Photo: AIBN

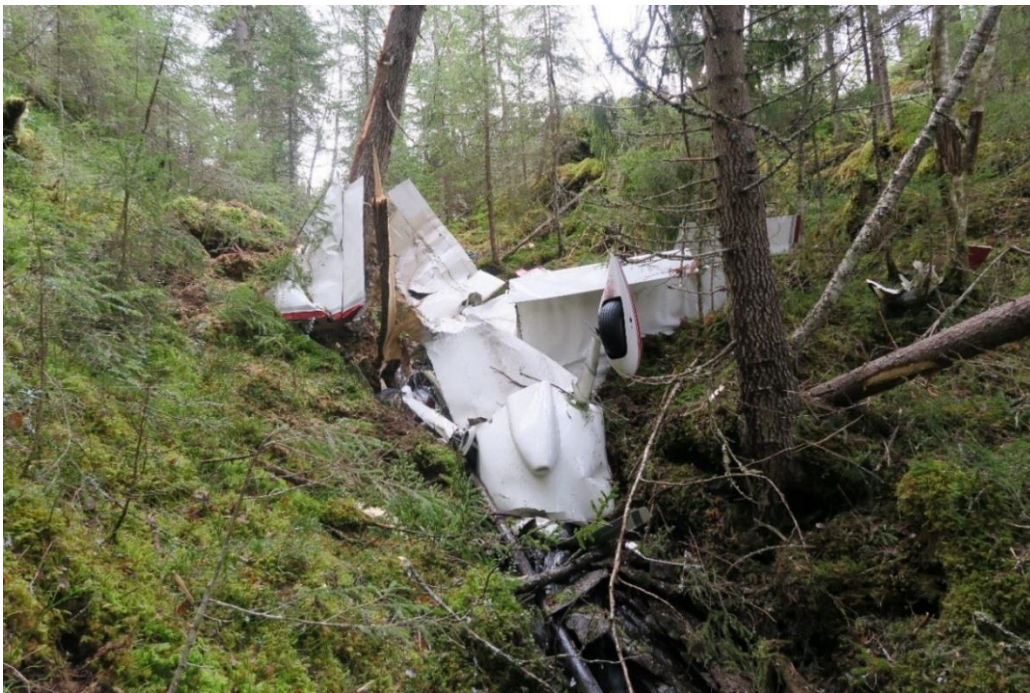
The aircraft was found upside down in a streambed, with its left wing curved around a tree. The fuselage was on the ground facing an approximate direction of 040°. The aircraft was more or less located at one place; only a few minor parts had broken off and were located in the immediate vicinity of the wreckage itself. The propeller, which was located in the middle of the stream, was the lowest part of the wreckage.

Figure 13: Photo taken facing south-west. The aircraft descended over the trees shown in the background in the top left section of the photograph. Photo: AIBN

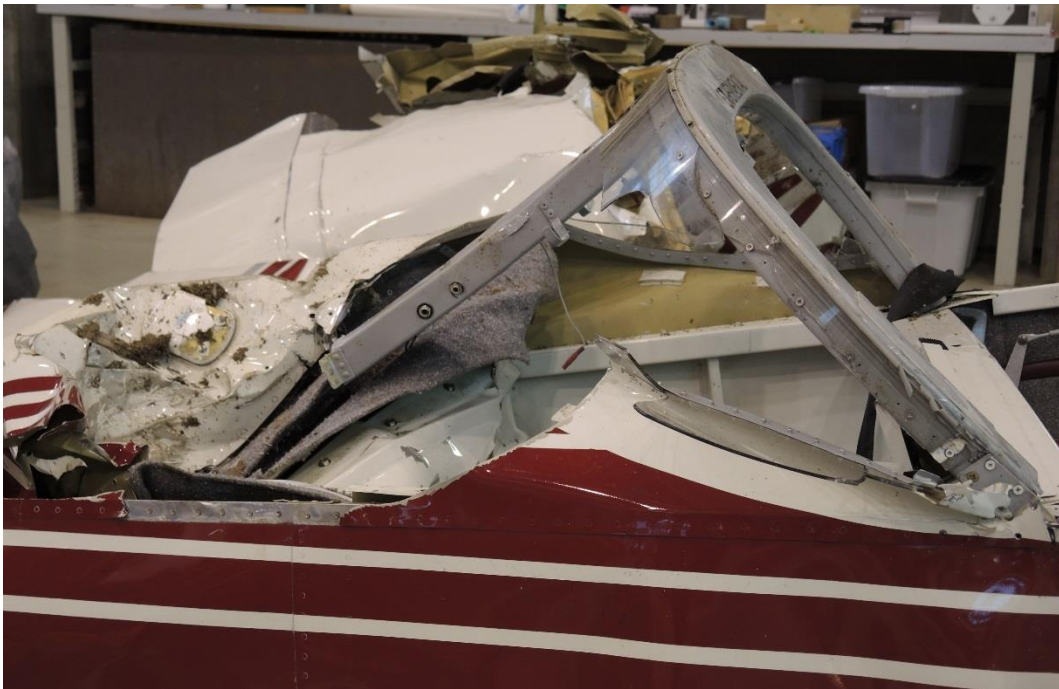
Figure 14: The frame in the canopy, which was bent all the way back and down (left). After the aircraft was turned over, the frame partially returned to its original position. Photo: AIBN

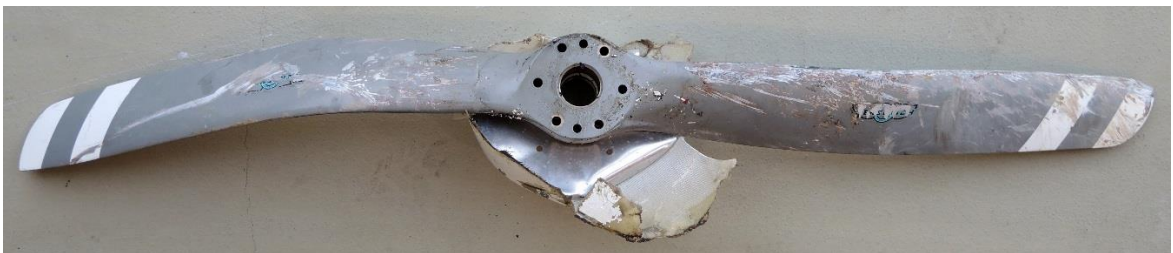
- 1.16.1.1 Both propeller blades were bent backwards. The right propeller blade was more sharply bent than the left one. Furthermore, the propeller shaft flange had in part come off and was bent about 30° to the left (see Figure 16). Neither blade was bent in the plane of rotation. All scratch marks on the front side of the right-hand blade were radial.⁶ Most of the scratch marks on the left-hand blade were also radial, but there were also some marks across the blade. At one point on the blade's leading edge, however, the scratch marks were across the blade (see Figure 15 and Figure 16).

Figure 15: Front view of the propeller. The right propeller blade is to the left in the photo. Photo: AIBN

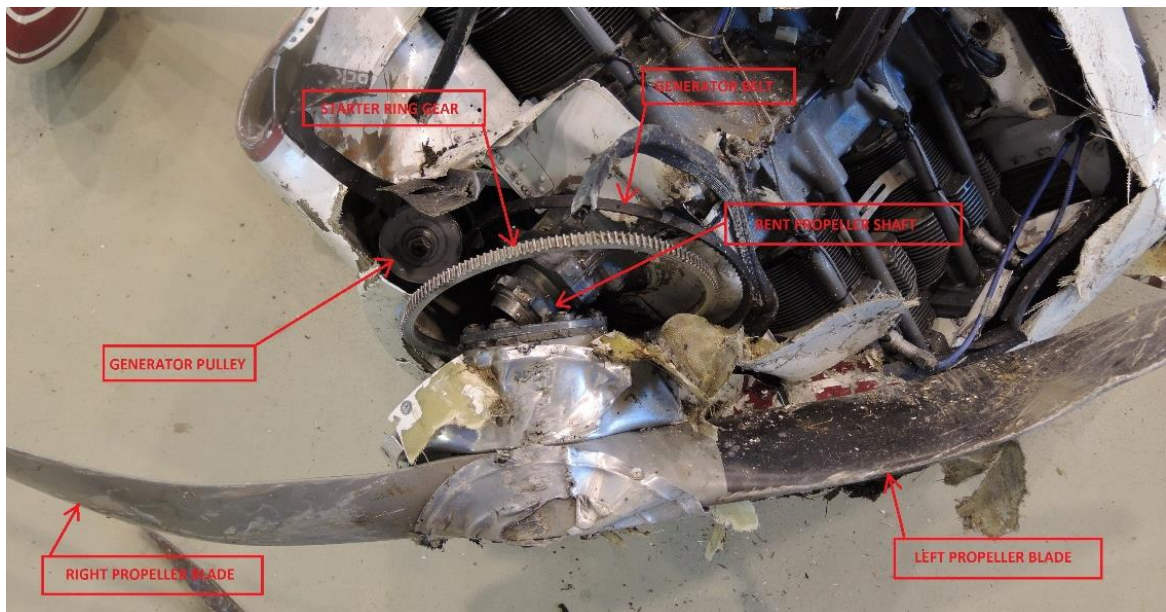
Figure 16: The propeller seen from above. The right propeller blade is to the left in the photo. Photo: AIBN

- 2.3.1.2 The AIBN has rarely seen a propeller shaft bent as shown in Figure 16. The bent shaft was primarily due to the fact that the propeller shaft had lightening holes, and that the material between these holes was torn off. Moreover, the AIBN assumes that the visible lines in the metal structure of the fracture surfaces indicate the direction of the forces that were applied. A purely bent propeller shaft would have dimples without any indication of

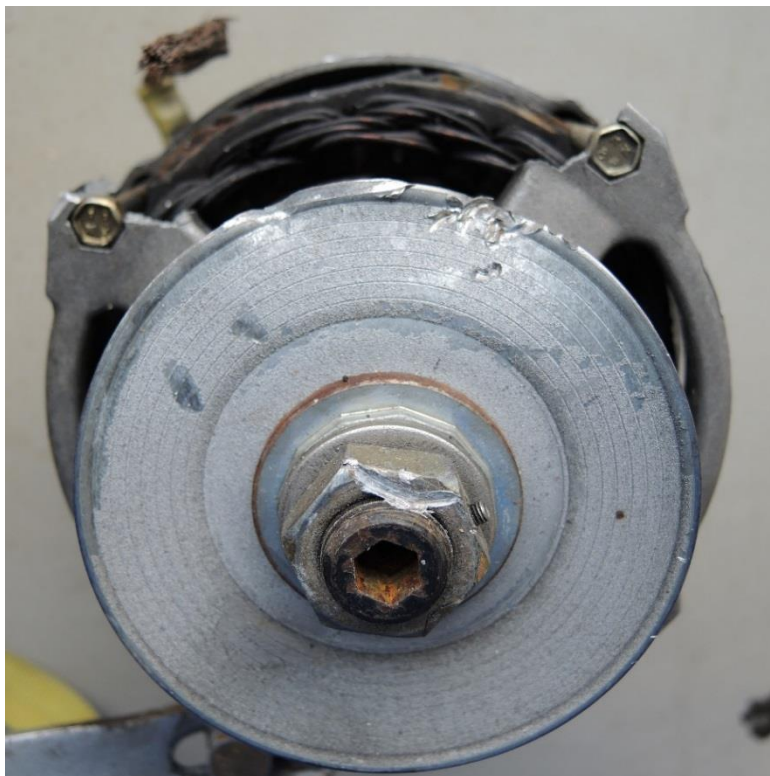
cracked as a result of contact between the starter ring gear and the starter. The generator belt was virtually undamaged. The generator pulley was bent as a result of the impact. The marks from the impact were radial, indicating that the pulley was not rotating at the time of impact. The impact was so severe that parts of the generator casing including the attachment lugs were broken off (see Figure 17).

Figure 17: The generator pulley was bent as a result of the impact. The broken generator casing can be seen at the top of the photograph. Photo: AIBN

- 2.3.1.3 The generator rotates about 2.7 times the speed of the engine. If the engine provided full power when the propeller hit the ground, the stopping of the engine from 2,700 rpm would be almost instantaneous. The generator pulley showed no signs of rotation damage. This indicates that the generator rotated at low or no speed when the damage occurred. If the generator rotated at 7,290 rpm when the aircraft hit the ground, it is unlikely that the pulley would have had time to stop completely before impact. Moreover, it is likely that the transmission belt would have been damaged had the engine and the propeller come to a sudden halt while the generator rotated at a speed of approximately 7,290 rpm. The AIBN believes that this supports the theory that the engine did not provide sufficient power and was operating at a significantly lower rotational speed than 2,700 rpm when the propeller hit the ground.

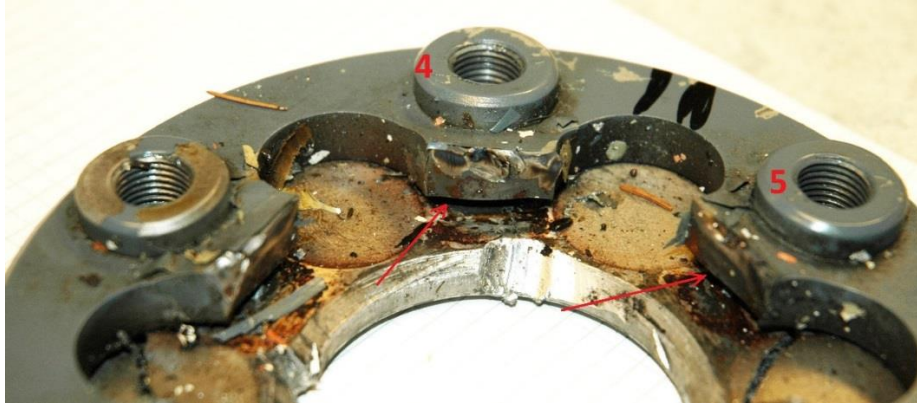
the engine. The propeller was removed from the propeller flange and the Norwegian Armed Forces' chemistry and material technology laboratory service (FOLAT) at Kjeller performed a more detailed examination of the six fracture surfaces. The propeller's retainer bolts were numbered from 1 to 6, where bolts 1 and 2 were closest to the left propeller blade, and bolts 4 and 5 were closest to the right propeller blade. Figure 18 shows the fracture surfaces near propeller bolts 4 and 5.

Figure 18: Parts of the propeller flange and parts of the disc that drives the generator belt and keeps the starter ring gear in place. The arrow shows the opening that formed as propeller bolts 4 and 5 were bent upwards. Photo: AIBN

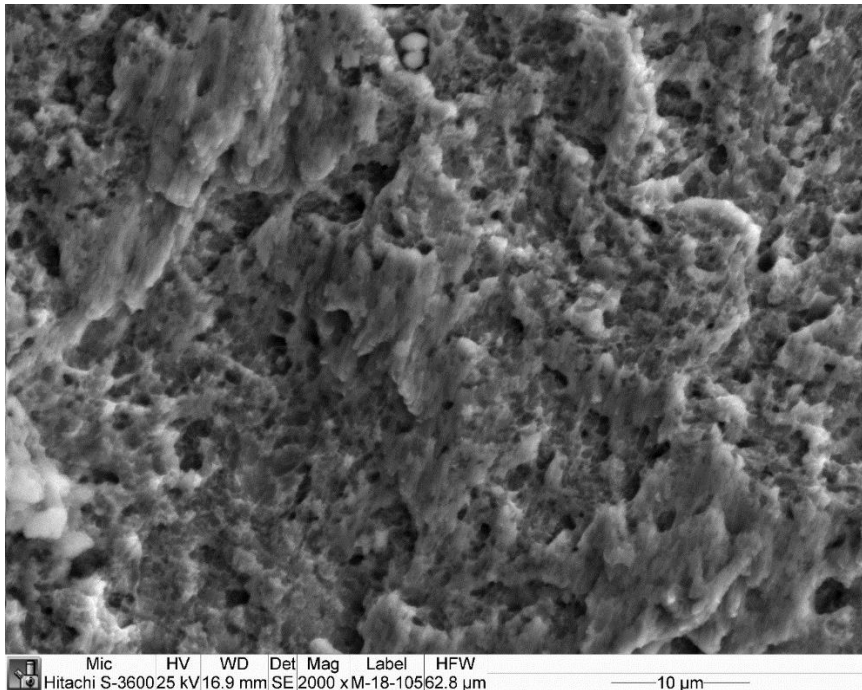
- 1.16.1.4 The fracture surfaces by propeller bolts 4 and 5 were examined more closely using a Scanning Electron Microscope (SEM). The purpose was to determine the direction of the fracture surface overload. The examination revealed typical dimples, which are associated with overload. There were few distinct lines on the fracture surfaces that could indicate the direction of the forces that had caused the fractures. However, it was possible to see the direction in some sections of the surface. Figure 19 shows an area where the dimples in some places run in a 20° direction to the right.

Figure 19: The fracture surface near propeller bolt no. 5. Some places the dimples run in a 20° right direction. Photo: The Norwegian Armed Forces' chemistry and material technology laboratory service (FOLAT)

direction or vertical lines. Mere overload caused by torsional forces transmitted from the engine (torque) would have produced horizontal deformation and lines. A direction of 20° to the left, which appears in some places in Figure 19, indicates that torsional forces make up a small part of the total load. This might indicate that the engine rotated at low speed and power.

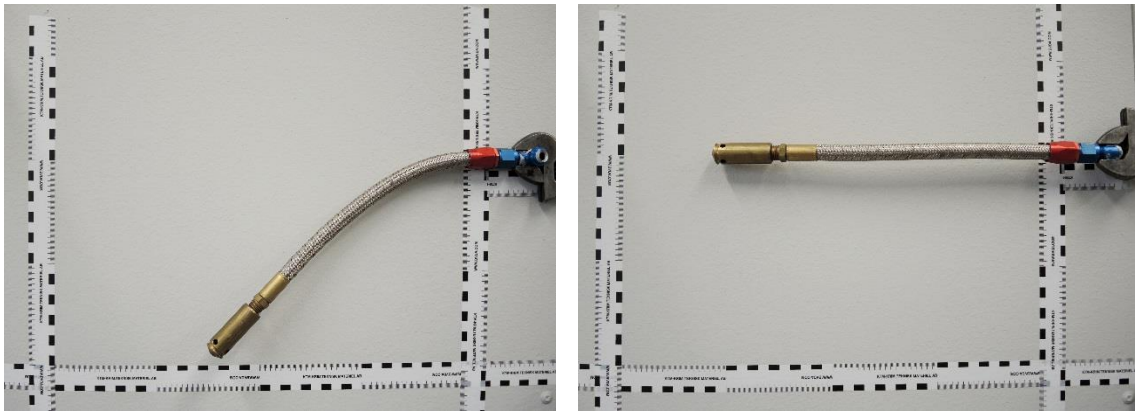
- 1.16.2.5 Upon inspection and dismantling of the fuel system, the following was observed:
- The pendant hose in the left fuel tank was relatively stiff. There was a natural bend in the hose pointing towards the bottom of the tank. However, the hose was so stiff that it could not be bent correspondingly in the other direction. An experiment showed that it straightened but did not bend upwards (downwards if the plane is flown inverted) when affected by gravity (see Figure 20).

Figure 20: The pendant hose from the left tank. In the picture to the left the hose is in the normal position with the combined pendulum bob/inlet pointing down towards the bottom of the tank. To demonstrate how stiff the hose had become, the hose in the picture to the right was turned upside down. As is shown in the picture, the weight of the pendulum only manages to straighten the hose. It is too stiff to bend down to what would be the bottom of the tank if the aircraft is flown inverted. Photo: AIBN

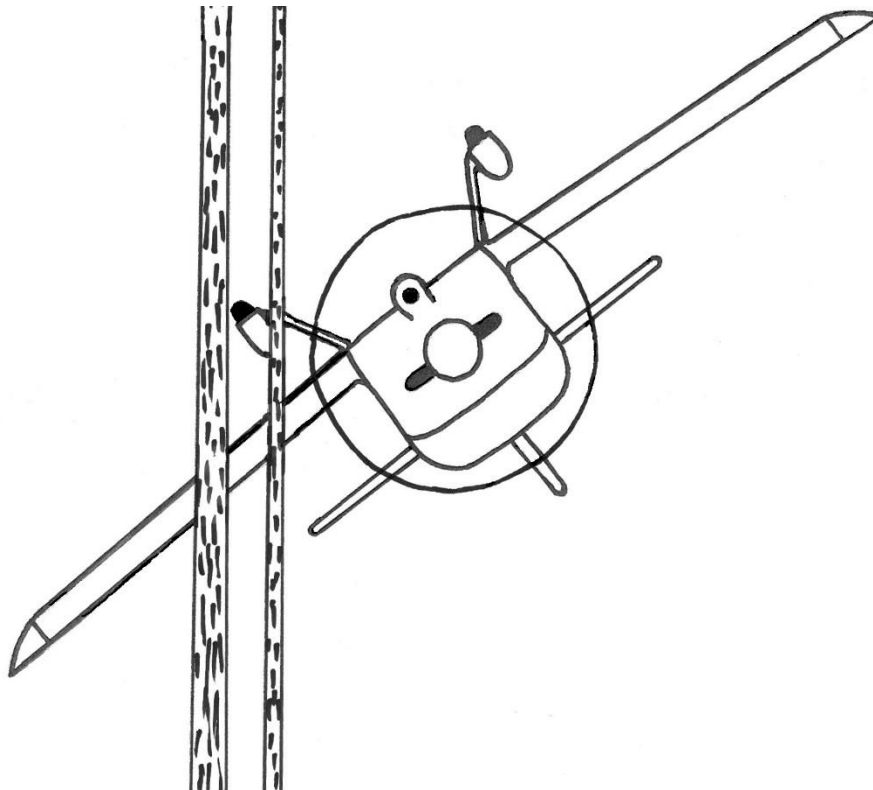
2.2.1 Measurements at the accident site indicate that the aircraft passed between two trees located 4 meters apart. In order for a 7-metre wingspan aircraft to pass the two trees without hitting the trunks, it must have flown at an angle (roll) of minimum 55° relative to the longitudinal axis. The damage pattern after the impact, when the aircraft struck two other trees at 9 meters, shows that the left wing must have been lower than the right wing. Furthermore, the damage pattern indicates that the aircraft had rotated another 20° towards inverted, striking the two trees at an angle of about 35° . This corresponds to a roll movement of 145° to the left. The AIBN believes that the aircraft hit the two trees as described in Figure 21 before coming to a halt and plunging into the stream.

Figure 21: How the AIBN believes the LN-AAL hit the two trees. The aircraft seen from the front. Sketch: AIBN
