REPORT

SL 2020/14

REPORT ON THE AIR ACCIDENT AT OSLO AIRPORT GARDERMOEN, NORWAY ON 18 DECEMBER 2018 WITH BOEING 787-9 DREAMLINER, ET-AUP OPERATED BY ETHIOPIAN AIRLINES

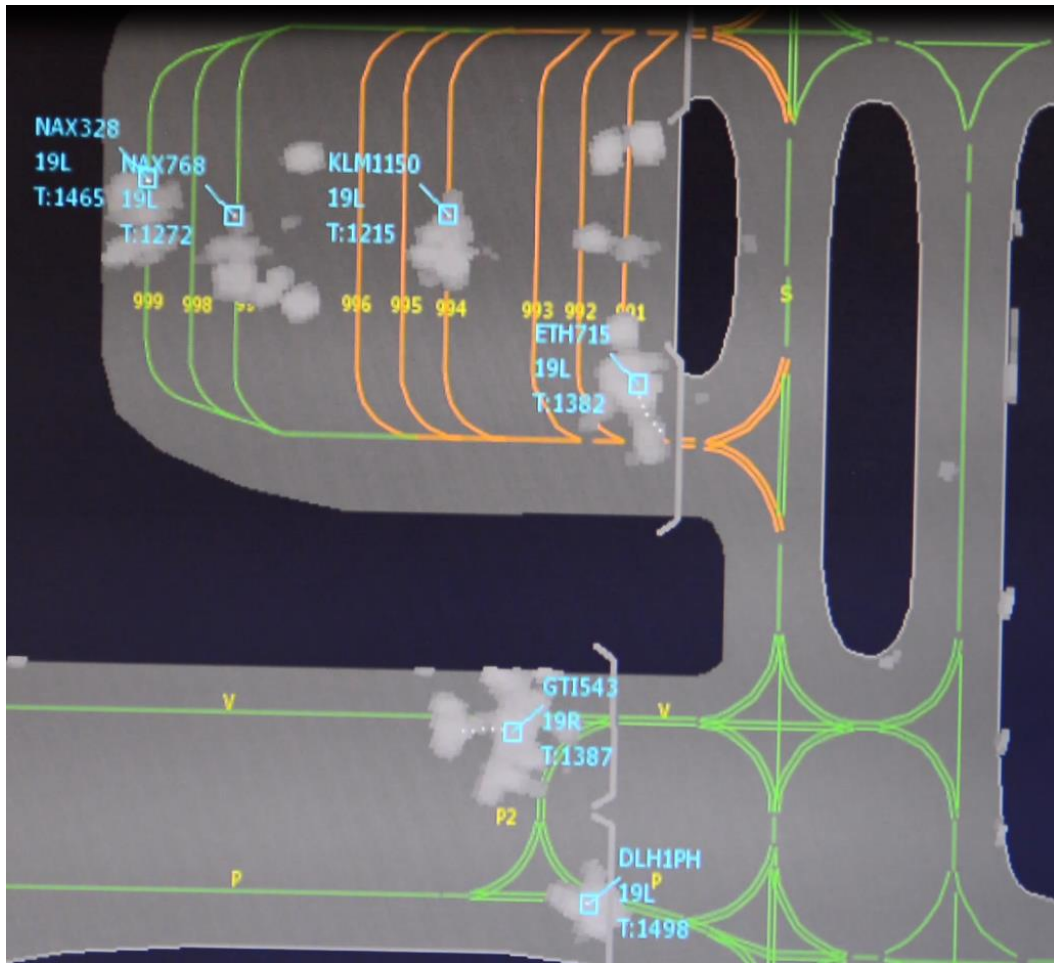
Figure 1: Ground radar screen shot of ETH715 as the aircraft is about to taxi into de-icing stand 991. Three other aircraft were at the “Bravo North” de-icing platform at the time (two aircraft belonging to Norwegian and one to KLM). In addition, the de-icing coordinators have information about the type of aircraft. Source: Avinor. Photo: AIBN

- 1.1.15 Before ETH715 was assigned de-icing stand 991, two old SGH de-icing vehicles (No. 11 and 12) were parked at the front edge of de-icing stand 991 (see Figure 1). There was an operator in each of the vehicles. As opposed to the more modern de-icing vehicles, the old de-icing vehicles were not equipped with a VHF radio. This meant that the two operators could not communicate directly with the ETH715 crew.

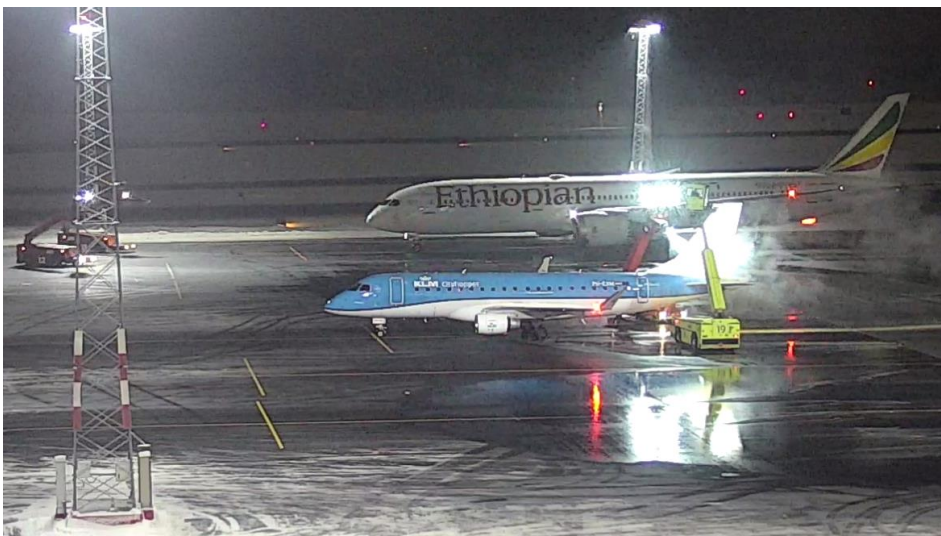
Figure 3: Position at 19:10:05 hours when ET-AUP collided with the light mast. Source: Avinor

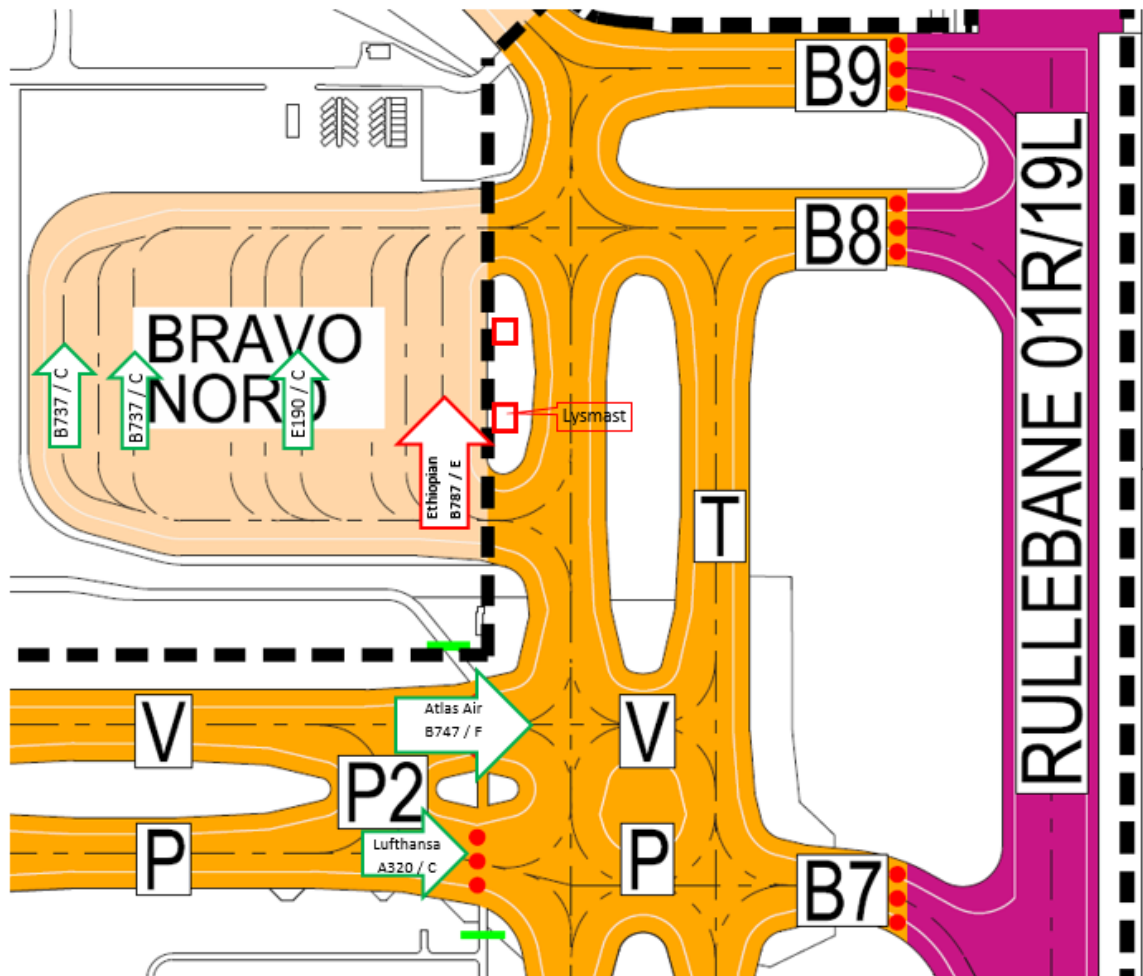
Figure 4: The de-icing platform “Bravo North”. The position of the aircraft at the time of collision, according to the ground radar. Source: Avinor. Illustration: AIBN

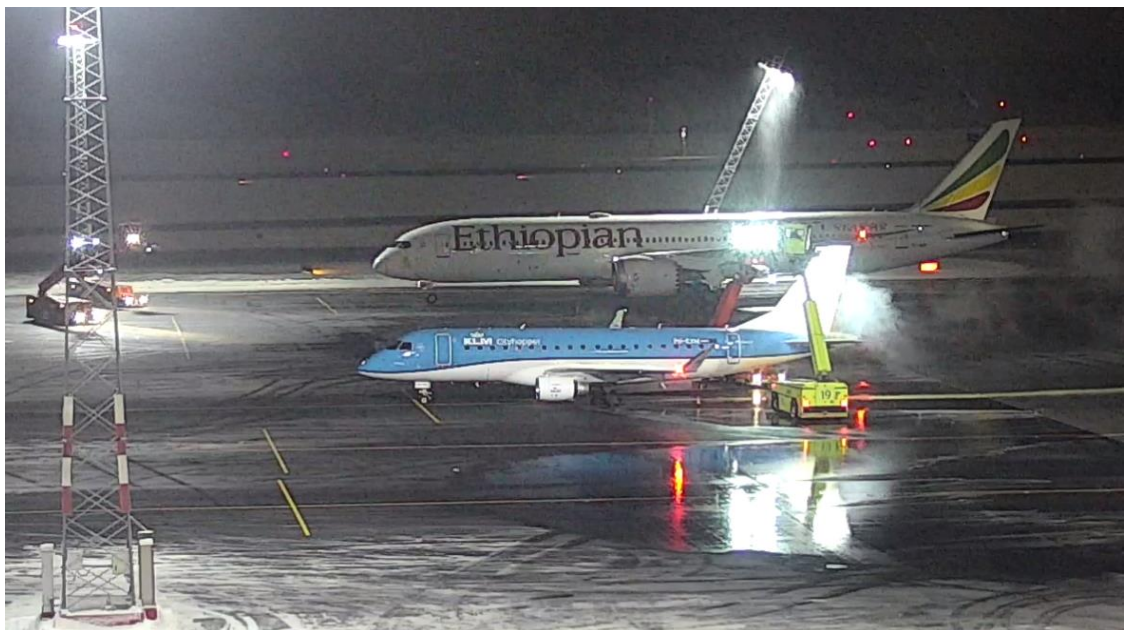
Figure 5: Position at 19:10:09 hours when ET-AUP had stopped approx. four meters after the collision. Source: Avinor

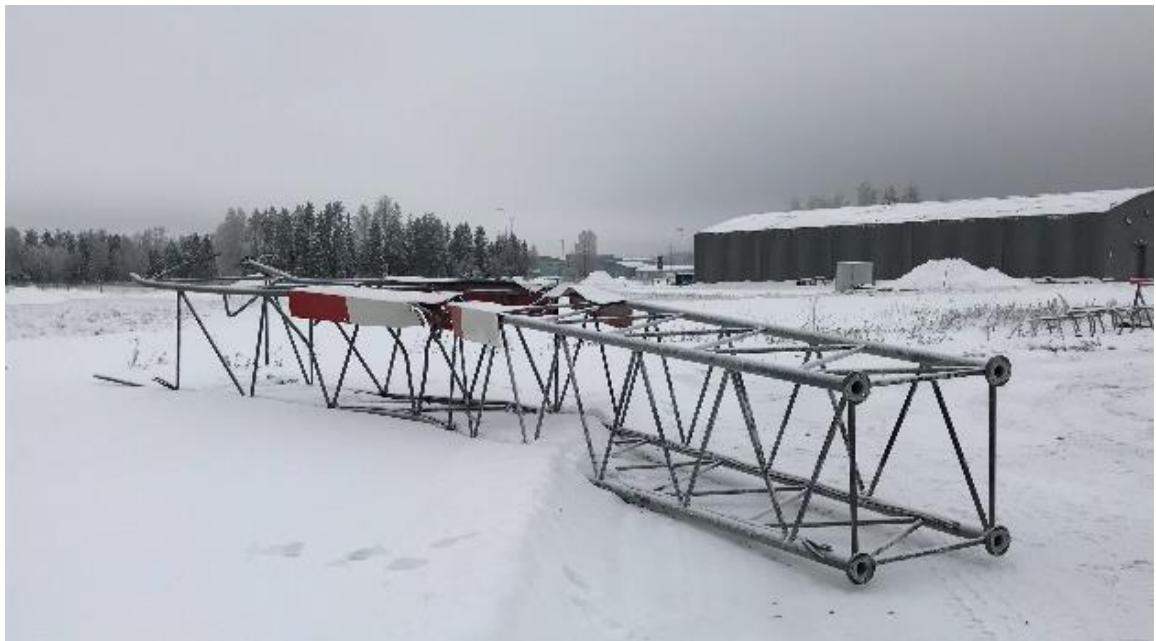
The light mast was significantly damaged and had to be replaced with a new one (see Figure 6).

Figure 6: Damage to the light mast (after dismantling). Photo: AIBN

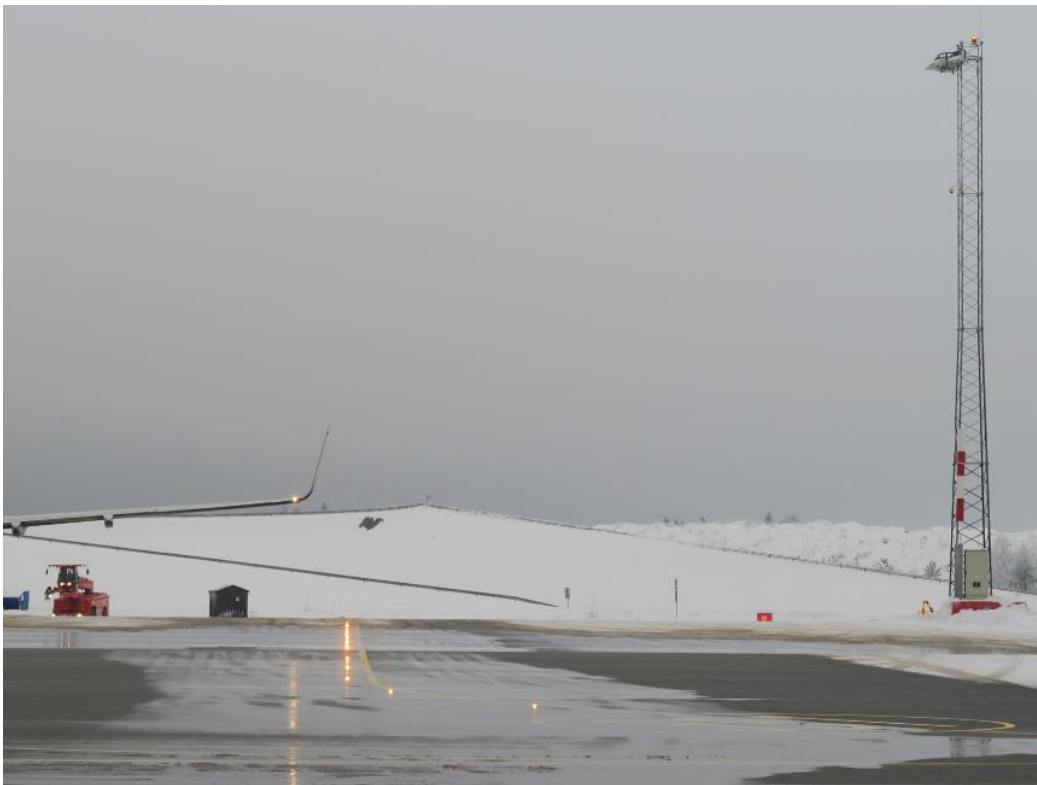
- 1.12.1.1 The Gardermoen de-icing platforms have lights in the tarmac along the guide lines leading to all de-icing stands (see Figure 9). From the establishment of Gardermoen as the main airport in 1998 and until 2019, it has been possible to activate individual lights for each guide line. Due to the design of the control panel, it proved impractical to activate individual rows of light.

Figure 9: Shows the center line lights in the tarmac leading up to de-icing stand 991. The photo was taken the day after the accident. Photo: AIBN

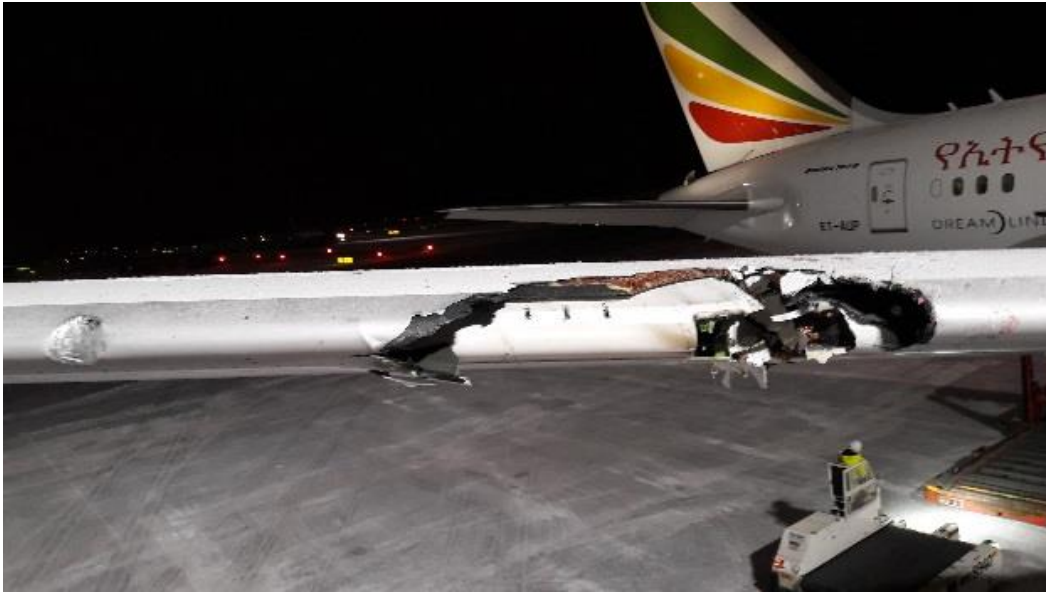
- 1.12.2.1 The ET-AUP suffered substantial damage to its right wing (see Figure 10). The point of impact was at the front of the surge tank (see Figure 11). The surge tank was not punctured (see Figure 12).

Figure 10: Damage to the right wing. Photo: Ethiopian aeronautical engineer

- 1.12.2.2 Ethiopian Airlines requested an inspection and repair report from Boeing. Extensive repairs of ET-AUP were necessary. The aircraft remained at Gardermoen for about one month before it was airworthy again.

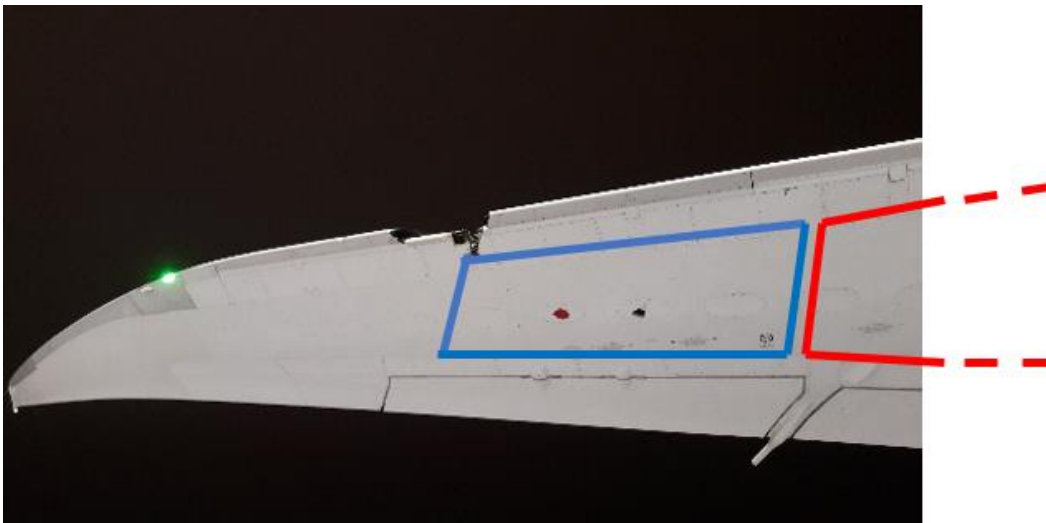
Figure 11: Position of the damage on the right wing. Blue marking: Indicates the position of the surge tank. Red indication: Indicates the position of the wing tank. Photo and illustration: AIBN

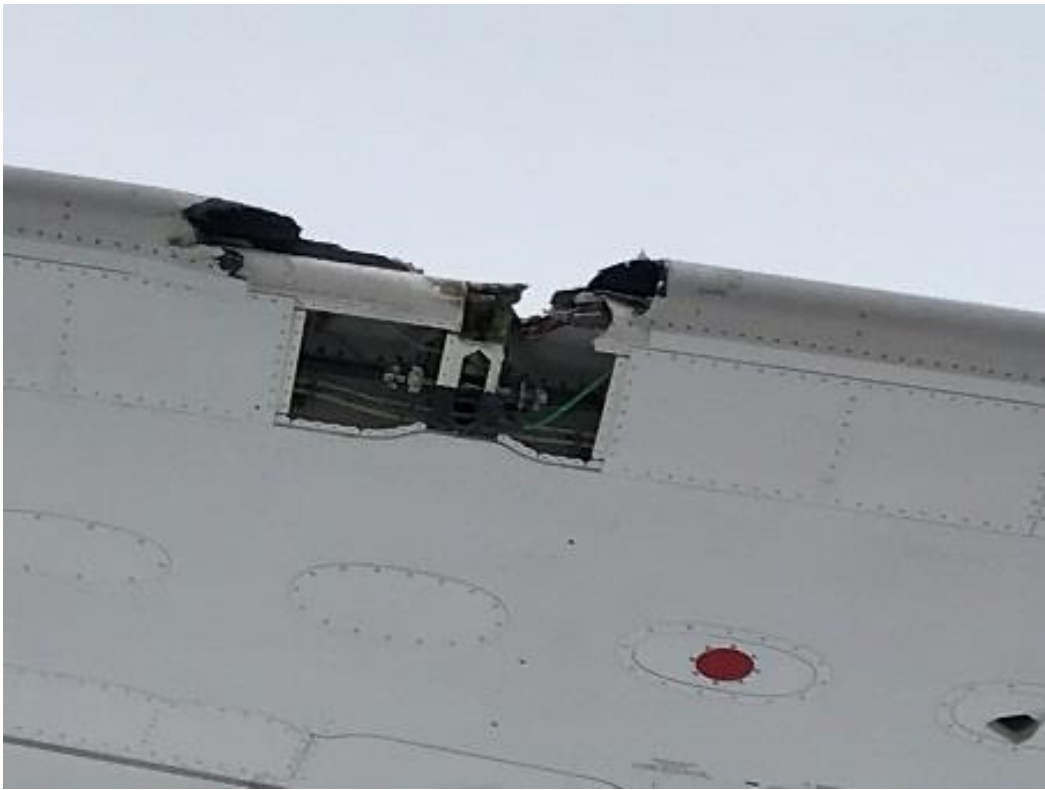
Figure 12: The damage. The surge tank can be seen in the background. Photo: AIBN

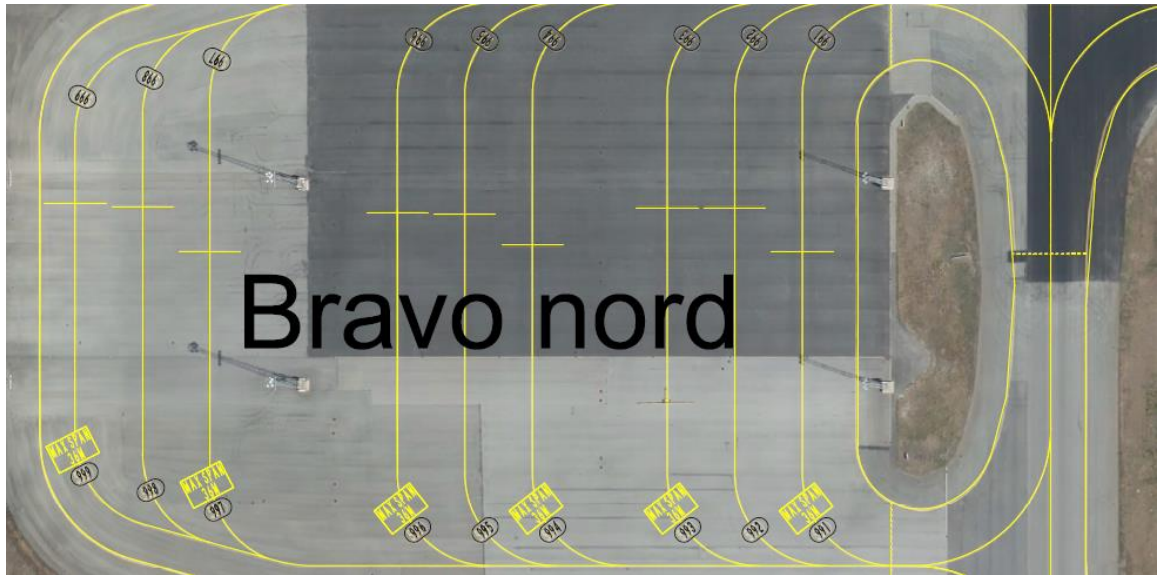
Figure 16: Markings installed in the autumn of 2019 indicating maximum wingspan for a de-icing stand with limitations. Corresponding markings at the other two de-icing platforms. Source: Avinor Oslo Airport

Avinor Oslo Airport had previously granted an exemption for “Alfa South” allowing aircraft with a wingspan of up to 60 meters to use de-icing stand 987. This has now been restricted to 52 meters.
