# REPORT

SL 2020/16

## *REPORT ON SERIOUS AVIATION INCIDENT WEST OF FØRDE AIRPORT BRINGELAND ON 14 NOVEMBER 2016 INVOLVING ATR 72-212A, OY-JZC, OPERATED BY JET TIME AS*

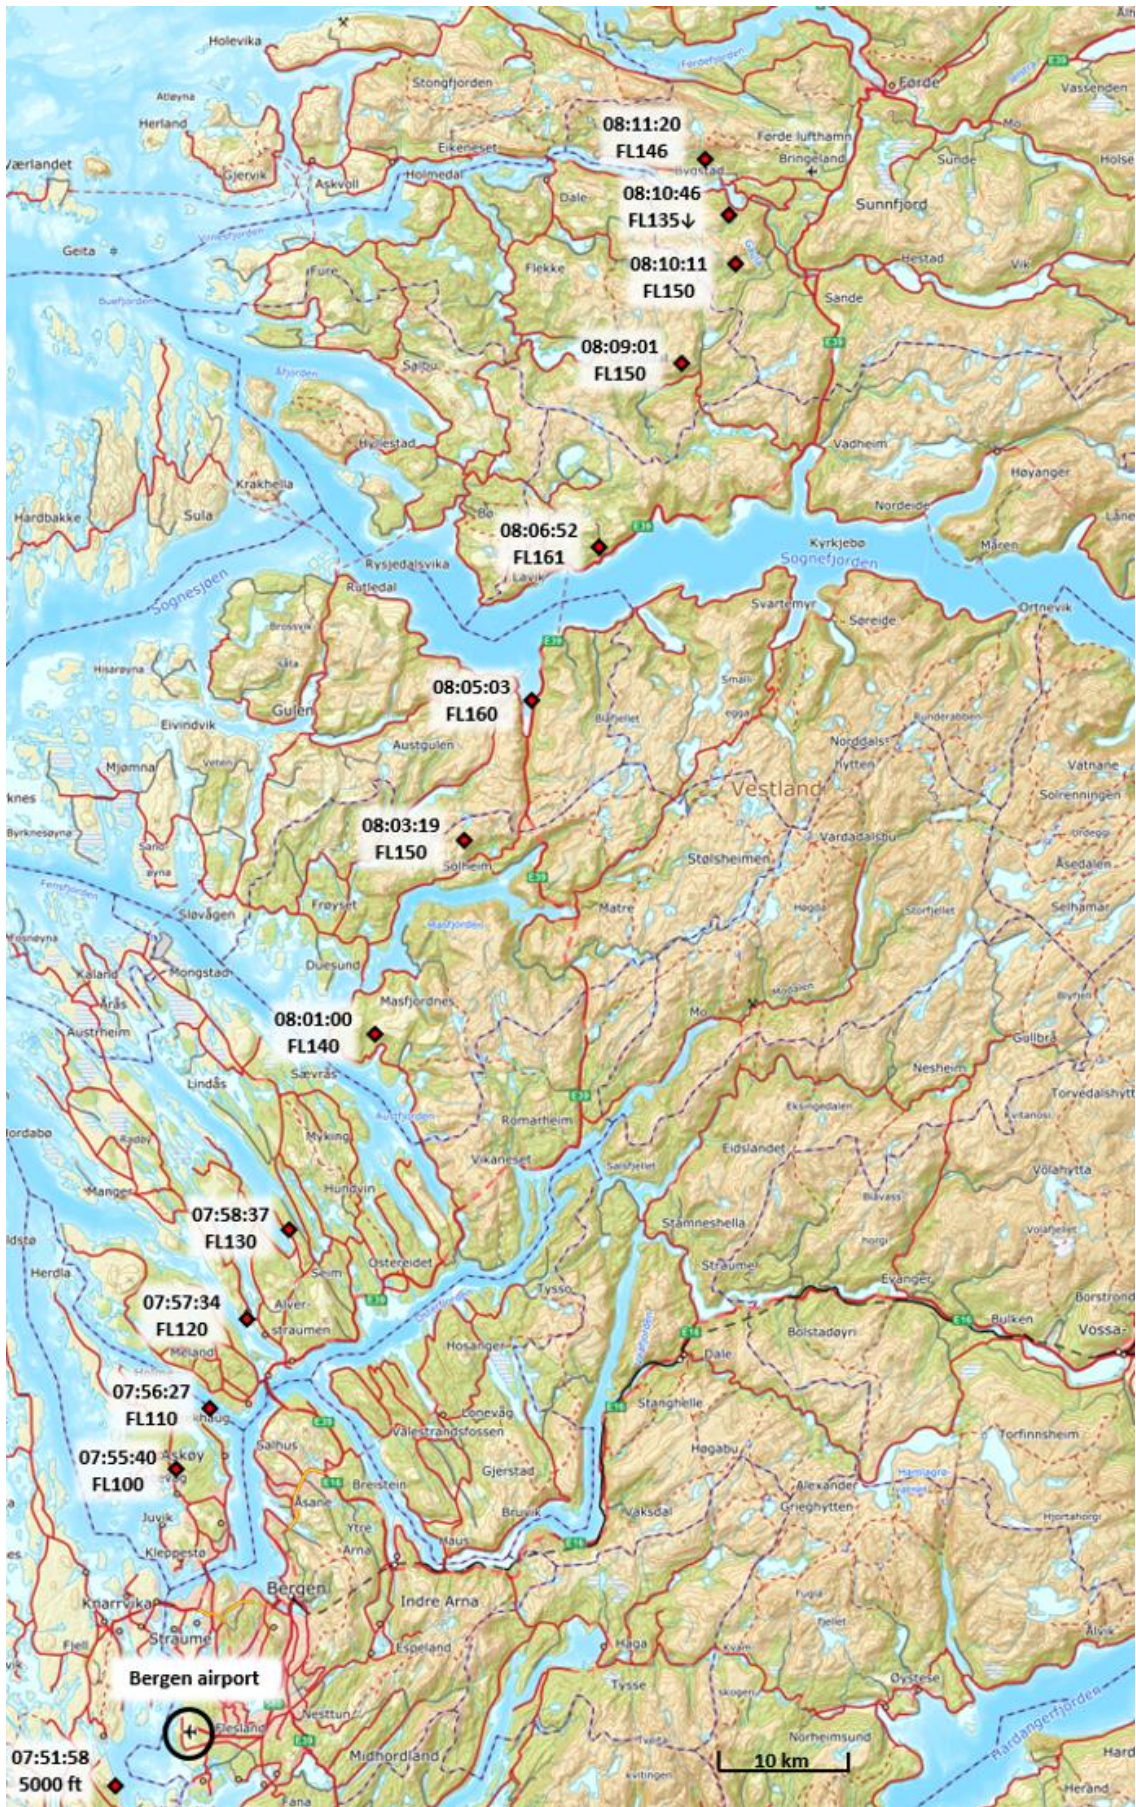
Figure 1: The map plot showing SAS4144's flight levels (FL) and positions at given times. The plot is based on radar data from Avinor. Illustration: AIBN

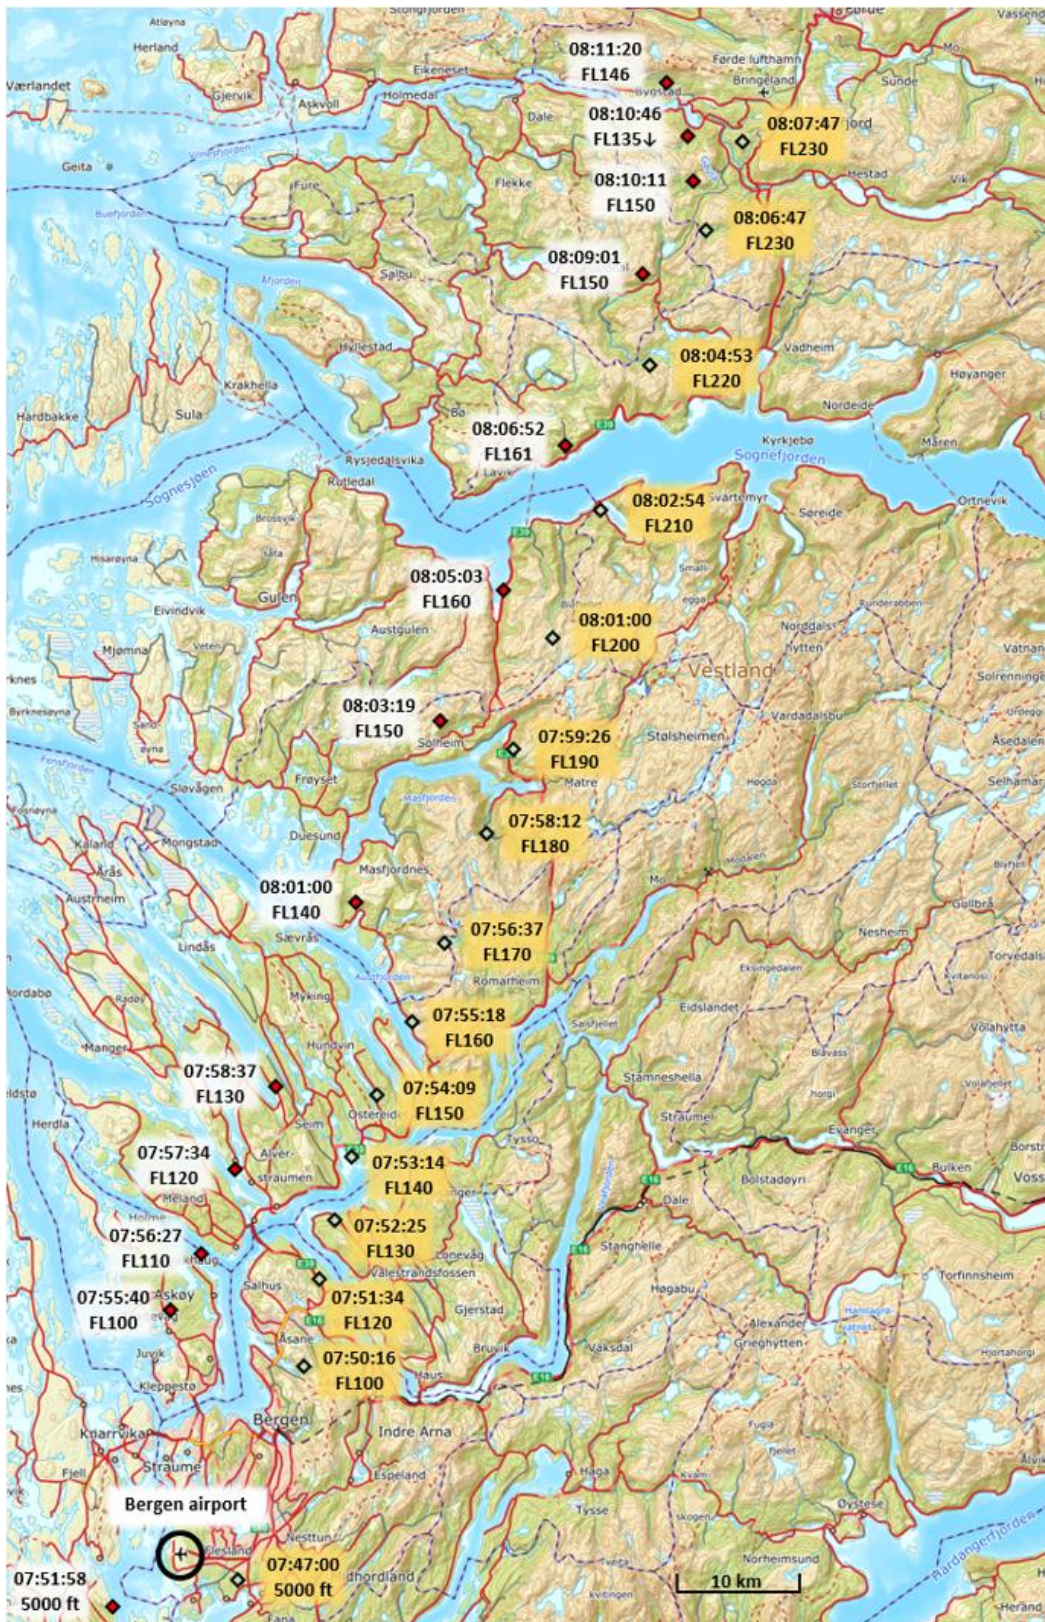
Figure 11: Comparison of the SAS4144 track (red dots and white text boxes) and WIF564 (yellow dots and text boxes) after departure from Bergen Airport Flesland. Illustration based on radar data from Avinor. Illustration: AIBN

1.18.4.2 After climbing for about 25 minutes, WIF564 was established at its cruise altitude FL230. The commander of WIF564 has stated that "icing was not of a particularly noticeable nature" and that the flight took place at the planned flight level (FL).

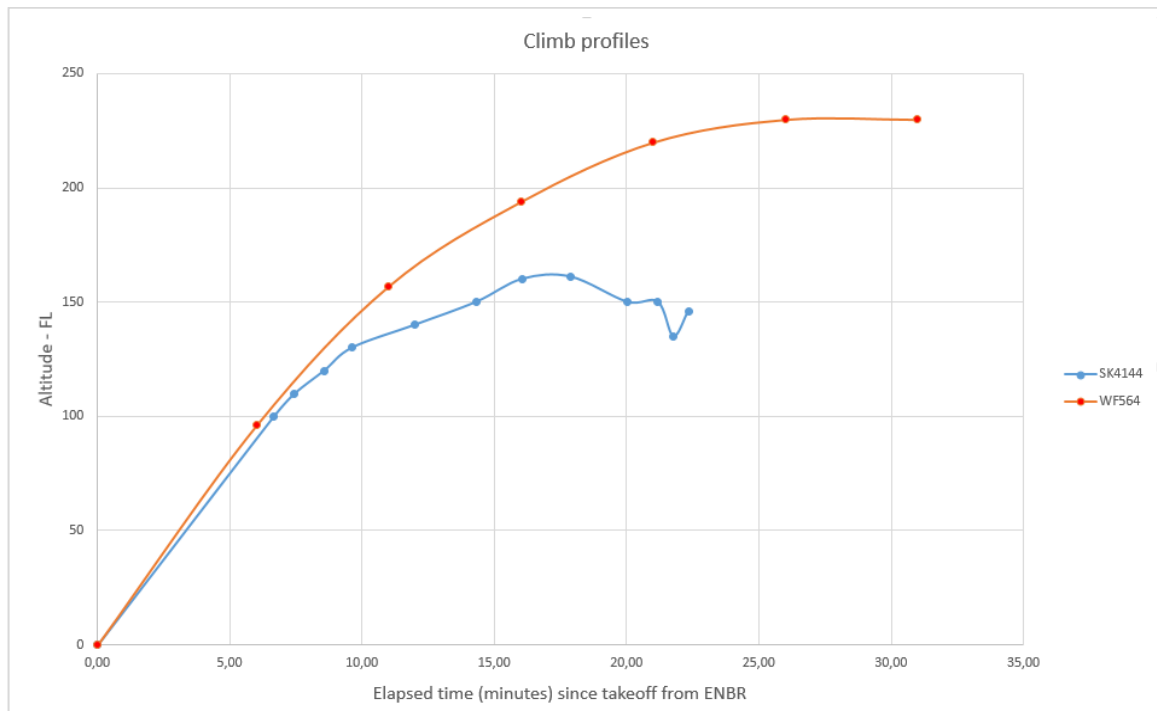
Figure 12: Comparison of SAS4144 and WIF564 climb profiles during the climb after take-off from Flesland. Note that WIF564 took off five minutes before SAS4144 and followed a slightly more easterly track than SAS4144. Illustration: AIBN

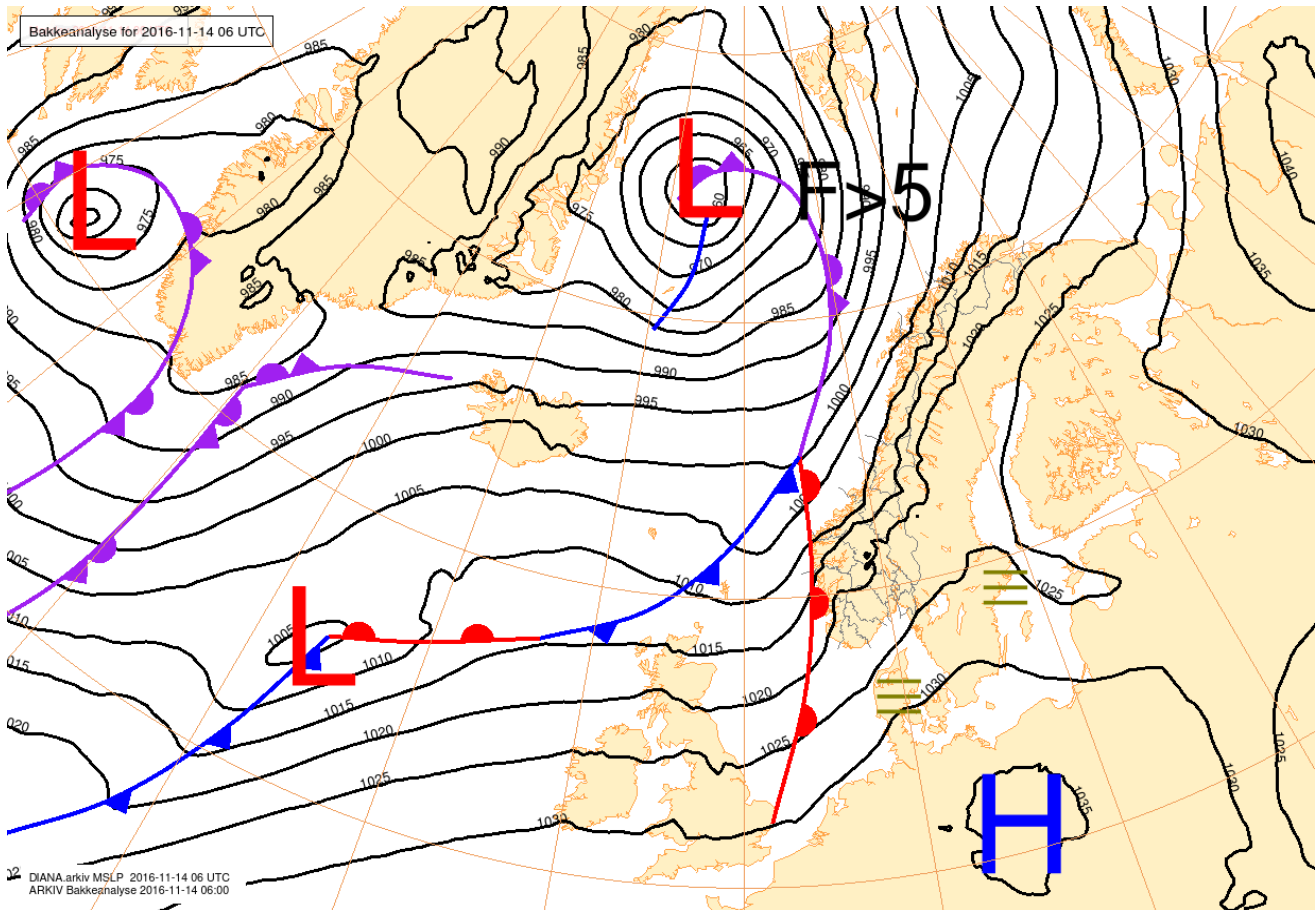
Analyse kl 0600 UTC 14. november. Varmfront langs kysten av Vestlandet.

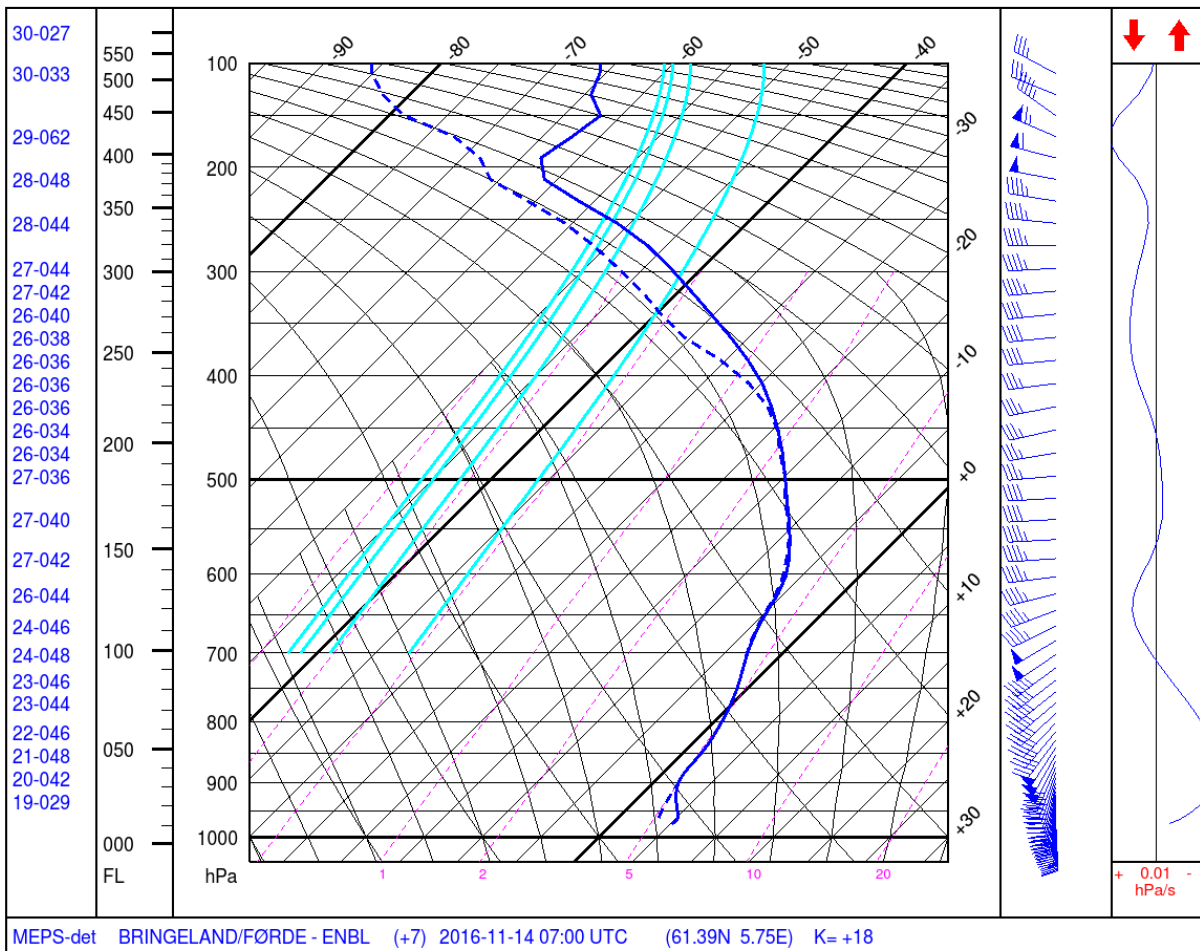
Figuren over viser temperaturprofil over ENBL kl 0700 utc. Temperatur er hel linje, duggpunktstemperatur er stiplet. Sørvest vind i høyden og fuktig luft (temperatur og duggpunkt er like) viser at der er venta ising mellom ca FL080 til FL200.

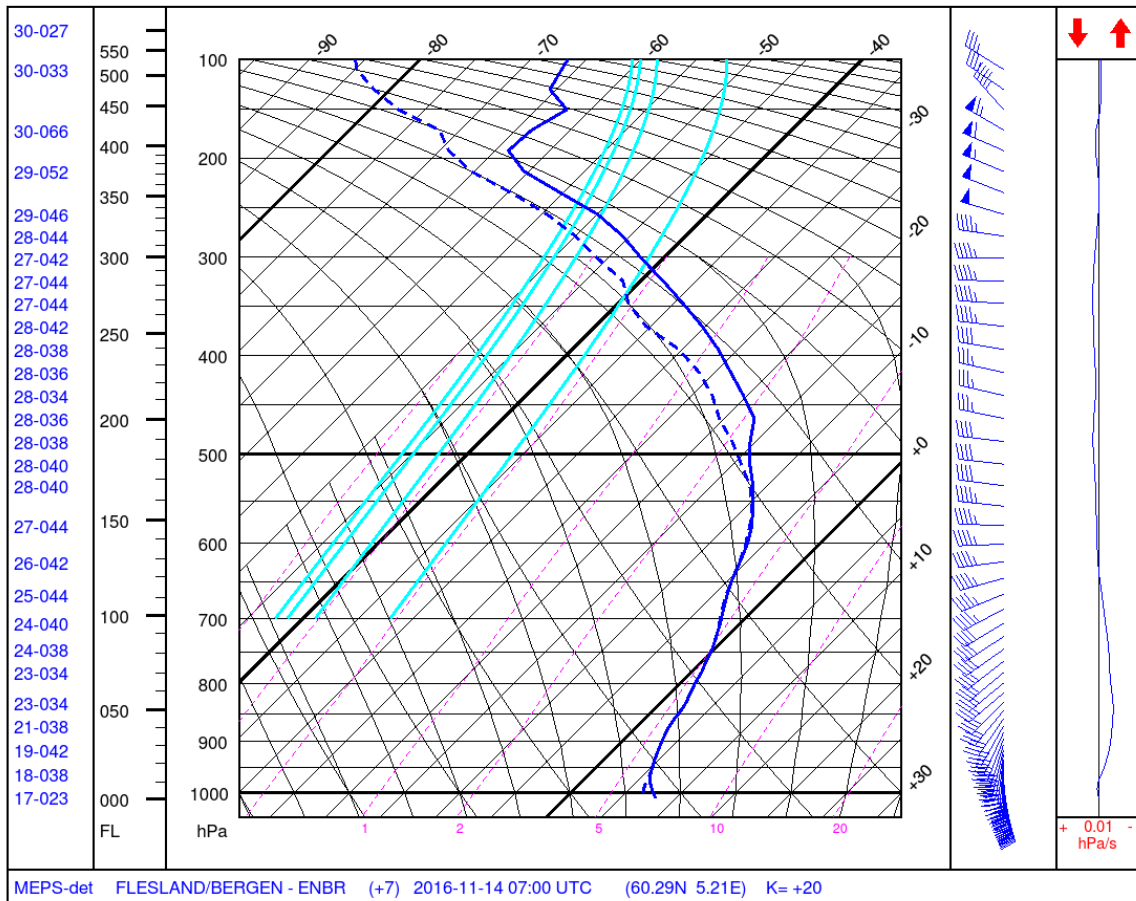
Figuren over viser temperaturprofil over ENBR kl 0700 utc. Ganske lik profilet fra ENBL, men det er litt svakere vind og isingen går ikke like høyt.

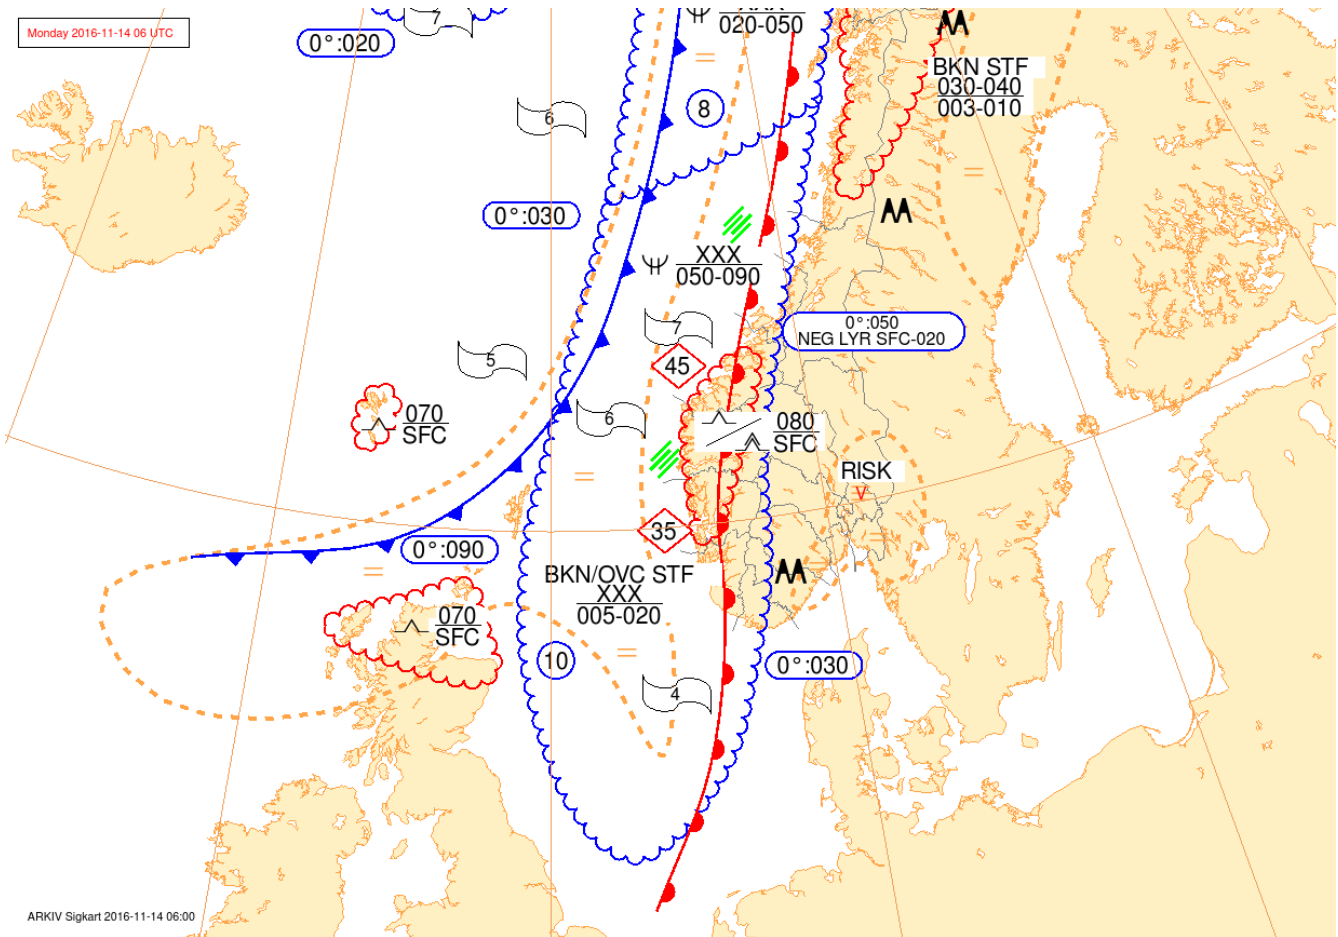
SIGWX-kart gjeldene 0600 utc 14. november. Det viser at det var vente moderat ising og lokalt kraftig turbulens på strekningen ENBR-ENBL.
