REPORT

SL 2020/17

REPORT CONCERNING AIR ACCIDENT ON STAVNES, KRAGERØ, NORWAY ON 23 MARCH 2019 INVOLVING A ROBINSON HELICOPTER R44, LN-OGF

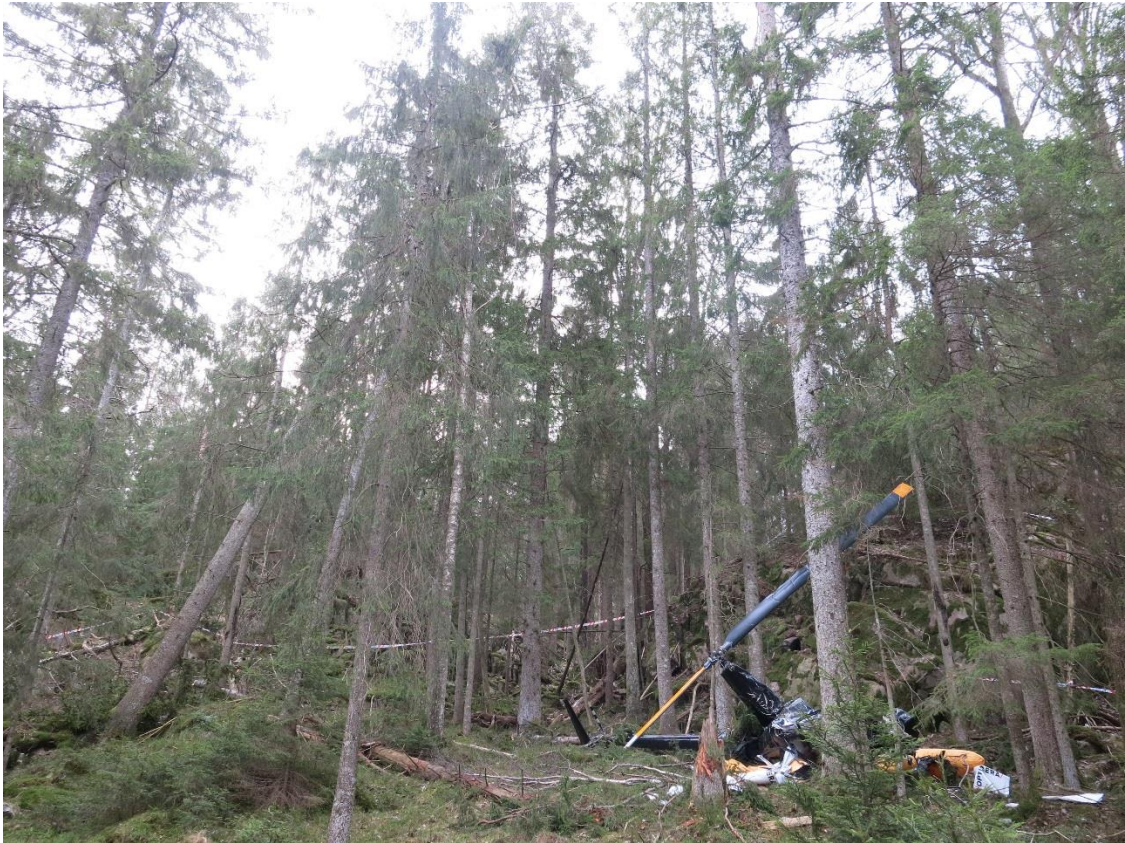
1.12.1.2 No tree trunks or branches showing clear signs of having been cut by the rotor were observed near the accident site. An approximately 30-meter tall fir tree approx. 15 meters south of the accident site was leaning sideways as a result of an impact (see Figure 2). The top of the tree and another two-meter piece of trunk from the same tree, were lying on the ground between the tree and the helicopter wreckage.

Figure 2: The accident site seen toward the southwest. The 30-meter tree that was knocked sideways is shown to the left in the picture. Photo: NSIA

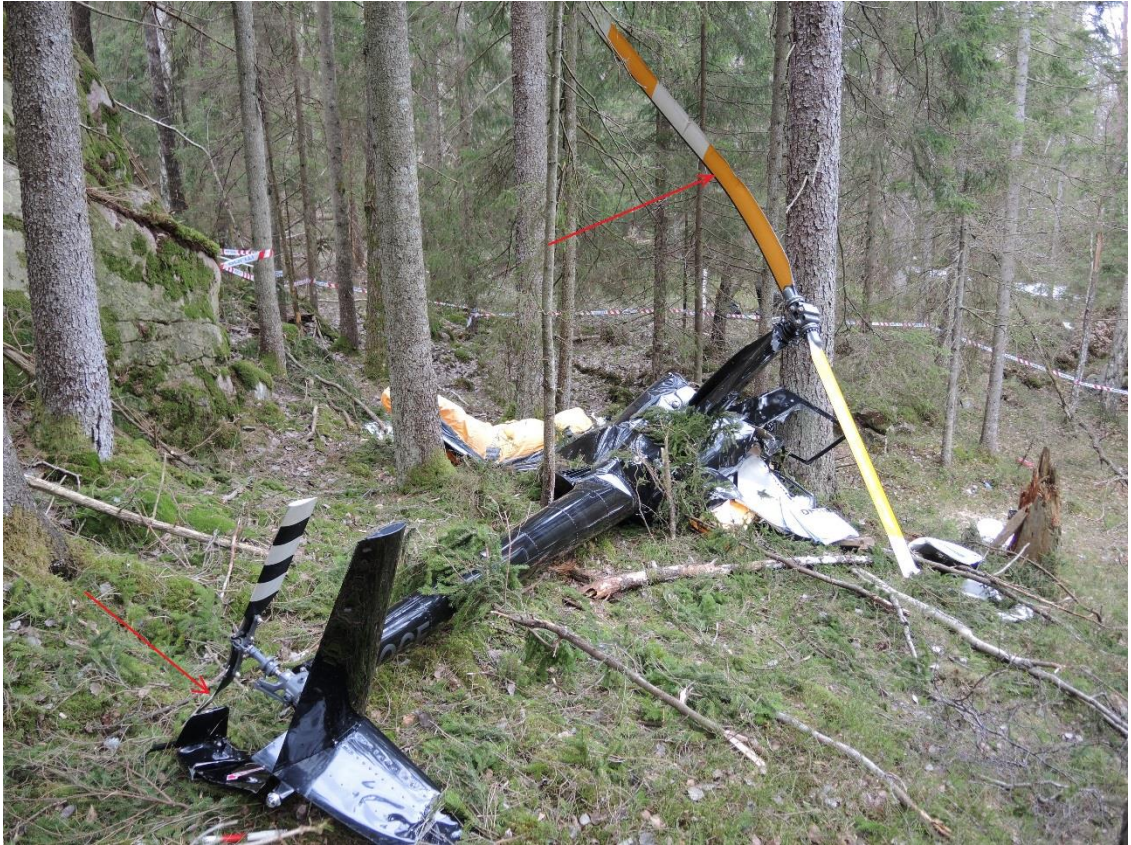
1.12.2.3 Both of the main rotor blades were bent and pointing upward. The pitch link to the intact blade had snapped allowing the blade to turn so that the trailing edge was pointing straight up. (see Figure 3). The broken blade showed clear signs of having been bent

- 1.12.2.4 Except for a bend in one of the two rotor blades, there was no apparent damage to the tail rotor (see Figure 3).
- 1.12.2.5 LN-OGF was equipped with inflatable floats for emergency landing at sea. These had inflated during the crash.

Figure 3: The accident site seen toward the northwest. The red arrows show a crack in one of the tail rotor blades and the bend in one of the main rotor blades. Photo: NSIA

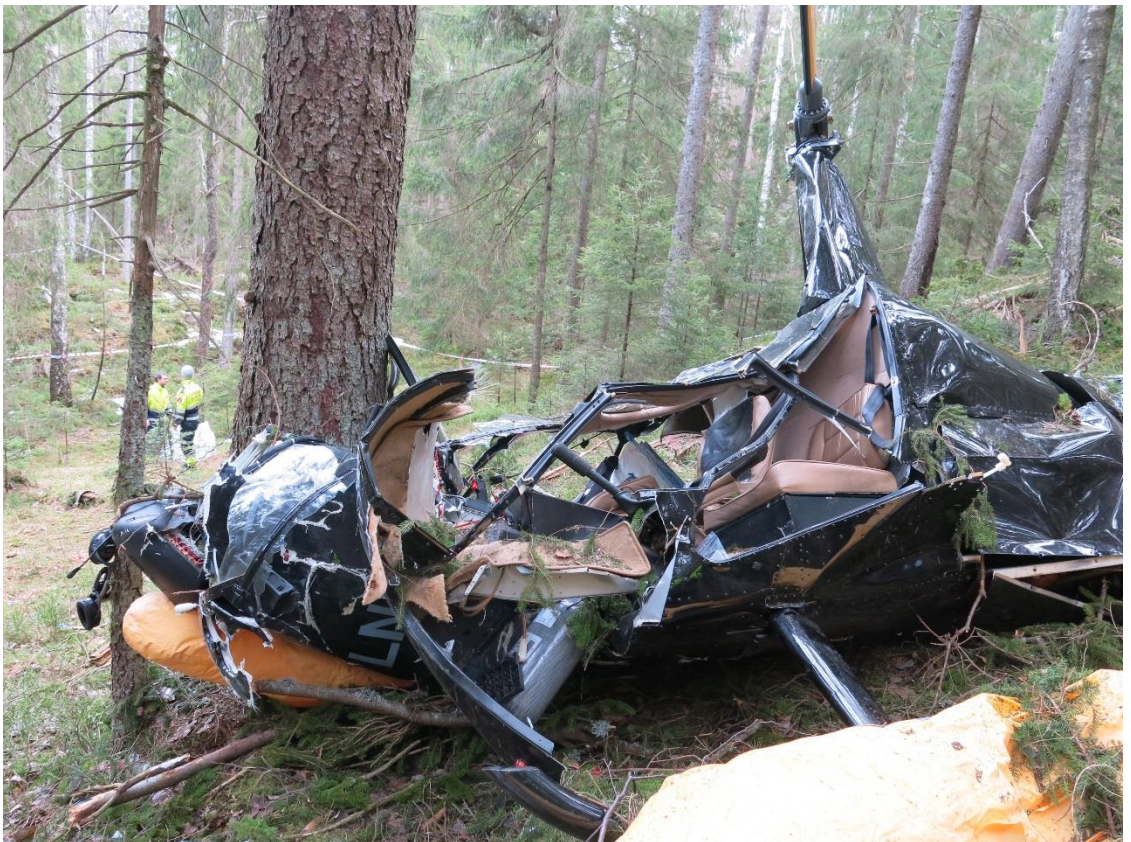
Figure 4: Damage to the cockpit/cabin. Photo: NSIA

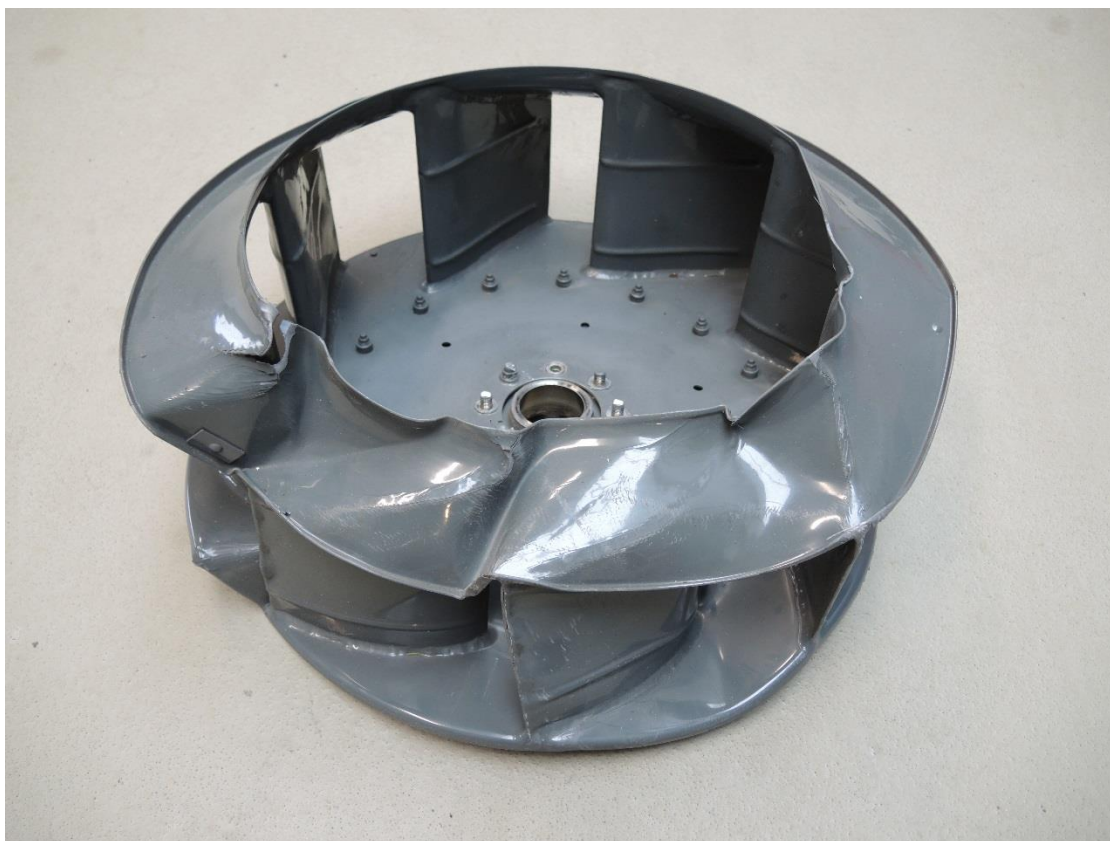
1.16.2.1 All components related to the main rotor and the tail rotor drive line were examined in detail. Initially, it was concluded that no components, neither in the drive line nor in the engine, showed any signs of having rotated when the helicopter crashed. For example, the underside of the cooling fan was flattened and had struck other parts during the crash. However, none of these damages showed any traces of rotation (see Figure 5).

Figure 5: The underside of the engine's cooling fan was flattened. There was no visible sign that it had been rotating when it was damaged. Photo: NSIA

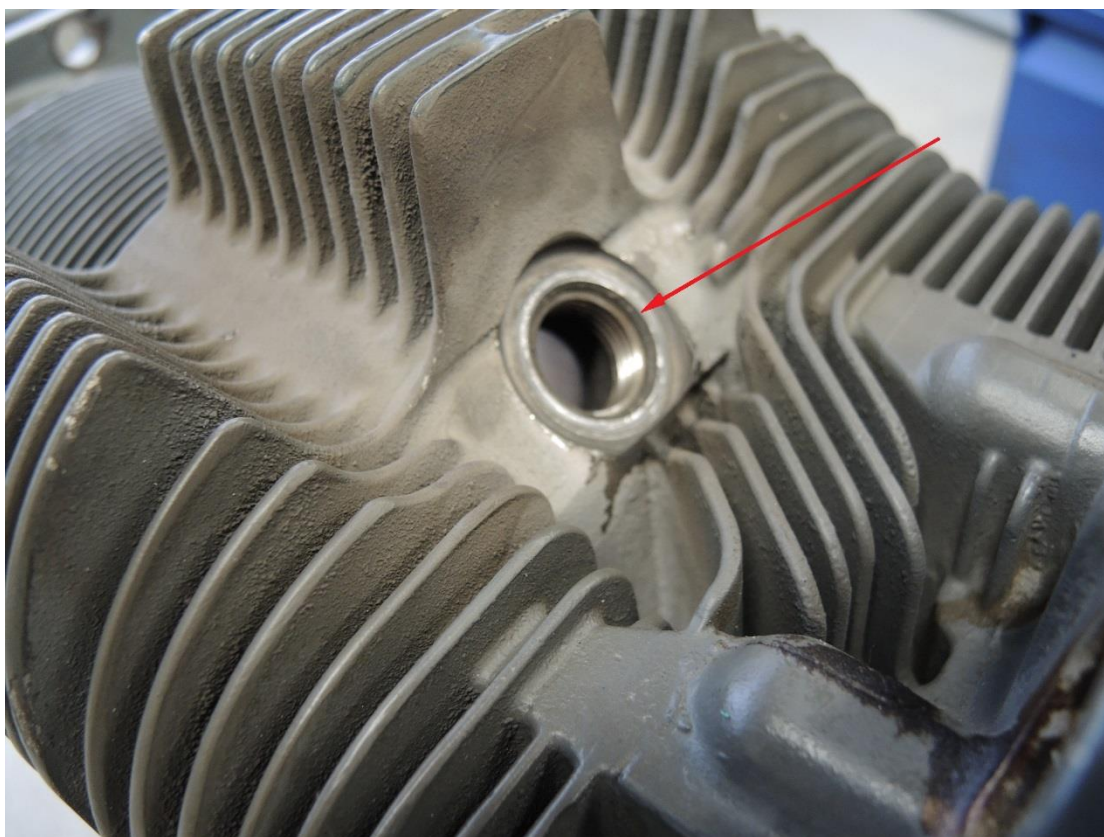
- 1.16.3.3 There were clear signs of an exhaust leakage (see Figure 7) around the loose spark plug and a new leak test was performed with the spark plug properly tightened. The new test gave only a negligibly improved result of 20 psi. When checking the other spark plugs on the engine's left side, it was found that the spark plug nuts on cylinders 1 and 3 were loose. It was also established that the lower rear (right) cylinder nut (9/16") attaching cylinder no. 5 to the crankcase, was loose. The torque of the other seven nuts was as intended.

Figure 7: Cylinder no. 5 after it was removed. The arrow points to the upper spark plug hole surrounded by exhaust leakage. Photo: NSIA

- 2.3.2 Soot in the area around the spark plug indicates a leakage past the spark plug. Over time, such a leakage and a resulting high temperature, can damage the valves and the valve seats. Findings during this investigation indicate that such damage has caused a significant leakage past the intake valve. A leakage past the intake valve will have a negative effect on the engine in a number of ways:

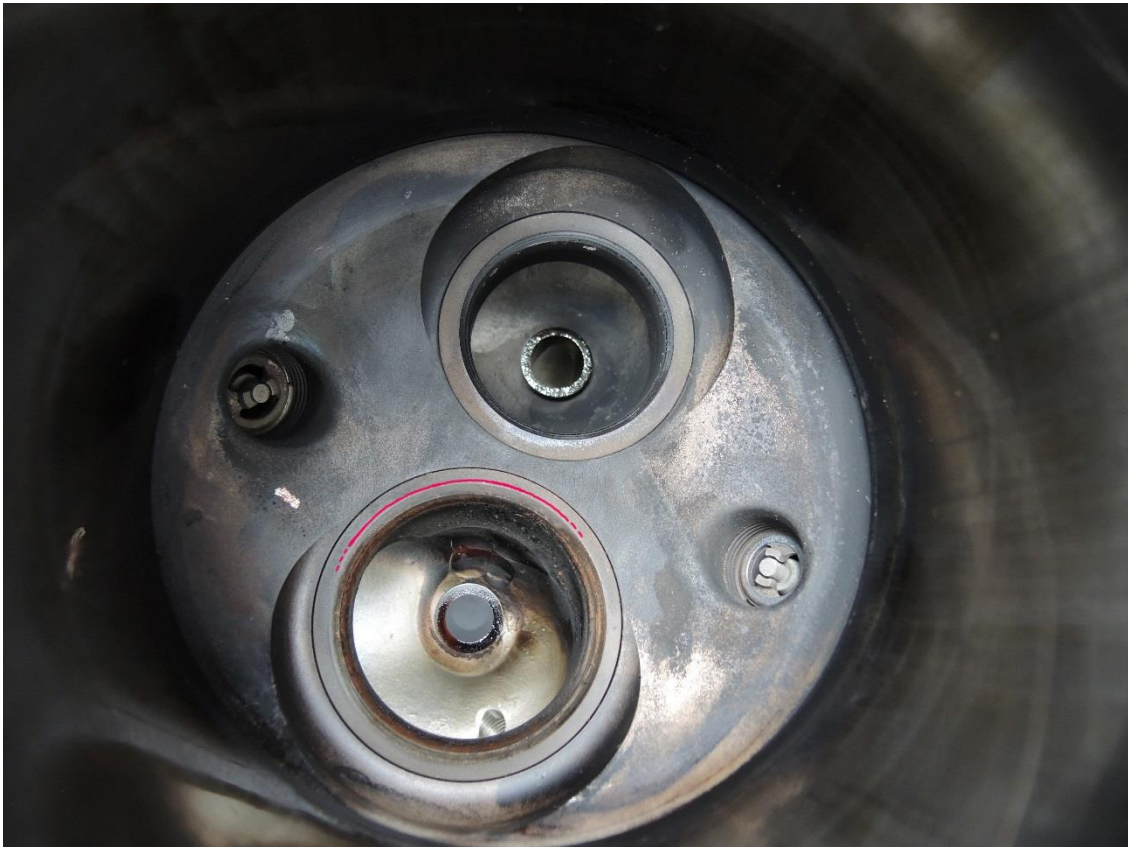
- 1.16.3.5 The valves in cylinder no. 5 were removed. The following was observed:
- The exhaust valve had uneven "steps" on the valve head face. (see Figure 9). Otherwise, the valve had kept its geometrical shape. Similar damage was discovered on the exhaust valve seat. The valve was light brown in places with some green patches. Such green patches indicate that the valve has been exposed to high temperatures.
 - There was only minor damage to the intake valve. The damage consisted in a step on about half the circumference on the valve head face and the surface was matt. However, the intake valve seat had a damaged surface on 60% of the area (see Figure

8). A closer inspection of the valve showed that the valve head had retained its geometrical shape, although the concentricity (run-out) was 0.3 mm.

Figure 8: Inside of cylinder no. 5 after the valves had been removed. The undamaged part of the intake valve seat is marked with a red line. The damaged part is darker/brown. Otherwise, it can be noted that the cylinder is clean and has a light color. Photo: NSIA

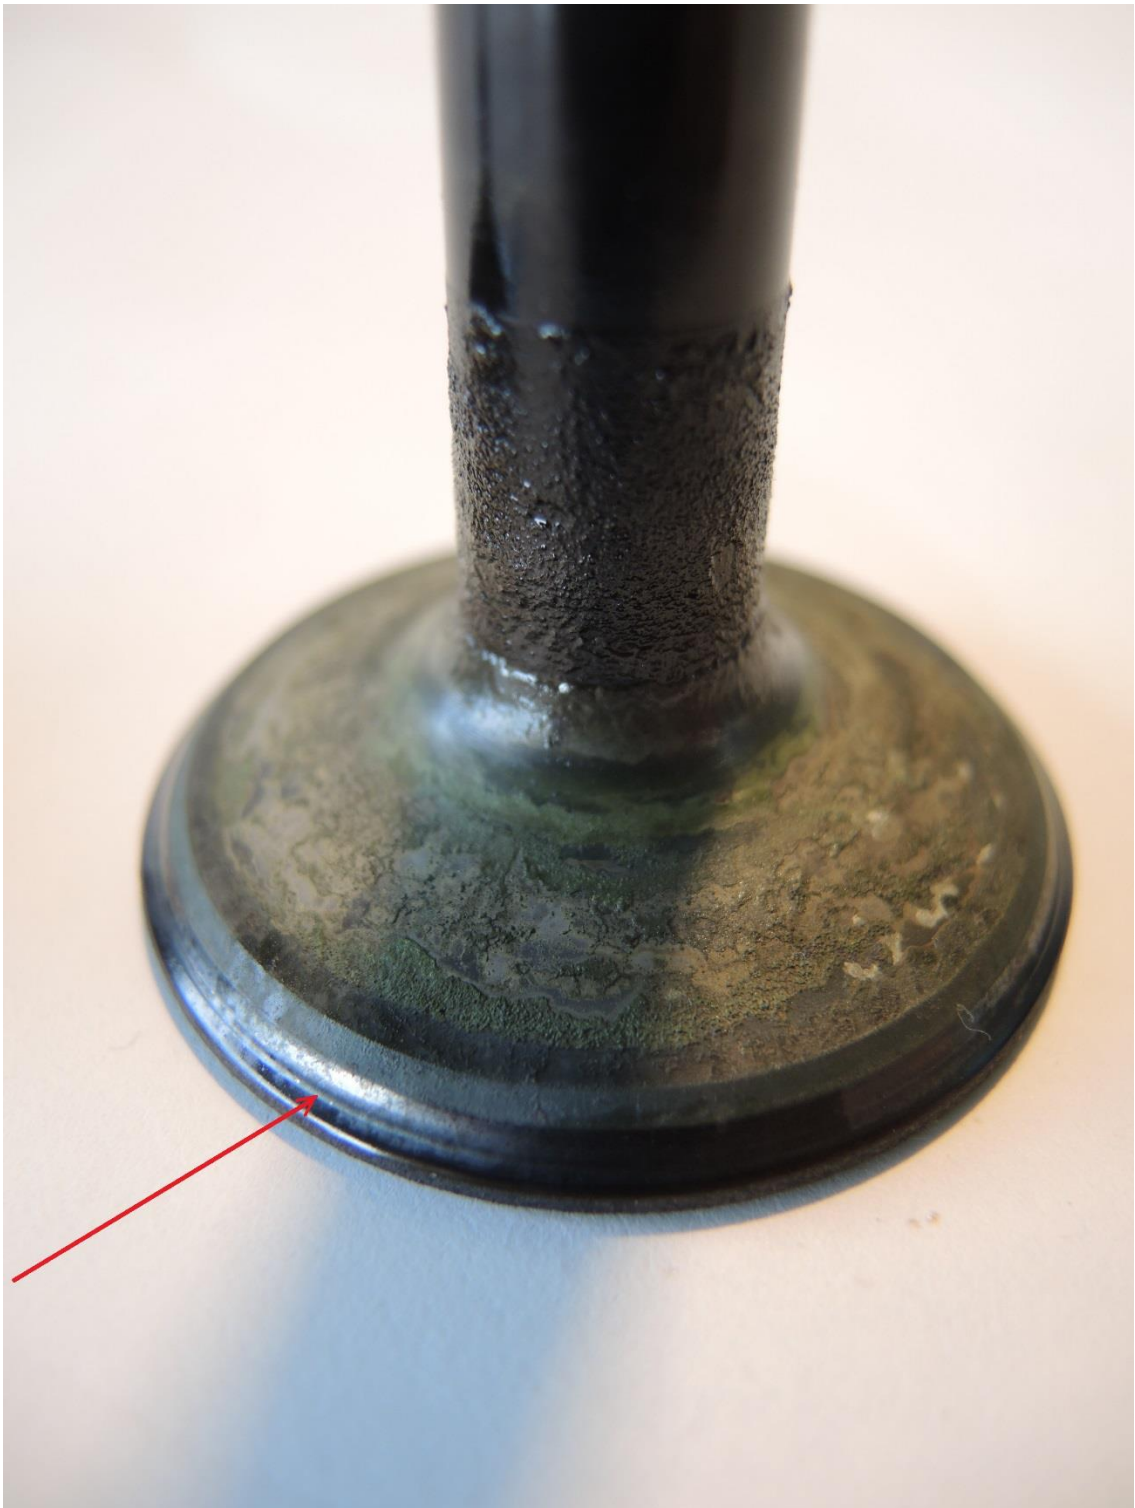
Figure 9: The exhaust valve from cylinder no. 5. The arrow points to the damage at the head face. The color of the valve is light brown with some green patches. Photo: NSIA

- 2.3.3 Consequently, the NSIA believes that, in isolation, the leakage past the spark plug had little effect on the engine power. The damage to the intake valves would have had the greatest impact on the engine. The green color on the exhaust valve indicates that the cylinder in a period must have been abnormally warm.
