# REPORT

Aviation 2021/03

## *REPORT ON AIR ACCIDENT ON NORDNESTJØNN, EAST OF ARENDAL AIRPORT GULLKNAPP ON 14 AUGUST 2019 INVOLVING PIPISTREL ALPHA ELECTRO, LN-ELA*

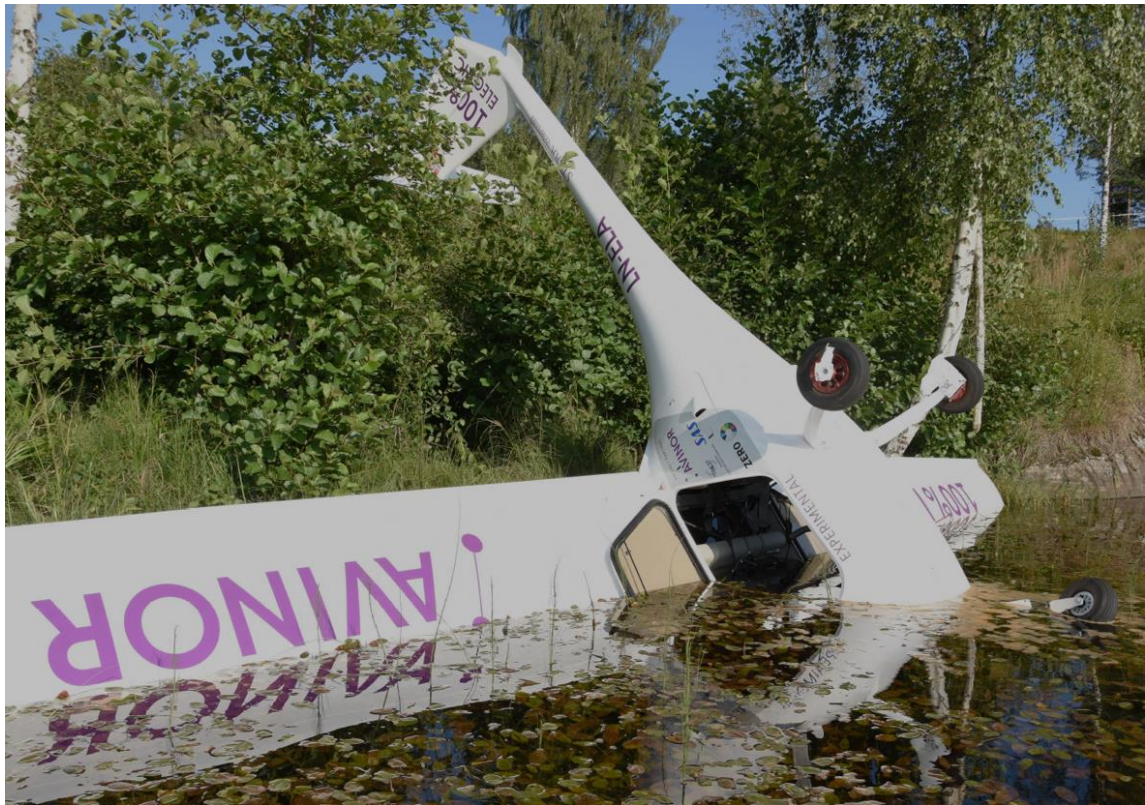
Figure 2: LN-ELA after the aircraft had been hauled partly onto the shore. Photo: Agder Police District

- 1.12.1.2 Figure 2 in section 1.1.9 shows how the aircraft was left by the lakeshore. It was possible to drive a tow truck all the way to the shore. The wings were removed before the fuselage was lifted out of the water. The aircraft was then placed on its own trailer and transported to the NSIA premises.

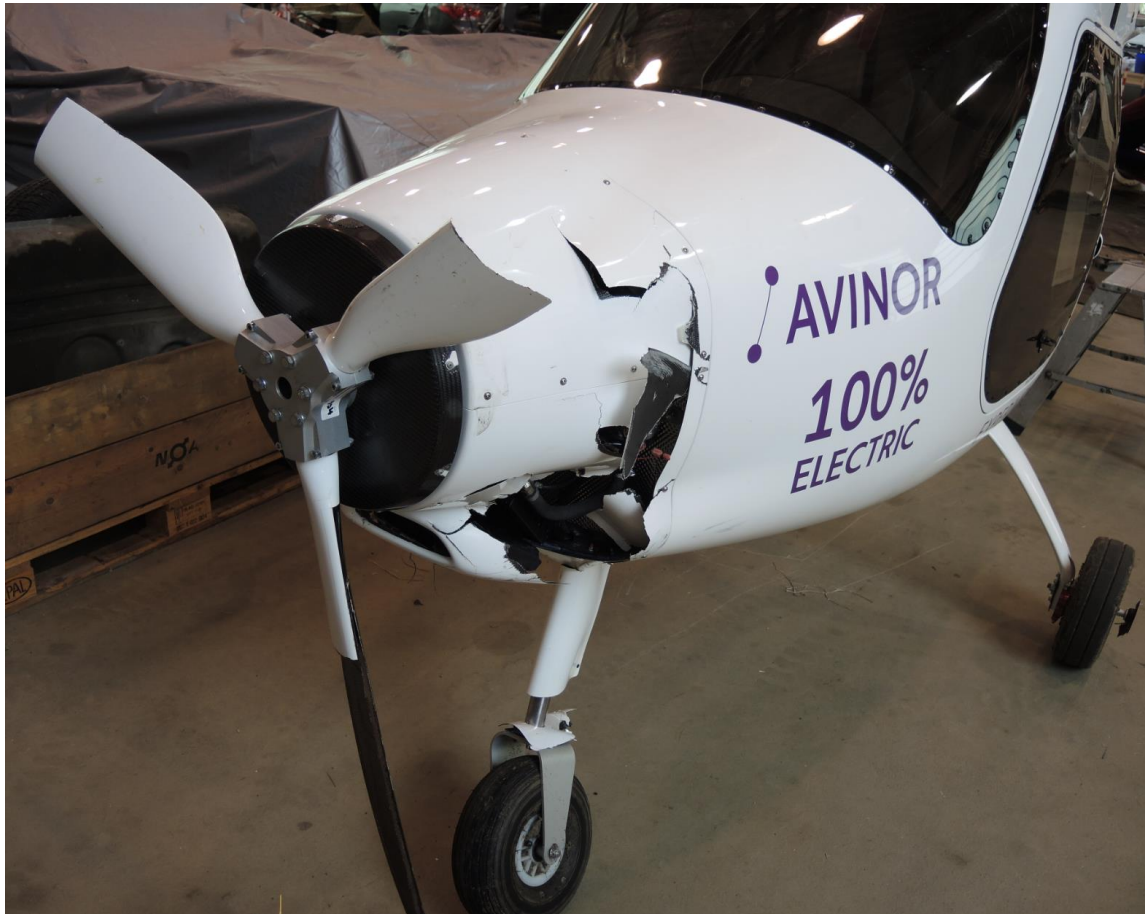
The aircraft was significantly damaged. For more details see section 1.12.2. There was also significant water damage to the instruments.

Figure 3: Photo of the fuselage, taken during the initial investigations in NSIA's hangar. Photo: NSIA

- 1.12.2.1 Except for substantial water damage, LN-ELA received relatively minor visible impact damage during the landing on the lake. The propeller and spinner were broken and there was damage to the top and lower part of the cowling. The nosewheel leg was bent, and all three wheel fairings had been torn off. There was also some minor damage to the wings, including a tear under the left wing flaperon<sup>11</sup>. The motor room, forward battery box and instruments received major water damage (see Figure 3).

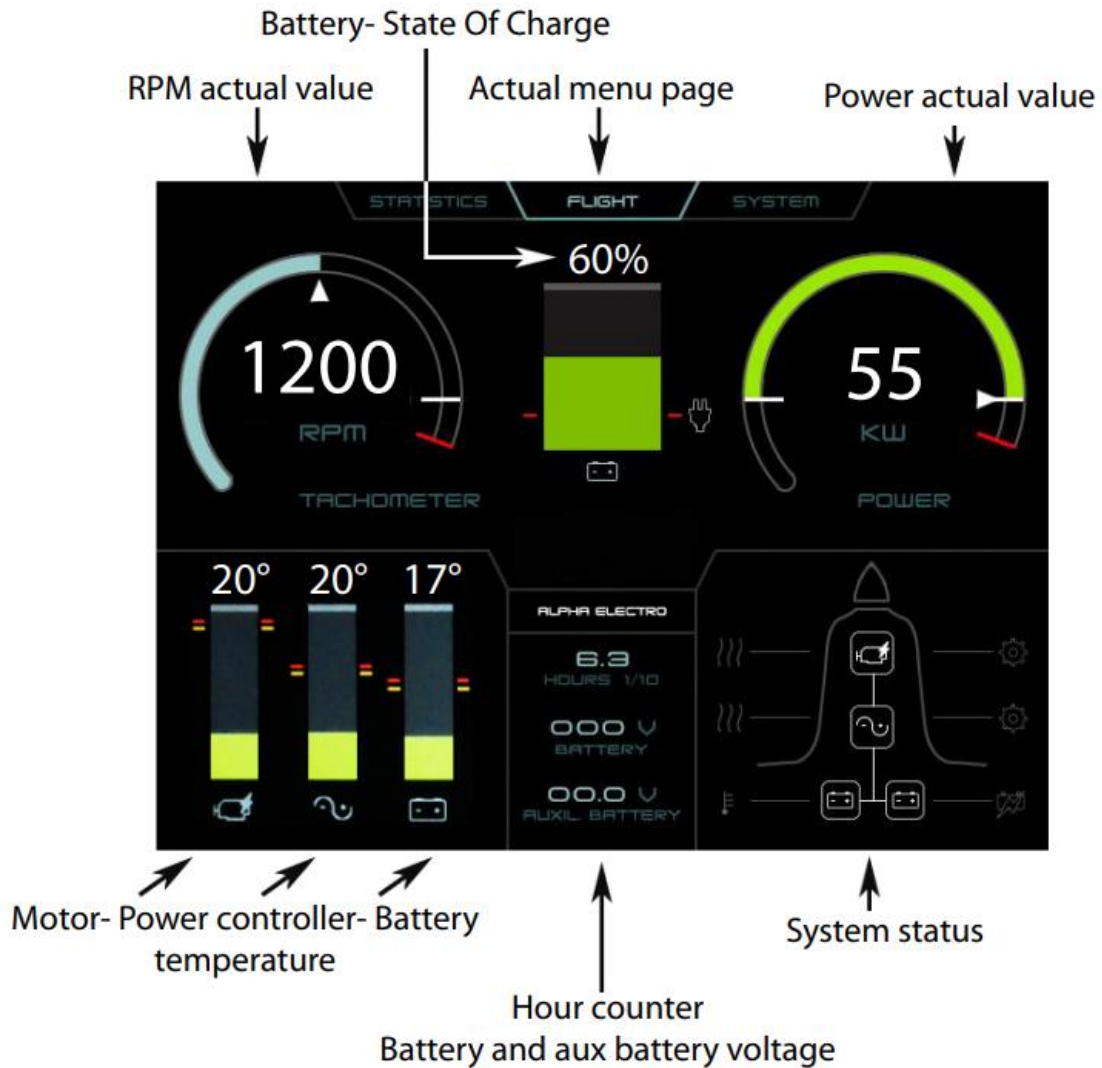
Figure 10: Flight manual illustration showing how EPSI 570 typically looks in flight mode. According to the commander on LN-ELA, it was the middle of the three temperature bars in the lower left-hand corner of the screen (power controller temperature) that increased and turned red. Illustration: Pipistrel.

- The commander's statement that the power failure was total, and that it occurred without prior warning. The motor power was lost, and the EPSI 750 power controller temperature column changed color to red, displaying too high value.
- The commander's statement that the motor did not respond normally when he moved the throttle lever after the motor failure had occurred.
- Thorough examinations and testing, including a test run of the motor before it was removed, revealed no technical faults that could otherwise explain why the motor failed.
- Both Pipistrel and EMSISO have stated to NSIA that they considered power controller interrupting power to the motor to be the most likely cause of the loss of motor power.

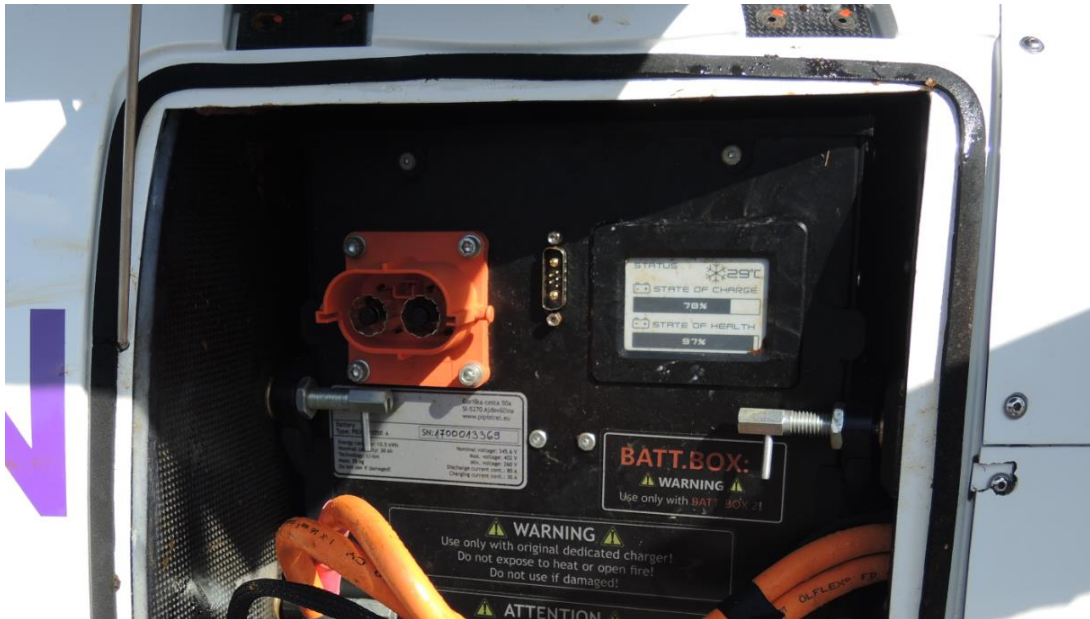
- 1.16.1.1 When LN-ELA arrived at NSIA's premises in Kjeller, the data from two main batteries were recorded before they were removed and stored in accordance with recommendations received from the manufacturer. The readings indicated that both battery boxes had sufficient state of charge and that the battery state of health was very good. The forward battery room had been submerged, and the battery box showed signs of having been under water. The aft battery box did not seem to have been exposed to water.

Figure 15: The charge status of the forward battery box was 78%, and the battery state of health was 97%. These readings were taken after the battery box had been submerged in water. Photo: NSIA

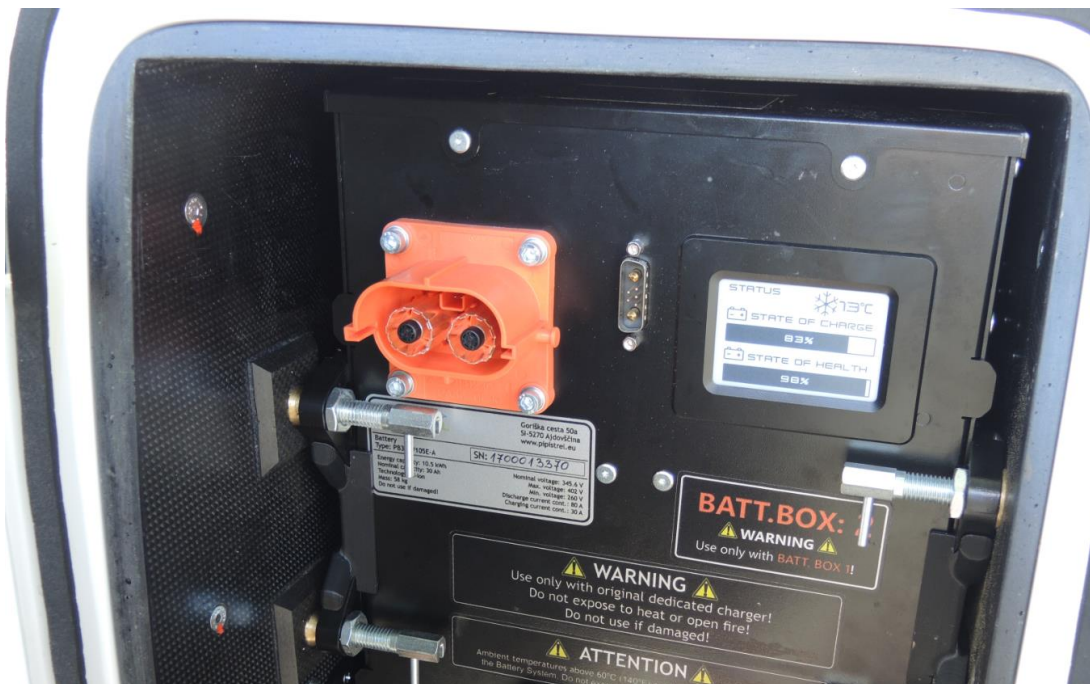
Figure 16: The charge status of the aft battery box was 83%, and the battery state of health was 93%. Photo: NSIA

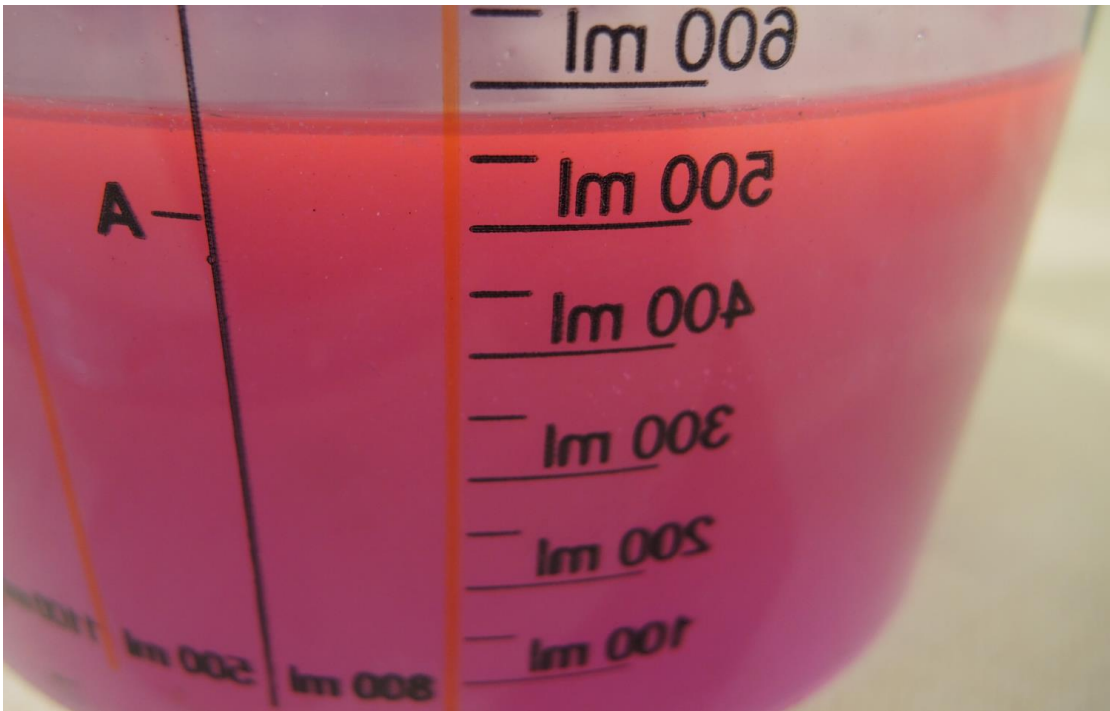
Figure 17: Coolant collected from LN-ELA. Photo: NSIA

- 1.16.1.7 The coolant appeared to be discolored and seemed possibly to contain some sediments/particles. Consequently, NSIA asked the Norwegian Armed Forces' chemistry and material technology laboratory service at Kjeller to perform an analysis. The report from this laboratory service concluded as follows:

*Both<sup>13</sup> coolants satisfy ASTM D3306, and should therefore be compatible. The concentration found in the sample from the aircraft shows a concentration of 78 vol%. This is somewhat high. The manufacturer does not recommend higher concentrations than 70 vol%.*
