Aviation 2021/09

*REPORT ON AIR ACCIDENT NEAR
SKJELBREITJØRNA IN SANDNES
MUNICIPALITY, ROGALAND COUNTY,
NORWAY ON 6 APRIL 2020 INVOLVING
AIRBUS HELICOPTERS AS350 B3,
LN-OFQ, OPERATED BY HELITRANS AS*

REPORT ON AIR ACCIDENT

Type of aircraft:	Airbus Helicopters AS350 B3
Nationality and registration:	Norwegian, LN-OFQ
Owner:	Skjolden Invest AS, Hønefoss, Norway
Operator:	Helitrans AS, Stjørdal, Norway
Crew:	1, the commander
Passengers:	None
Accident site:	Northwest of Skjelbreitjørna in Sandnes, Rogaland, Norway (N 58° 49.951´ E 5° 51.434´)
Time of accident:	At 0857 hours on Monday 6 April 2020

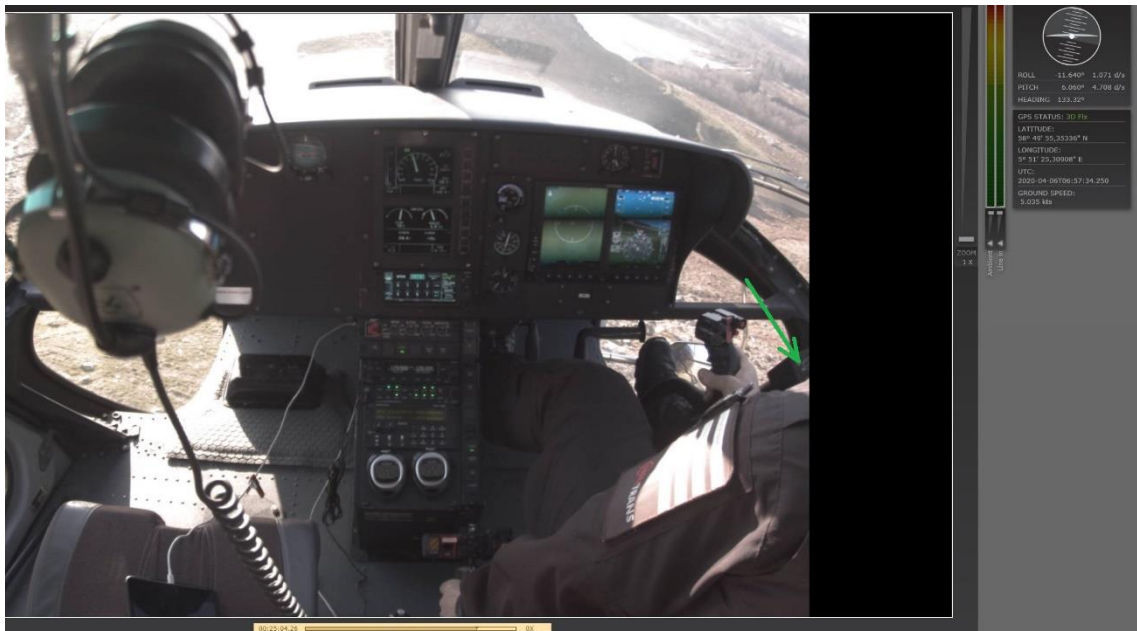
- 1.1.7 The recordings show that the helicopter started rolling to the left, at the same time as the nose started to pitch up. The commander moved the cyclic stick forward and to the right to counteract this movement, but the movement continued. When the helicopter had rolled 11.6 degrees to the left and with an upward nose angle of 6 degrees, moving the cyclic stick all the way to the right caused the commander's right foot to slip off the right pedal. At the same time, a green diode on the cargo hook load indicator came into sight on the far right in the image, indicating that the load on the hook was less than 100 kg at the time. The helicopter then started turning to the left.

Figure 2: The helicopter has rolled left to an angle of 11.6 degrees and has a nose high angle of 6 degrees. The commander has moved the cyclic stick all the way to the right, and his right foot has just slipped off the pedal. A single green light can be seen on the far right in the image, indicating a load of less than 100 kg (green arrow). Source: Appareo Vision 1000/NSIA

- 2.2.3 Information from Appareo Vision 1000 suggests that there was a wind gust just as the longline between the helicopter and the container was being tautened. The commander had turned the helicopter so it was at 140 degrees heading. The southerly wind could therefore move the helicopter backwards and to the left unless the commander used the cyclic stick to counteract the movement. The image (Figure 2) shows that the cyclic stick had been moved all the way to the right without this stopping the leftward roll.

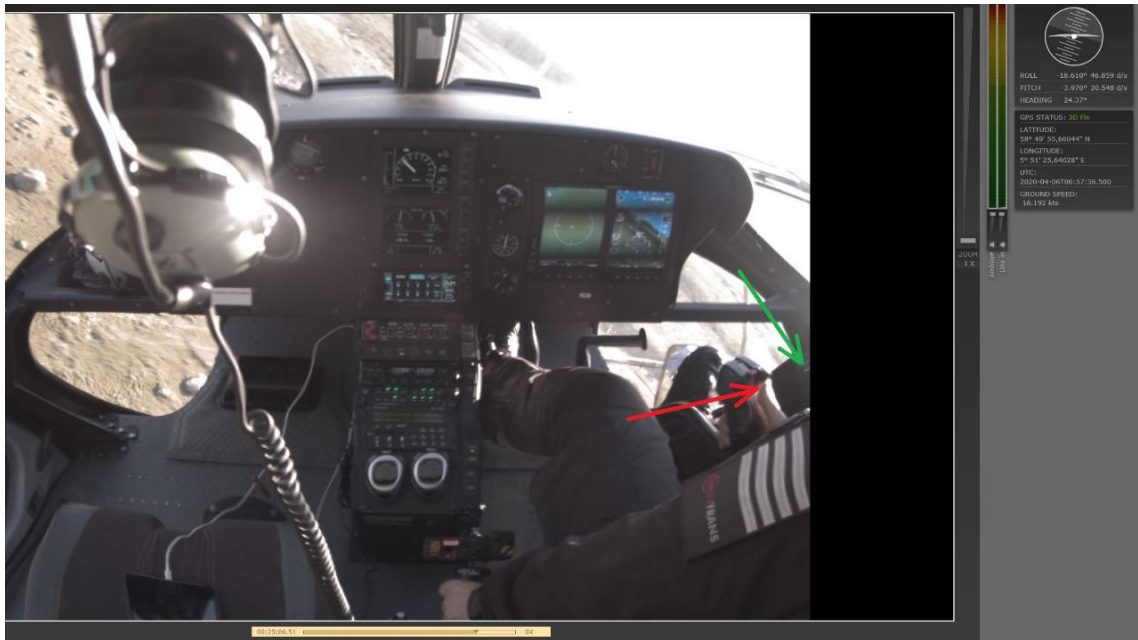
- 1.1.8 Seven seconds after being in a normal position, the helicopter heading passed 59 degrees during the leftward turn, at the same time as the left roll to reached 31 degrees. It had a nose high angle of 5.1 degrees. Two green lights on the cargo hook load indicator indicated that the load on the hook was at least 100 kg.¹

¹ Two green lights can be seen on the indicator on the far right in the image. Any additional lights are outside the field of view. It is therefore not possible to determine the exact load on the cargo hook, but it was at least 100 kg, as indicated by the two lights.

Figure 3: Two green lights (green arrow) can be seen on the far right in the image, indicating that the cargo hook load has exceeded 100 kg. The commander pressed the switch on the cyclic stick to release the cargo (red arrow). At this point in time, after spinning out of control, the helicopter had turned 116 degrees to the left. The nose angle had dropped to -4 degrees. Source: Appareo Vision 1000/NSIA

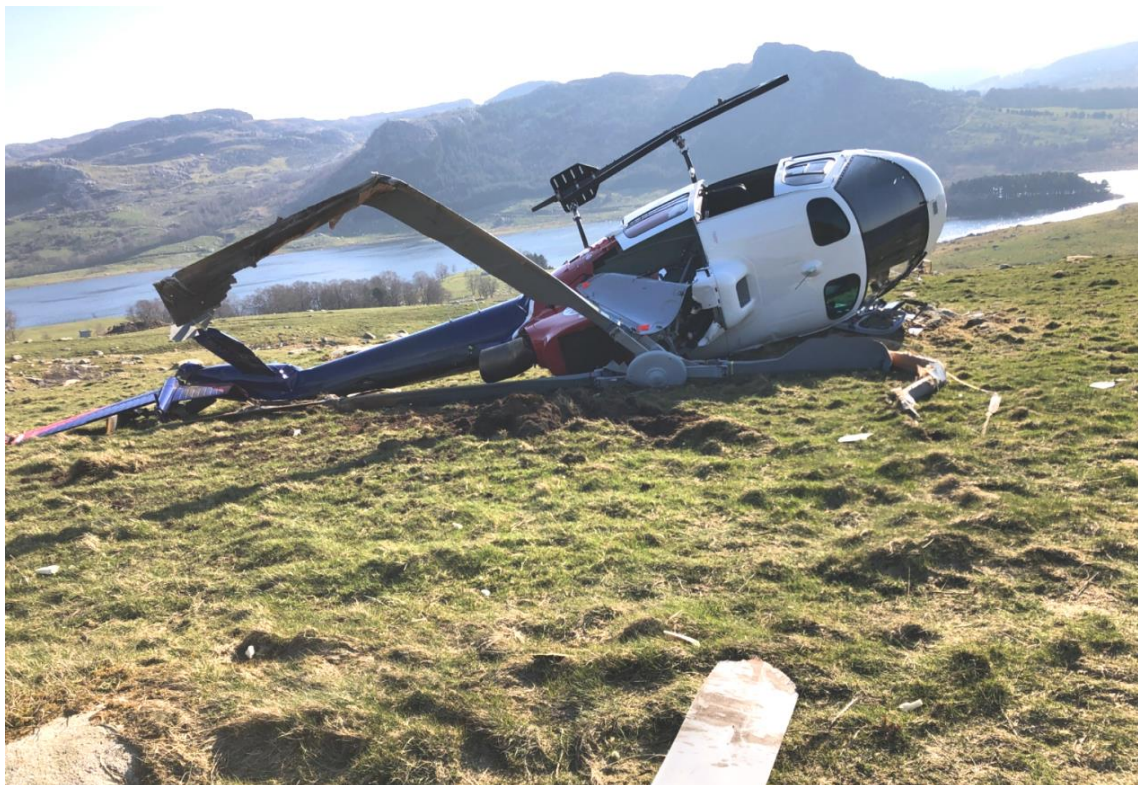
- 1.1.11 The rotation continued and the helicopter was getting close to the ground. Twelve seconds after being in a normal position, the helicopter's main rotor hit the ground and the helicopter ended up lying on its right side with its nose pointing south. The helicopter had thus almost completed a full rotation to the left before it came to rest (see Figure 4).

Figure 4: Southeasterly view of LN-OFQ. Photo: The police

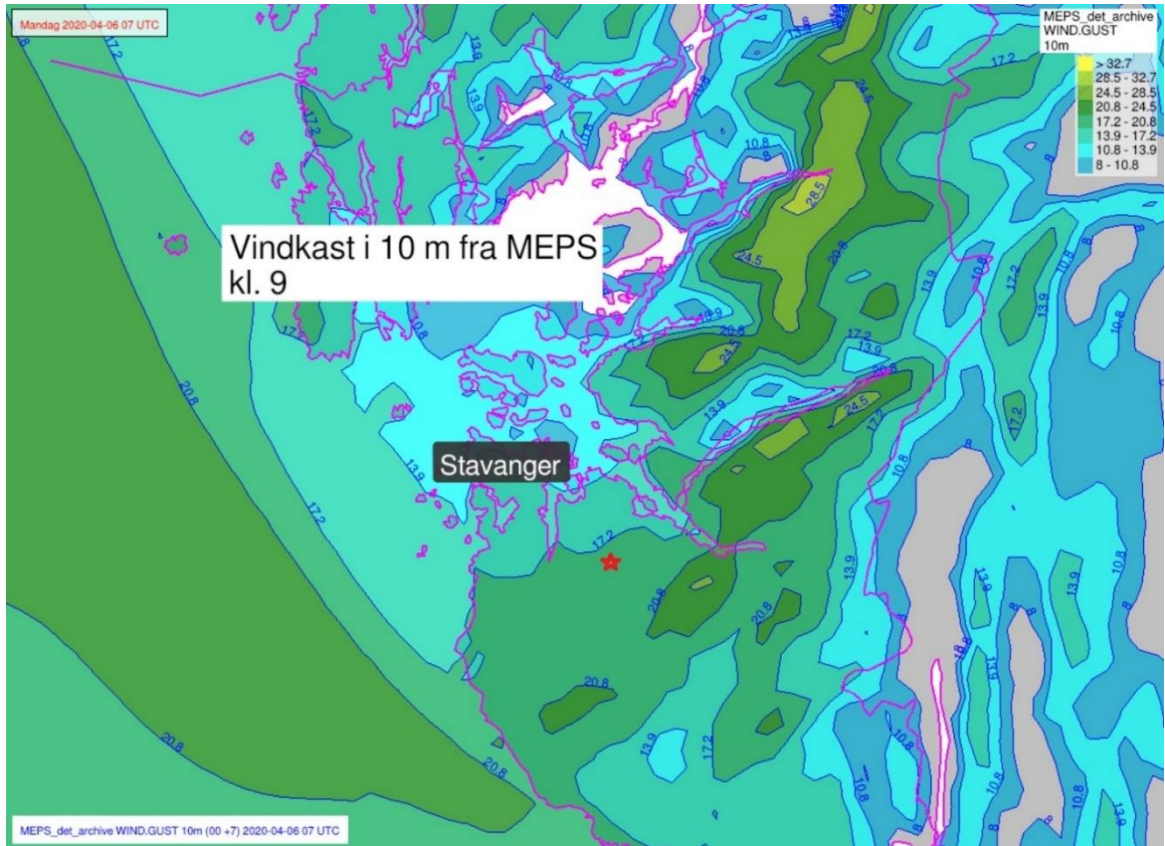
Figure 6: Map showing gusts at 10 metres above ground level at 0900 hours. The accident site is marked with a red star. According to the table, there were gusts of 17.2–20.8 m/s (33.4–40.5 kt) in the area. Source: Norwegian Meteorological Institute

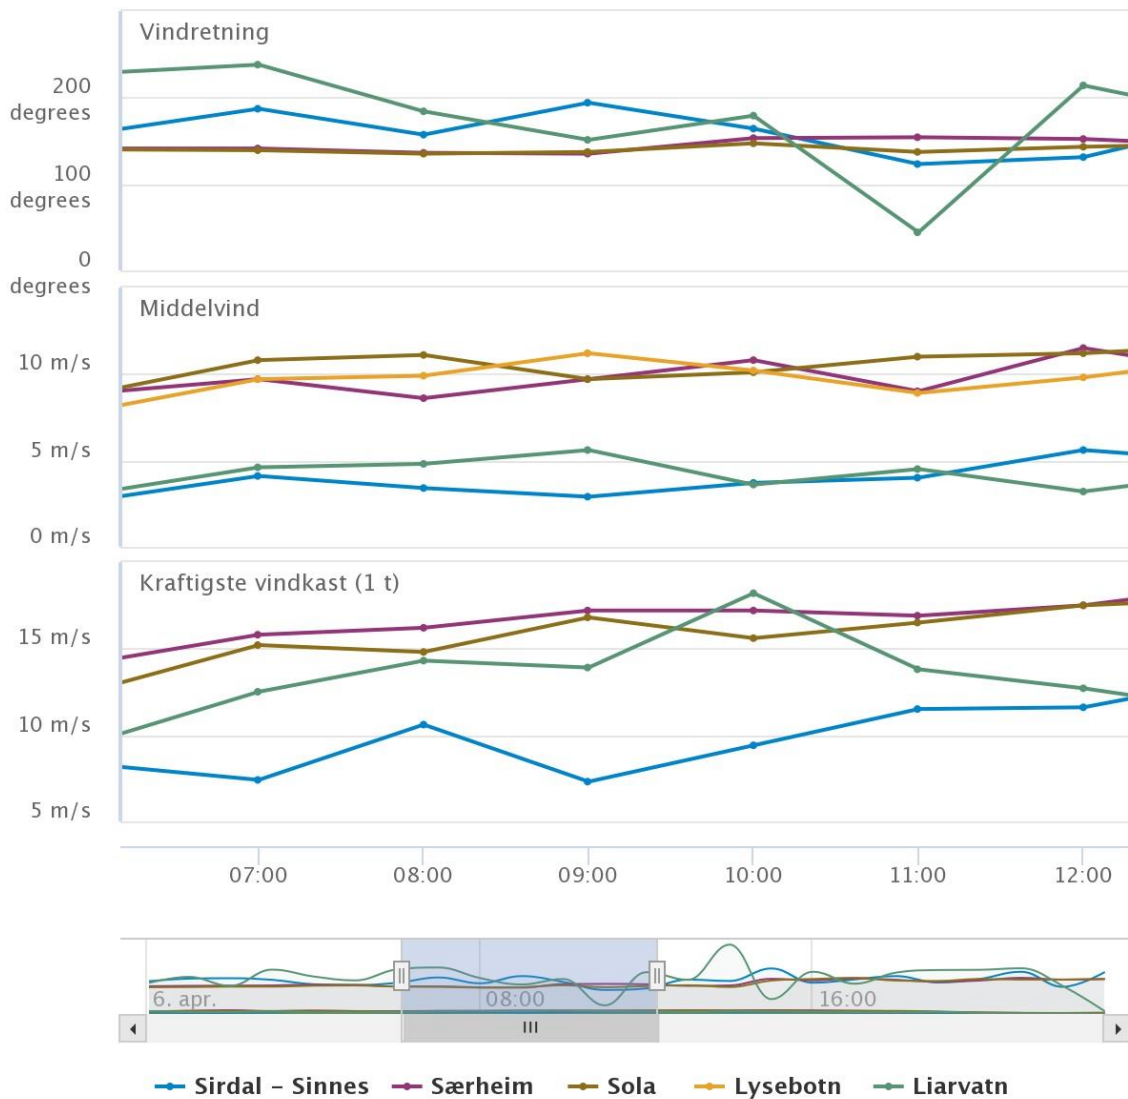
Figure 9: Wind during the period 0700–1200 hours at the most relevant locations for which data are available. Sola and Særheim (13 km south of Sola) are closest to the accident site. (Vindretning – Wind direction, Middelvind – Mean wind speed, Kraftigste vindkast (1 t) – Highest wind gust (1 hour)). Source: Norwegian Meteorological Institute

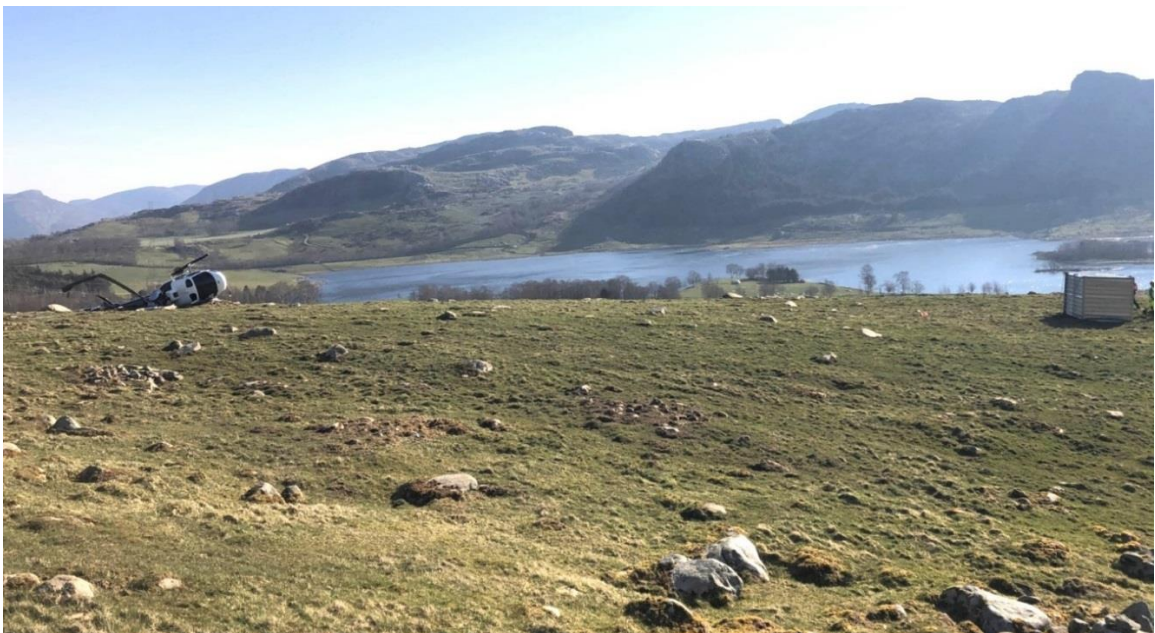
- 1.12.1.1 The accident took place in a relatively flat, open and rocky grazing area 460 metres northwest of Skjelbreitjørna lake (see Figure 10). The helicopter came to rest partly on a big rock protruding from the ground. The accident site is approximately 170 metres (558 ft) above sea level. South of the accident site, the terrain slopes down towards Skjelbreitjørna. In the whole sector south of the accident site (from 80 to 270 degrees), the terrain was partly mountainous, with peaks of from 200 to 384 metres above sea level.
- 1.12.1.2 The accident took place shortly after Norway was shut down as a result of the Covid-19 pandemic. The NSIA did not travel to the accident site and decided to order drone documentation from Nordic Unmanned. The work consisted of, among other things, 3D documentation as shown in Figure 11 and Figure 12.

Figure 10: The accident site, looking east with Skjelbreitjørna in the background. The overturned container can be seen to the very right in the photo. The distance between the helicopter wreckage and the container is 47 metres. Photo: The police

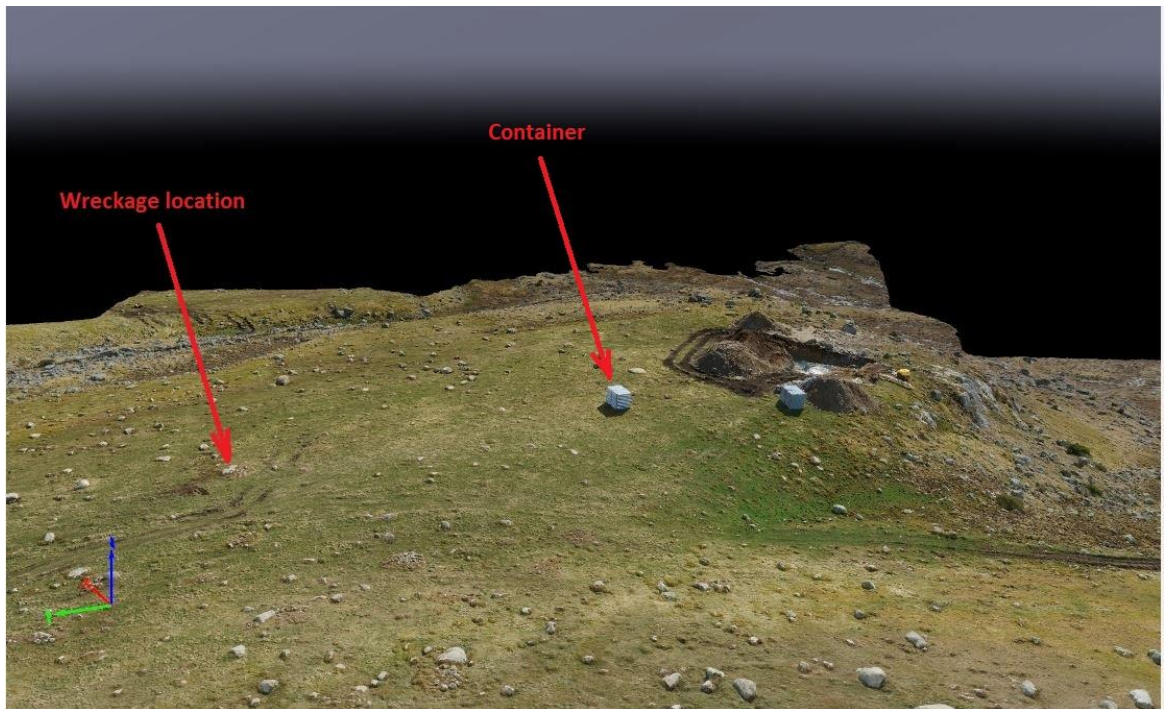
Figure 11: 3D illustration of the accident site, looking southeast, the day after the wreckage was removed. The arrow on the left points to the rock on which the helicopter was lying. The hole in the ground is for pylon 155. A rocky outcrop and steeply sloping terrain can be seen on the far right. Source: Nordic Unmanned/NSIA

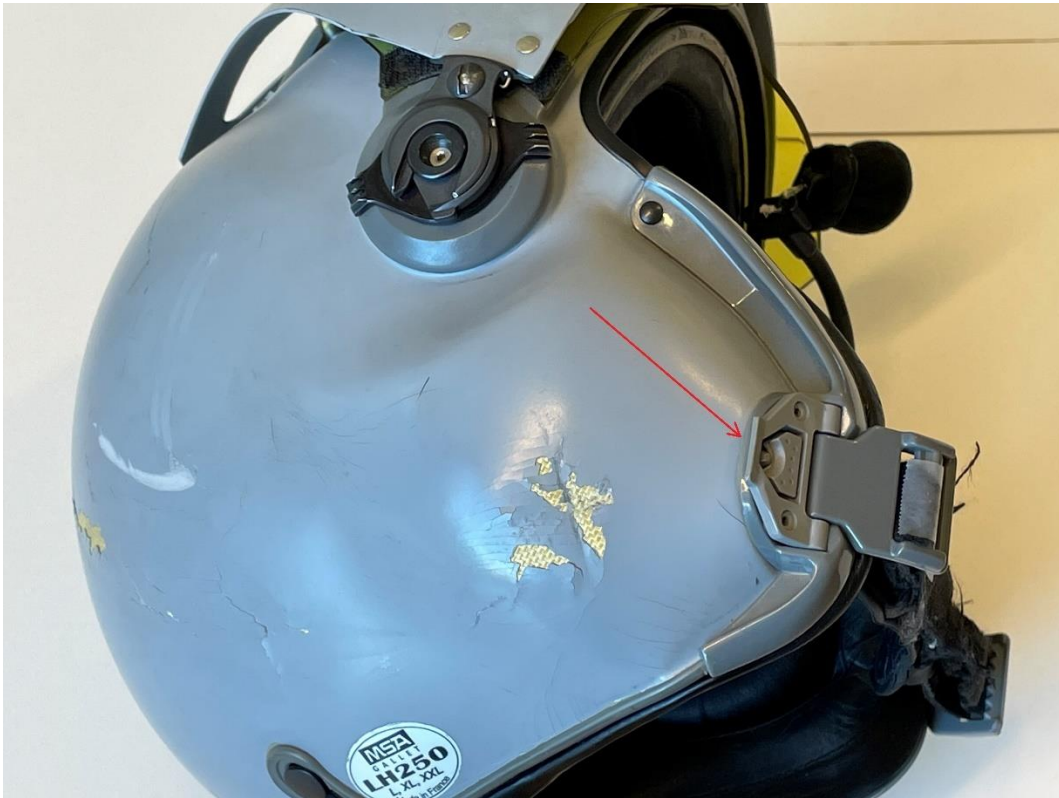
- 1.15.2 The commander was wearing a helmet and was strapped to his seat with a four-point seatbelt. The helicopter and the right cockpit door were lying over a large rock and the commander may have hit this rock with his helmet. The chin strap came loose on the right-hand side and the helmet fell off during the crash. A detailed examination showed damage to the protective hard shell on the right side of the helmet, and the helmet was subsequently scrapped (see Figure 13). One of the damaged areas was close to the right ear, near the chin strap attachment. It was also found that very little force was required to

open the chin strap lock. The attachment mechanism of the chin strap worked correctly, however, in that it was not possible to pull the chin strap loose with the lock engaged.

Figure 13: The commander's helmet, showing damage to the right side. The arrow points to the chin strap lock that came undone. Photo: NSIA

- 2.4.2 The commander's helmet came off in connection with the crash, most likely because the lock came undone, so that the chin strap was pulled out when the protective shell was deformed. It had no consequences, as the helmet came off after the commander banged his head against the cabin/rock. In the NSIA's view, this does not indicate faults in the helmet design. Worn locks should be replaced, however, and the company should have procedures for checking this.
