REPORT AVIATION 2022/01

***Aviation accident at Notodden Airport
Tuven, 15. August 2021 involving
Diamond DA40 NG, LN-PFJ***

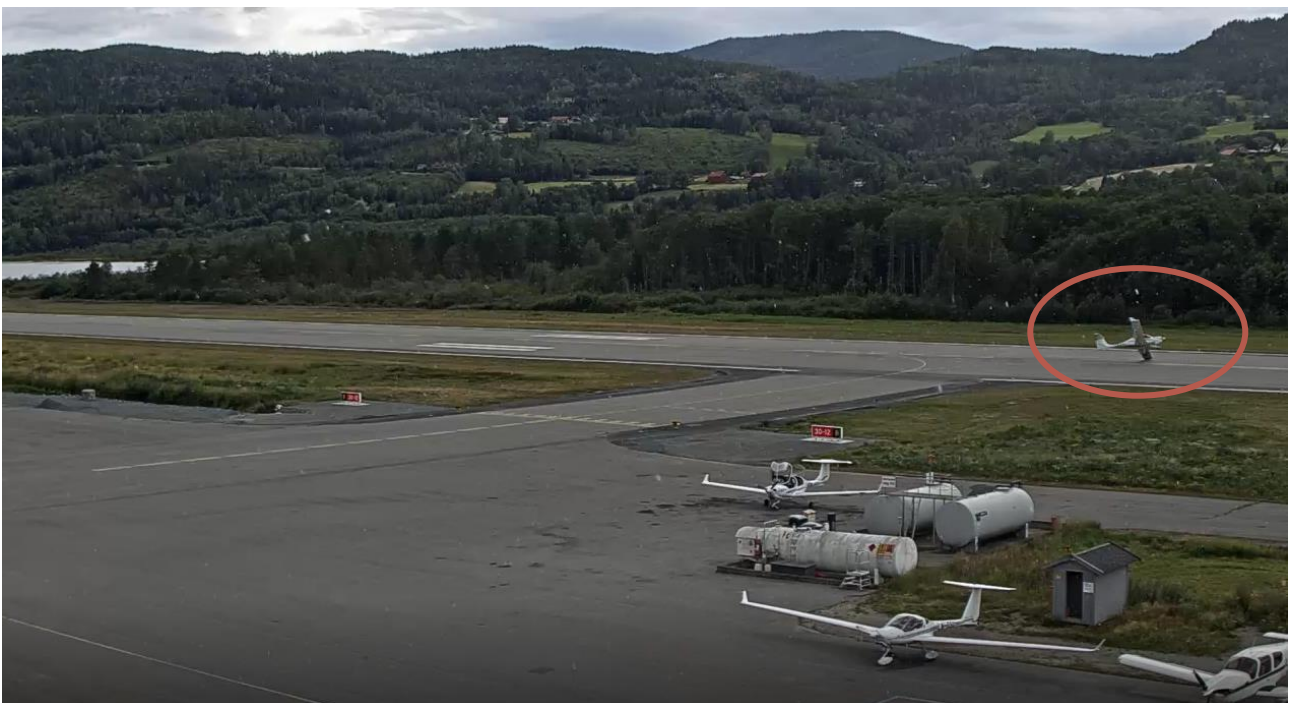
The commander has explained that he did not find the approach stable this time either and that the aircraft floated for some time above the runway. The speed decreased to stall speed approx. 55 kt. The commander noticed that the aircraft was veering to the right. He corrected this with the left aileron and applied full throttle to abort the landing. This led to the aircraft veering to the left at the same time as the aircraft nose pitched markedly. A video received from the airport shows that LN-PFJ, in connection with the landing, initially touched the runway with its landing gear, partly bounced up, hit its left wing on the asphalt and skidded to the left off the runway. The uncontrolled veering to the left led to the aircraft ending up on the grass off the runway (see Figure 1). The aircraft finally stopped 30 m from the edge of the runway with its nose pointing west (see Figure 2).

Figure 1: Still of LN-PFJ, circled in red, with its left wing-down on the asphalt. Video: Notodden Airport

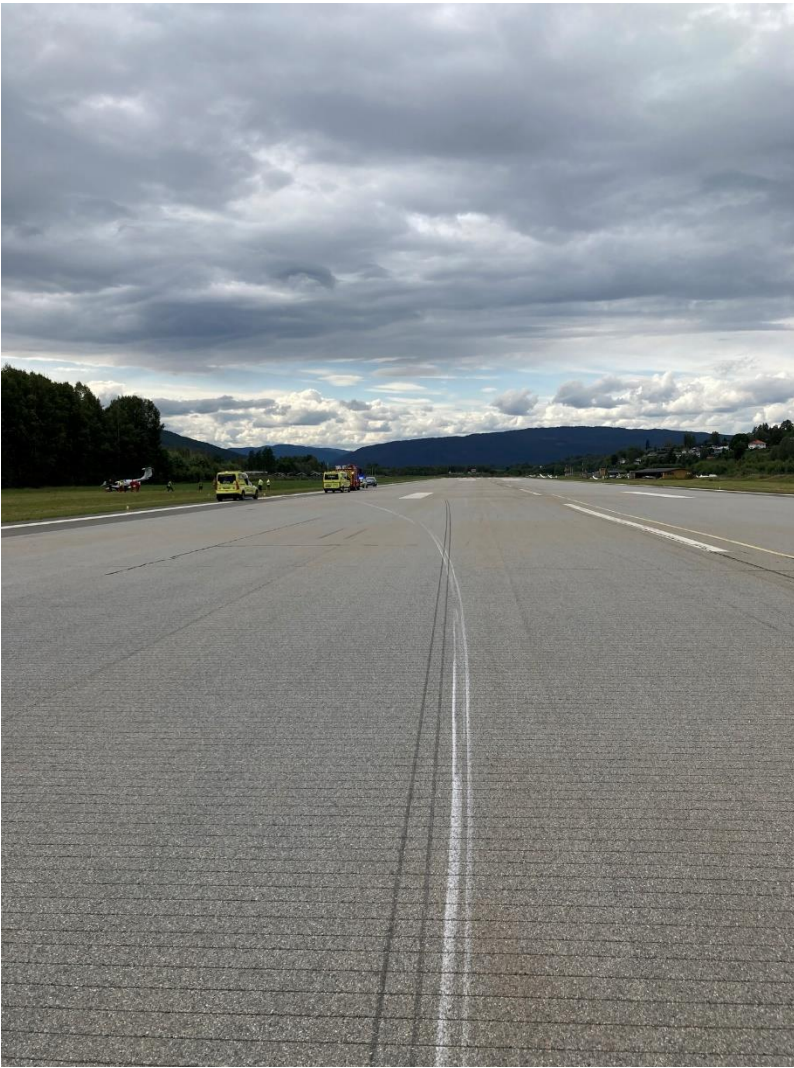
Figure 2: Mark made by the left wing tip. Photo: The Police

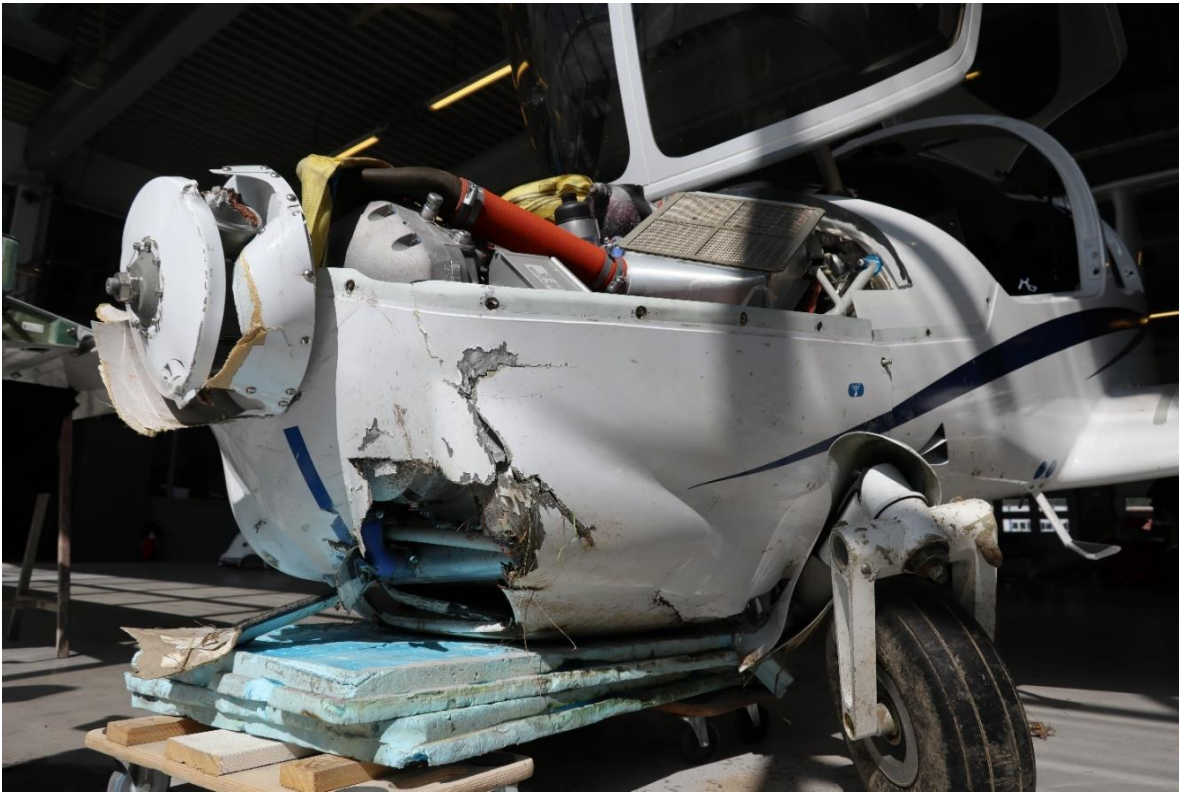
Several people present at the airport ran to the accident site to help the commander. The airport fire and rescue services reached the scene six minutes after the accident. The commander was not physically injured in the accident but spent one night in hospital for observation. The aircraft sustained significant damage with damage to the aircraft fuselage, wings, landing gear, propeller and engine (see Figure 3). No technical malfunctions have been found in the aircraft that may have had any impact on the sequence of events.

Figure 3: LN-PFJ photographed after it was moved to the hangar. The photo shows damage to the front of the fuselage, damaged landing gear and damaged propeller, where all the blades have been knocked off. Photo: NSIA
