REPORT AVIATION 2022/04

Report on the air accident on the E18 road in Eidanger, Vestfold and Telemark county, Norway on 17 June 2021 involving a Robinson R44 Raven I helicopter, LN-OGT

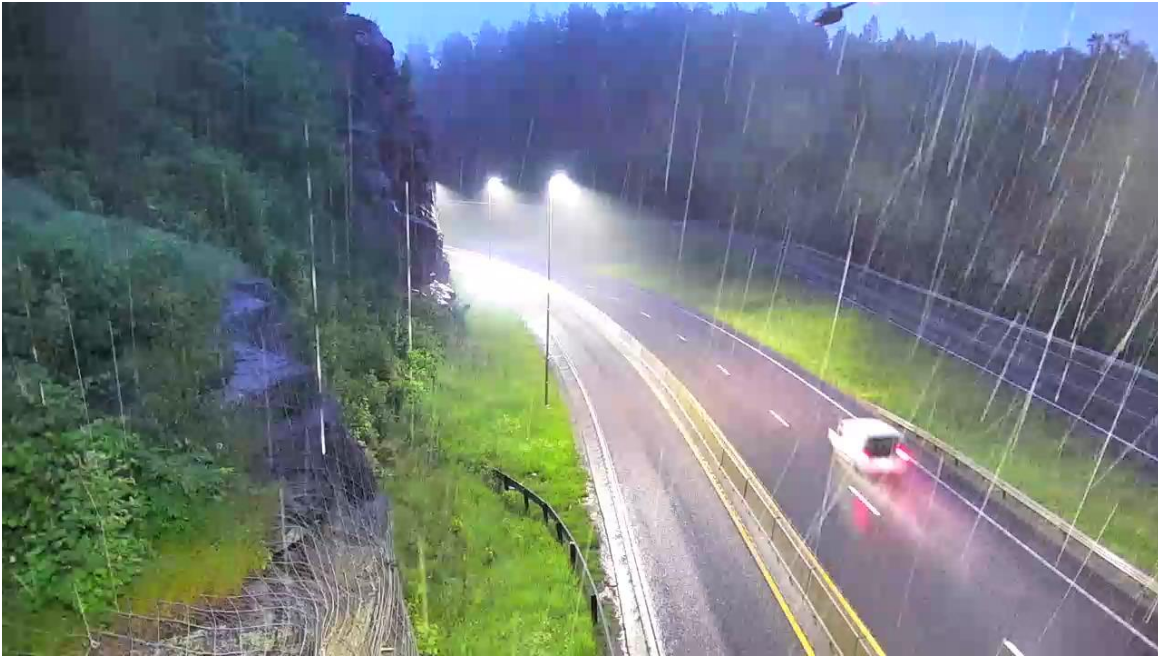
In the video, the helicopter appears as it is flying steadily along the E18 at about the same height as the top of the rockface on the left side of the road (see figure 3). It is going at approximately the same speed as a car that is driving along the road. The image shows that it is raining heavily. After approximately 2.5 seconds, the helicopter hits the high-voltage power line. A flash of light starts to appear before the recording is interrupted when the camera's power supply is cut (see figure 4). The crash to the ground is therefore not recorded.

Figure 3: Still image from video. The helicopter appears at the top of the image. The image may give the impression that there was more daylight than what there actually was. Video: NPRA/NSIA

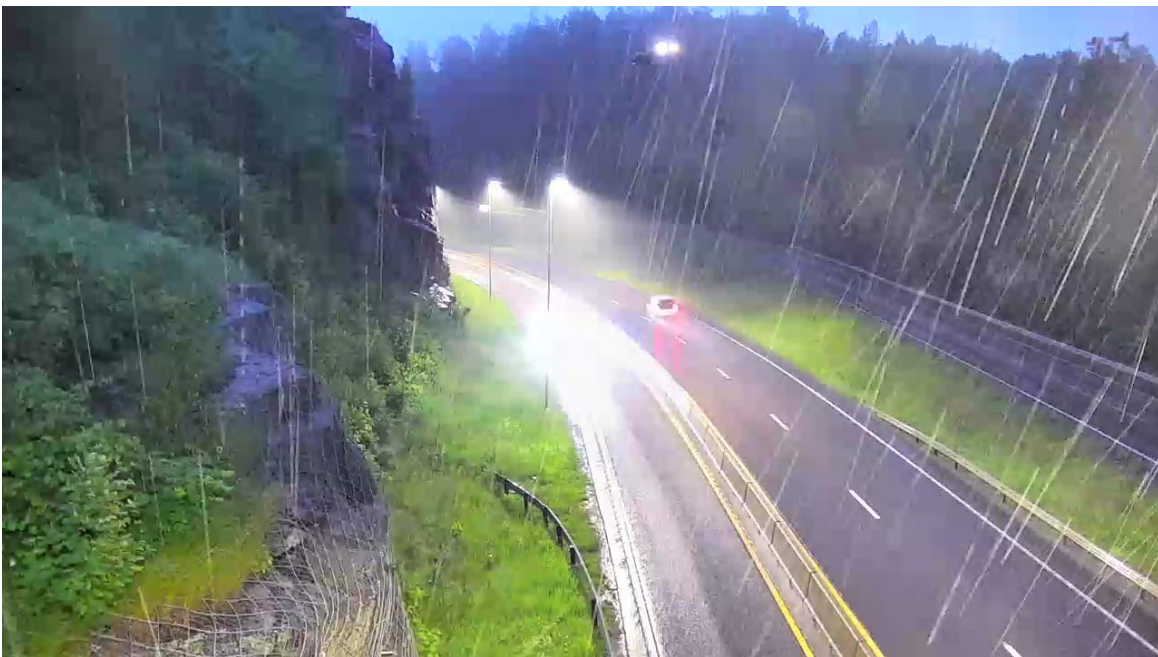
At least seven witnesses have explained to the police that they saw a flash of light when the helicopter hit the high-voltage power line. A witness who saw the helicopter thought that she saw a lightning strike and heard a loud bang from the area where the helicopter crashed. One witness stated that he saw the helicopter fly in a circle immediately before hitting the power line.

Figure 4: Still image from video. A flash of light can be seen next to the white navigation light on the helicopter's tail. The video recording was cut off after that. The image may give the impression that there was more daylight than what there actually was. Video: NPRA/NSIA

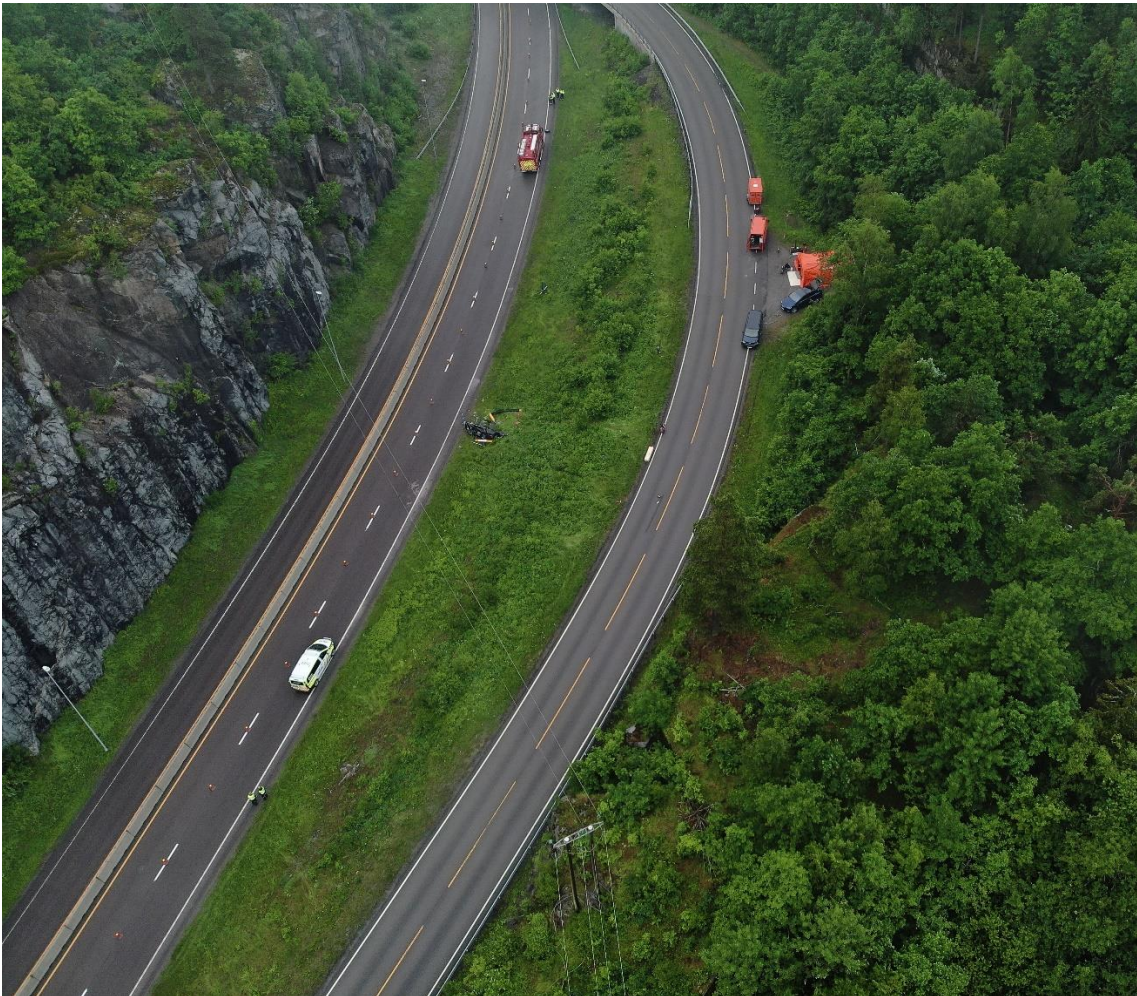
When looking towards Oslo, the E18 road runs in a direction of approximately 150°. The power line the helicopter hit runs approximately 13 metres above the roadway in a direction of 100°–280°. The 22-kV power line belonged to the power distribution company Lede and consisted of three 12-mm-thick steel-cored aluminium conductors. In addition, an earth conductor was installed approximately two metres below the conductors. The three conductors were installed horizontally in relation to each other and spaced approximately 1.5 metres apart. The two northernmost conductors were severed by the helicopter approximately 40 metres from the western pylon. The overhead line was not marked, nor was it required to be.

Figure 7: South-easterly view of the accident site. The E18 is the road on the left. The helicopter wreckage can be seen in the centre of the photo. The one remaining conductor and the earth conductor are visible in the photo. Photo: Porsgrunn fire and chimney sweep service/NSIA

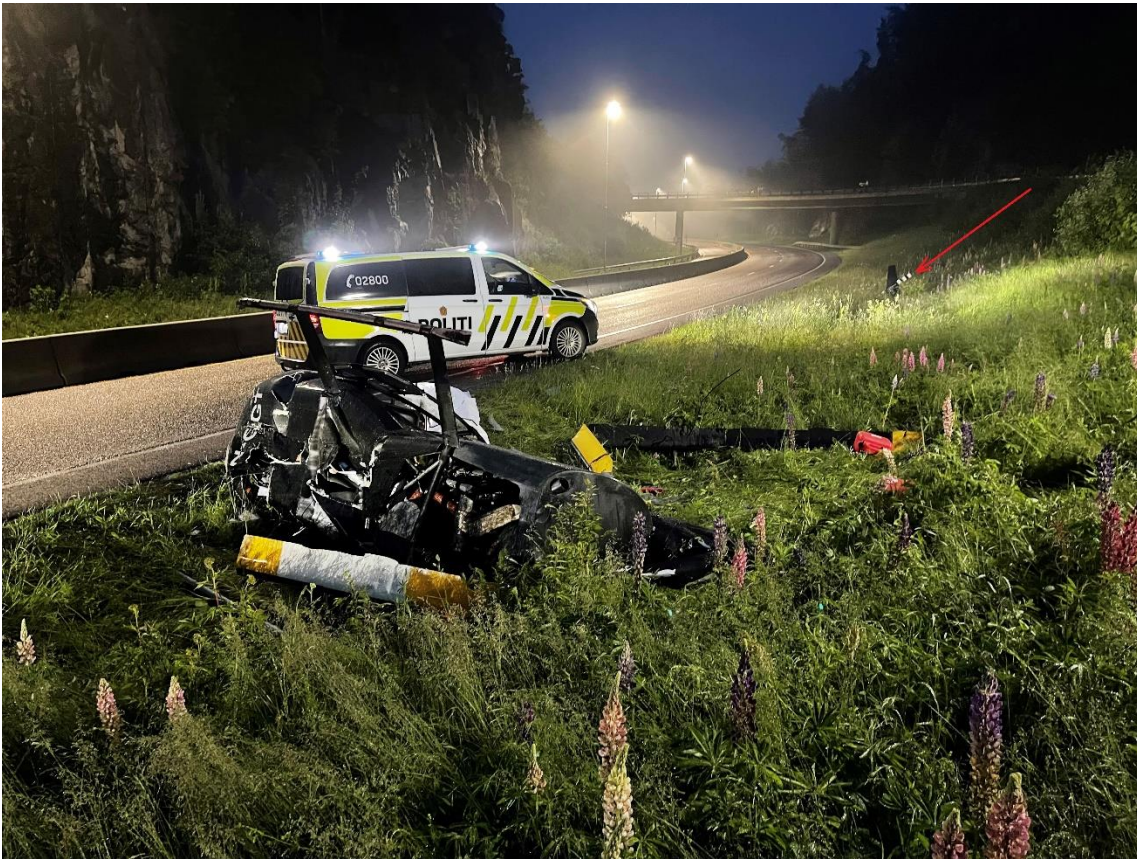
The helicopter primarily sustained damage to the tail boom and the right side. The windshield and all the windows on the right side were broken. The skid on the right side was knocked off, and both main rotor blades were broken off about one metre from the rotor head.

Figure 8: South-easterly view of the helicopter. The red arrow points to the tail rotor. Photo: NSIA

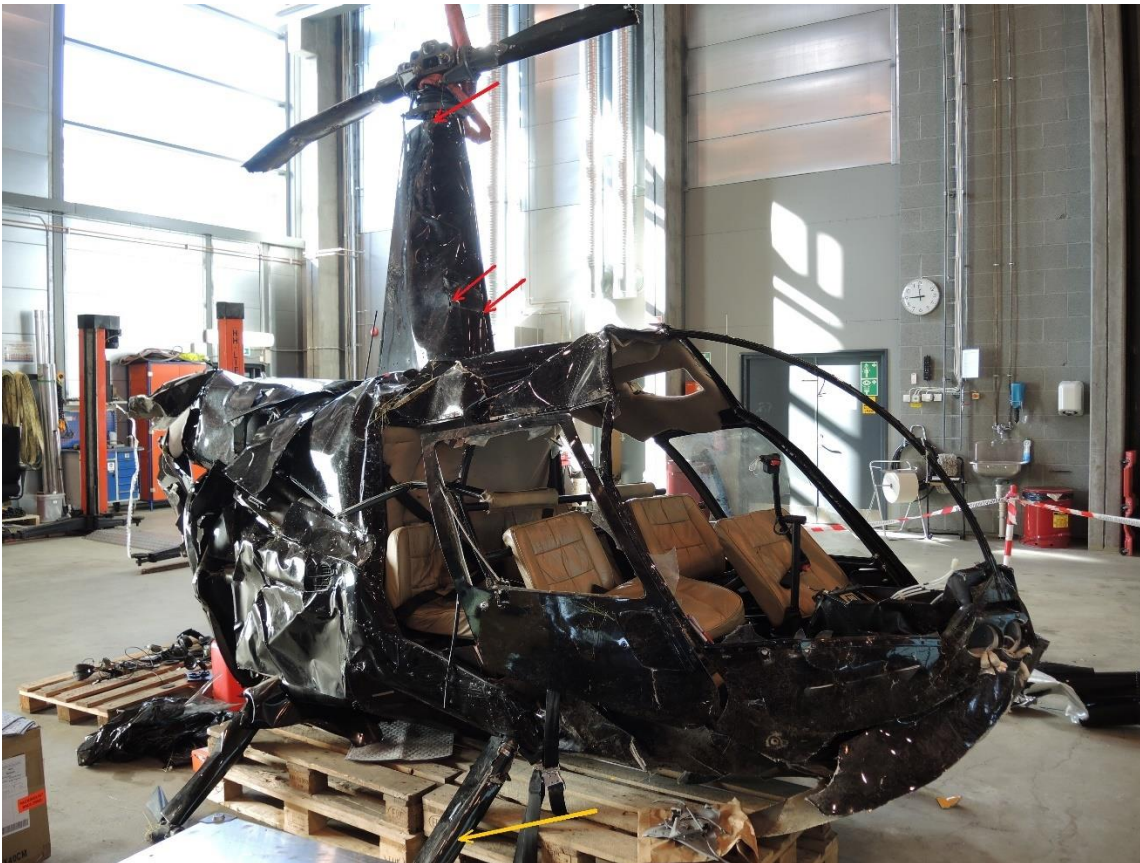
Figure 9: The damage to the right side of the helicopter photographed in the NSIA's hangar. The red arrows point to areas with melted aluminium. The yellow arrow points to scratch marks on the right forward landing gear leg. Photo: NSIA

Poor visibility and light conditions combined with rain on the windshield suggest that it may have been virtually impossible for him to spot the power line in time. The damage to the helicopter indicates that the lower part of the right forward landing gear leg hit the northern conductor of the power line first. The conductor then slid up along the landing gear leg before being severed at the leg's attachment point. It is likely that the impact of the collision caused the helicopter to turn to the left at the same time as it rolled to the right.

During this sequence, the helicopter also came into contact with the middle conductor. This caused a short circuit and a strong flash of light that was observed by several witnesses. As that happened, a strong electric current passed through parts of the helicopter, causing aluminium to melt. One of the conductors, probably the middle one, hit the tail boom and cut it in half. After the two conductors had been severed, the helicopter fell more or less straight to the ground, hitting the road shoulder with its right side first. The loose tail with the tail rotor continued moving for approximately 25 metres before it fell down onto the grass along the road.
