REPORT AVIATION 2022/05

Serious aviation incident near Råde Church in Østfold, Norway, on Wednesday 21 June 2017 involving Diamond DA 40 NG, LN-FTR, operated by Pilot Flight Academy

Report on serious aviation incident

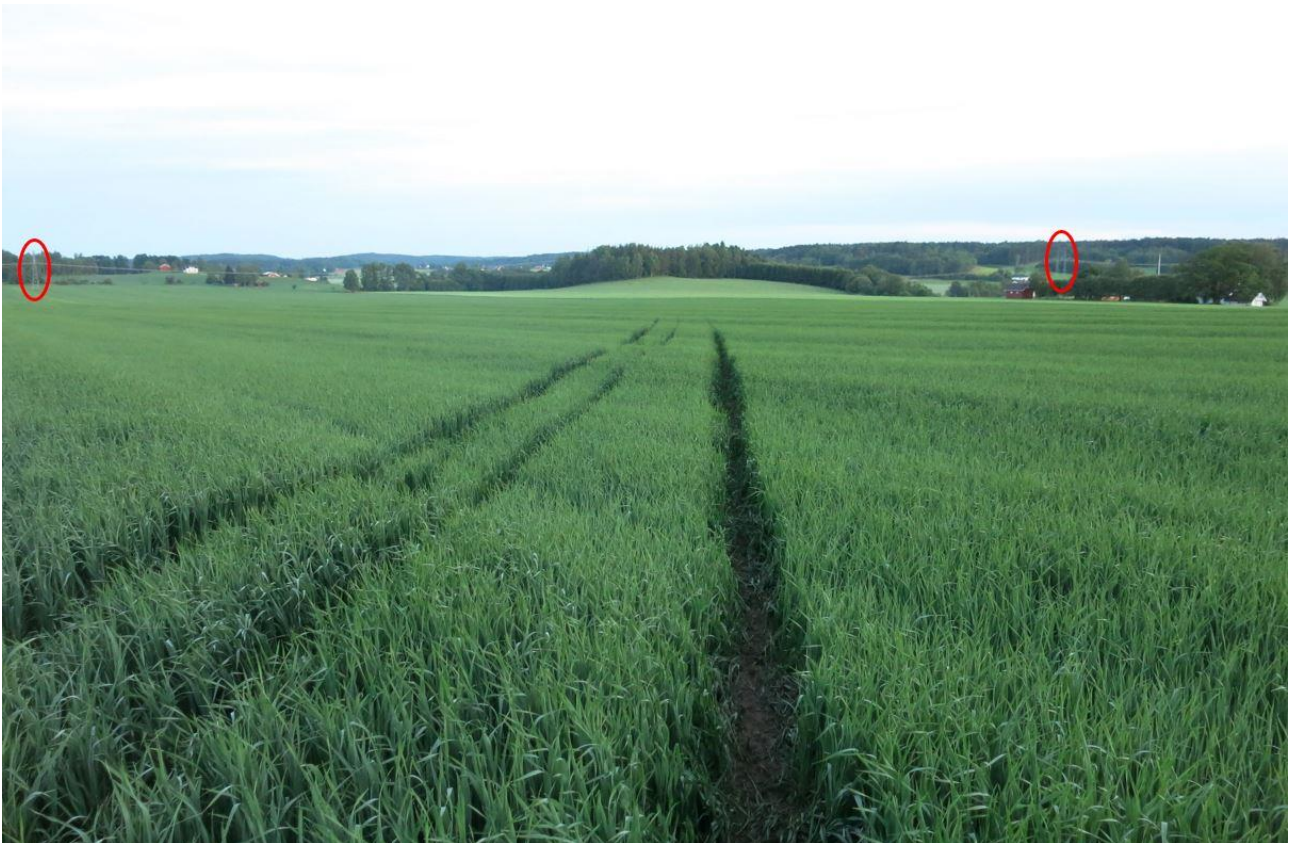
Figure 1: The wheel tracks seen from the opposite direction to the landing direction. The red circles mark the high-voltage pylons that were passed before landing. Photo: NSIA

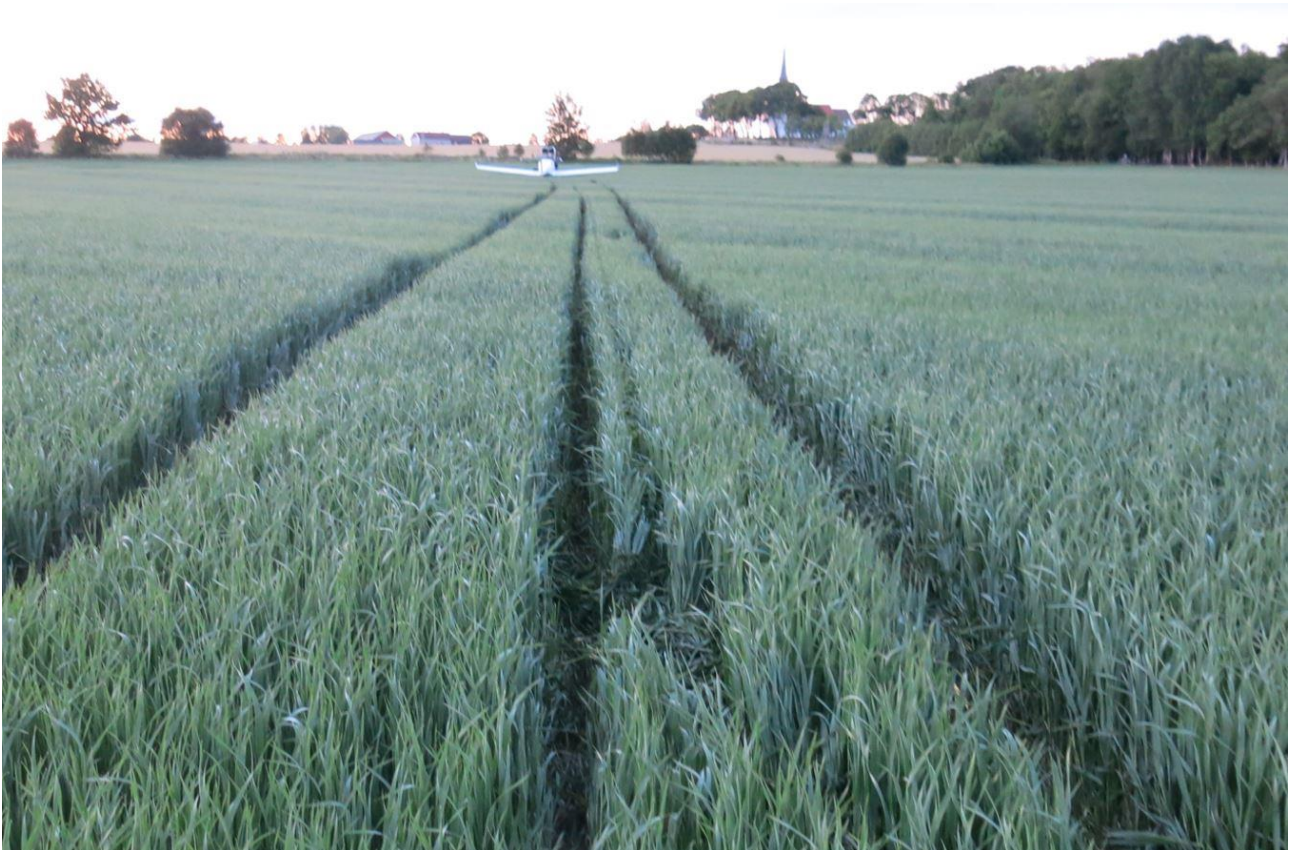
Figure 2: LN-FTR after the forced landing. Råde Church in the background, to the right of the aircraft. Photo: NSIA

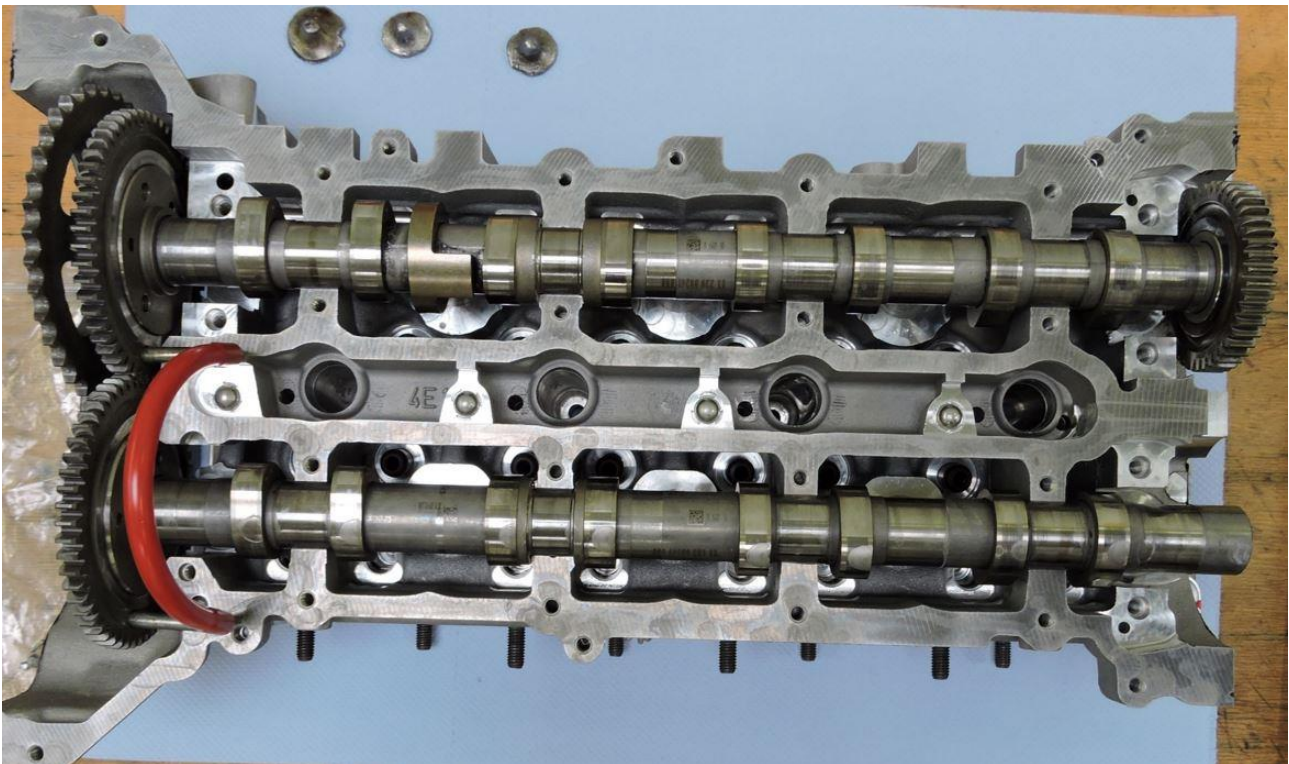
Figure 4: The camshaft gear locked in the correct position using a special tool (with a red plastic handle). The timing chain is to be connected to the camshaft drive wheel on the outside of the intake camshaft gear. Photo: Austrian Civil Aviation Safety Investigation Authority

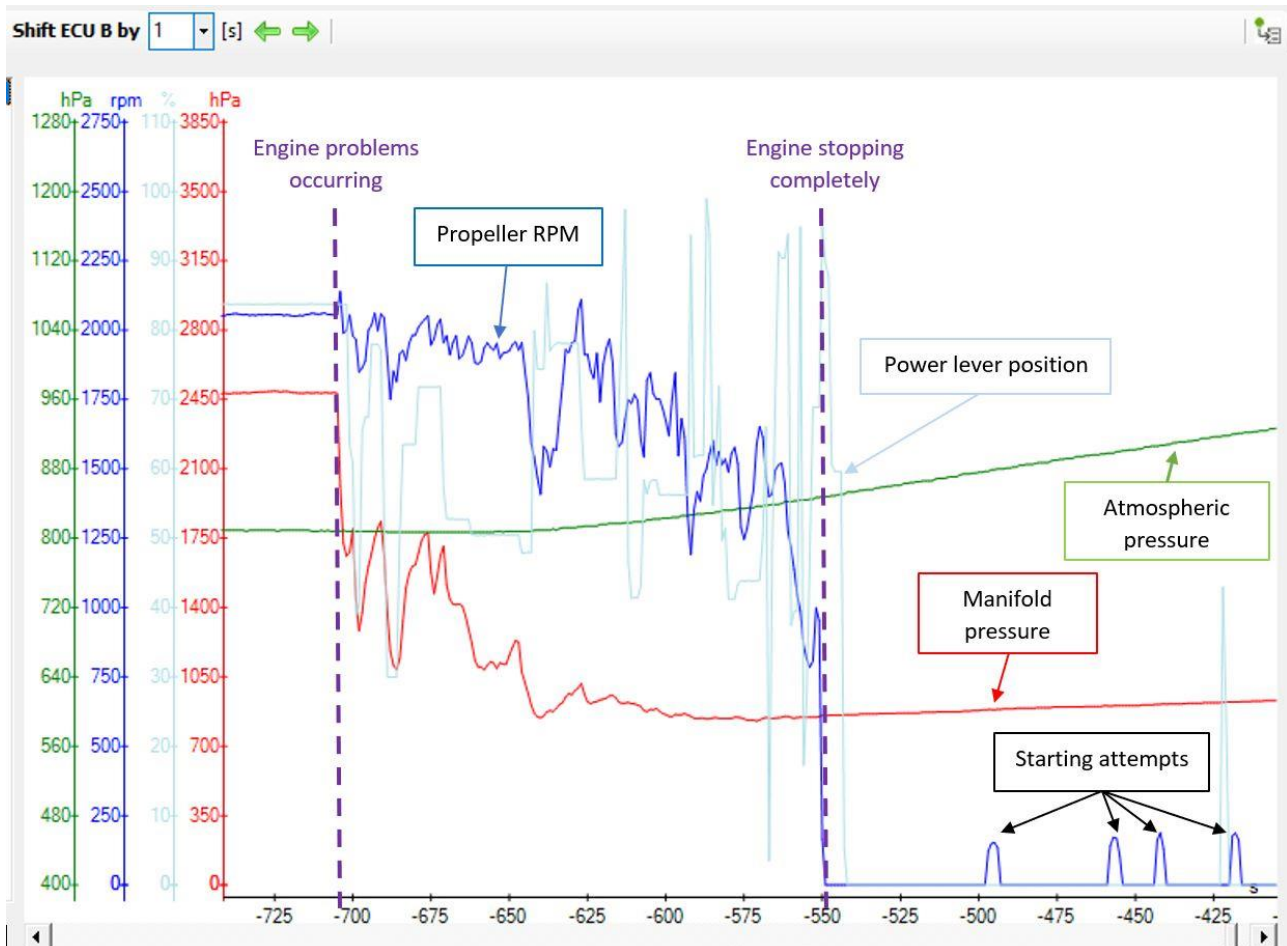
Figure 5: Engine data from the incident involving LN-FTR. The graphs were produced using Austro Engine AE300 Wizard. Illustration: NSIA

It has not been possible, on the basis of the engine parameters in the data log, to determine whether or not the crankshaft/camshaft timing was correct. After the LN-FTR incident, Austro Engine has made changes to AE300 Wizard, the software for analysing EECU data, whereby it should be possible to diagnose faulty timing. In connection with the work on the NSIA's investigation report, the manufacturer stated that work was in progress to further develop this tool to ensure that timing faults could be even more easily detected.

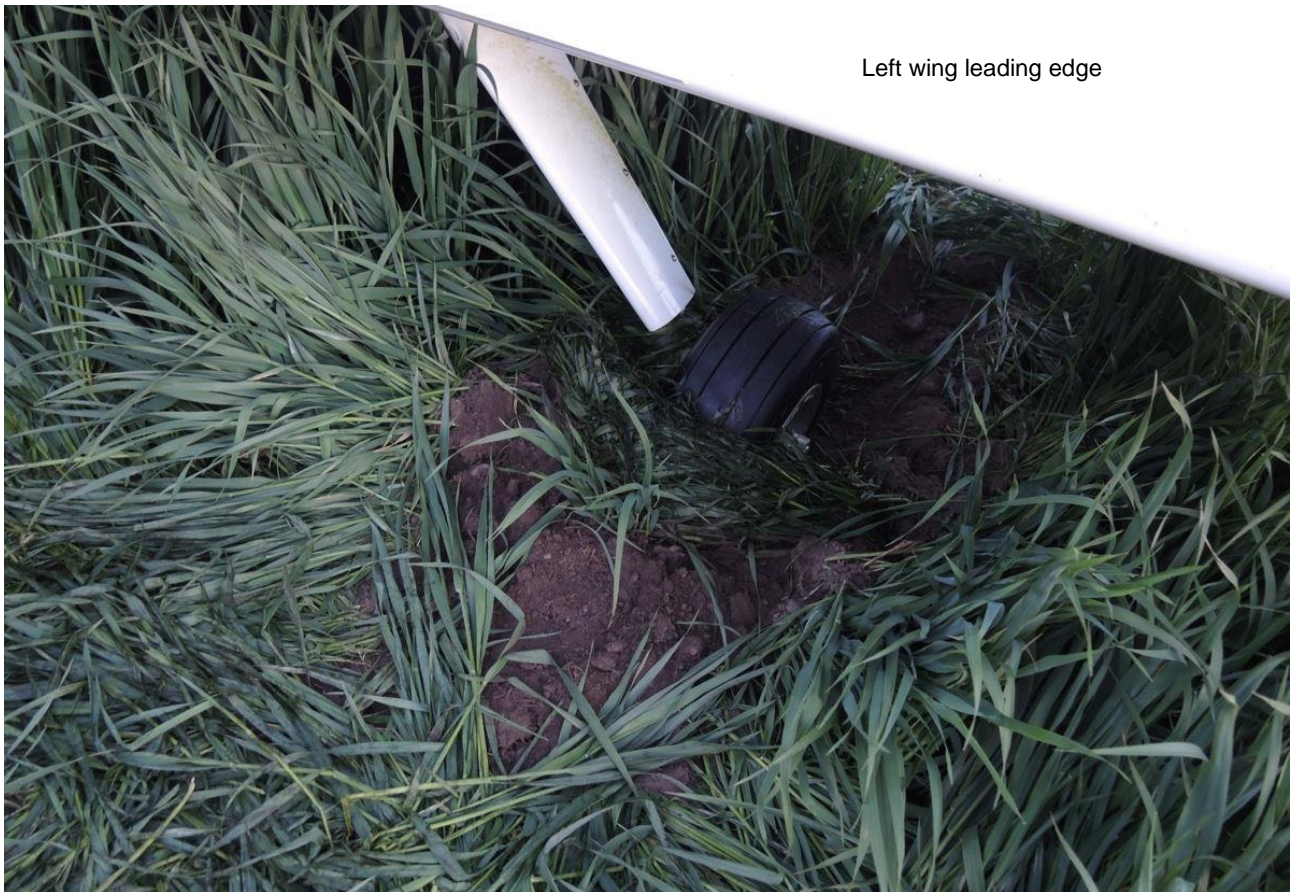
Figure 7: Deep tracks in the surface from the left main wheel. Photo: NSIA

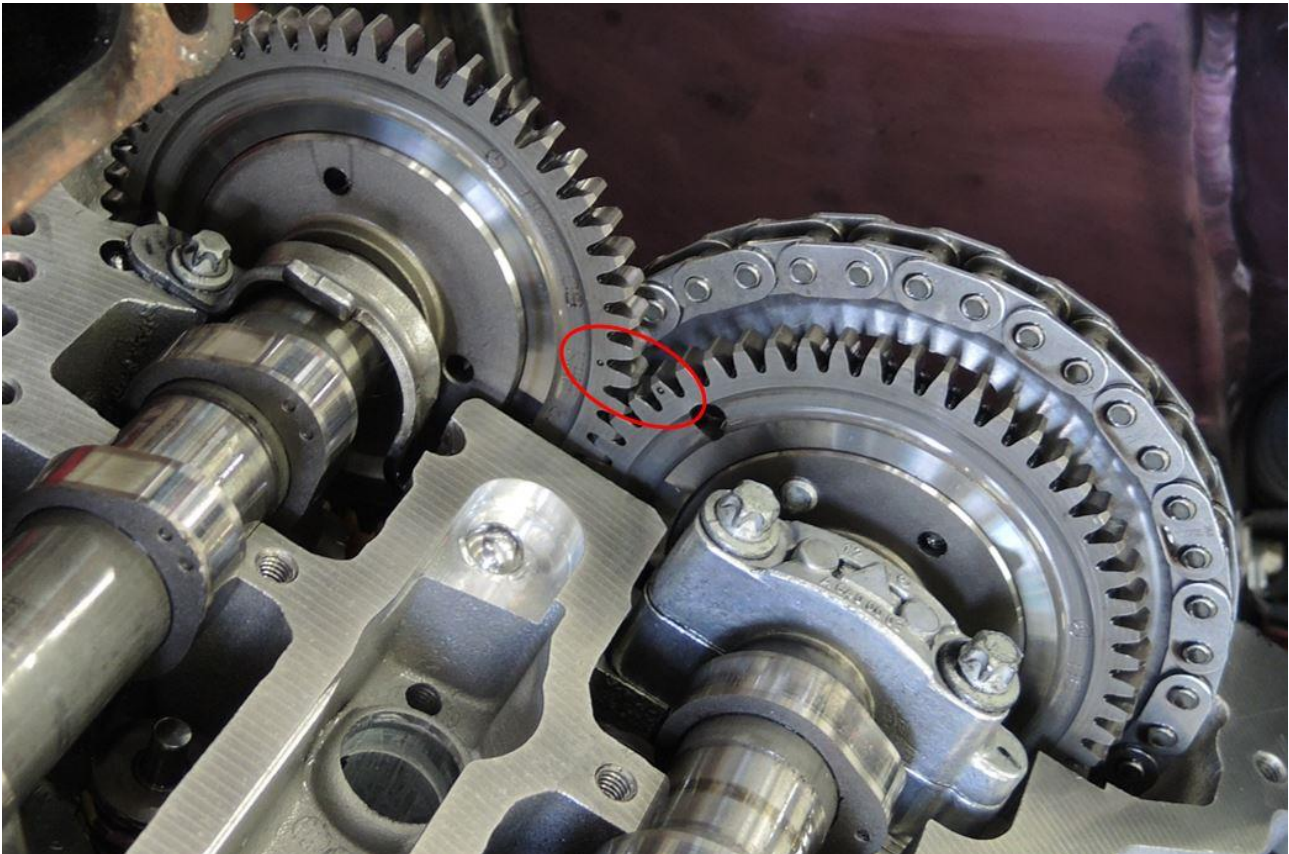
- The glow plug for cylinder 1 was broken. The other three glow plugs were intact.
- The alignment marks on the camshaft gear wheels showed that they were correctly positioned in relation to each other (see Figure 8). By mistake, the crankshaft position was not measured before the chain was removed.

Figure 8: The photo shows that the camshaft gear wheels were correctly positioned in relation to each other. The red circle marks the alignment marks on the wheels. Photo: NSIA

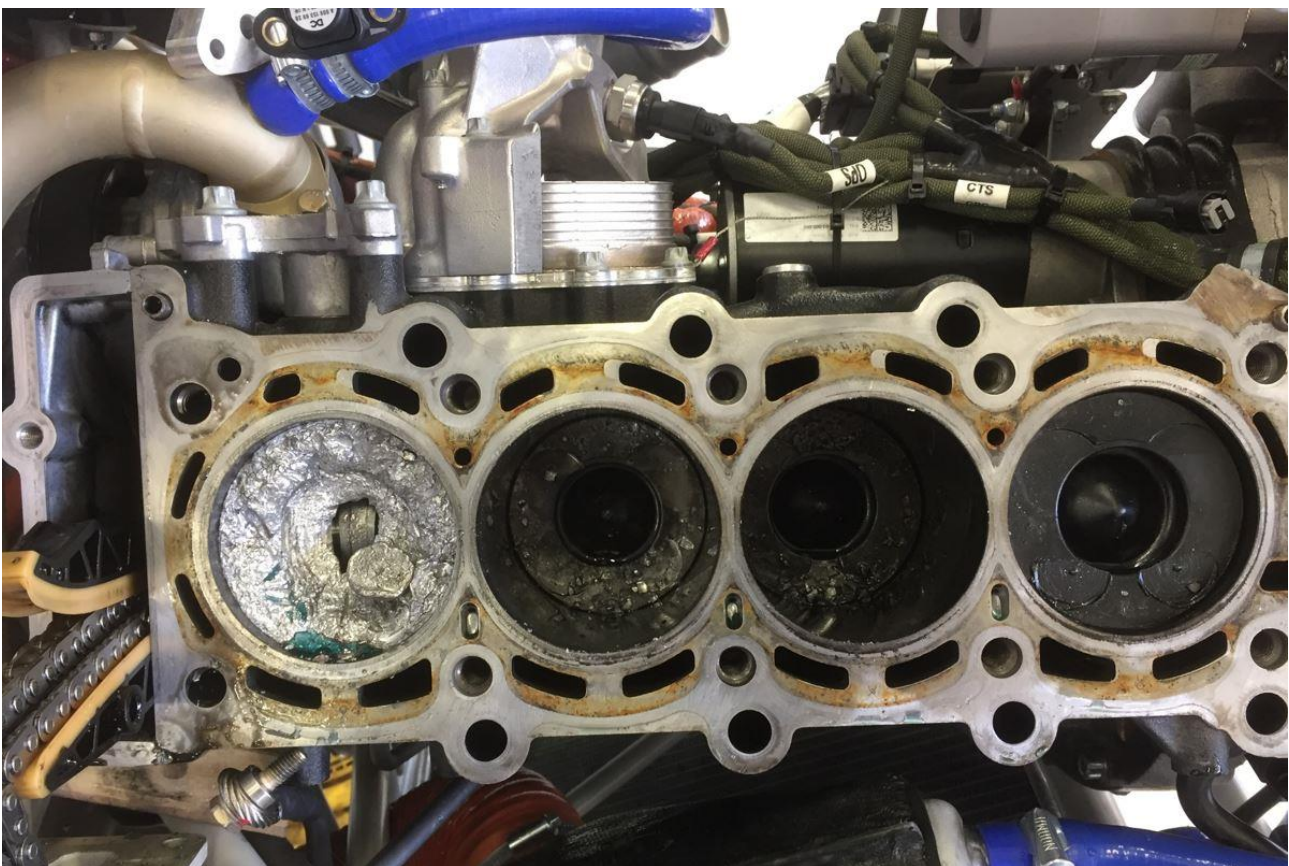
- The rocker arm for the forward exhaust valve in cylinder 1 was broken.
- The chain tensioner was tensioned and appeared to be intact.
- After removal of the cylinder head, the piston crown in cylinder 1 was found to have been completely destroyed. Parts of a broken valve protruded from the piston crown. Part of the piston rod was visible through a hole in the piston (see Figure 9). Three of four valve stems were broken.

- The other pistons were also damaged with scars, notches and pits after impact with jagged foreign objects. Metal fragments were found on the crowns of these pistons, mostly in cylinder 2, but with decreasing amounts in cylinders 3 and 4, respectively (see Figure 9).

Figure 9: The engine's piston crowns. Cylinder 1 can be seen on the far left. The top of the piston rod (grey in colour) can be seen in the hole near the centre of piston 1. A broken exhaust valve is lodged in the piston. Coolant residue (turquoise in colour) can be seen on the piston crown. Photo: NSIA

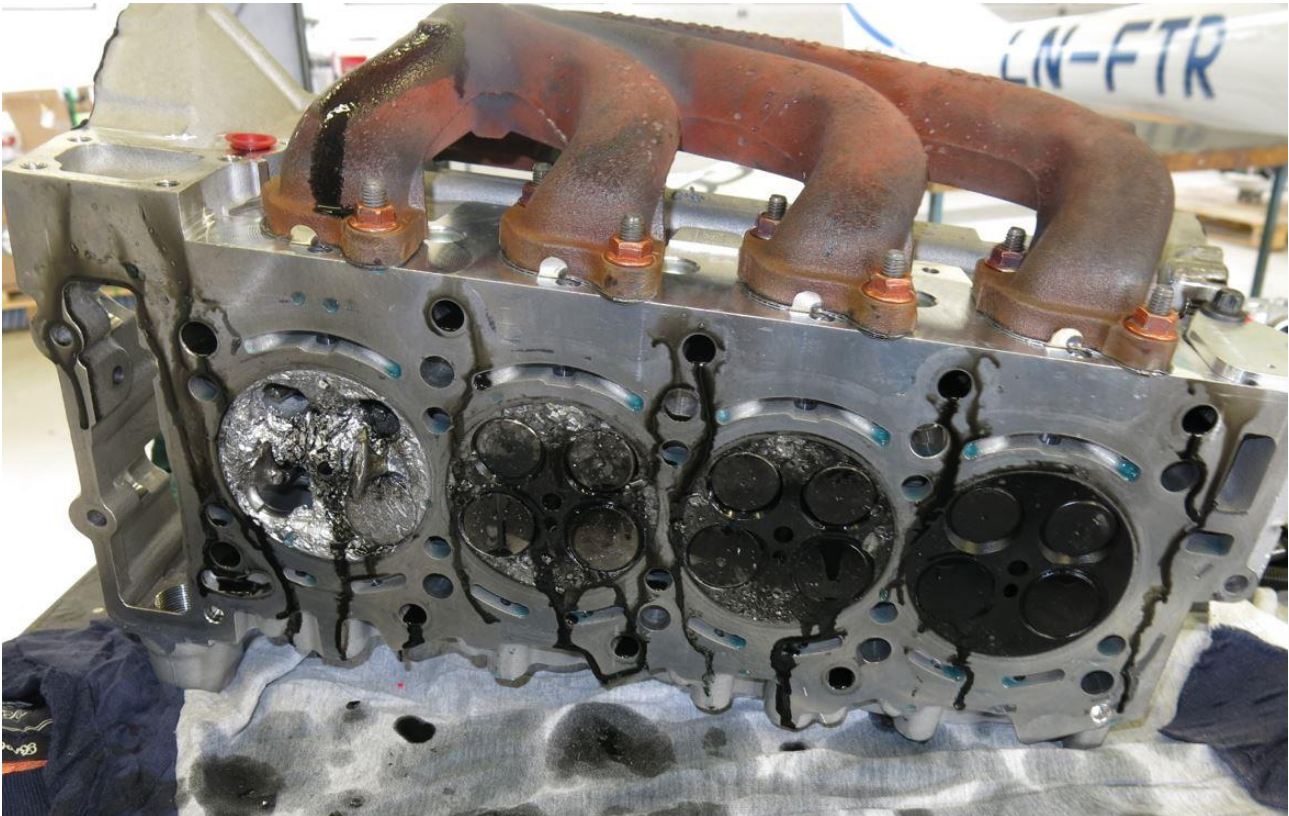
- Imprints from the exhaust valves could be observed in the three pistons crowns that had not been completely destroyed.
- The cylinder head had sustained damage corresponding to that on the piston crowns. The most extensive damage was found in cylinder 1 (see Figure 10).

Figure 10: The engine's cylinder head. Cylinder 1 can be seen on the far left. Two valves had been knocked into the metalwork and one intake valve was found to be in the closed position. The photo shows that cylinder 4, on the far right, was the least damaged. Photo: NSIA

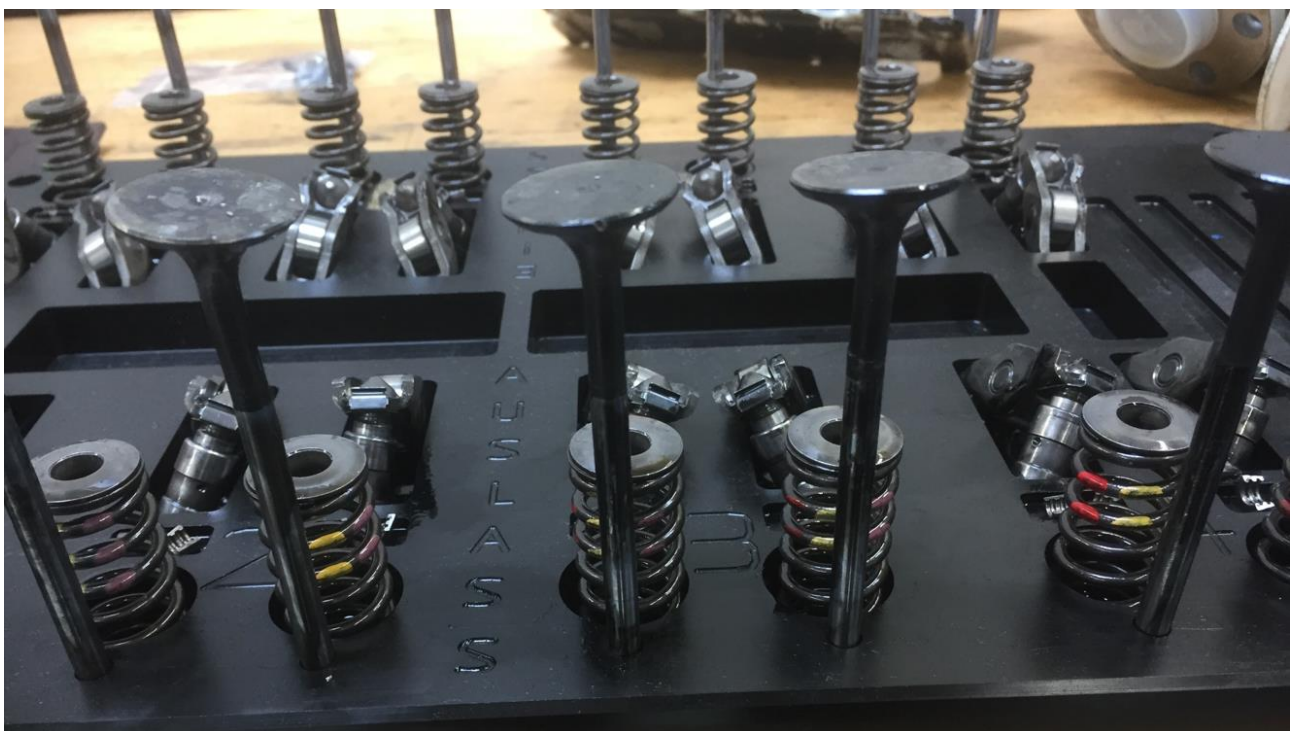
According to the manufacturer, the incorrect timing theory was supported by findings in the form of three broken and one bent valve stem in cylinder 1, and bent exhaust valve stems in cylinders 2, 3 and 4. Reference was also made to the valve imprints on the piston crowns in cylinders 2, 3 and 4. Figure 11 shows bent valve stems, while Figure 12 shows exhaust valve imprints on piston crown 4.

Figure 11: Exhaust valves from cylinders 2 and 3 with bent stems. Photo: NSIA

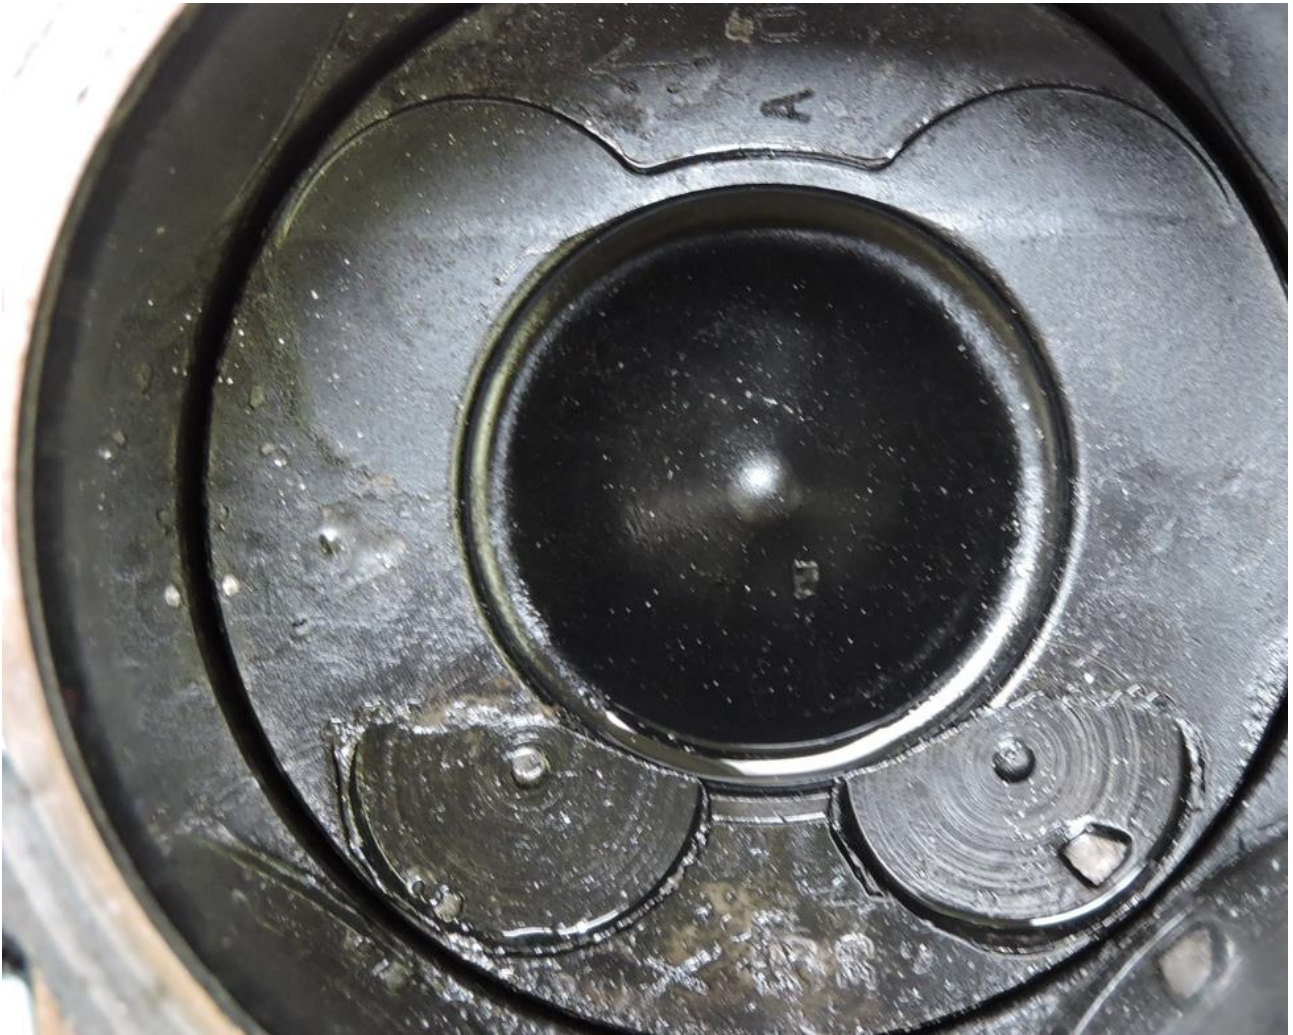
Figure 12: Imprints in piston crown 4 after impact with both exhaust valves (lower part of photo). Photo: Austrian Civil Aviation Safety Investigation Authority

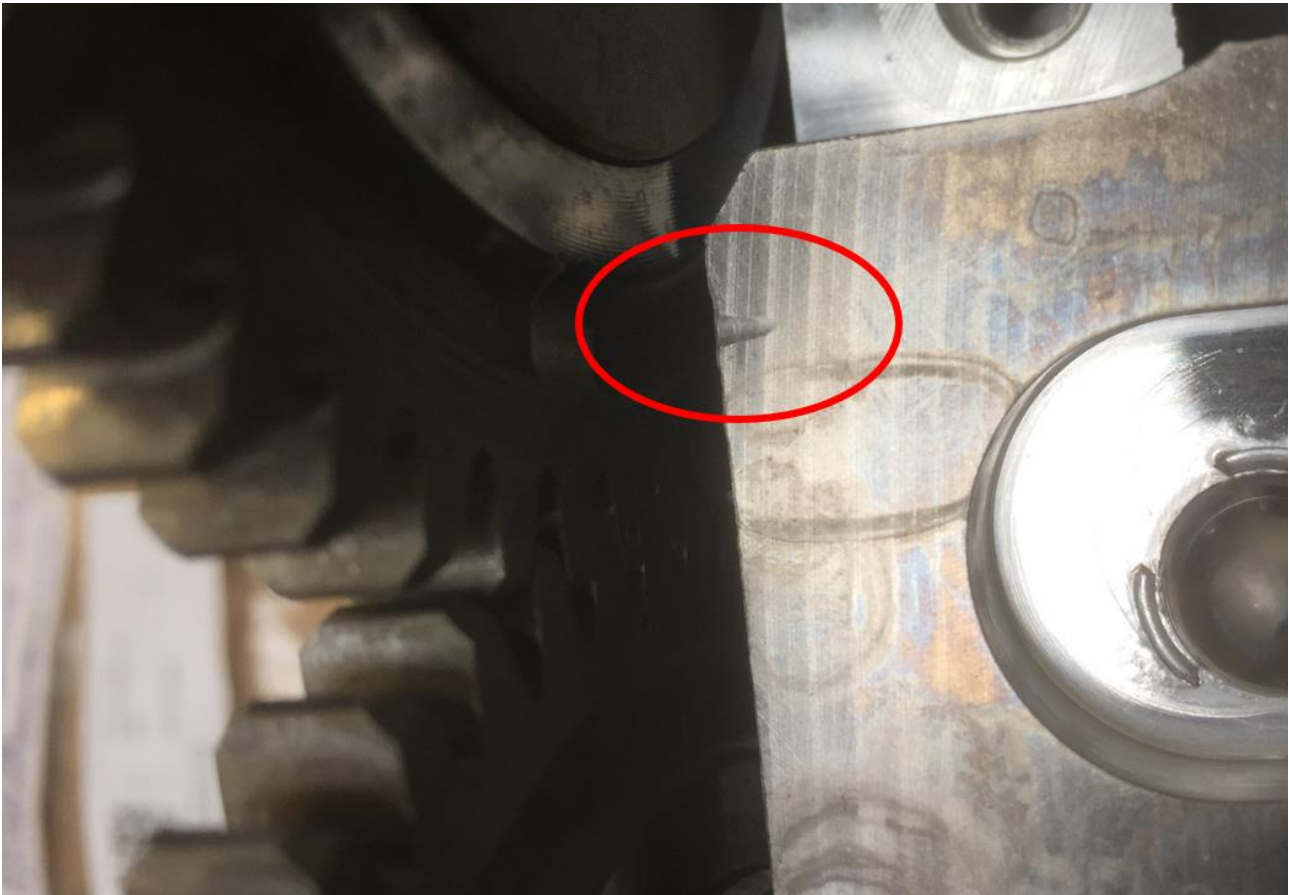
Since the camshaft and timing chain had not been removed previously, the timing fault was seen as having to do with the replacement of the cylinder head shortly before the incident occurred. Signs were found that, according to Austro Engine, could indicate that relatively strong force was applied to reinstall the timing chain after replacement of the cylinder head. Among other things, the locking tool had left marks on the metalwork (see Figure 13).

Figure 13: Marks left by the camshaft locking tool. Photo: NSIA
