REPORT

AVIATION 2022/08

***Aviation incident offshore by Ekofisk
Lima in the North Sea on 25 September
2021 involving Sikorsky S-92A, LN-ONH
operated by Bristow Norway AS***

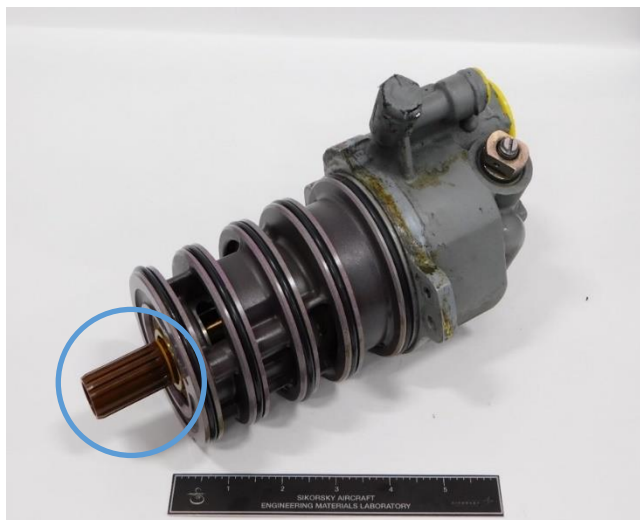
Figure 3: The oil pump. The Vespel spline adapter is marked with a ring. Photo: Sikorsky/NSIA

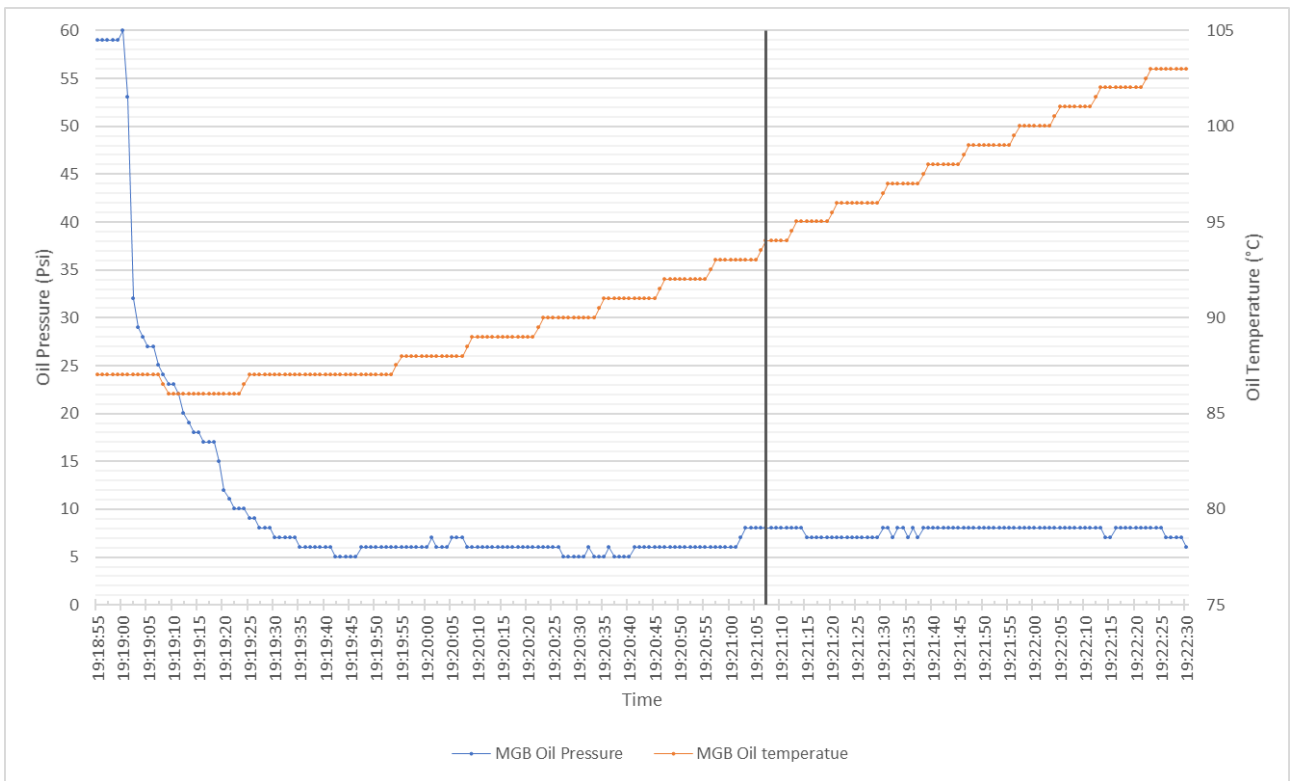
Figure 6 shows the oil pressure and oil temperature during the incident. It shows that the oil pressure dropped from 60 psi to 33 psi in three seconds. It took a further 33 seconds before the pump stopped rotating and started acting as a pseudo regulating valve. The oil temperature started to rise after about one minute. Thereafter it rose steadily during the incident, but never reached a temperature high enough to trigger an alert.

Figure 6: Oil pressure and temperature during the incident. The black line marks the landing on the oil rig. Source: FDR/NSIA

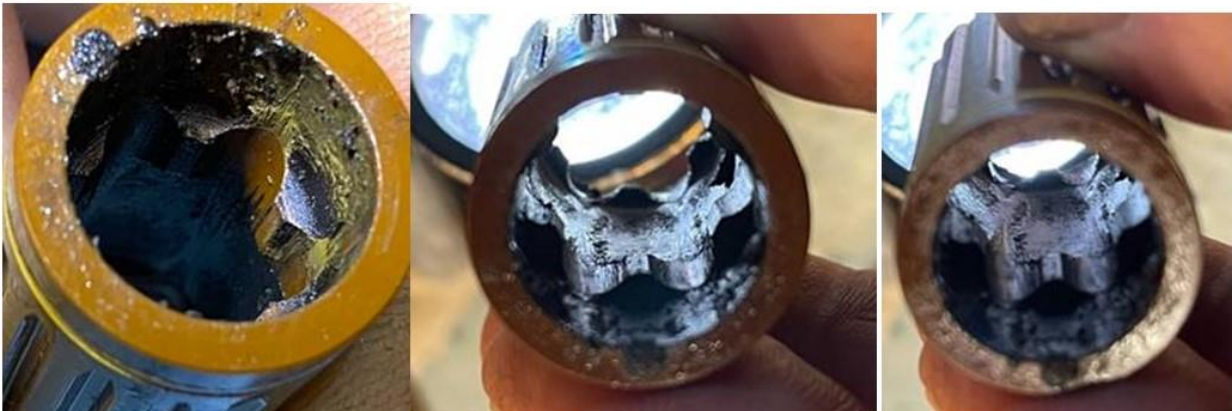
Pump nr.1 Vespel:

Figure 8: Photos of the removed Vespel spline adapters. The photo clearly demonstrates that spline adapter #1 is completely worn down internally. Wear can also be seen on spline adapter #2. Photo: Bristow/NSIA

Vespel spline adapter #1 was examined using Fourier Transform Infrared (FTIR) spectroscopy to determine its chemical composition. The composition matched with the data stored in Sikorsky's material library for Vespel material. The adapter was also imaged using microscopes. There were clear signs of heat damage to the internal diameter of the adapter.

Both the inner and outer diameter of the spline were covered in material residue. The adapter was cleaned, and all the residues were collected for further analysis. The adapters were also CT-scanned. These pictures showed a large axial crack on the inner diameter of the spline.

The crack that was discovered on the inner diameter during the CT-scanning was examined next. It was first inspected under a microscope, before opening the crack to investigate the crack surface. The crack was opened by sectioning the Vespel spline adapter on the opposite side of the crack, then the crack was forced open and the Vespel spline adapter split in two.

The fracture surface was examined using an electron microscope. These images showed a dimpled surface, which is typical for a ductile overload fracture. No unusual wear patterns or characteristics were observed. The Vespel spline adapter did not contain any voids or porosity. No foreign material was found in the crack. The original fracture surface was similar to the crack that was created when the Vespel spline adapter was sectioned.

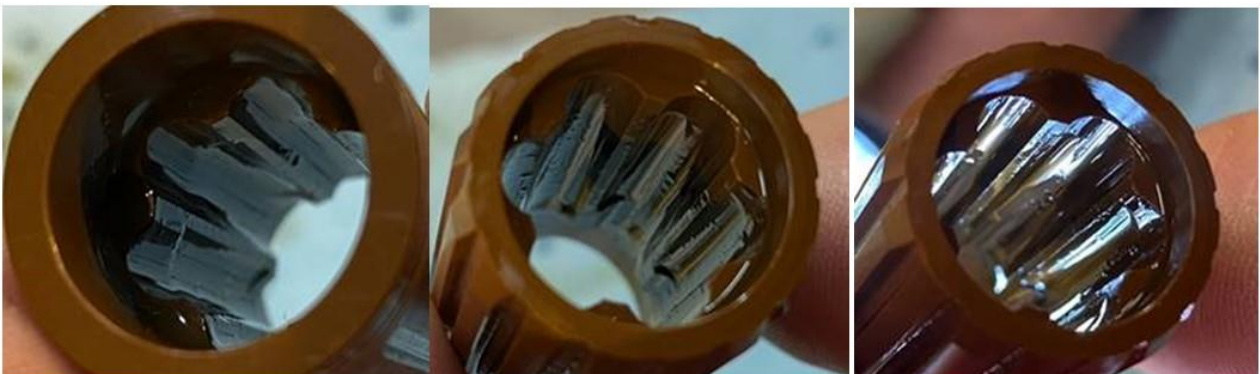
Pump nr.2 Vespel:

Vespel spline adapter #2 also had some wear on the inner diameter, but nothing abnormal for a Vespel spline adapter with a high service life.

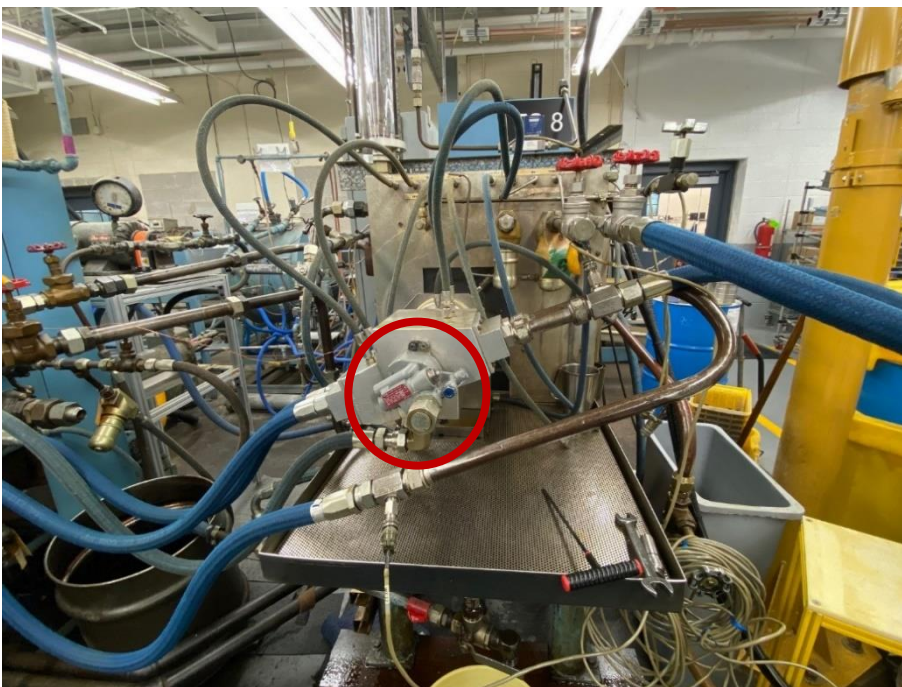
On 17 January 2022 oil pump #1 was inspected and tested by Crane Aerospace. The NSIA was present during the testing. The box containing the oil pump and Vespel spline adapter was opened, and the oil pump was inspected visually. It was noted that a lock wire was missing from the regulating valve. It was possible to rotate the pump by hand and there were no signs of binding. The pump driveshaft is normally a gold colour but was found to be purple and black. This is indicative of overtemperature. Nothing else unusual was detected.

The pump was then mounted in a test rig and an Acceptance Test Procedure was performed, which it passed. The purpose of the test was to identify whether there was anything wrong with the pump and to determine the pump's current performance. No faults or anomalies were detected, and the pump operated within expected limits. It was noted that the pump had an output flow of 15.8 Gallons per minute (GPM), while it should normally lie between 14.6–14.8 GPM.

Figure 9: The oil pump from LN-ONH in the test rig. The pump is marked with a red ring. Photo: Crane Aerospace/NSIA
