# REPORT AVIATION 2022/10

***Serious aviation incident in  
Kongsvikdalen, Tjeldsund municipality in  
Troms og Finnmark county  
20 November 2021 involving Airbus  
Helicopters MBB-BK117 D-2, LN-OOS,  
operated by Norsk Luftambulans AS***

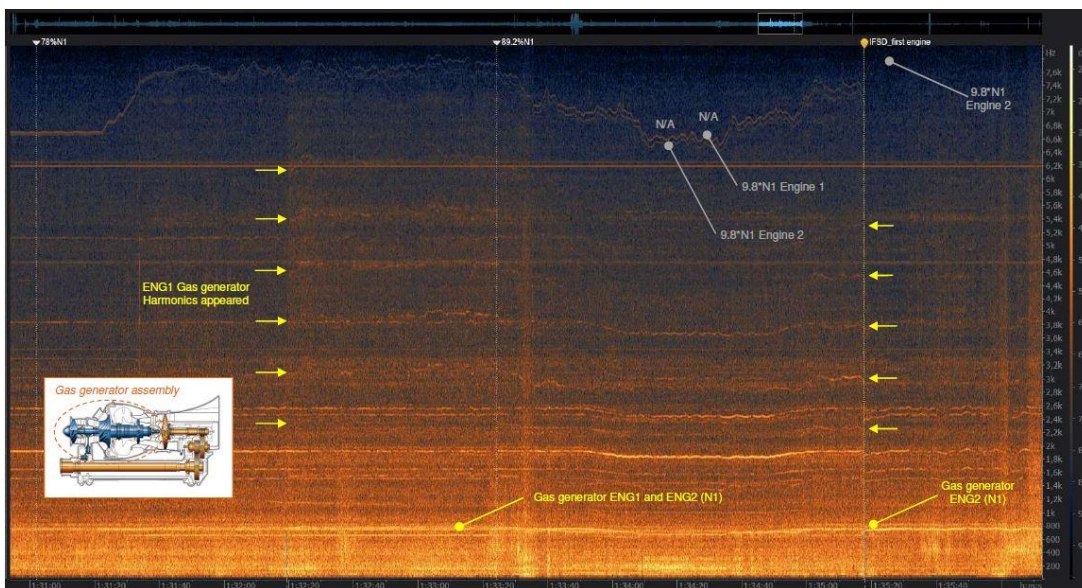
On behalf of the NSIA, the BEA conducted a spectral analysis of the noise in the cockpit. This found that 2 min and 57 seconds before the left engine shut down, several unusual harmonics emerged from the engine's gas generator. This type of acoustical irregularity is typical of foreign object damage to an engine.

Figure 8: The spectral analysis conducted by the BEA. Source: BEA / NSIA

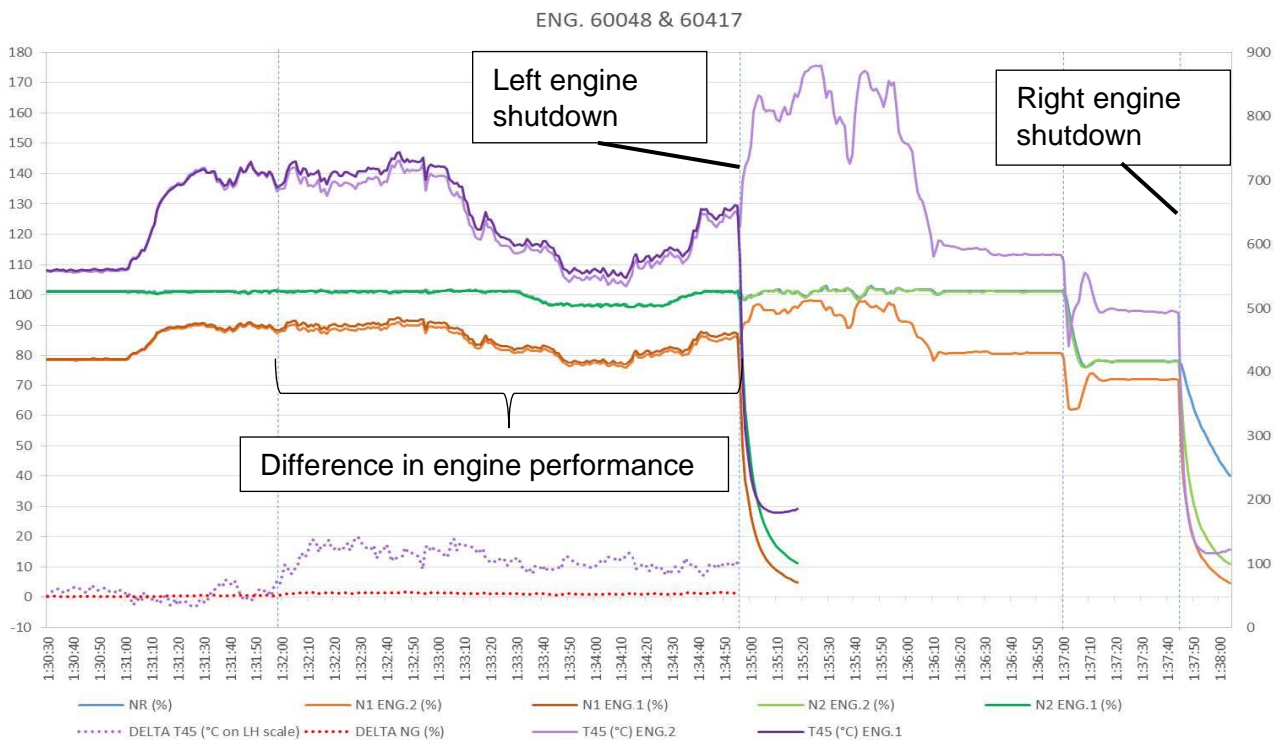
Figure 9: Graph of some of the engine parameters during the last eight minutes of the flight.  
Source: Safran / NSIA

Figure 9 shows the engine parameters for the 8 last minutes of the flight. It can be observed that a difference in gas generator rpm and turbine temperature about 3 minutes before the left engine shut down. The difference correlates in time with when the acoustical anomaly appeared.

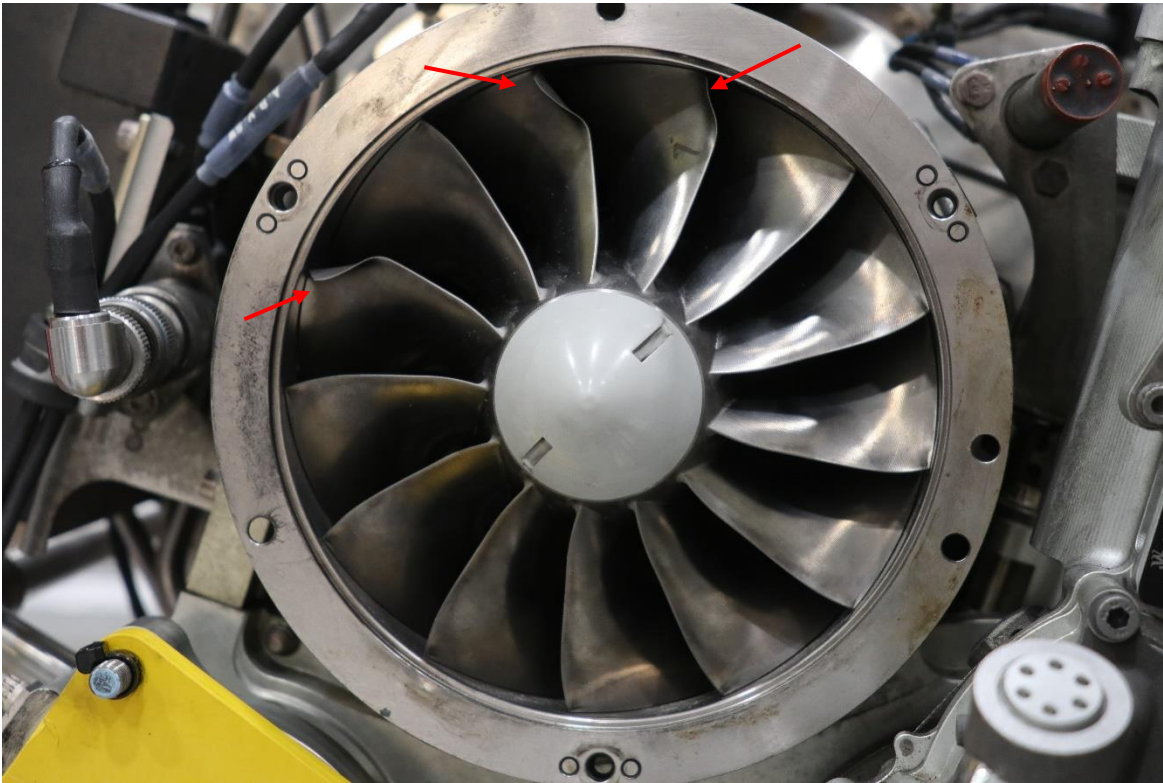
Visual inspection a few days later showed soft FOD<sup>17</sup> damage on the compressor blades in the axial compressor of both engines. There was more damage to the left engine. The right engine had minor damage that was detected using a specialist tool.

Figure 11: The left axial compressor. The arrows highlight bent compressor blades.  
Photo: NSIA

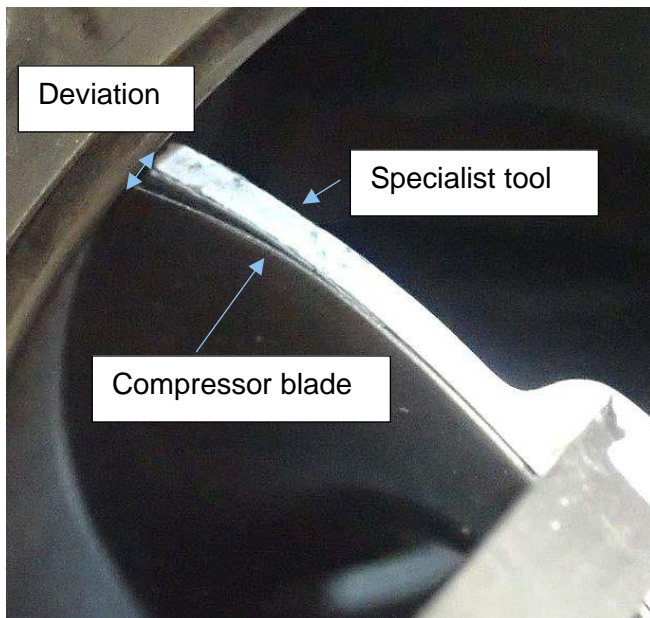
Figure 12: One blade on the right axial compressor that deviates from the specialist tool used to indicate the correct blade shape. Photo: Safran / NSIA

less damage to the right compressor blades can be explained by the reduced rotation speed when the engine was set to idle. The NSIA cannot exclude that the ice in the right air inlet was also sufficient to cause an inflight shutdown of the right engine.

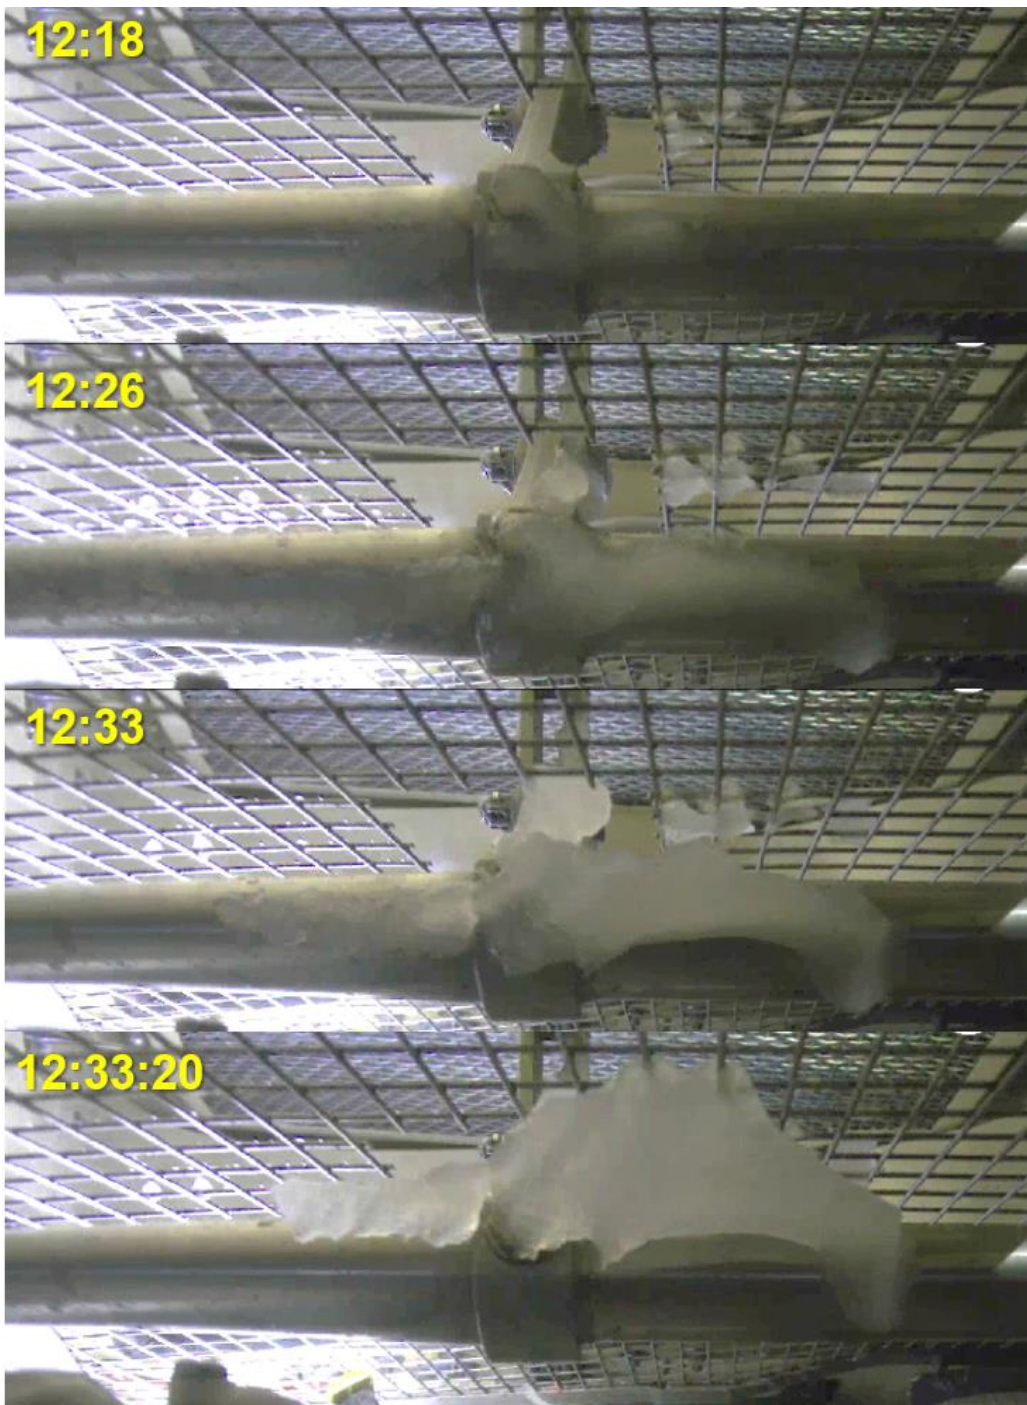
The flight tests consisted of Airbus Helicopters operating in varying snow, rain and sleet conditions to investigate how the IBF system would react. The NSIA was forwarded the results of the flight testing. The results identified a risk of significant icing in the IBF system when the air temperature is between -5 and 1 °C with high humidity (snow, sleet, rain), see Figure 13 and Figure 14.

Figure 13: Ice build-up on the bypass door actuator. The photo is taken from the underside of the IBF filter tray. Photo: Airbus Helicopters / NSIA

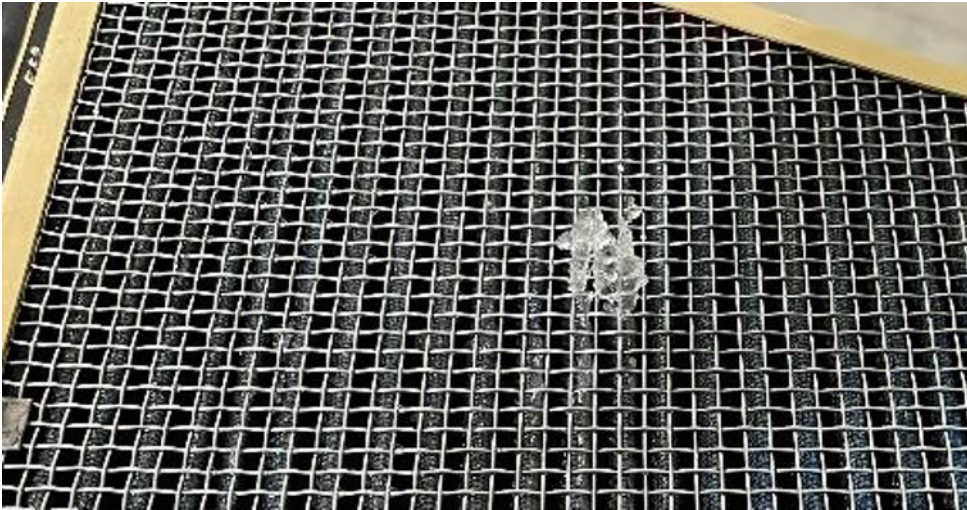
Figure 14: Ice build-up on the underside of the IBF filter. Photo: Airbus Helicopters / NSIA
