# REPORT

AVIATION 2023/01

***Serious aviation incident 20 NM north of  
Flesland on 20 January 2020 involving  
DHC-8-311, LN-WFO***

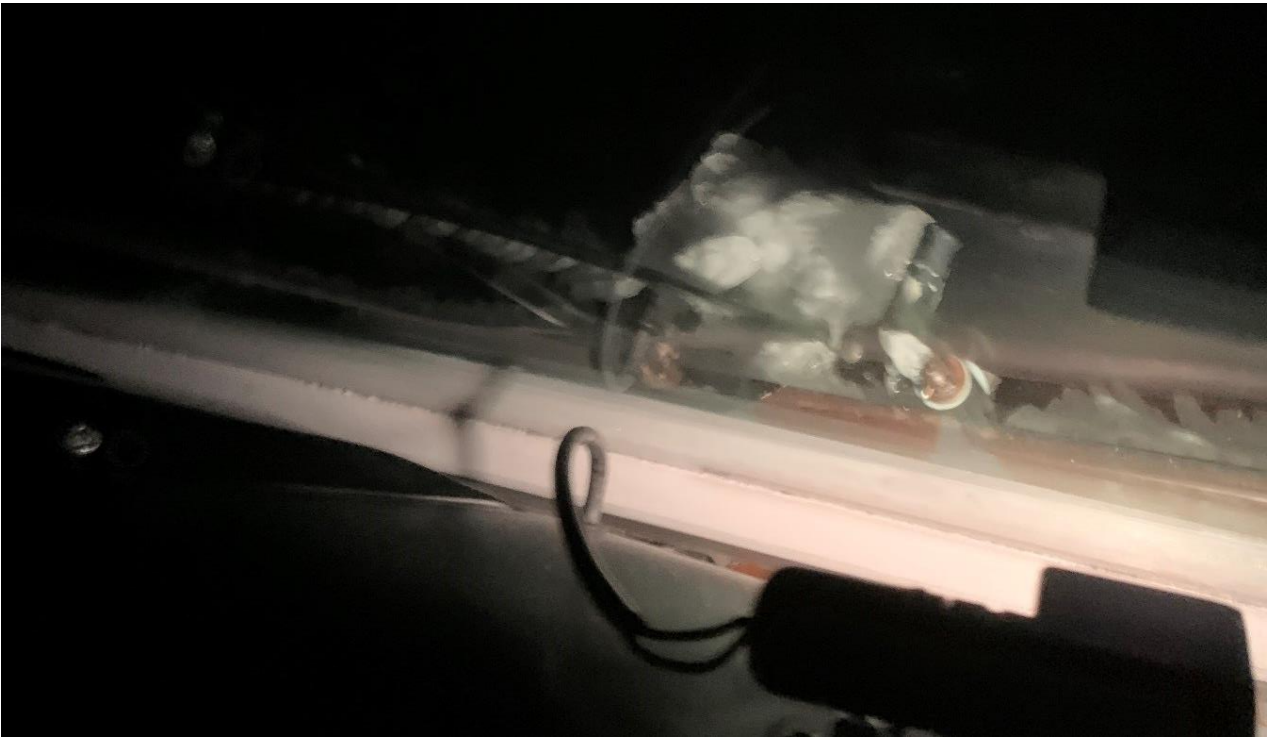
The aircraft continued at FL120 on a southerly course towards Flesland. The crew still observed thick ice on the spigot, flap fairings and spinner (see Figure 2, Figure 3 and Figure 4). In interviews with the NSIA, they have stated that they had great confidence in the aircraft's ability to withstand icing, as they had experienced similar situations several times before.

*Figure 2: Ice on spigot. The photo was taken at FL120 approx. 50 minutes after departure.  
Photo: First officer of WF577*

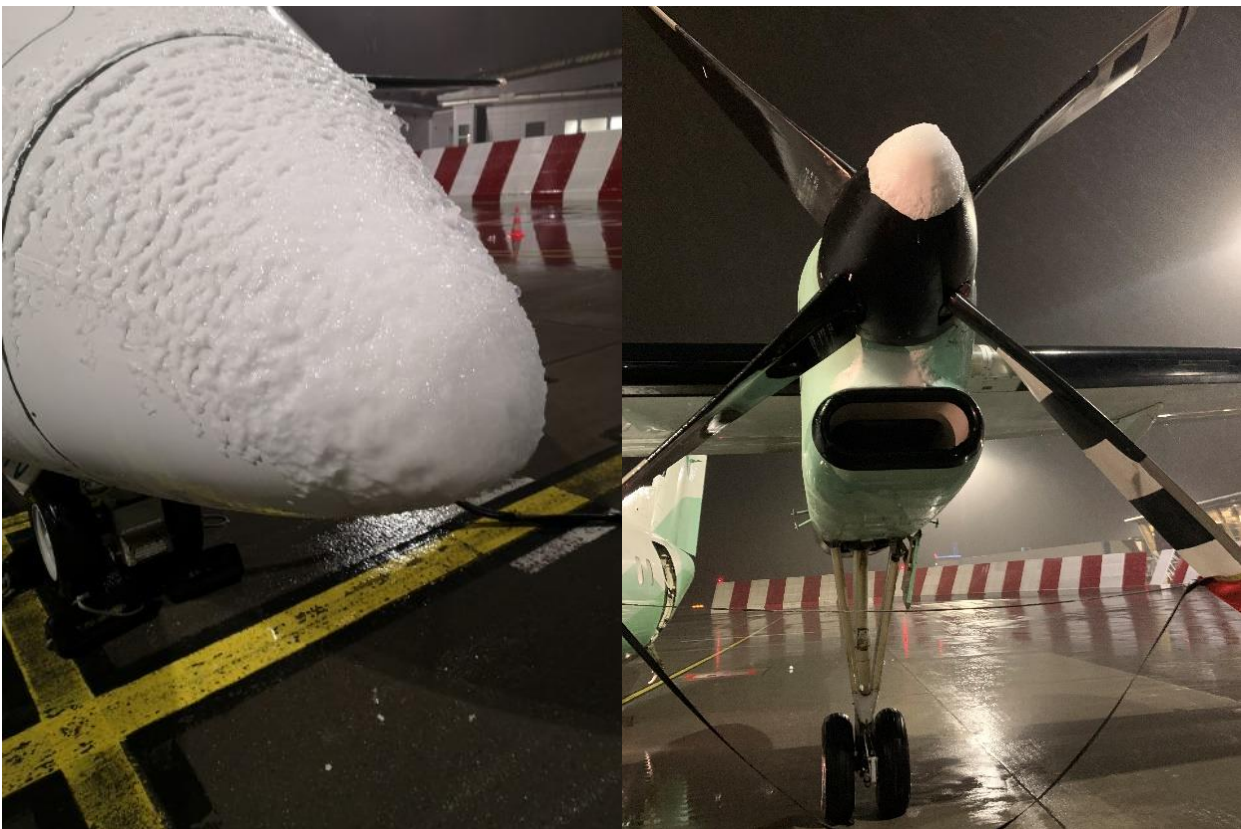
Figure 4: Remaining ice on the nose, spinner and the area between the air inlet and the spinner despite 8°C and rain at the airport. Photo: Commander of WF577

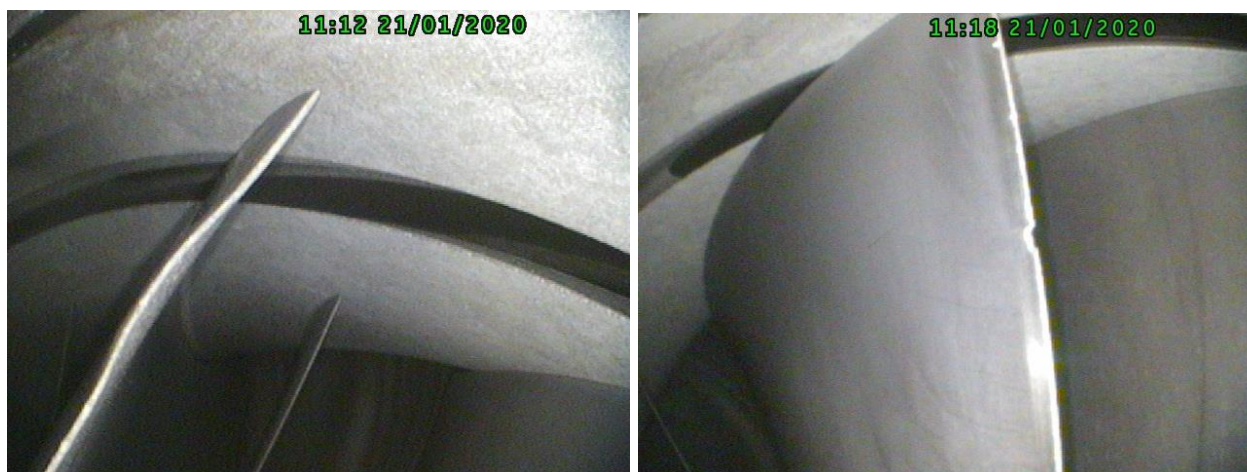
After landing in Bergen, the aircraft was towed into a hangar where a technical inspection of the fuselage and engine was performed. Both engines were inspected with a borescope<sup>8</sup>. The inspection identified damage to some of the blades in the first-stage low-pressure compressor in both engines, and some damage to blades in the high-pressure compressor in engine number 2. One compressor blade was bent, and several others were chipped. No other damage to the aircraft was identified.

Figure 5: Borescope images showing damage to compressor blades caused by ice that came off the engine inlet and was sucked into the engine. Photo: Widerøe
