AVIATION 2023/02

***Air accident 8 km west-northwest of
Larvik in Vestfold og Telemark County,
Norway on 23 November 2021 involving a
Diamond DA 42 NG, LN-PFM, operated by
Pilot Flight Academy***

Aviation accident report

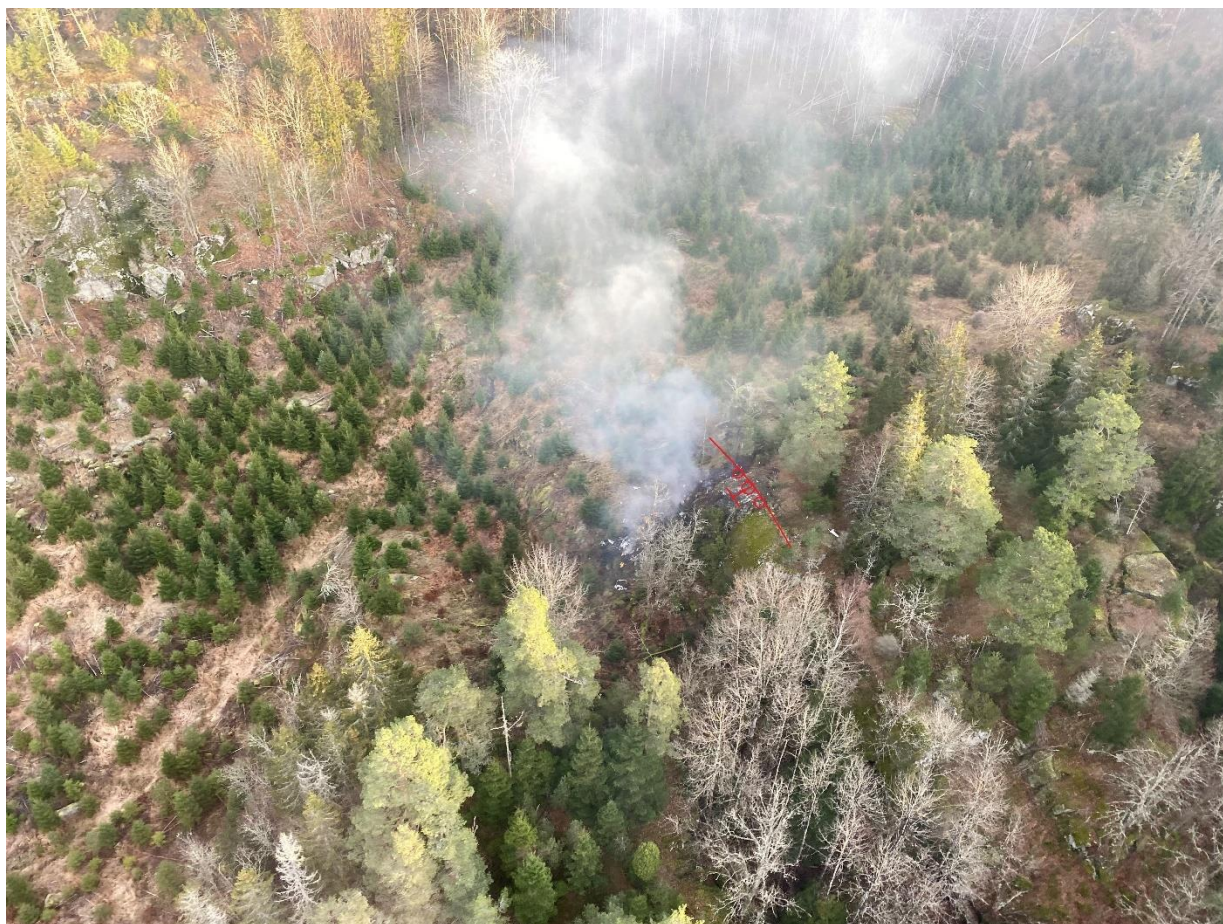
The airplane first hit a rocky outcrop at 109 m (358 ft) AMSL. It then skid 10–12 metres down a steep rock slope and came to rest at the bottom of the slope. There are bushes and trees in the area, and several trees verging on the point of impact were not hit by the airplane.

Figure 10: Overview photo looking north-northeast, taken from a helicopter that was above the crash site a few minutes after the accident. The aircraft is outlined in red at the point of impact with the ground. Photo: Private/NSIA

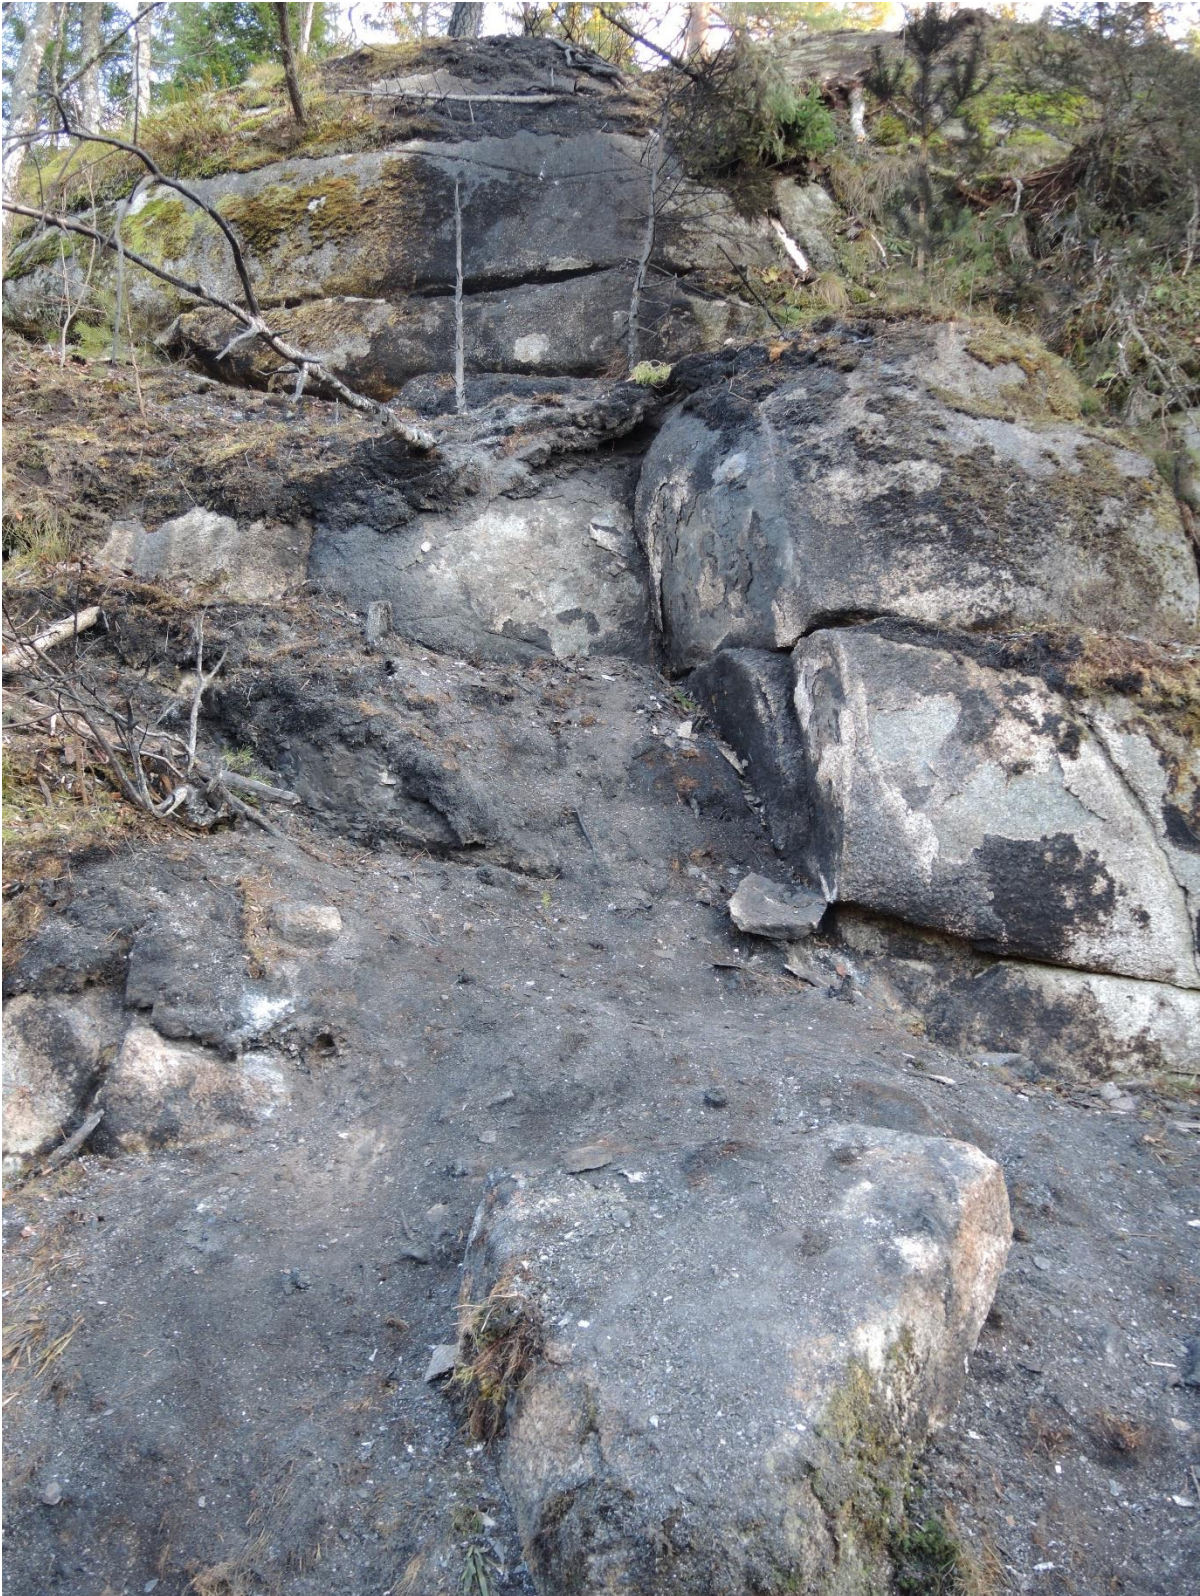
Damage to some small trees and fire damage to the ground over a limited area (see Figure 12).

Figure 12: The crash site looking east-southeast, after the area was cleared. The point of impact was the rocky outcrop near the top edge of the photo. Photo: NSIA

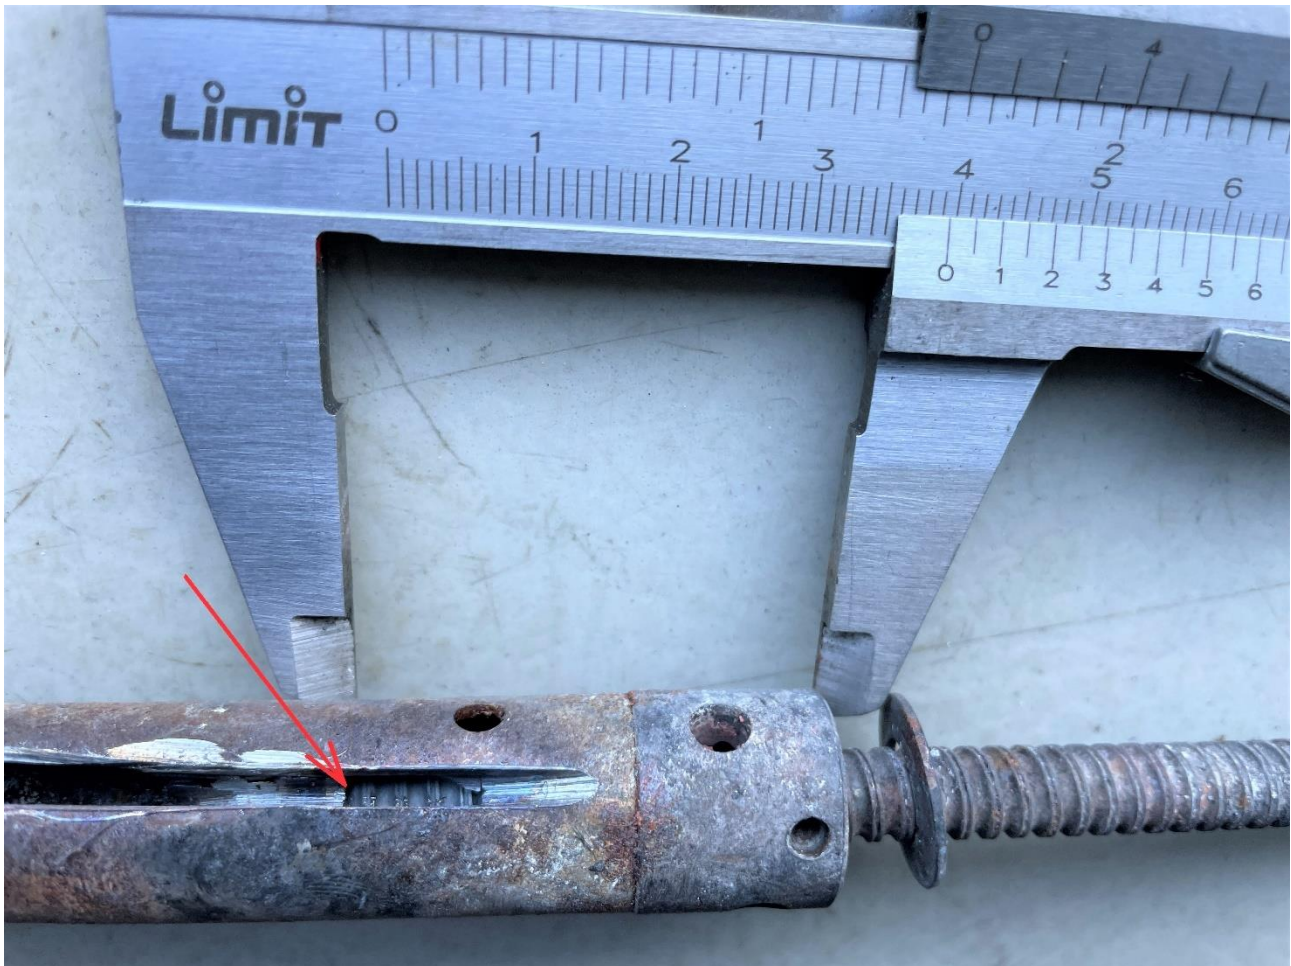
Figure 15: The rod for the flaps actuator on the left, with the jackscrew extending out to the right. The arrow points to the place where the screw has stopped against the end stop. Photo: NSIA

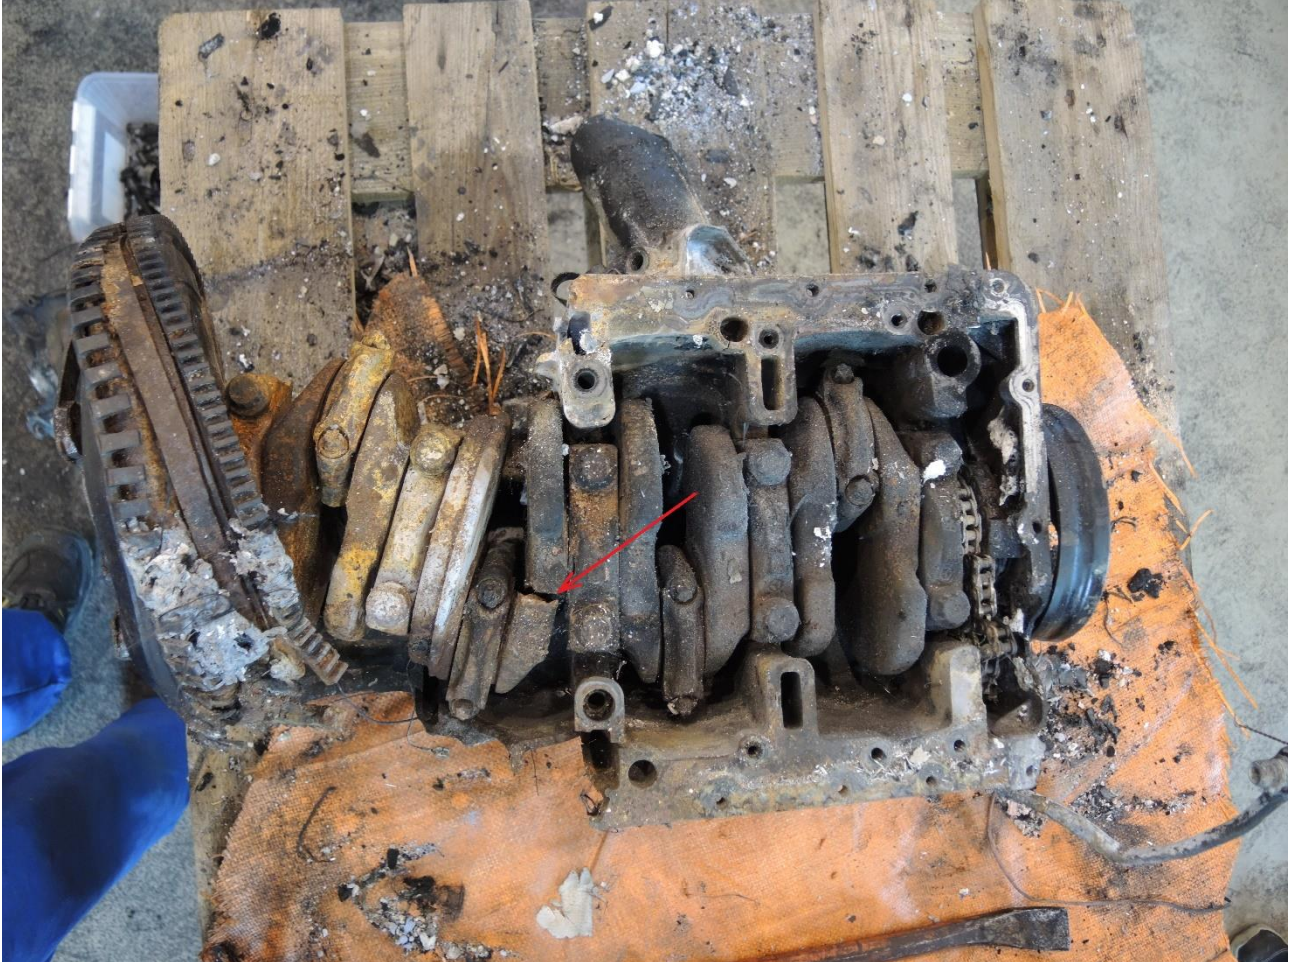
- The oil pump housing had partially melted, but the pump bore no other obvious damage.
- The forward part of the crankcase was crushed (see Figure 18).
- Unambiguous traces could not be found of contact between the flywheel and crankcase during flywheel rotation.
- All damage in the reduction gearbox was compatible with heavy impact with the ground.

Figure 18: Damage to the left engine, viewed from below. The crankcase is largely crushed or missing. The red arrow points to where the crankshaft is broken. Photo: NSIA

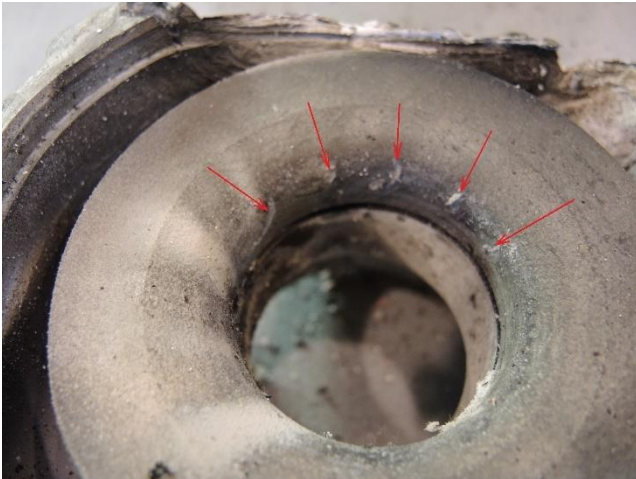
Figure 19: Compressor housing from the turbo for the right engine. The arrows point to damage to the housing from contact with the compressor rotor.
Photo: NSIA

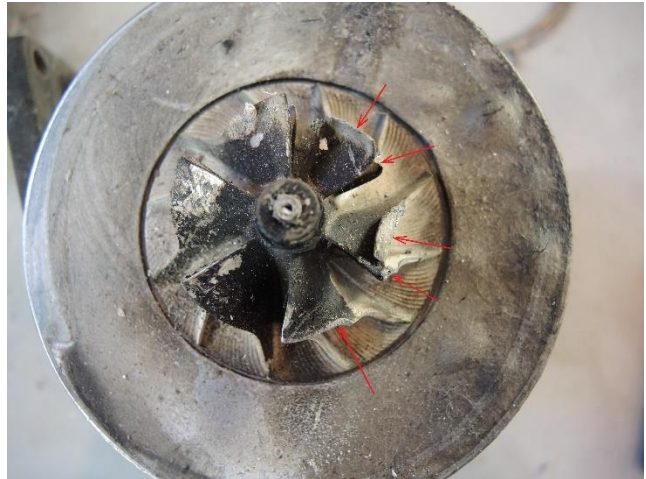
Figure 20: Compressor rotor from the turbo for the right engine. The arrows point to bent rotor blades.
Photo: NSIA

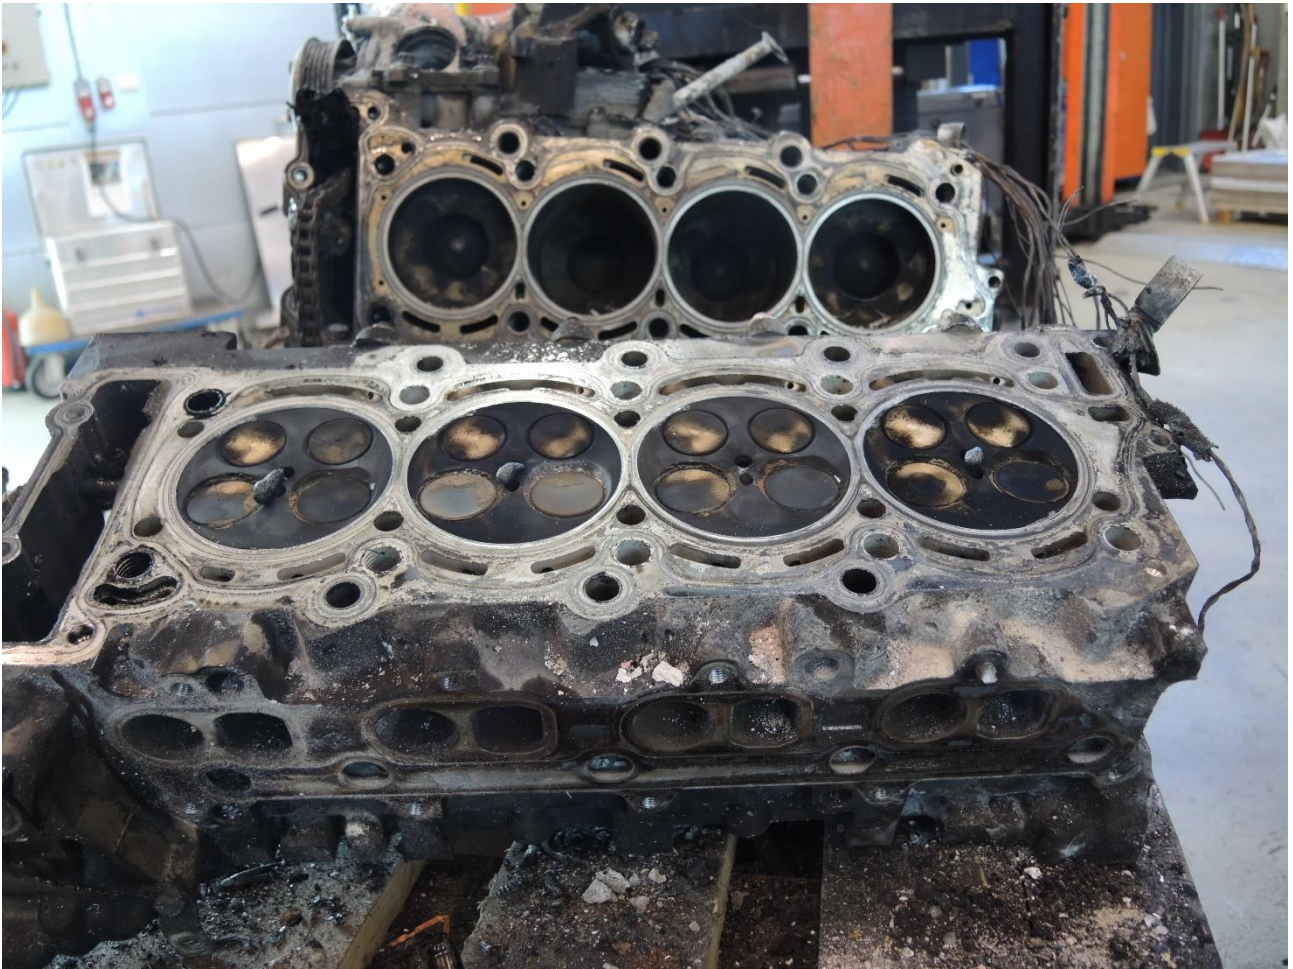
- The cylinder head and valves appeared to be in good order (see Figure 21).
- The pistons and cylinder walls above the pistons bore no traces of abnormal combustion or wear.
- The crankcase was empty of oil. The interior of the engine showed patches of soot and corrosion.
- The oil pump could rotate freely.
- Damage was found on the aft face of the flywheel (facing the crankcase), indicating that the flywheel had rotated while being pushed against the crankcase. Furthermore, several of the boltholes had become oval (see Figure 22).
- All damage in the reduction gearbox was compatible with heavy impact with the ground.

Figure 21: The cylinder head from the right engine with the engine block behind. Photo: NSIA

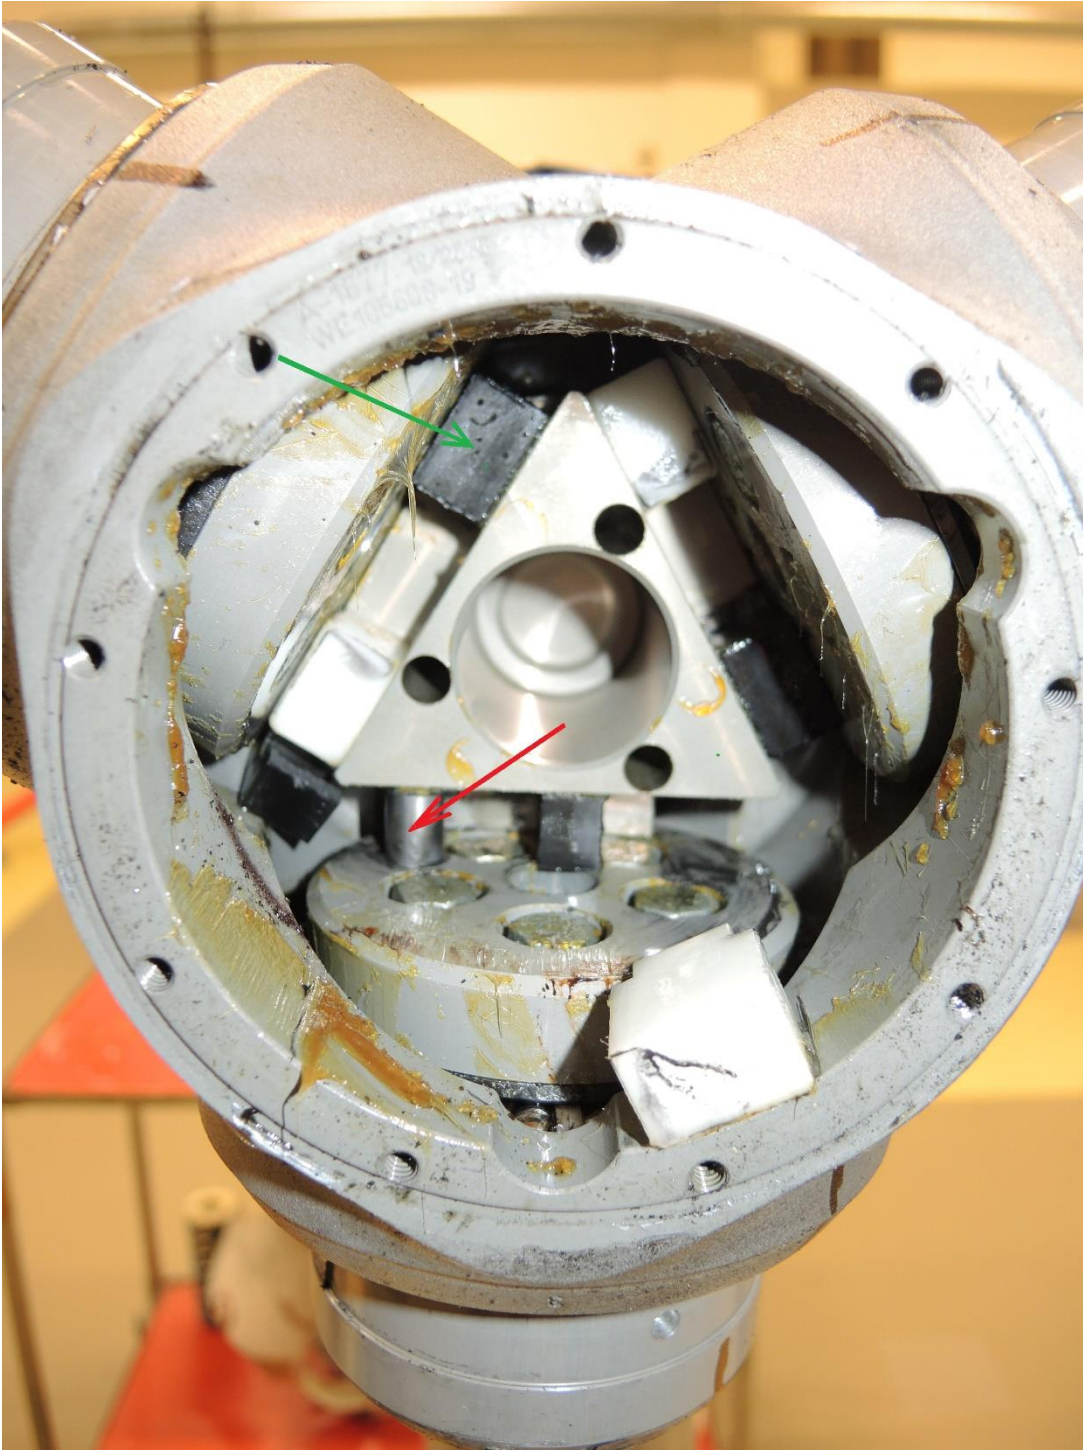
Figure 24: The right propeller after removal of the piston extension. The green arrow points to the black plastic block around the guide pin for blade 1. The red arrow points to the guide pin for blade 3, whose plastic block had fractured and fallen off. The white blocks in the photo are end stops that limit blade movement. Photo: NSIA

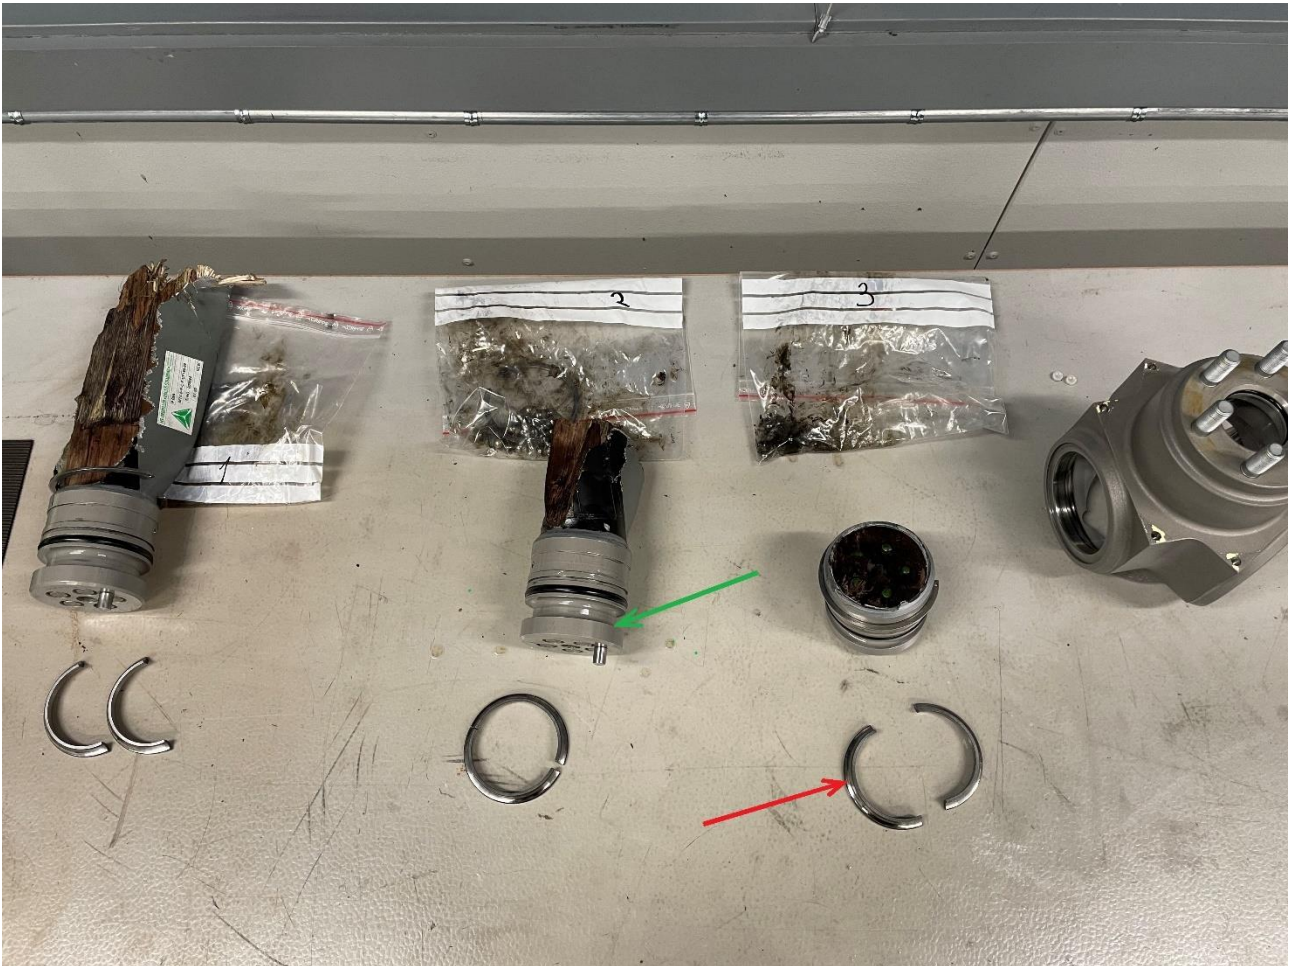
When disassembling the right propeller at Norrønafly Propeller & NDT, it was decided to mark the position of the bearing races on the blade roots (see Figure 26). Once the blade roots and bearing races for blades 1 and 2 had been cleaned of dirt and grease, they were glued back into their correct position.

Figure 26: The three blade roots from the right propeller (blade 1 on the left) and the propeller hub (on the far right). The red arrow points to the two half races that were found on blade 3. The green arrow points to the groove on the blade roots where the bearing races belong. Photo: NSIA

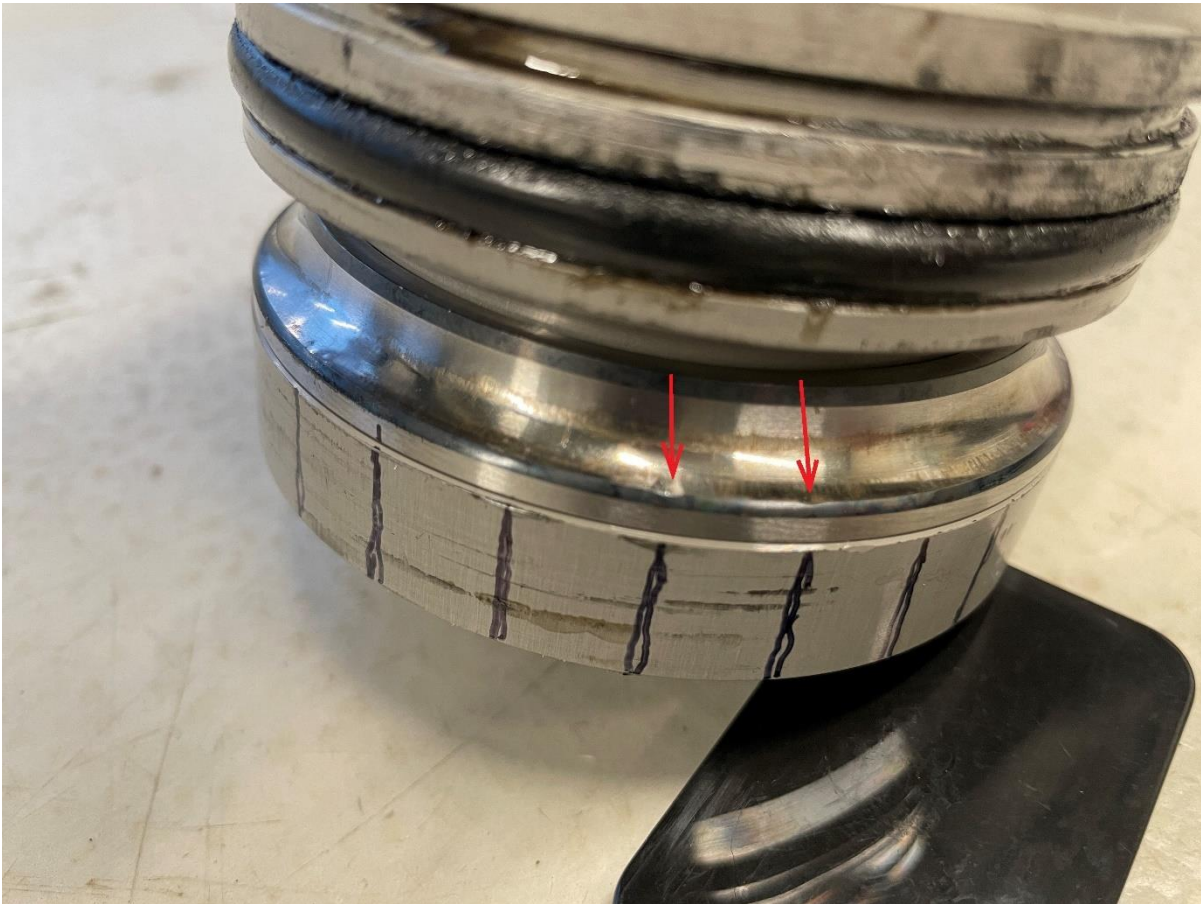
Figure 27: Photo of the root of blade 1 after marking the dents with a black marker pen. Two dents that are visible in the photo are marked with red arrows. Photo: NSIA

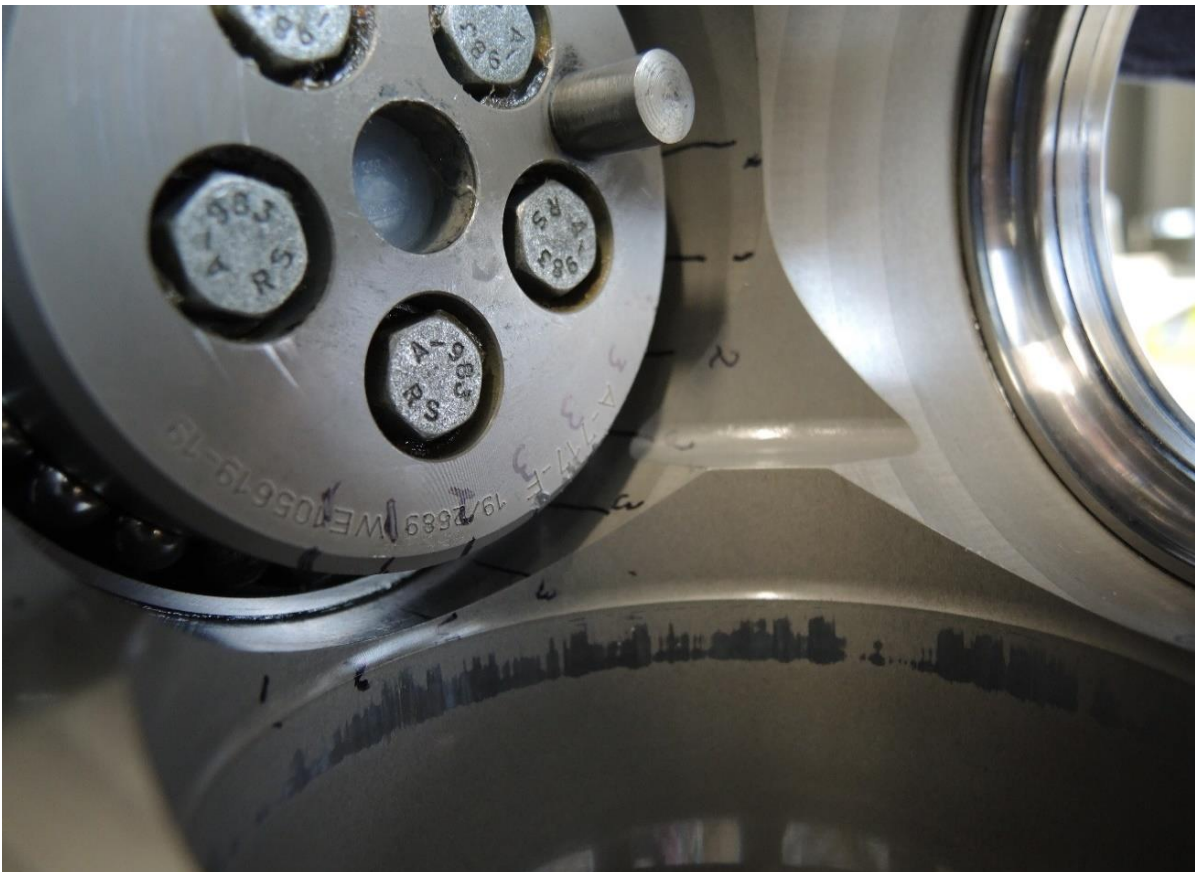
Figure 28: Blade 1 installed in the propeller hub. The numbers representing the extent of damage can be seen on both the blade root and hub. Photo: NSIA

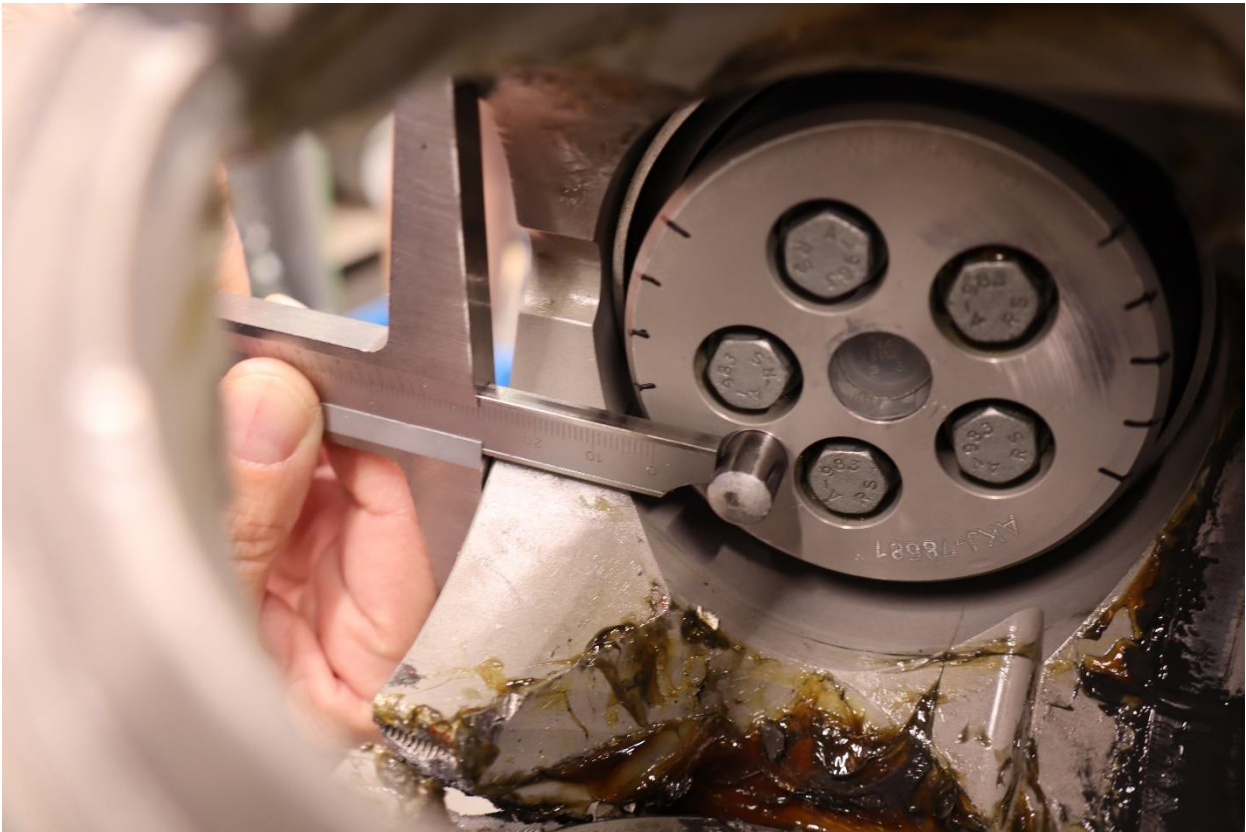
With the aid of an undamaged propeller and measuring equipment at Norrønaflly Propeller & NDT, these measurements were found to correspond to blade angles of 12.1° and 12.2° for blade 1 and 3, respectively.

*Figure 29: Measuring the distances between the blades' guide pins and the face of the propeller hub.
Photo: BFU/NSIA*
