Published December 2023

REPORT AVIATION 2023/09

***Air accident in Verdal in Trøndelag
County on 1 November 2022 involving
an Airbus Helicopters AS 350 B3,
LN-OBP operated by Midtnorsk
Helikopterservice AS***

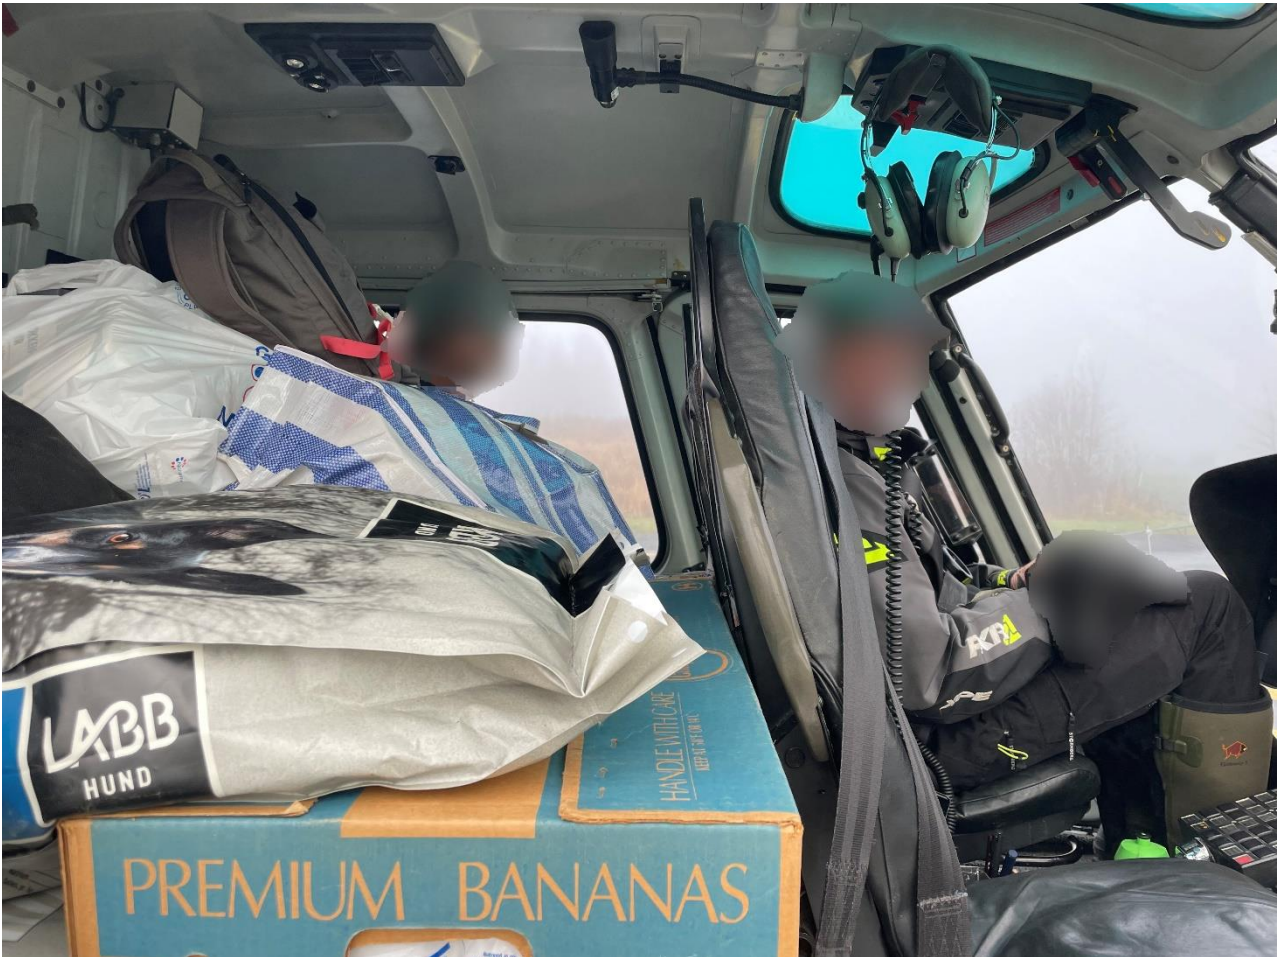
Figure 6: Photo taken by the commander towards the north-east right before take-off. Photo: The commander / NSIA

The seat of the front passenger had a five-point safety harness. Figure 6 shows that the safety harness was not fastened correctly for maximum protection. The harness was placed too high up on the stomach and not down towards the hips. The crotch strap was found stowed underneath the seat and was therefore not in use, see Figure 11. Most AS 350 helicopters are fitted with a four point safety harness from the factory.

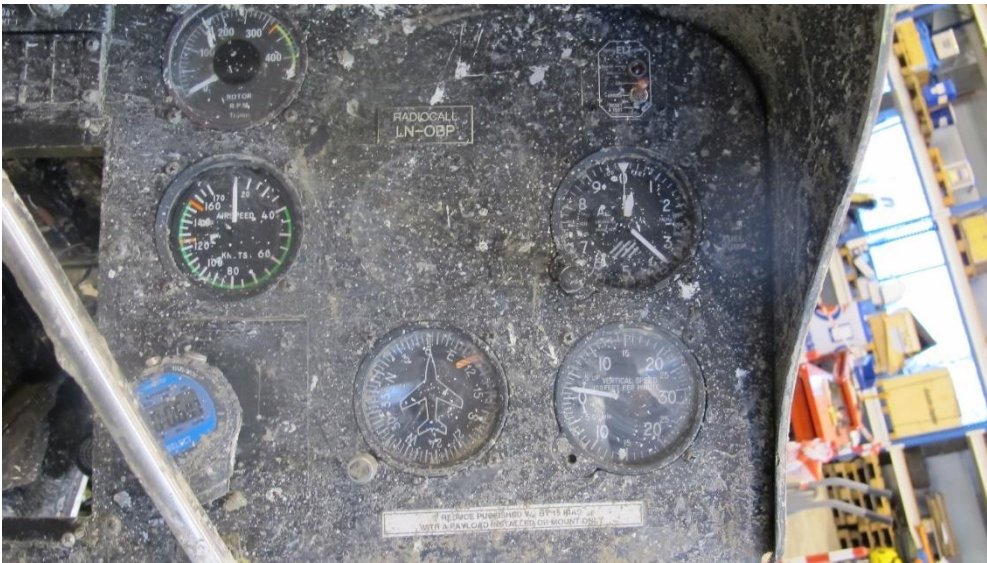
All of the irregularities had been present a while based on witness accounts and their condition. The helicopter was inspected before renewal of the Airworthiness Review Certificate⁶ in June 2022⁷. The artificial horizon was at this time removed and the centre console was present. Before the ARC is renewed, the helicopter is inspected by an approved organisation, which forward its

Figure 8: The artificial horizon should have been installed under the sign “Radiocall LN-OBP”. The hole after the instrument was covered with electrical tape. Photo: NSIA

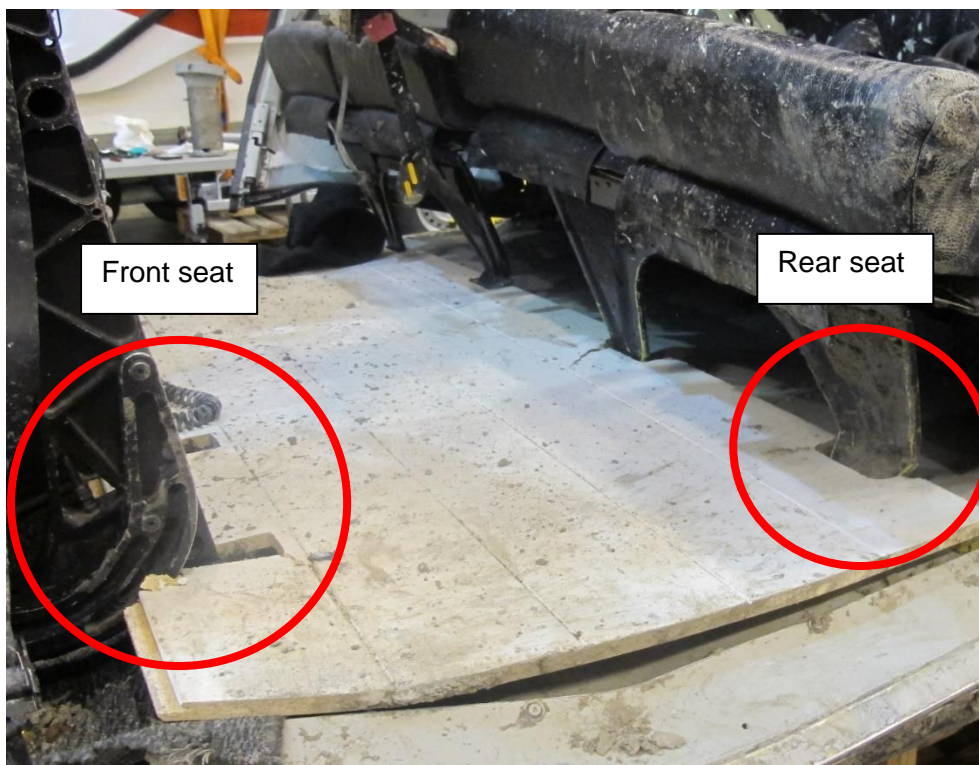
- A fibreboard plank was found on the floor in the rear cabin. The plank was cut such that it fit with the seat fixtures. It did not fulfil fire requirements and interfered with the structure of the rear seats and the energy absorption mechanism of the front seats during the accident. The plank was just laid on the floor and not fastened.

Figure 9: The fibreglass plank on the floor of the rear cabin. This came in conflict with the energy absorption mechanism of the front seat and the structure of the rear seats, marked with red rings. After the accidents it was no longer possible to remove the plank without destroying it. Photo: Airbus Helicopters / NSIA

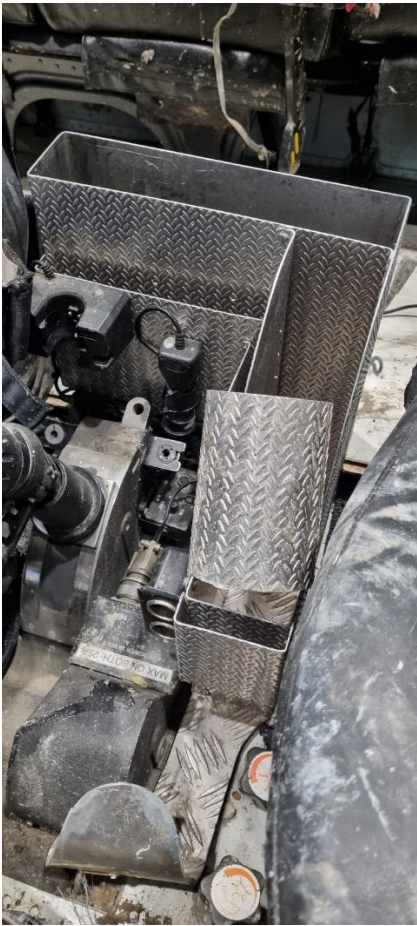
- A homemade centre console of corrugated aluminium was found in the helicopter. A bottle holder on this console broke during the accident. This meant that an aluminium cylinder was thrown about the helicopter. Airbus Helicopters produce certified consoles for installation. The console was fastened to the helicopter by latches and three cargo rings. One of the latches broke during the accident and another was loose since the bolt had slid open.

Figure 10: The homemade centre console. The bottle holder is placed in the console for the photo. It was fastened on the front of the console where it can be seen that the plate is bent upwards. The console used latches to attach to three of the helicopters cargo rings. One of the latches broke while for one of the others the bolt had slid open. A green bottle can be seen in the bottle holder in Figure 6. Photo: NSIA

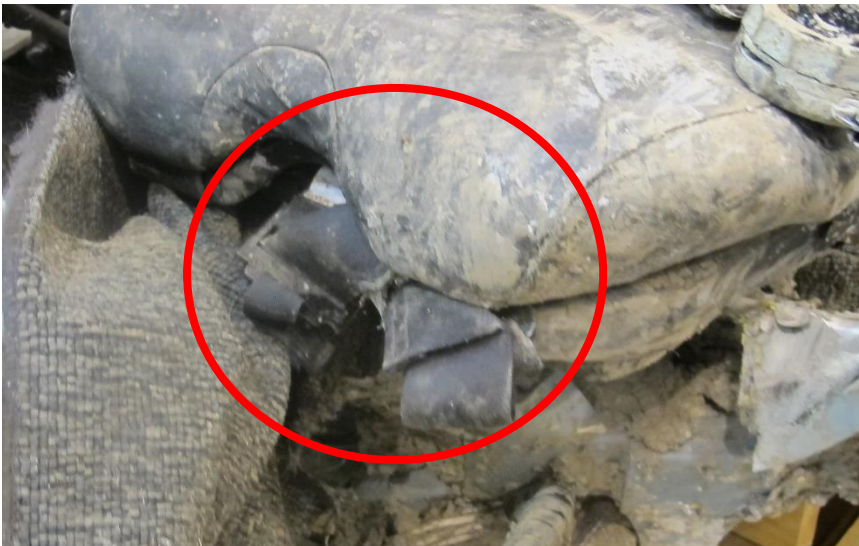
- Both the seats in the cockpit were equipped with five point safety harnesses. The crotch strap of the front passenger was found stowed underneath the seat and was unavailable for use.

Figure 11: One of five straps for the front passenger seat was stowed underneath he seat. Photo: SHK

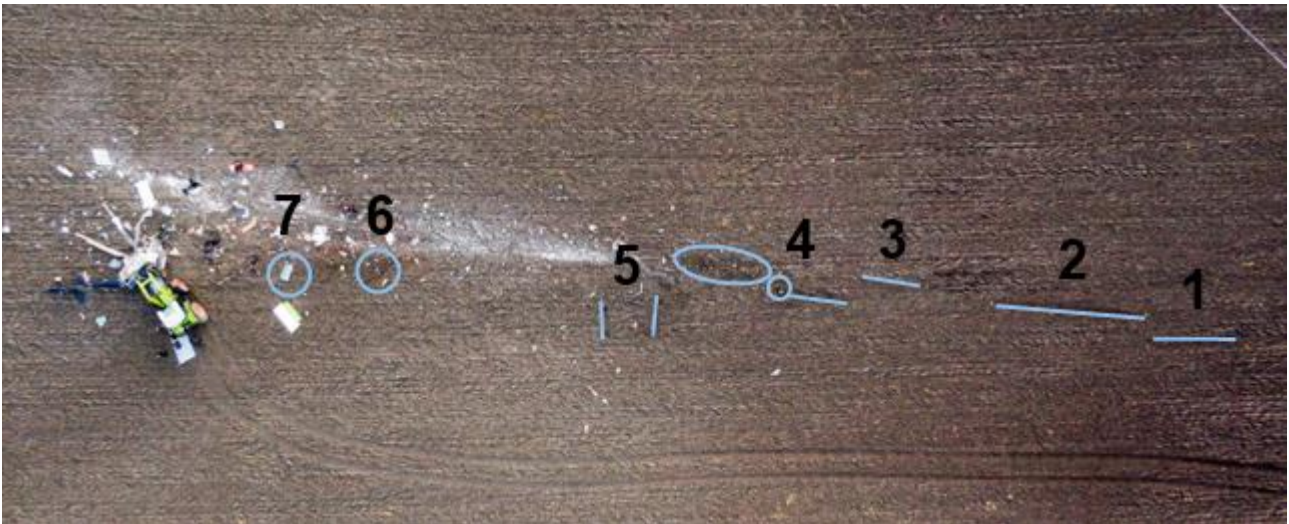
The first contact marks on the ground, see Figure 16, were from the left skid and had a length of about 5 m (1). After that, there was a contact mark from the right skid for about 13 m (2). There were then no marks for about 6 m before further marks from the right skid for about 6 m (3) and then marks from the left skid again. There were also marks indicating that the left skid had hit a rock and a large hole in the ground (4).

There were two almost parallel marks transverse to the direction of travel 5 m after the hole, with a distance of about 3.2 m between them (5).

There was then a gap of about 25 m before there were further marks from the helicopter (6). This was followed by a gap of 6 m before further marks (7) and a final gap of about 10 m between the last marks and the helicopter wreckage.

Figure 16: The accident site with contact marks highlighted. The numbers reference the text description above. The tractor that was used to free one of the passengers is seen in the picture. A bucket of paint, which was part of the luggage, was destroyed and the paint has left white stains from point 5. Photo: Trøndelag Police District. Illustration: NSIA

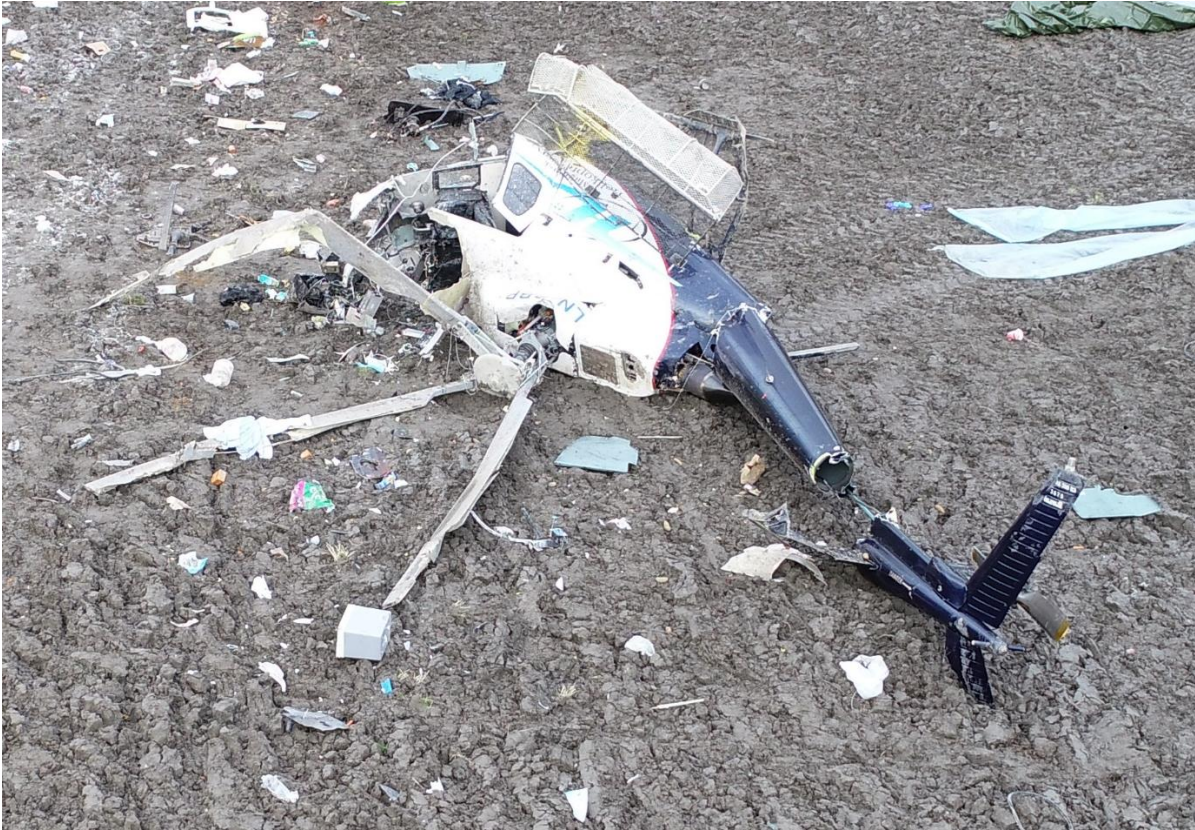
The helicopter wreckage was mostly contained in a small area, but a lot of the luggage had been spread out in front of the helicopter in a fan shape. All rotor blades were attached to the main and tail rotor. The cockpit of the helicopter was destroyed and the instrument panel had been knocked loose. The tail boom was not attached to the helicopter and was broken in two places. The fuel

tank had moved and all the fuel had leaked out through the fuel fill tube on the left-hand side. The helicopter was not fitted with a crash resistant fuel system, and this is not a requirement. If this had been the case it is likely that there would not be a fuel leak. There was generally more damage on the left-hand side of the helicopter than the right-hand side. The rotor head cover was dented and deformed with remnants of soil. The front section of the cabin floor was pressed upwards. All the seats were still attached and only sustained minor damage. Both cockpit doors and the sliding door on the left-hand side had detached. The front part of the right skid had broken off while the entire left skid had broken off.

Figure 17: The helicopter wreckage seen towards the west. Photo: NSIA

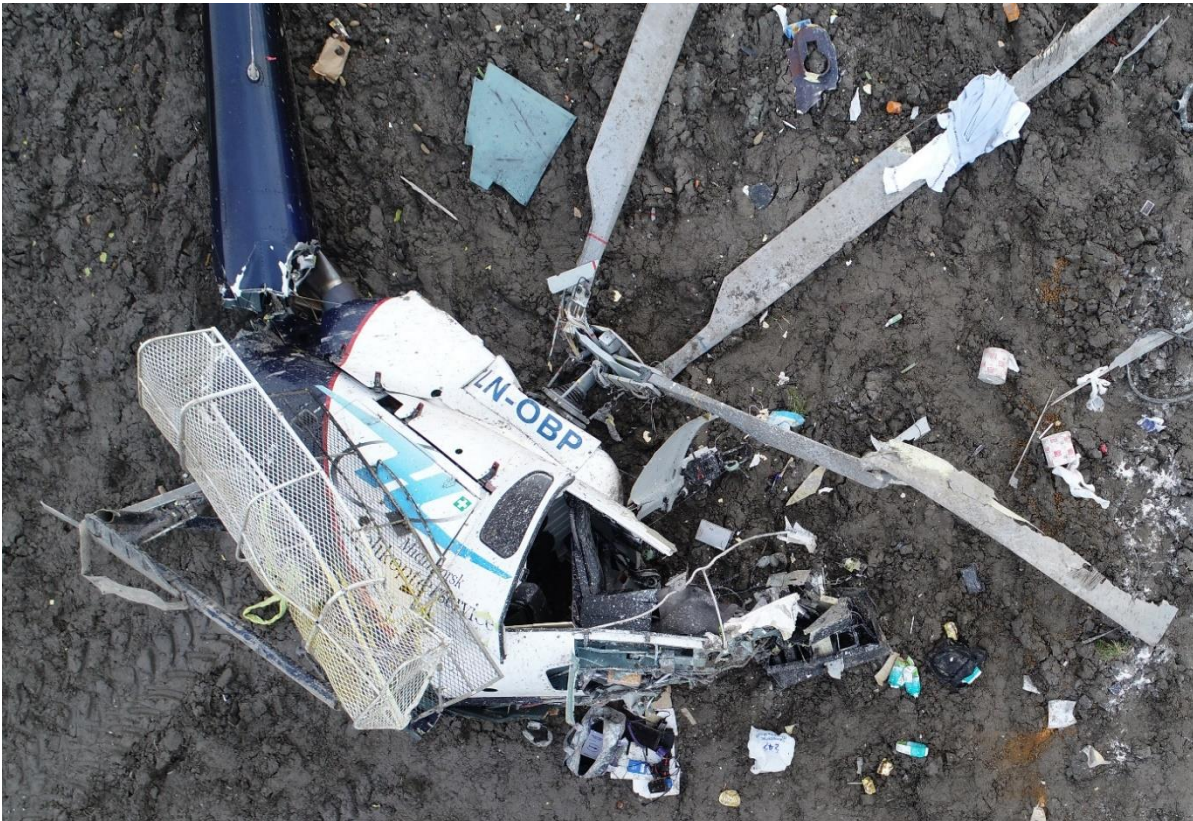
Figure 18: The helicopter wreckage seen from above. The floor of the cockpit is pressed upwards at about 30 degrees. Photo: NSIA

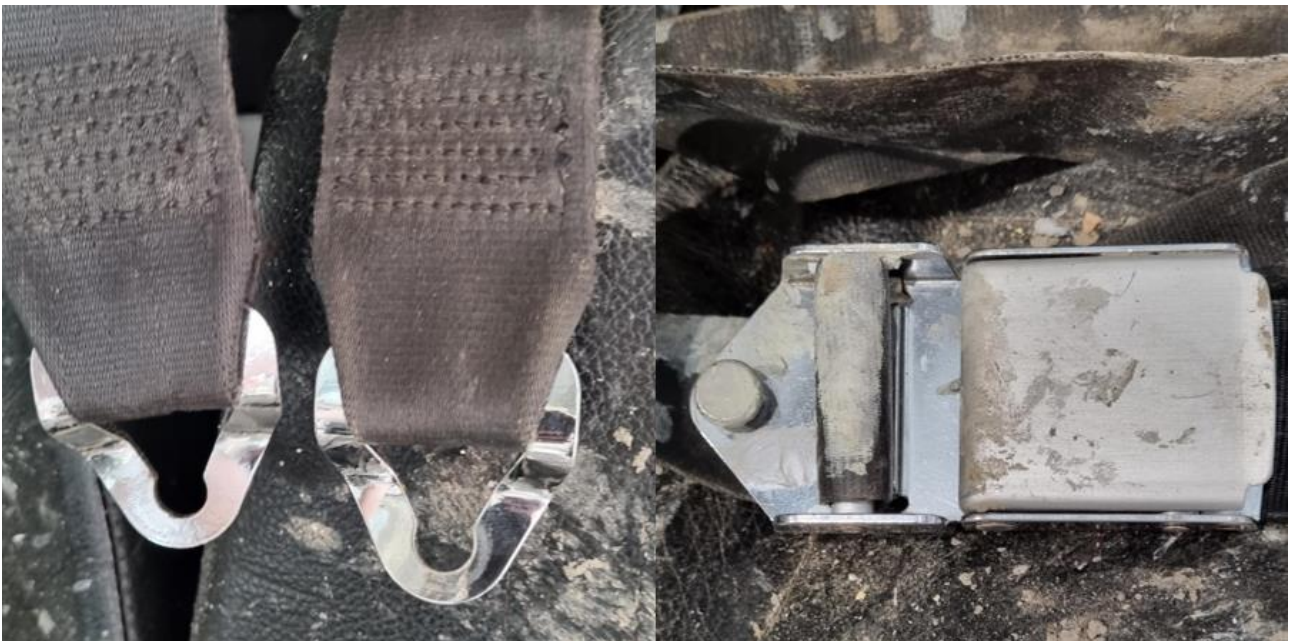
The passenger in the rear seat had a three-point safety harness. Findings in the helicopter indicate that the diagonal shoulder strap was not in use, see Figure 19. The NSIA cannot determine how the lap strap was fastened. The passenger ended up partly outside the helicopter and was stuck under the wreckage. Rescue workers had to lift the helicopter and cut the safety belt to free the passenger. The seat sustained insignificant damage. The passenger also sat next to significant amounts of unsecured cargo, see Figure 6. The cargo was found in a fan shape in front of the helicopter, see Figure 16. The unsecured cargo which was placed on the right-hand side of the helicopter must have moved to the left during the crash.

Figure 19: Foto of the safety harness of the passenger in the rear seat. There are no signs of paint on the shoulder strap, while a lot of paint can be seen on the lap strap. Both shoulder straps which are mounted in the same fixture was investigated to see if the passenger had used the wrong shoulder strap. Photo: NSIA

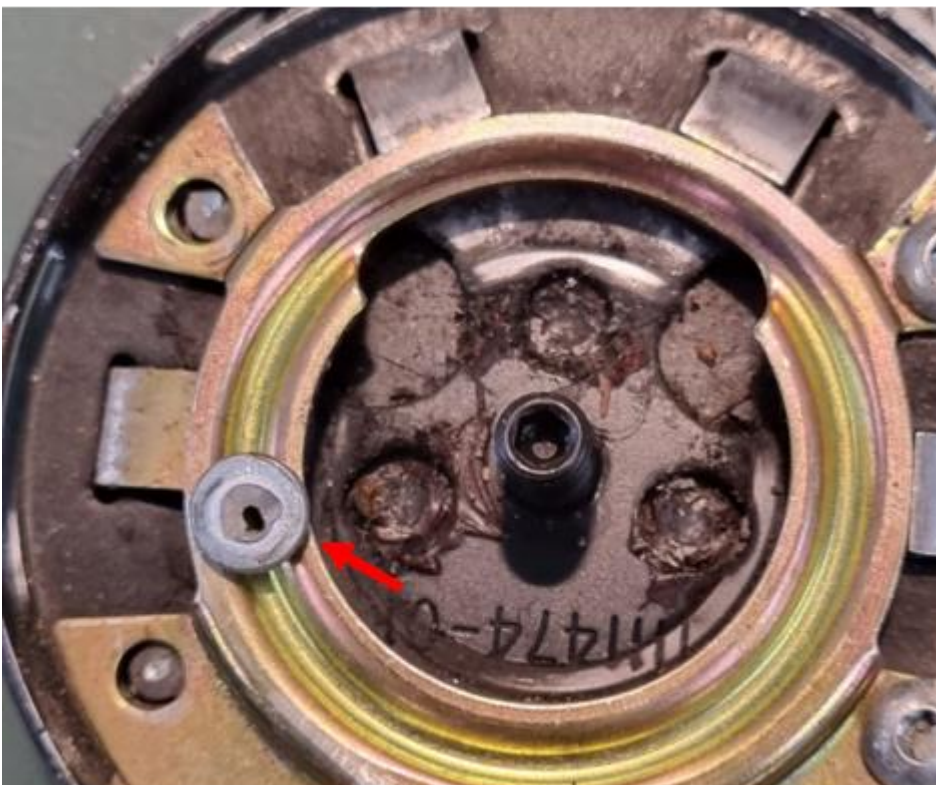
The rotary buckle was brought to the Norwegian Defence Laboratories (FOLAT) for closer examination. Parker-Meggitt was present during the examinations, which found that at least 3 out of 4 screws were subject to hydrogen embrittlement, see Figure 23. Both screws on the right-hand side (in the direction of travel) had fractured. One of the screws had lost its screw head before the accident, while the other probably had a pre-existing crack and fractured during the accident. When these screws fractured, the belt could displace the thrust plate that held the belts in place, which meant they could become undone.

The screws that keep the rotary buckle together are zinc-plated steel screws, see Figure 20 and Figure 21. As part of the production process, the screws have to be baked at a high temperature after the plating to prevent hydrogen embrittlement¹³. The way the subcontractor performed this process meant that not all the screws were heated enough to diffuse out the hydrogen. This led to some of the screws undergoing hydrogen embrittlement and therefore fracturing when torqued. The production of rotary buckles was stopped, and all buckles already manufactured were inspected. Due to the incident in 2012, Parker-Meggitt chose to change the screw material to stainless steel in 2013, which eliminated the problem of hydrogen embrittlement.

Figure 22: The passenger's rotary buckle. The two screws on the right-hand side (in the direction of travel) had fractured at the root of the screw heads. The screw head of the top screw was found inside the rotary buckle (marked with red arrow). The lower screw was missing its screw head. Photo: NSIA

issued two safety bulletins (SB 1111548-25-001-2023 and SB 1111475-25-001-2023) informing customers about the issue and how to correct it. The FAA and EASA has informed the NSIA that they will issue Airworthiness Directives, which make the correction mandatory. The NSIA therefore does not issue any safety recommendation about this.

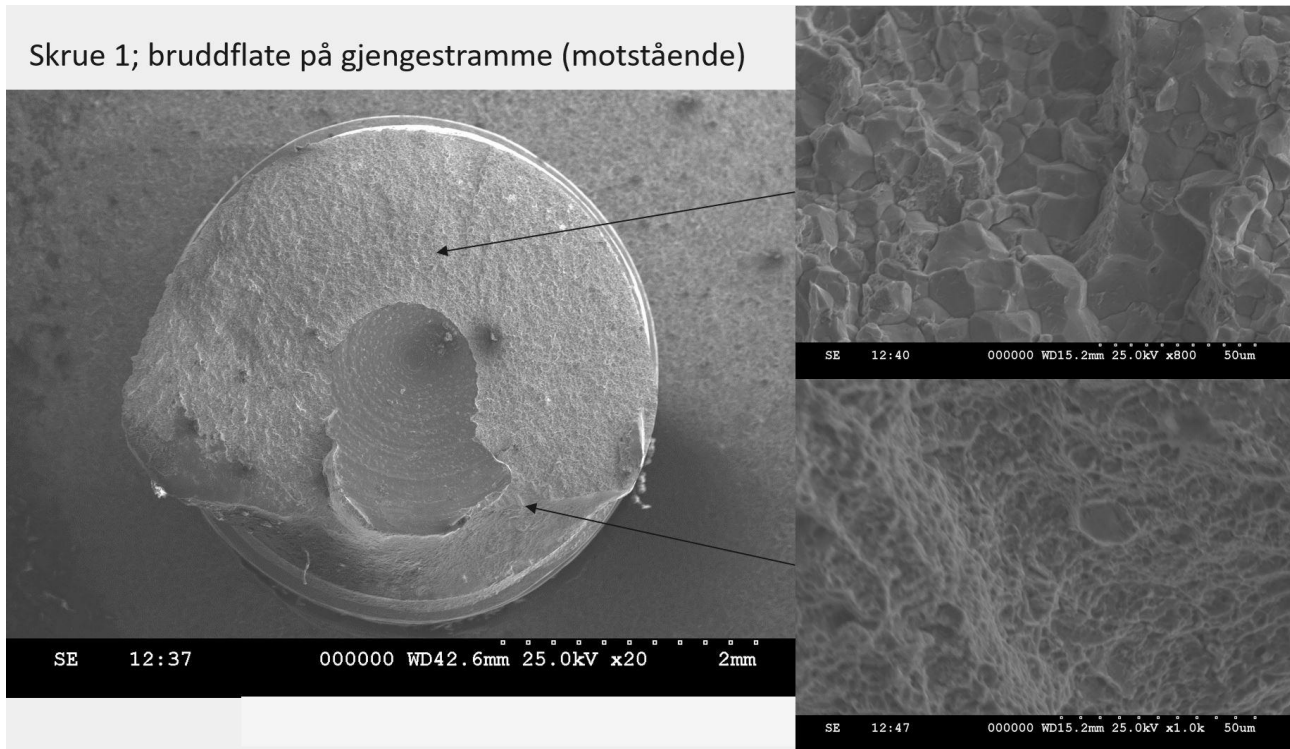
Figure 23: Microscope image of the threaded rod of the top screw. The two smaller images show different fracture mechanisms. The top shows hydrogen embrittlement where the different grains are visible. The lower is a ductile overload fracture with dimples. Image: FOLAT / NSIA
