REPORT AVIATION 2024/01

Serious incident at Bryne in Rogaland county, Norway, 25 October 2022 with Airbus Helicopters AS 350B3, LN-OGN operated by Helitrans AS

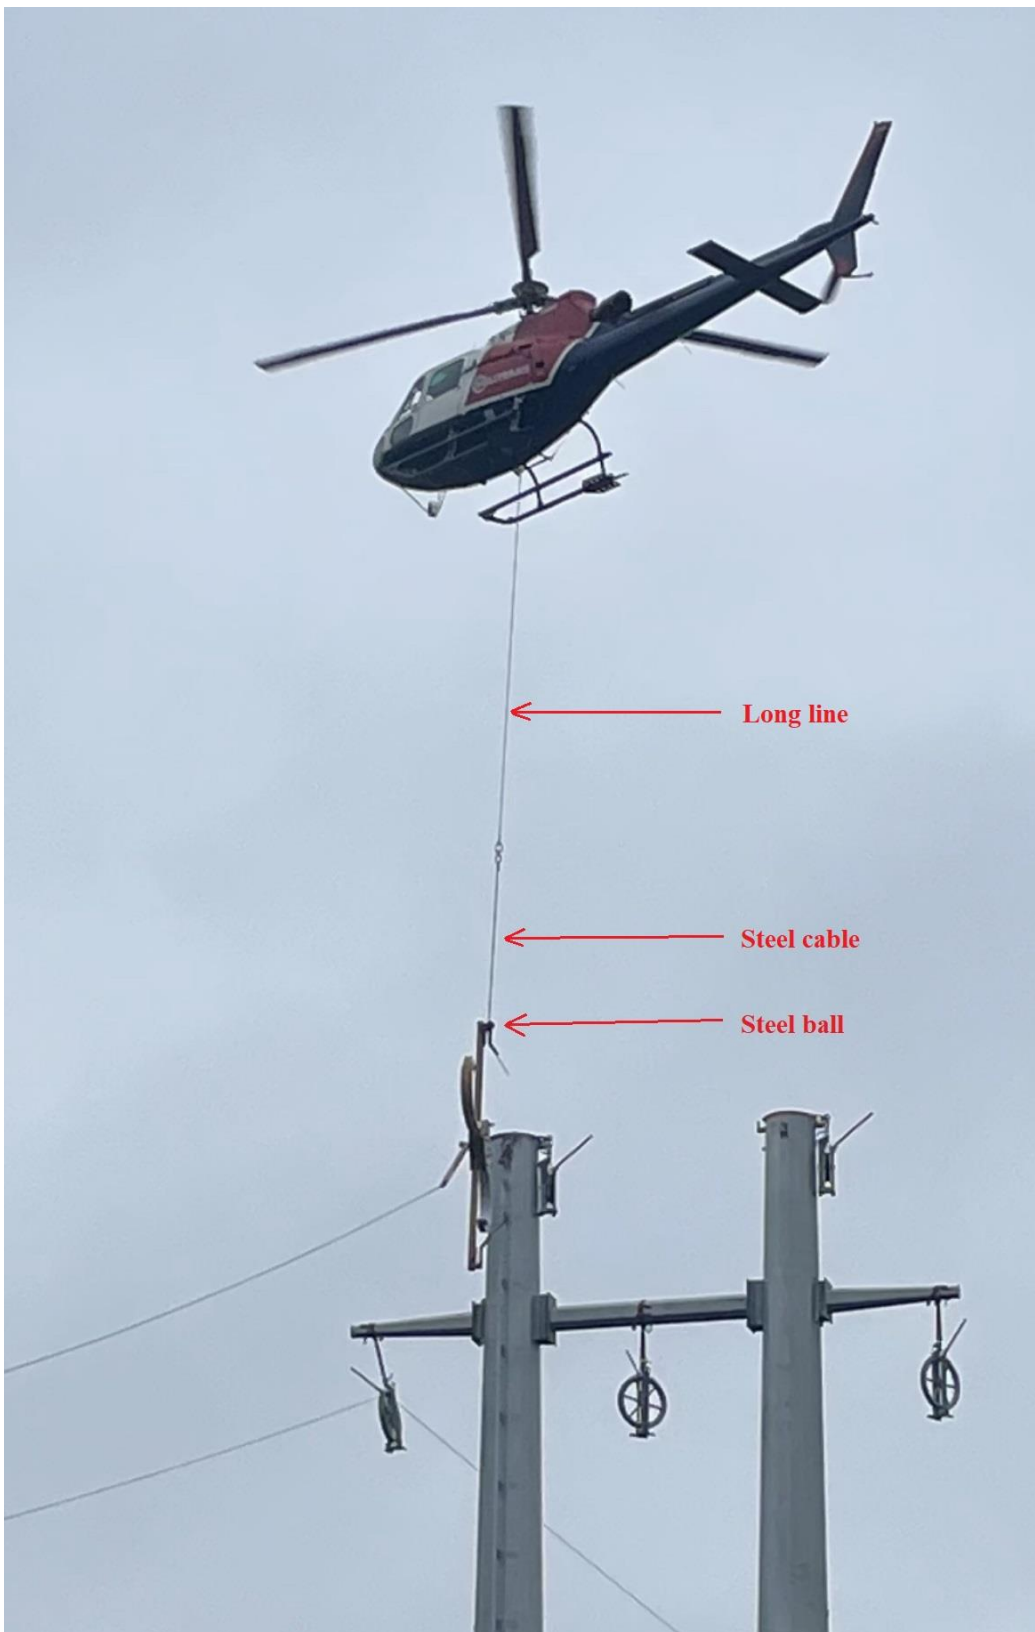
Helitrans AS had a contract with the energy company Eviny in connection with the construction of a 9 km long 132 kV power line from Opstad in Ålgård to Håland at Bryne. The masts were already erected, and on the day in question, work was scheduled to begin installing the power lines. Each mast consisted of two approximately 22 meter high poles with a crossbeam between them. The mast was to have five lines, one of which was to hang under the crossbeam between the poles, and one line under each end of the crossbeam (see figure 1). The remaining two lines were to be suspended at the top of the poles.

Figure 1: An illustration of the tool with the connected pilot line hanging under the helicopter. A pilot line is already installed on the left end of the crossbeam. At the photo the helicopter is approaching the crossbeam where the tool is to be hung. The photo was not taken in connection with the incident and shows a somewhat different connection between the tool and the helicopter. Photo: Helitrans/SHK

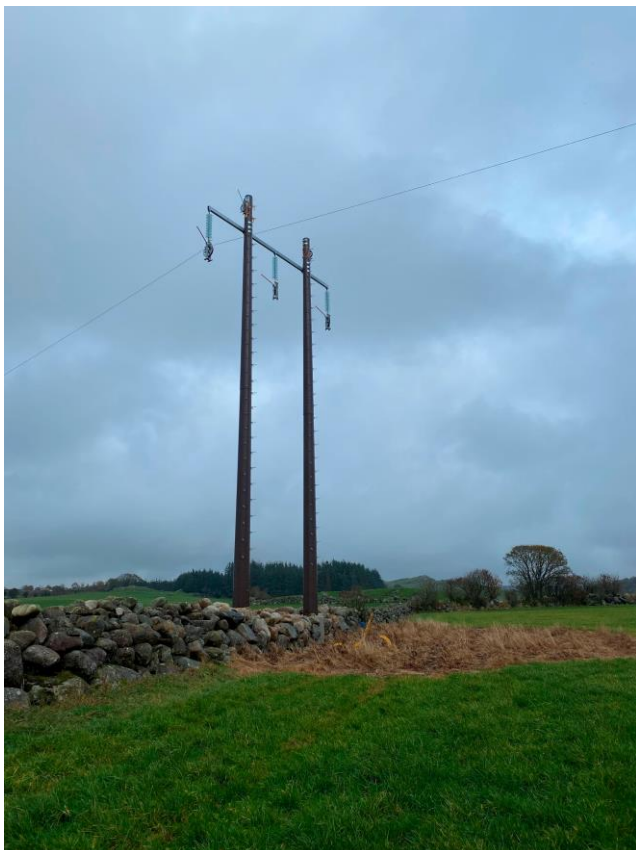
At the first mast the pilot line jammed in the pulley, and work had to be paused until the line was freed. Stringing then proceeded normally until the third mast. The Commander was in the process of hanging the tool on the crossbeam when the helicopter suddenly started to move uncontrollably. He dropped the line including the tool a second before the helicopter struck the top of a pole with the right skid (see figure 2). However, the Commander regained control and landed.

A cover on top of one of the poles was damaged during the incident. The tool, along with the line and steel cable, fell into soft marshy soil next to the mast and was not damaged.

Figure 2: The actual mast where the incident happened. Photo: Helitrans/NSIA

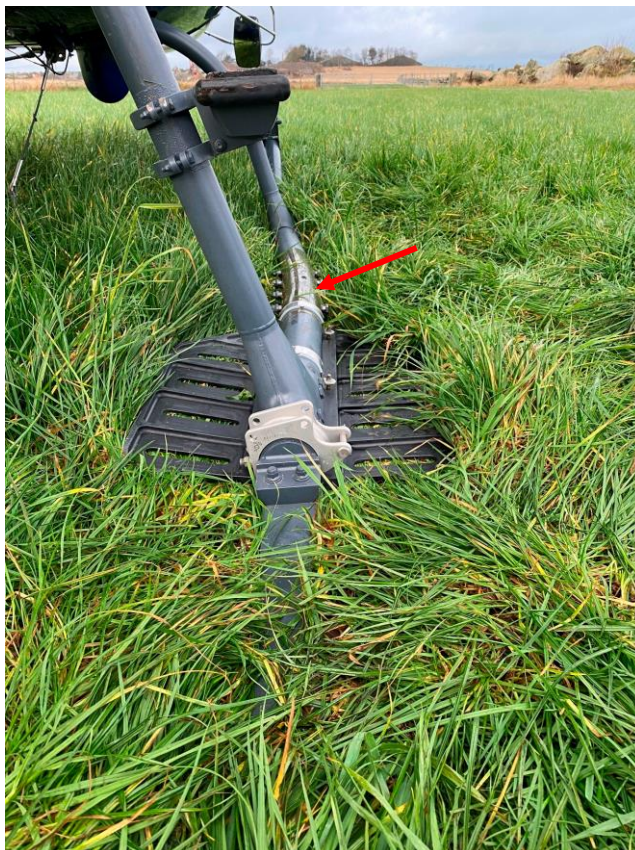
After landing, it was found that the right skid had been bent outward between the landing gear x-tubes (see Figure 3). Helitrans AS found no other damage or faults with the helicopter before it was put into operation again.

Figure 3: The right skid. The red arrow is pointing towards the bend: Photo: Helitrans/NSIA
